3D characterisation of RCF crack networks

Johan Ahlström, Casey Jessop, Lars Hammar and Christer Persson

Abstract. Rolling contact fatigue (RCF) damage is becoming more frequent with increased traffic and loading conditions in the railway industry. Defects which are characterized by a two-lobe darkened surface and a V-shaped surface-breaking crack are often so-called squats. The origination and propagation of squats in railway rails is the topic of many recent studies; the associated crack networks develop with complicated geometry near the surface of rails that is difficult to characterise using most non-destructive methods. The cracks can be examined with repeated metallographic sectioning, but the process is time-consuming and destructive. In order to reduce time, as well as information and material loss, high-resolution and high-energy X-ray imaging of railway rails was done in the current study. Combining the exposures from a range of angles using image analysis, a 3D representation of the complex crack network is achieved. The latter was complemented with metallographic sectioning to determine the accuracy of prediction of the geometrical reconstruction.

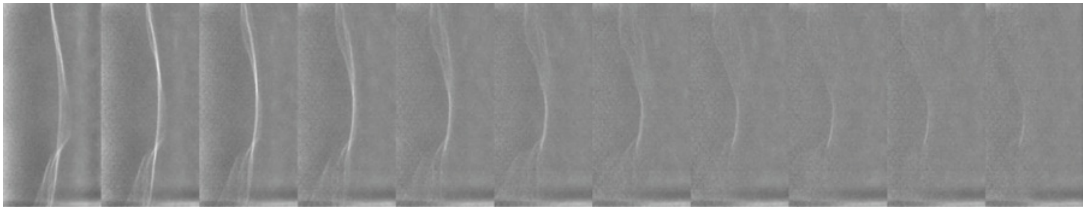
Figure 1. Series of pictures exposed at different angles from +80—+60 degrees relative to the rail head normal.

Figure 1 shows a compiled picture of one squat showing the different angles of exposure from +80 – +60 degrees relative to the rail head normal. It is evident that the relation between the angle of exposure and the crack plane is critical for the visibility of the crack.
