## **Recreation of cultural historical values in buildings from before 1945: Inventory with focus on building physics performance**

# Recreation of cultural historical values in buildings from before 1945: Inventory with focus on building physics performance

JOHANSSON Pär<sup>1,a\*</sup> and WAHLGREN Paula<sup>1,b</sup>

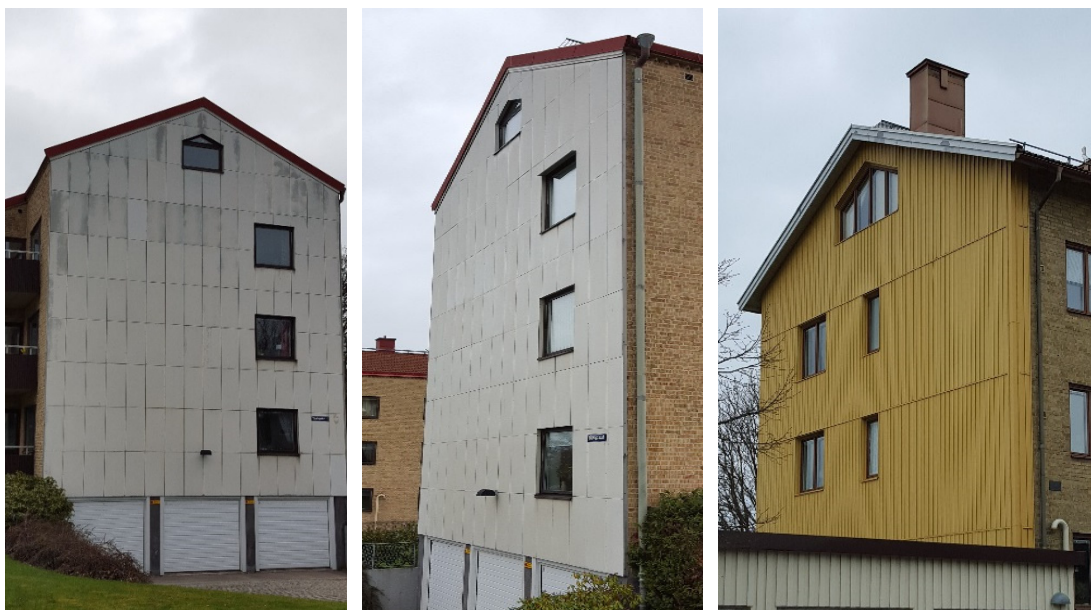
The façades facing south are overrepresented when it comes to additional insulation. This is in particular common when there are few windows in the south façade. This is probably due to the fact that Gothenburg has a large amount of driving rain with predominant direction from south/south-west. Driving rain often cause water leakage into the façades [13]. Furthermore, solar radiation can cause deterioration of the façade material, both due to UV-radiation and thermally induced stresses and the southern facades are very exposed in this respect. An example of two renovated façades facing south is shown in Figure 7.

Figure 7. Often the south façade is renovated. Examples of two different strategies where cementitious boards (left) and a metal cladding (right) were chosen on the south facade.

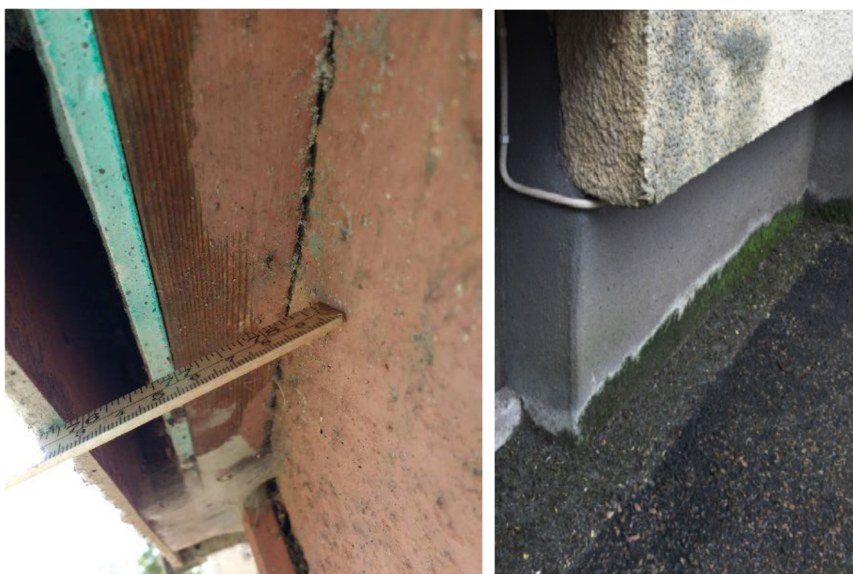
Façades that have insulation or a new rain barrier all the way to the ground, see Figure 8, are almost always damaged, with the exception of façades of concrete, brick or very thick plaster.

Figure 8. Example of two façades with additional insulation, seen from below.

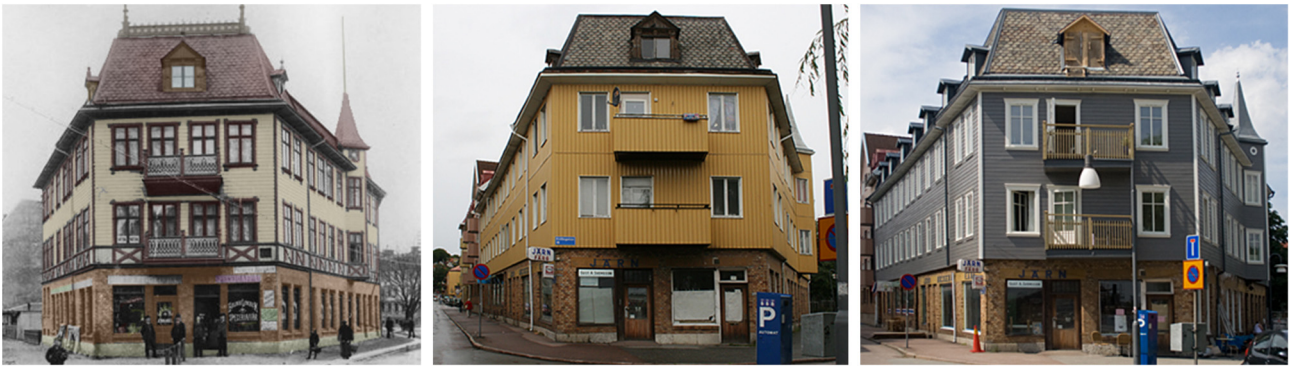
Concerning the rain barrier, wooden boards has been a common material in Swedish exterior walls. Due to durability and maintenance reasons, these are sometimes exchanged to other types of rain barriers, such as metal claddings, cementitious boards or plastic. In the inventory, façades with metal cladding were generally in good condition. However, in many cases there are problems with aesthetics but successful examples can also be found. New board materials and new wooden façades also have problems with the aesthetics. For the appearance of the façade it is preferable to use the original board width and profiles. In general, the best appearances are the ones stripped back to original design, the ones with a new exterior envelope and where original, imitations or similar looking materials have been used, see Figure 9. Attention to the detailing is very important to preserve the appearance.

Figure 9. Good example showing recreation of values on a building from the 1890s with initially one family on each floor and now containing 19 apartments (housing cooperative).
