Recreation of cultural historical values in buildings from before 1945: Inventory with focus on building physics performance

JOHANSSON Pär^{1,a*} and WAHLGREN Paula^{1,b}

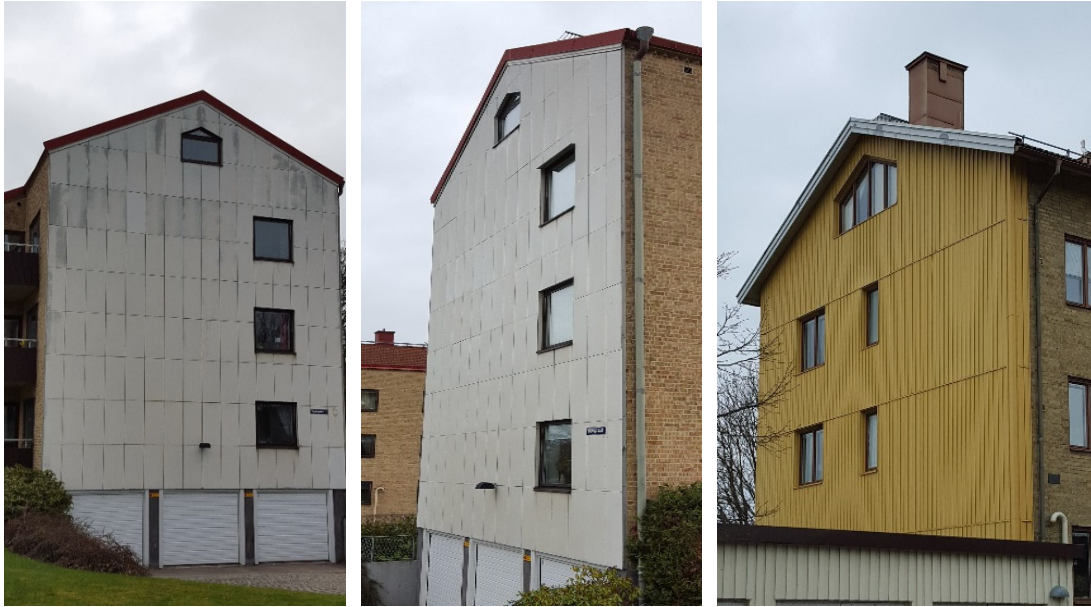
The façades facing south are overrepresented when it comes to additional insulation. This is in particular common when there are few windows in the south façade. This is probably due to the fact that Gothenburg has a large amount of driving rain with predominant direction from south/south-west. Driving rain often cause water leakage into the façades [13]. Furthermore, solar radiation can cause deterioration of the façade material, both due to UV-radiation and thermally induced stresses and the southern facades are very exposed in this respect. An example of two renovated façades facing south is shown in Figure 7.

Figure 7. Often the south façade is renovated. Examples of two different strategies where cementitious boards (left) and a metal cladding (right) were chosen on the south facade.

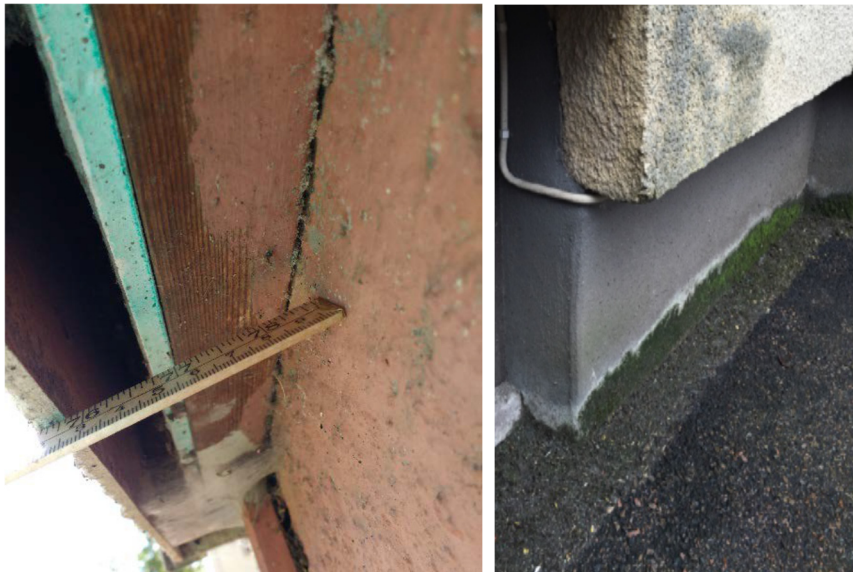
Façades that have insulation or a new rain barrier all the way to the ground, see Figure 8, are almost always damaged, with the exception of façades of concrete, brick or very thick plaster.

Figure 8. Example of two façades with additional insulation, seen from below.

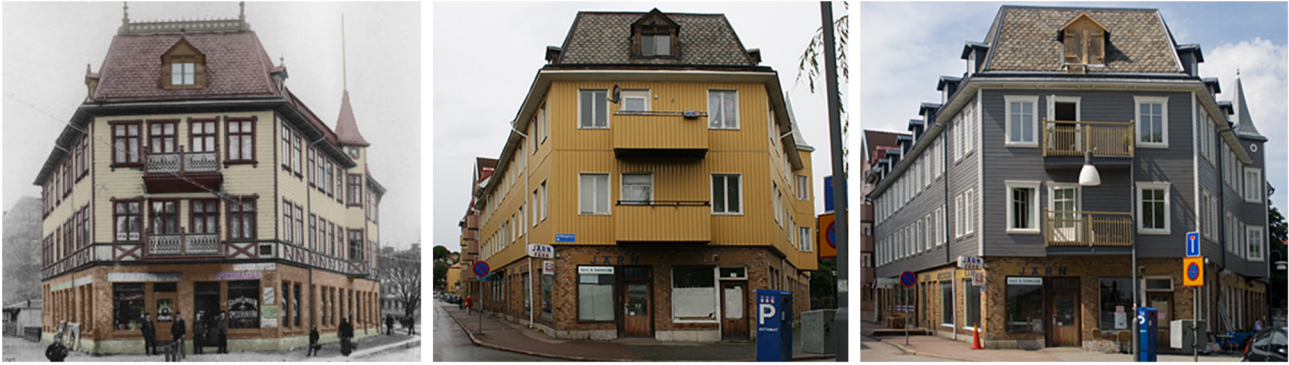
Concerning the rain barrier, wooden boards has been a common material in Swedish exterior walls. Due to durability and maintenance reasons, these are sometimes exchanged to other types of rain barriers, such as metal claddings, cementitious boards or plastic. In the inventory, façades with metal cladding were generally in good condition. However, in many cases there are problems with aesthetics but successful examples can also be found. New board materials and new wooden façades also have problems with the aesthetics. For the appearance of the façade it is preferable to use the original board width and profiles. In general, the best appearances are the ones stripped back to original design, the ones with a new exterior envelope and where original, imitations or similar looking materials have been used, see Figure 9. Attention to the detailing is very important to preserve the appearance.

Figure 9. Good example showing recreation of values on a building from the 1890s with initially one family on each floor and now containing 19 apartments (housing cooperative).
