Effect of Powder Recycling on the Fracture Behavior of Electron Beam Melted Alloy 718

EFFECT OF POWDER RECYCLING ON THE FRACTURE BEHAVIOR OF ELECTRON BEAM MELTED ALLOY 718

H. Gruber, P. Karimi, E. Hryha, L. Nyborg

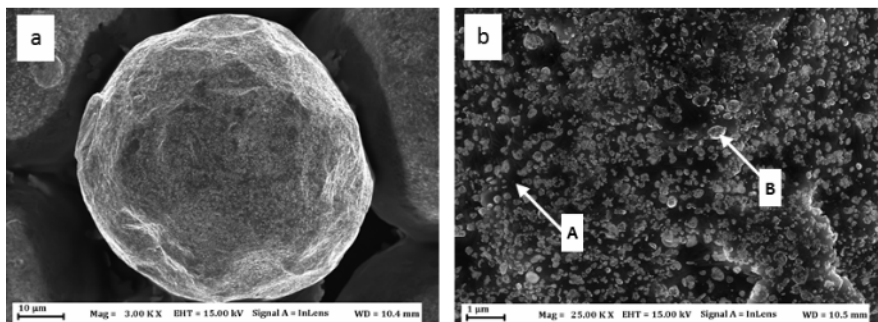
Fig.3. Surface morphology of the Alloy 718 powder after 14 re-use cycles. Corresponding EDX point analysis data are presented in Table 2.

Tab.2. EDX analysis data corresponding to analysis points in Fig.3b.

Location	Structure	Chemical composition								
			Ni	Cr	Fe	Nb	Mo	Ti	Al	O
A	Gamma matrix	wt.%	52.5	19.4	19.0	4.2	3.0	1.2	0.7	-
		at.%	51.6	21.5	19.8	2.6	1.8	1.4	1.4	
B	Aluminum-rich oxide	wt.%	36.7	15.3	14.5	3.6	2.0	1.5	13.2	13.2
		at.%	24.2	11.4	10.1	1.5	0.8	1.2	18.9	31.9

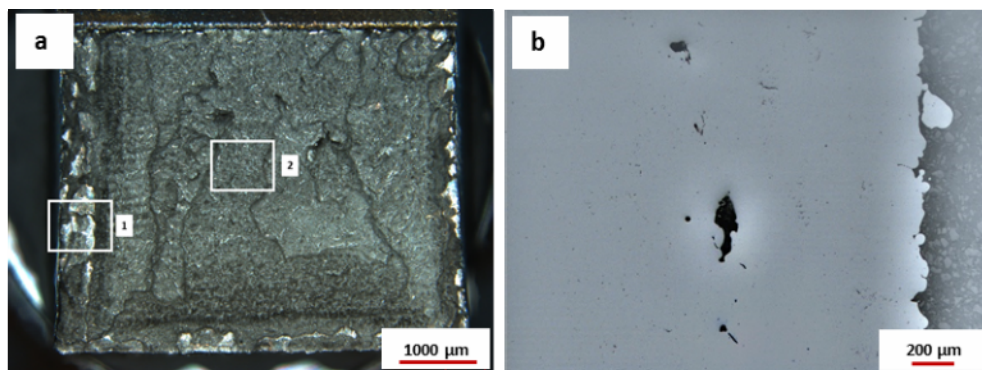
The fracture surface of a sample produced from virgin powder is shown in Fig.4a. On a macroscopic level, all investigated fracture surfaces had a similar overall appearance. They all showed only minor lateral expansion, which is an indication of a relatively brittle fracture. The fracture surface can be divided into two distinct regions – the core or bulk region of the sample, where a hatch exposure was performed, and the around 1 mm wide region along the surface edges which corresponds to the contour region (around 1,5 mm before machining). Macroscopically, the whole fracture surface is highly irregular and contains numerous ridges and depressions. Un-melted metal particles and secondary phases such as oxides were often observed in these sites, indicating damage initiation and crack front propagation along defect-containing weak interfaces. Similar observations have been done by, for example Deng et al. [8]. However, in that case presence of carbides and porosity was identified as a reason for the weak interfaces. At higher magnifications, as in Figure 5 and 6, it is realized that a large part of the areas close to and within the contour region consists of large, strikingly flat areas, partly covered with oxide films. As a consequence of the considerable amount of oxide phase on the surface of the re-cycled powder, the oxide covered areas in the samples produced from re-cycled powder (Fig.6) are significantly larger, as compared to the samples produced from virgin powder (Fig.5). Also in these areas, presence of un-melted powder particles and non-metallic phases indicate that many of these defects originate from both insufficient melting (lack of fusion) and/or weak bonding between non-metallic phases (oxide and nitride) and matrix material. Also in metallographic samples, larger sized defects preferentially located to the sample edges identify a high defect density close to or within the contour region, as shown in Fig.4b. In both cases, secondary phase particles such as Al-rich oxide and Ti-rich nitride are often spotted in the oxide-covered areas, as can be seen in Fig.5b. Corresponding qualitative chemical analysis measured by EDX analysis is presented in Table 3. The macroscopically rough topography in combination with the large fraction of defects suggests an intergranular type of failure, through crack propagation along weak interfaces, to be the main fracture mechanism close to or within the contour region. Due to the brittle nature evidenced by the widespread defect areas in this region, its contribution to the overall material toughness is most likely very small.

Fig.4. (a) Fracture surface of a CVN test sample produced from virgin powder. Denoted regions are further presented in Figs. 5 and 7, respectively. (b) Metallographic cross section of a sample produced from virgin powder showing large defects along sample edges.

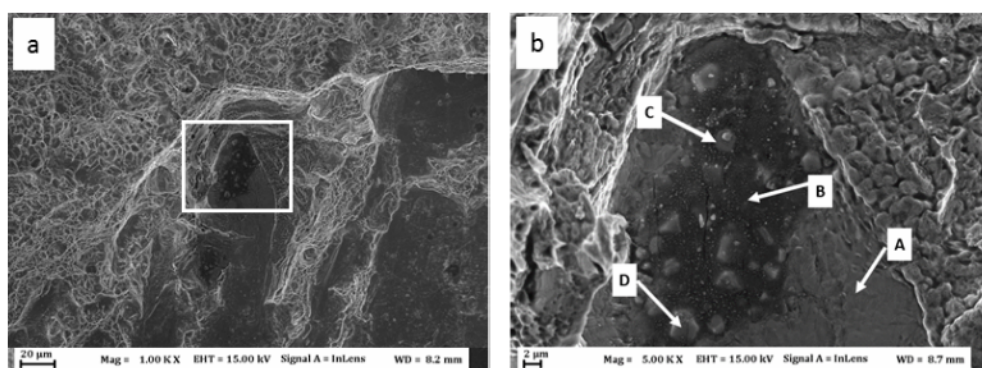
Fig.5. (a) Contour region on the fracture surface of a CVN test sample produced from virgin powder. (b) Higher magnification of denoted region showing oxide covered area with the presence of non-metallic particles. Corresponding EDX analysis data are presented in Tab.3.

Table 3. EDX analysis data from areas in Fig.5b.

Location	Structure	Chemical composition									
			Ni	Cr	Fe	Nb	Mo	Ti	Al	N	O
A	Gamma matrix	wt. %	51.6	18.7	19.2	5.3	3.1	1.3	0.8	-	-
		at. %	50.9	20.8	19.9	3.3	1.9	1.6	1.7	-	-
B	Al-rich oxide film	wt. %	1.1	1.2	0.7	-	-	9.7	44.1	-	43.2
		at. %	0.4	0.5	0.3	-	-	4.4	35.6	-	58.8
C	Al-rich oxide particle	wt. %	10.7	5.4	4.1	5.0	-	10.8	31.7	-	32.3
		at. %	4.8	2.7	1.8	1.4	-	5.9	30.7	-	52.7
D	Ti-rich nitride particle	wt. %	1.8	0.7	0.7	5.0	-	74.2	0.6	13.4	3.4
		at. %	1.1	0.5	0.5	1.9	-	54.3	0.8	33.5	7.4

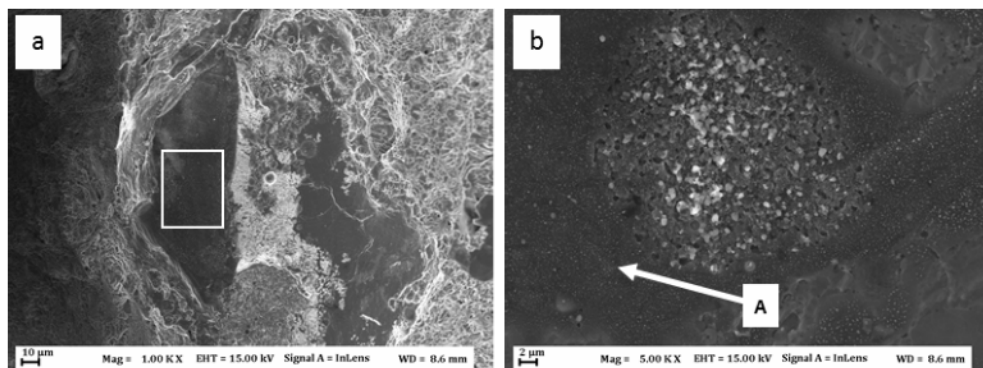
Fig.6. (a) Contour region on the fracture surface of a CVN test sample produced during cycle 14. (b) Higher magnification of denoted region showing oxide covered area. Composition in point A is almost identical to point B in Fig.5b.

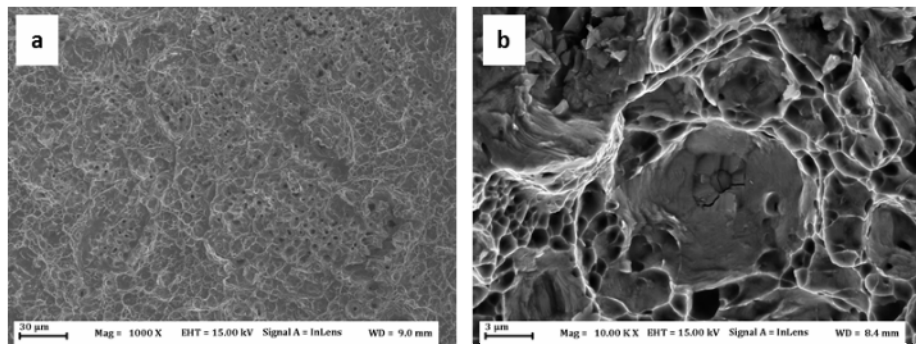
Figure 7 shows the fracture surface in the hatching region of a sample produced from virgin powder. Generally, it consists of fairly equiaxed dimples, indicating ductile failure occurring through microvoid coalescence. Residual porosity, TiN and oxide particles, acting as micro-void nucleation sites were occasionally observed inside the dimples. In Figure 8, the corresponding images from a sample produced from recycled powder show presence of aluminum-rich oxide clusters (denoted area in Figure 8a) sizing up to around 50 μm . It is realized that the size and shape of the individual oxide particulates are very similar to the particulates observed on the recycled powder surface (Figure 3b). However, whether these particles are directly transferred from the powder feedstock or rather re-nucleated and clustered together in the melt pool has to be further elaborated. As already mentioned, weak bonding between oxide and metal and also different elastic properties may result in de-bonding and subsequent coalescence of the voids formed under tensile loading. Even though considerable amounts of defects were present in these samples, a major part of the fracture surfaces has dimple character. This shows that a considerable amount of plastic deformation took place during fracture, indicating an overall ductile fracture in a large portion of the sample. Anyhow, it is well known that that presence of agglomerates of non-metallic particles can have a significant negative effect on fatigue properties. Smaller sized agglomerates, similar to those observed in the hatch regions, may act as crack initiation sites in the high to very high cycle regime [11], whereas larger sized inclusions (preferentially observed close to the contour region) has been reported to be the main cause for fatigue life scattering in the low cycle regime [12]. Therefore, the larger amount of mainly oxide-containing defects in the samples produced from recycled powder shows that powder recycling may have a negative effect on the cleanliness and therefore also on the structural integrity of EBM processed Alloy 718, especially under dynamic loading. Hence, further research is needed to increase the knowledge about imperfections in AM built components, concerning both defect formation and their effects at different loading conditions, preferably using more sophisticated techniques such as fracture toughness and/or fatigue testing.

Fig.7. Hatching region on the fracture surface of a CVN test sample produced from virgin powder.

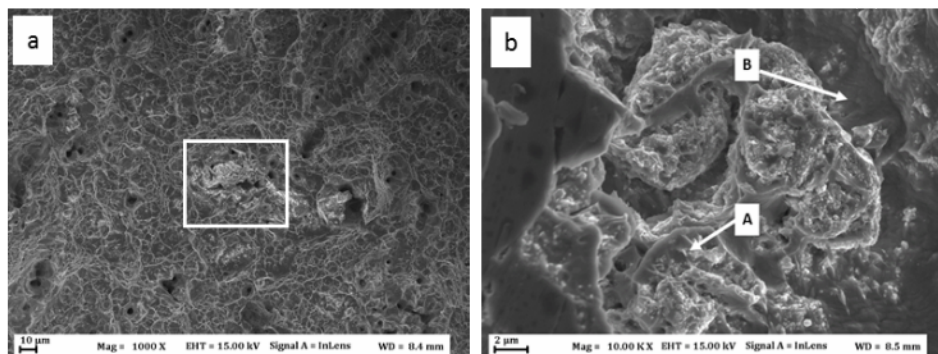
Fig.8. (a) Hatching region on the fracture surface of a test sample produced during cycle 14. (b) Higher magnification of denoted region showing aluminum rich oxide cluster. Corresponding EDX analysis data are presented in Table 4.

Tab.4. EDX analysis data from the areas in Fig.8b.

Location	Structure		Chemical composition,							
			Ni	Cr	Fe	Nb	Mo	Ti	Al	O
A	Aluminium-rich oxide	wt.%	19.4	8.5	7.9	3.4	2.1	2.1	25.5	31.2
		at.%	9.1	4.5	3.9	1.0	0.6	1.2	26.1	53.7
B	Gamma matrix	wt.%	51.8	19.4	19.4	4.7	2.8	0.9	1.0	-
		at.%	50.7	21.4	20.0	2.9	1.7	1.1	2.1	-
