8th CIRP Conference on High Performance Cutting (HPC 2018)

# Study of flank wear topography and surface-deformation of cemented carbide tools after turning Alloy 718

Philipp Hoier\*, Amir Malakizadi, Peter Krajnik, Uta Klement

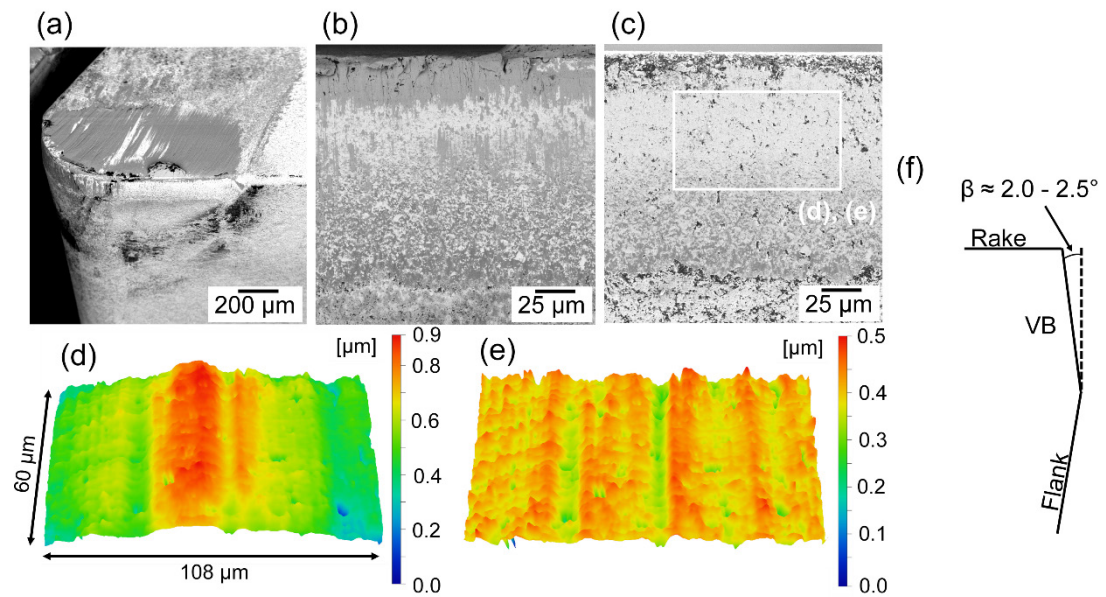
Fig. 1. Worn cutting edge after the conducted tests: (a) tilted overview; flank wear land at higher magnification (b) before and (c) after etching in HCl; 3D topography of the flank wear land obtained by WLI (d) before and (e) after filtering for removal of waviness; schematic cross-sectional view of the flank wear land (VB) with its inclination angle ( $\beta$ ). The workpiece sliding direction during cutting is from top to bottom.

Figure 1 shows SEM micrographs of one of the worn tools before (Fig. 1a and b) and after (Fig. 1c) the etching procedure for removal of adhered Alloy 718 from the worn surfaces. As seen in Fig. 1a, the majority of the chip contact-zone on the rake face and parts of the flank wear land are subjected to

adhesion of Alloy 718 (dark contrast). Removal of adhered workpiece material is therefore necessary to reveal the true wear topography. As seen in Fig. 1c, etching in HCl led to removal of the majority of adhered workpiece material from the flank wear land. In Figs. 1d and e, WLI scans of the adhesion free flank wear land are shown. The 3D topography image (Fig. 1d) reveals large-scale waviness, whereas grooves on smaller scale are evident in Fig. 1e together with pits in the worn surface. Note that the grooves are aligned parallel to the workpiece sliding direction. The WLI scan furthermore revealed that the surface of the flank wear land is vertically inclined by around 2 to 2.5 ° (see schematic in Fig. 1f).

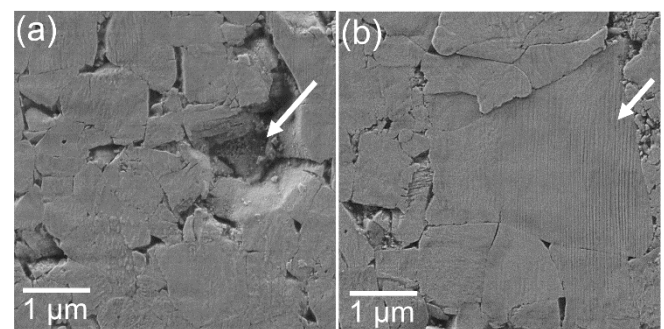
Fig. 2. Wear topography viewed at high magnification: (a) pit in flank wear land; (b) abrasion marks on WC grain. The sliding direction of the workpiece is from top to bottom.

Figure 2 shows the flank wear topography imaged at higher magnification. Figure 2a shows a SEM micrograph of a pit which was previously revealed by WLI (Fig. 1). Such pits can be formed due to adhesion and subsequent pull-out of individual WC grains. The WC grains are smoothly worn with occasional presence of nm-sized abrasion marks or grooves (see arrow in Fig. 2b) aligned parallel to the sliding direction.

Smoothly worn WC grains together with presence of grooves at different length scales (see Figs. 1e and 2) indicate that abrasion is an active wear mechanism. This is likely due to presence of different hard, abrasive phases (nm and  $\mu\text{m}$ -sized, see section 2) in the superalloy microstructure. However, both the large-scale waviness and inclination of the flank wear land (Figs. 1d and e) indicate that the tool geometry was altered by plastic deformation of the tool material.

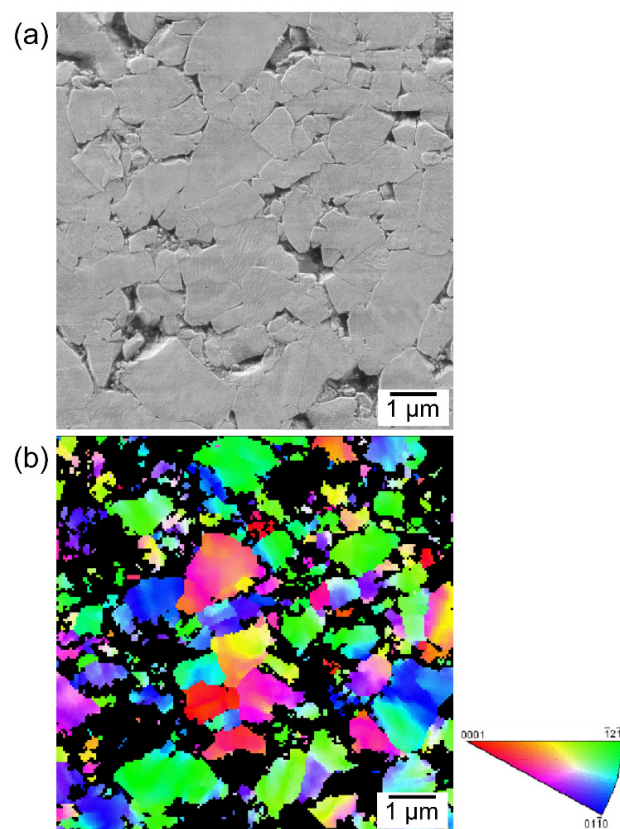
EBSD examination was performed to observe whether plastic deformation contributes to the flank wear. Figure 3 shows a SEM micrograph combined with an EBSD orientation map of the same area. The EBSD map is displayed in inverse pole figure (IPF) coloring. For every measured point (pixel), the local crystallographic orientation of the respective worn WC grain is shown according to the provided color code.

Even though the EBSD orientation map in Fig. 3b has a significant fraction of non-indexed (black) areas, many individual WC grains are clearly distinguishable (compare to SEM micrograph). Non-indexed areas can mainly be attributed to the voids present in the worn surface. Additionally some of the WC surfaces could not be indexed. However, the indexed, individual WC grains are characterized by noticeable color variations (see Fig. 3b) which indicate crystallographic orientation spread (misorientation) and hence that the worn grains exhibit intragranular strain. Note that an undeformed grain would be shown with a single color.

Fig. 3. Characteristics of flank wear land: (a) SEM micrograph of worn WC grains; (b) corresponding EBSD scan presented as inverse pole figure map (non-indexed pixels appear in black). The workpiece sliding direction during cutting was from top to bottom. The inverse pole figure color code is provided on the right.

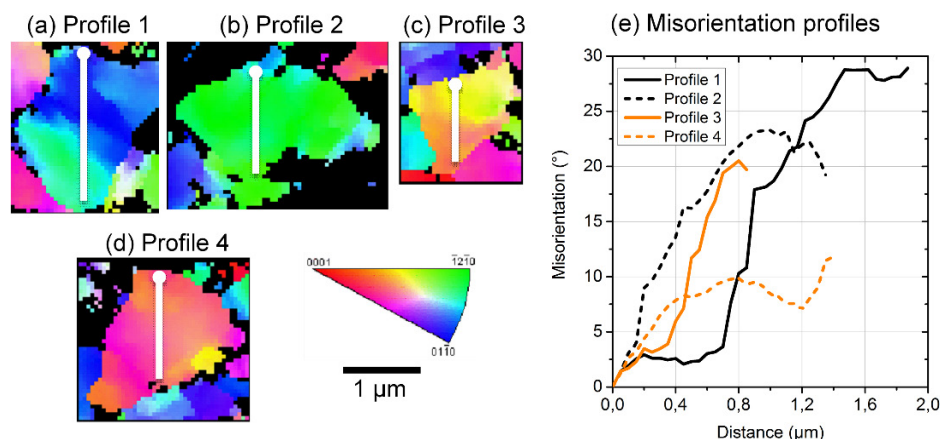
A more detailed representation of intragranular strains of some WC grains is provided in Fig. 4. Here, EBSD orientation maps (IPF coloring) of four worn WC grains (Figs. 4a-d) are shown, with lines indicating the locations of misorientation profiles parallel to the sliding direction of the workpiece during cutting. The misorientation profiles plotted versus distance are provided in Fig. 4e. It can be seen that misorientations of about 10 to 30° relative to the first points of the profiles are measured. Similar observations were made on misorientation lines within a total of 15 grains.

Intragranular misorientation is likely to be caused by plastic deformation induced during machining. Even though WC is generally considered brittle, it has been shown to deform plastically during tribological testing by means of scratch

The large misorientations in worn WC grains therefore imply that the individual grains as well as the complete network of WC grains on the cutting edge undergo plastic deformation under such machining conditions. The degree of plastic

Fig. 4. Examples of intragranular strain present in worn WC grains: (a)-(d) inverse pole figure maps with locations of misorientation profiles indicated; (e) plot of misorientation profiles relative to the first points of the lines (indicated by dot in (a) to (d)).

deformation may vary with the composition/amount of metal binder and WC grain size. This is of vital importance, as a significant plastic deformation of the cutting edge can, for instance, change the thermo-mechanical condition around the edge and thereby the wear rate due to other mechanisms such as abrasion, adhesion and diffusion/dissolution. For example, an investigation by Thomsen et al. [15] indicated a significant increase in thermal and mechanical loads on the flank wear land when a ground tool with 1° flank inclination angle is used. Note here that their flank surface was inclined in the same manner as observed in the present study (see Fig. 1f). If occurring locally, such geometrical changes may explain the previously reported unstable flank wear development when turning Alloy 718 [7].
