8th CIRP Conference on High Performance Cutting (HPC 2018)

# Study of flank wear topography and surface-deformation of cemented carbide tools after turning Alloy 718

Philipp Hoier\*, Amir Malakizadi, Peter Krajnik, Uta Klement

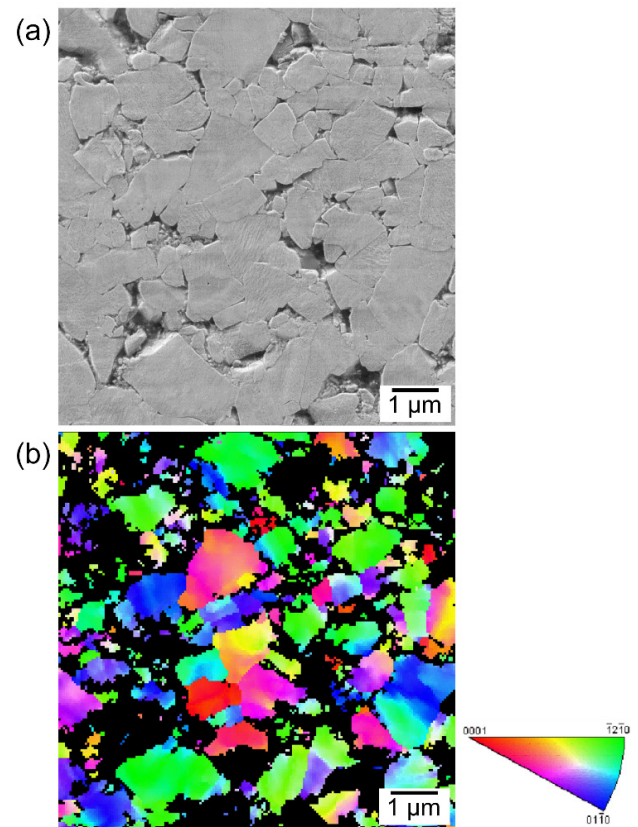
EBSD examination was performed to observe whether plastic deformation contributes to the flank wear. Figure 3 shows a SEM micrograph combined with an EBSD orientation map of the same area. The EBSD map is displayed in inverse pole figure (IPF) coloring. For every measured point (pixel), the local crystallographic orientation of the respective worn WC grain is shown according to the provided color code.

Even though the EBSD orientation map in Fig. 3b has a significant fraction of non-indexed (black) areas, many individual WC grains are clearly distinguishable (compare to SEM micrograph). Non-indexed areas can mainly be attributed to the voids present in the worn surface. Additionally some of the WC surfaces could not be indexed. However, the indexed, individual WC grains are characterized by noticeable color variations (see Fig. 3b) which indicate crystallographic orientation spread (misorientation) and hence that the worn grains exhibit intragranular strain. Note that an undeformed grain would be shown with a single color.

Fig. 3. Characteristics of flank wear land: (a) SEM micrograph of worn WC grains; (b) corresponding EBSD scan presented as inverse pole figure map (non-indexed pixels appear in black). The workpiece sliding direction during cutting was from top to bottom. The inverse pole figure color code is provided on the right.

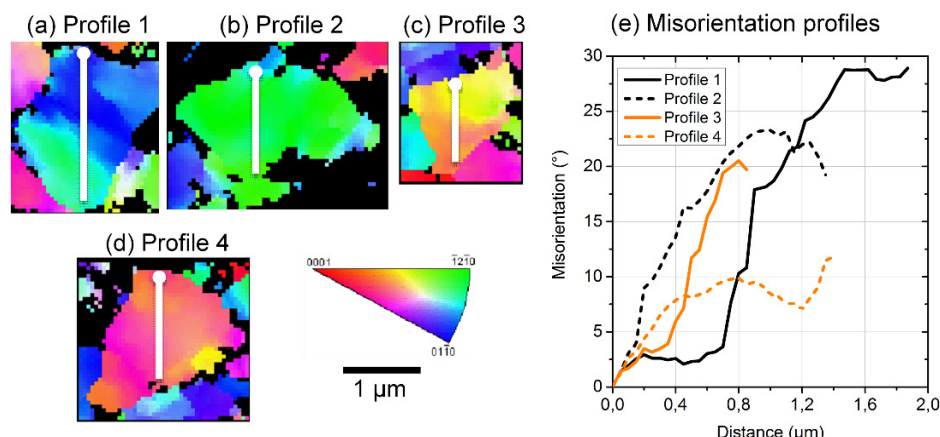
A more detailed representation of intragranular strains of some WC grains is provided in Fig. 4. Here, EBSD orientation maps (IPF coloring) of four worn WC grains (Figs. 4a-d) are shown, with lines indicating the locations of misorientation profiles parallel to the sliding direction of the workpiece during cutting. The misorientation profiles plotted versus distance are provided in Fig. 4e. It can be seen that misorientations of about 10 to 30° relative to the first points of the profiles are measured. Similar observations were made on misorientation lines within a total of 15 grains.

Intragranular misorientation is likely to be caused by plastic deformation induced during machining. Even though WC is generally considered brittle, it has been shown to deform plastically during tribological testing by means of scratch

The large misorientations in worn WC grains therefore imply that the individual grains as well as the complete network of WC grains on the cutting edge undergo plastic deformation under such machining conditions. The degree of plastic

Fig. 4. Examples of intragranular strain present in worn WC grains: (a)-(d) inverse pole figure maps with locations of misorientation profiles indicated; (e) plot of misorientation profiles relative to the first points of the lines (indicated by dot in (a) to (d)).
