Damage and defects in railway materials:

Influence of mechanical and thermal damage on crack initiation and propagation

CASEY JESSOP

CHALMERS UNIVERSITY OF TECHNOLOGY

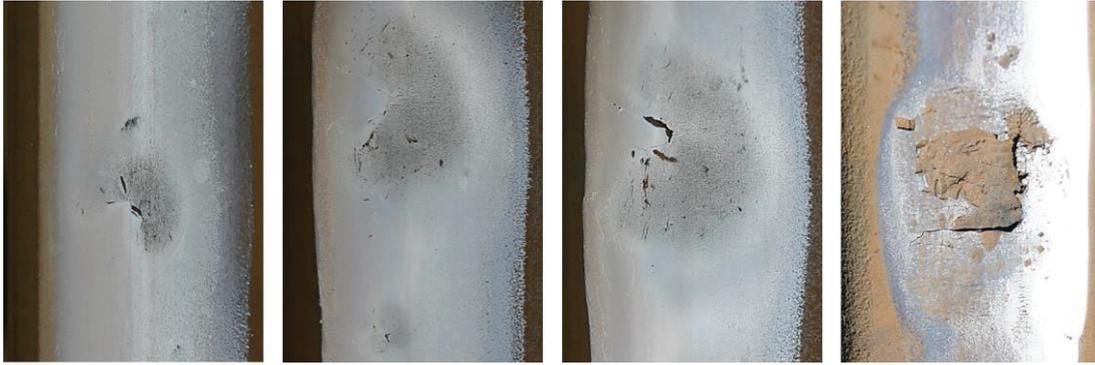
Figure 3. Examples of squats of different severity in field, as well as an example of spalling (far right). [27]

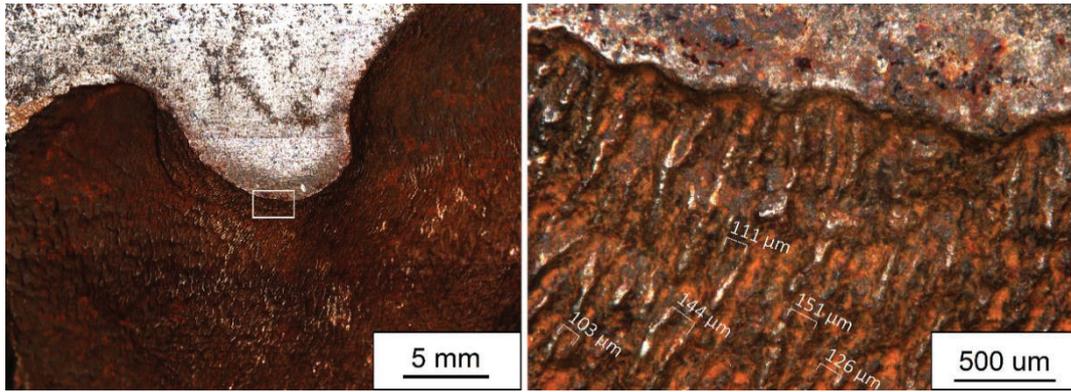
Figure 12. Images from stereomicroscopy of (left) squat surface, and (right) detail close to the tip of the v. [27]

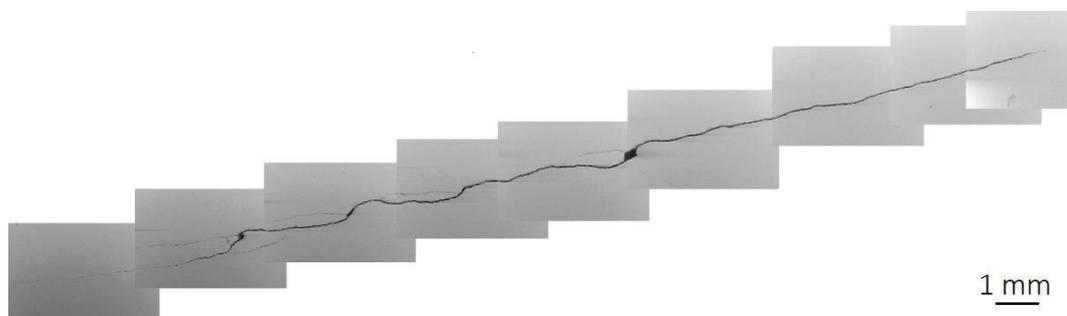
Additional investigation with SEM revealed crack branching in the transverse sections (e.g. Figure 14); while the longitudinal sections provide additional information about the crack geometry below the surface. Figure 13 shows undulations near the end of the crack network as compared to the detail maps. Furthermore, the 3D mapping (Figure 13b) shows a highly textured surface on different scales: some beach marks, ridges, and surface roughness. It can be speculated that the ridges on the fracture surface (Figure 12b) are a result of repeated relative movement of the two crack surfaces in the same direction, while the smoother regions observed near the surface-breaking part of the crack (Figure 12a, top) are a result of rubbing of crack faces in different directions due to an additional shear displacement. This is thought to be a result of the stresses propagating the crack [35].

Figure 14. SEM micrographs of sections from a squat, showing crack branching in transverse sections, not distinguishable by geometric reconstruction.

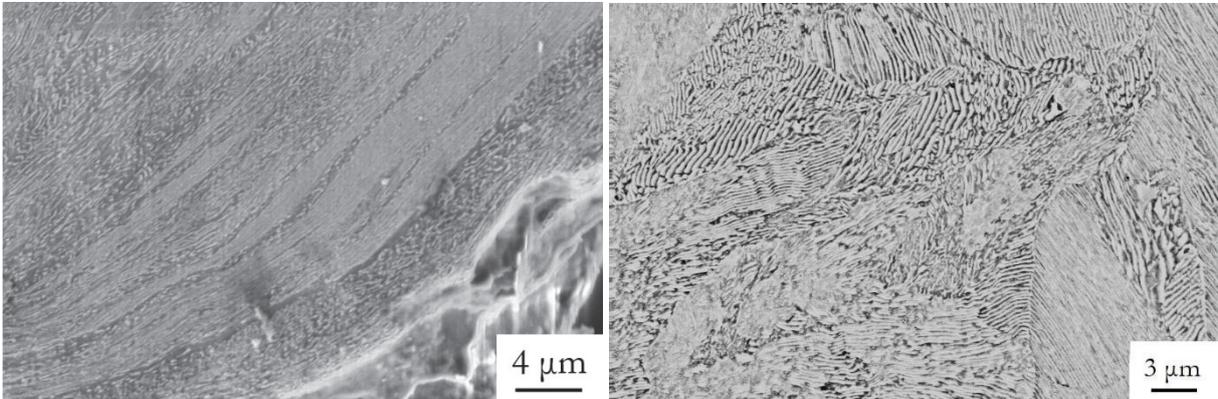
Further metallographic investigation of rail sections taken from the field allowed for a closer look at the area within and around the crack, providing better insight into the mechanisms involved in crack propagation, such as plastic deformation and possible thermal damage. It was found that plastic deformation had occurred, mostly around the surfaces of the crack (e.g. Figure 16). However, it is not seen along the entire length in the transverse sections. Around the crack opening, the deformation of pearlite grains was clearly seen, shown in Figure 16. Realignment of grains was apparent at certain areas along the crack, however, some areas seem unaffected. This suggests the crack did not grow following the severely deformed microstructure, and that other parameters affect the growth path through the bulk of the material.

Figure 16. Deformation of pearlite colonies along the edge of the crack (left), compared to the bulk material (right).

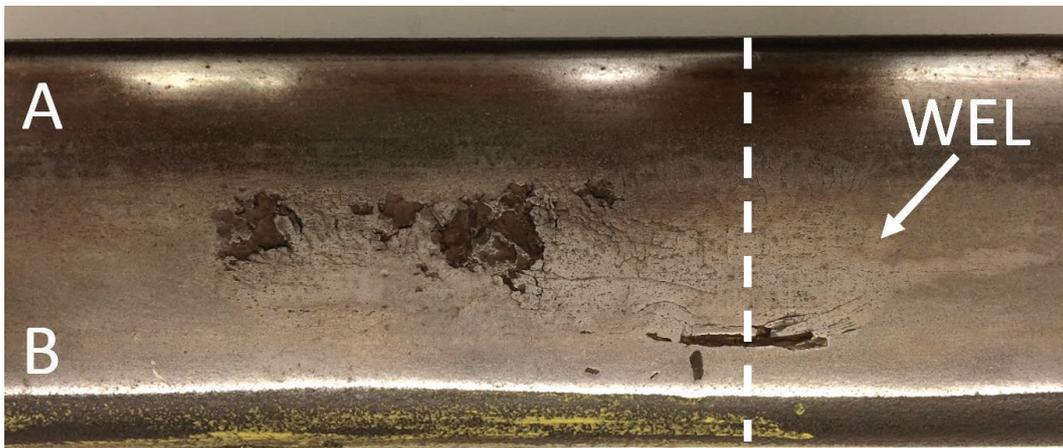
Thermal damage is often found on rails and wheels, and initial inspection of a rail section taken from the field showed quite severe spalling occurring on the surface, in addition to a large thermally damaged strip, the origination of which cannot be determined (Figure 17). The surface was cleaned and etched using Nital in order to reveal the presence of a WEL, suggesting some event caused martensite to form as a thin layer on the rail surface. Many small cracks within this layer highlight the brittle nature of the WEL.

Figure 17. Rail surface after Nital etching; spalling off of large sections is observed in the running band. Section location is shown with a dashed line.

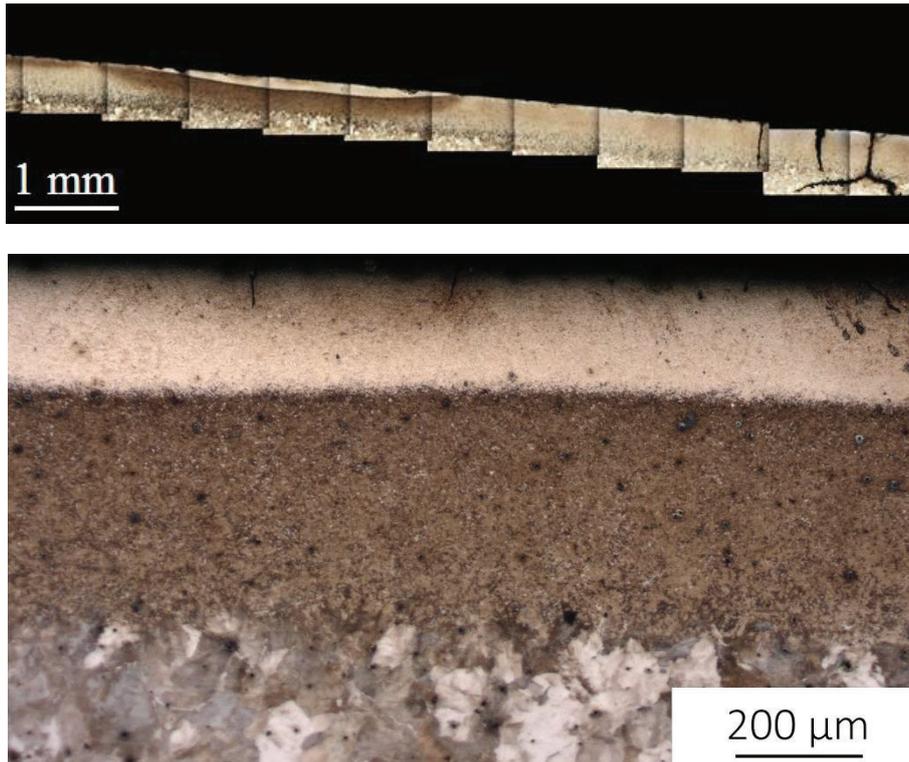
Upon sectioning as shown in Figure 17, the depth of the damage can be more closely examined, including crack patterns and crack depths. The thermal damage is clearly seen in Figure 18. A closer look at the WEL (Figure 18, bottom) shows that there are in fact two different WELs present: a thin ($\sim 200 \mu\text{m}$) layer appears above a thicker ($\sim 550 \mu\text{m}$) layer on the surface. The presence of two layers is the result of multiple occurrences of thermal damage (e.g. wheel burns) on the same place. The primary layer exhibits a heat-affected zone, appearing darker just below the secondary layer, which suggests some tempering of the martensite accompanying a second heating event [66]. Furthermore, near the bottom-right corner of Figure 18 deep cracks are present, traveling through the WEL and along the transition between the WEL and bulk material. This could be due to the rolling contact loading occurring between the wheel and rail, affecting the harder and more brittle material within the WEL as well as causing localized strain concentrations beneath the harder layer.

Figure 18. (top) WEL on cross-section from optical microscopy, and (bottom) close-up of double WELs.

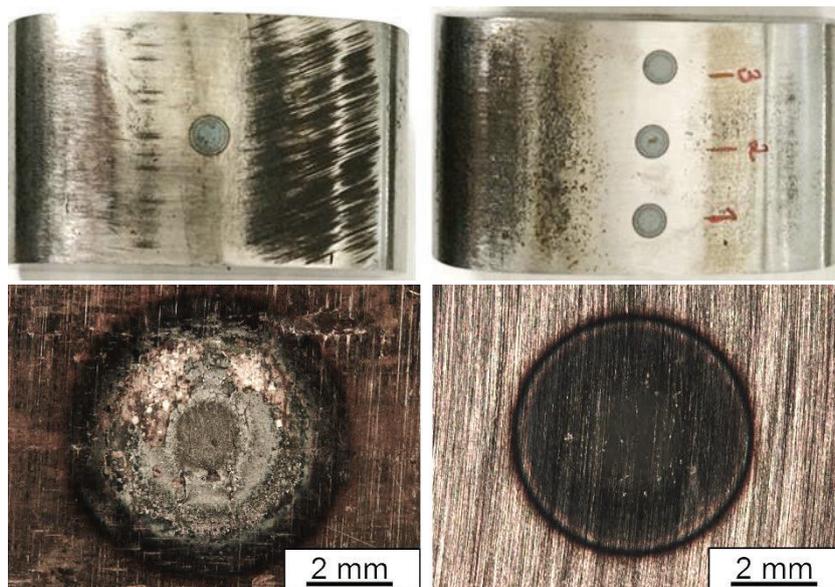
Figure 19. WEL spots on (left) used and (right) new rails.

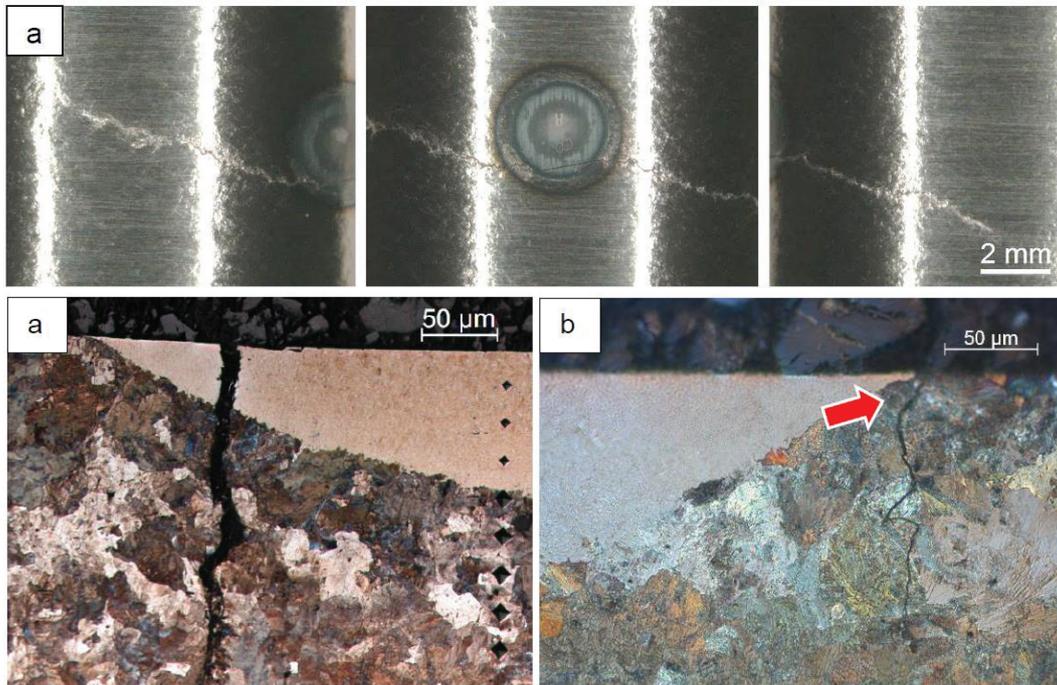
Upon closer examination of the failed test bars with thermal damage, it was found that in some instances, the dominant crack was growing through the WEL (Figure 23), whereas in other test bars, the crack followed the interface between the WEL and the bulk pearlitic material. In addition to metallographic sectioning, X-ray tomography was used to view the crack network in three-dimensions inside the test bar. This method is non-destructive, as previously described, and allowed for the entire crack network to be seen following the WEL on the surface, then propagating in a plane perpendicular to the loading direction, typical of mode I crack propagation. No crack branches were observed.

Figure 23. (a) Crack propagation through WEL on fatigue test bar.[45] (b) The crack initiated in the WEL and propagated down into the bulk material. (c) A small crack initiated at the edge of the WEL (polarized light in optical microscope).[62]

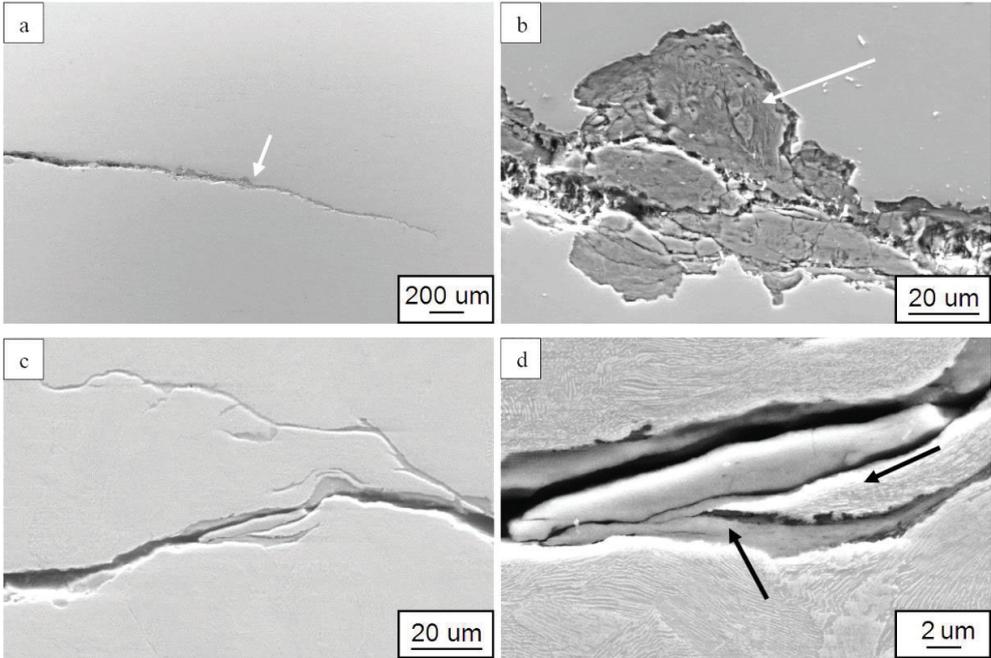
Figure 26. SEM image showing residues in cracks. a) Dark grey material near crack tip are residues, b) close-up showing deformed microstructure within the residues, c) and d) are from a transverse section of the rail.

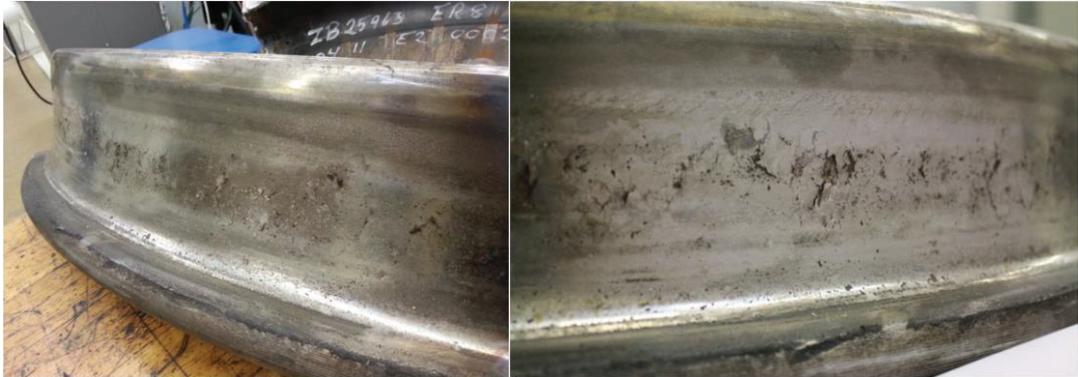
extends approximately 2 mm into the wheel. Furthermore, a crack is seen at a depth of 5 mm from the surface. This confirms that dominant cracks extend to at least to this depth, as seen in the longitudinal section, since each section only represents a 2-dimensional image of the whole crack network. It can be concluded that the main damage mechanism is RCF3.

Figure 31. Wheel treads with RCF1 and RCF3 damage bands.

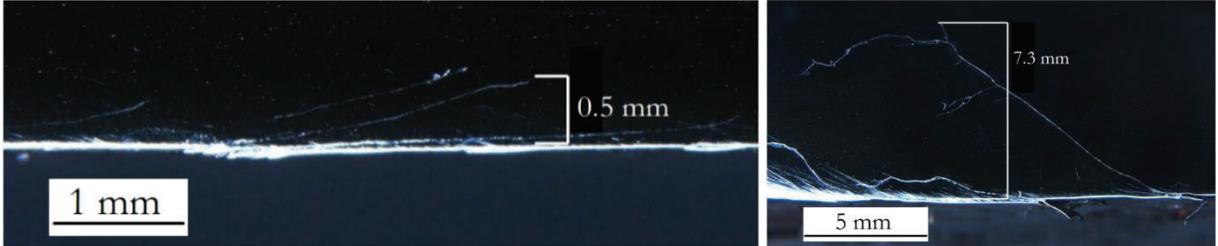
Figure 32. (left) RCF 1 and (right) RCF3 longitudinal sections.

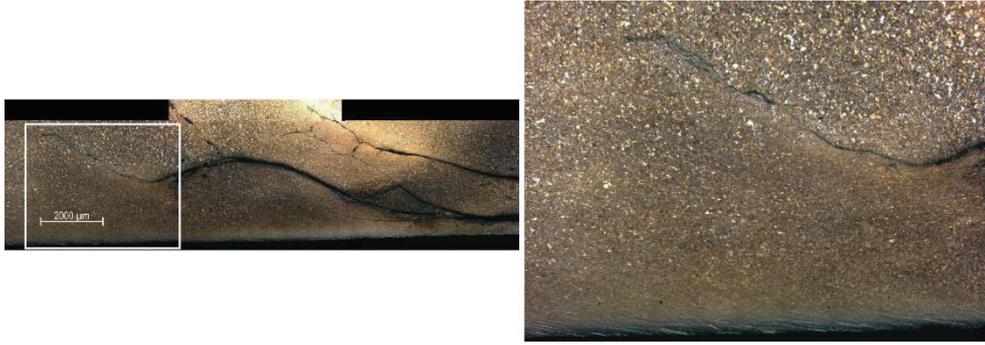
The sections were further examined by optical microscopy, to investigate in particular the occurrence of plastic deformation and thermal damage. No thermal damage was found in any of the sections, however plastic deformation was observed around the cracks. Figure 34 shows an example of plastic deformation in the vicinity of a RCF3 zone crack; the deformation and grain elongation that appears along the surface of the wheel (bottom) and the faces of the crack can be clearly seen in the magnified view. The damage pattern is typical for surface initiated rolling contact fatigue and there were no signs of severe thermal damage.

Figure 34. (Left) Example of cracks in longitudinal section through the RCF3 zone. (Right) Magnified view showing plastic deformation around crack and along the wheel surface (bottom of micrograph).
