## **Deterioration in brick buildings: hygrothermal performance and measures to save them**

Pär Johansson<sup>1,\*</sup> and Paula Wahlgren<sup>1</sup>

<sup>1</sup>Chalmers University of Technology, Department of Architecture and Civil Engineering, SE-412 96 Gothenburg, Sweden

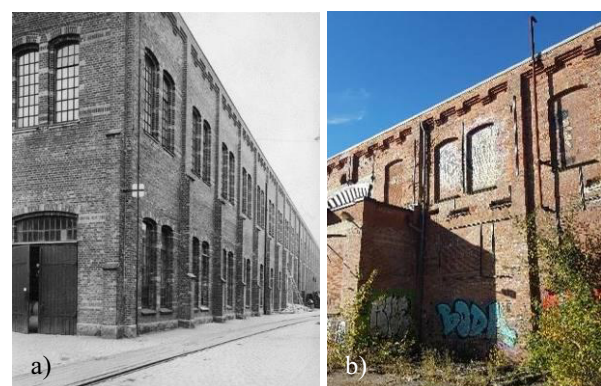
**Fig. 1.** (a) The building from 1896 in south of Gothenburg, photo from 1918, (b) The exterior of the tested external wall.

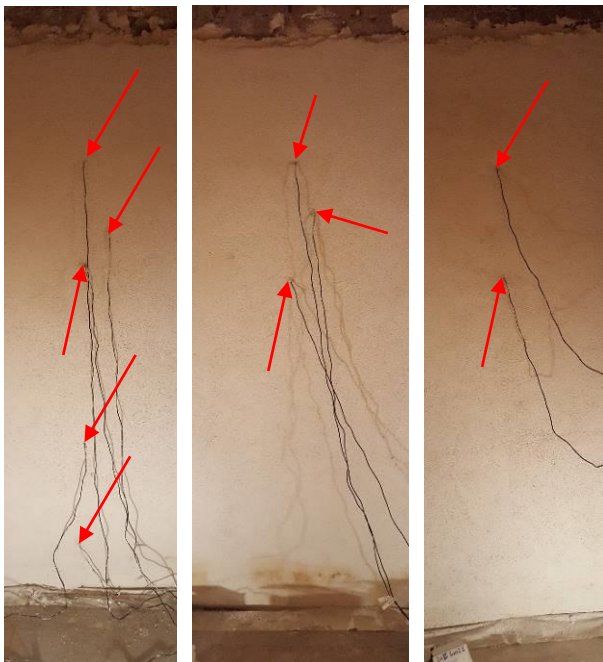
**Fig. 3.** Hygrothermal sensors (marked with arrows) in the middle of the bricks and surface of the plastered brick wall.

Prior to the installation of the sensors, the existing plaster was removed from the interior brick surface. There was substantial capillary suction from the ground and from the exposure to driving rain from south-west, which is the dominant wind direction. The old plaster was loose up to approximately 1 meter above the concrete slab and came down easily, without applying force, while the upper part of the wall required demolition hammer to remove the plaster. The initial estimations showed that the rate of water flow in the

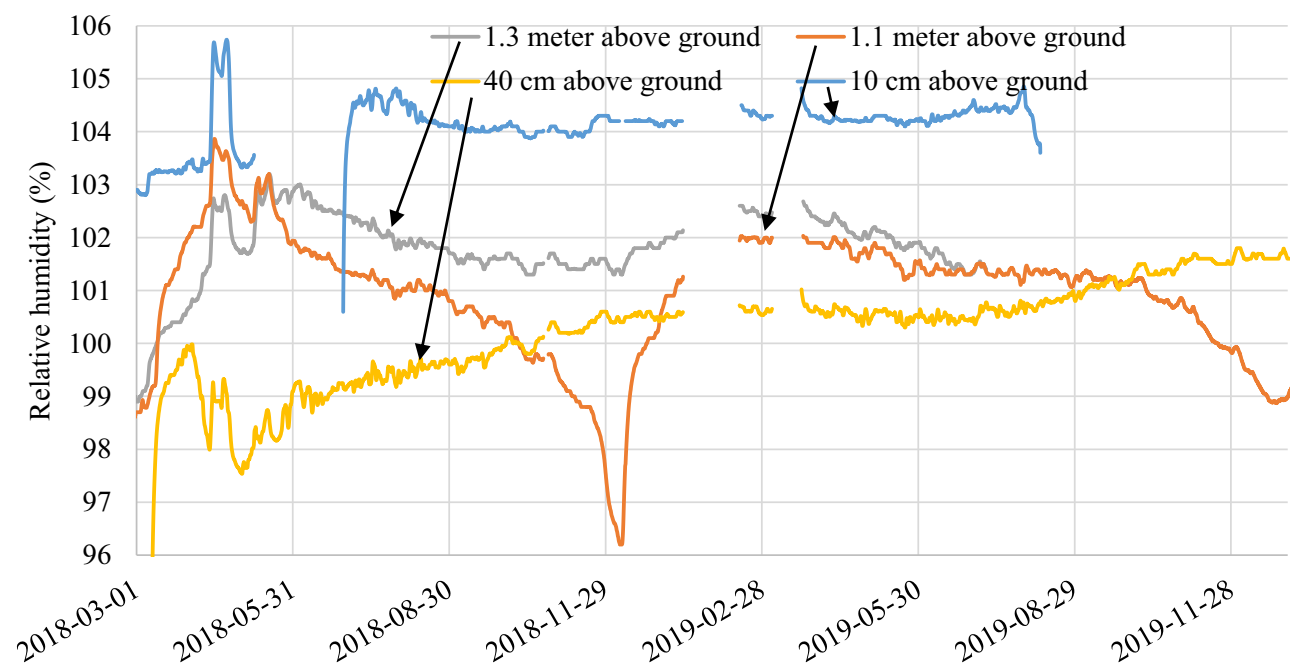
**Fig. 7.** Relative humidity in the middle of the wall at different heights, from March 2018 to January 2020, sliding 24-hour average.

According to the measurements, the temperature is highest further up in the wall, where it can be expected that the impact of the surrounding ground is smaller. The relative humidity is above 100% in the measurements. This is due to the interpretation of the measurement results in the sensor itself. The relative humidity is highest close to the slab while it varies between the measurement positions in the upper part of the wall. This could be caused by a crack in the mortar or bricks, as well as whether the sensor is in contact with brick or mortar inside the wall.

Due to the detrimental effects by the salt efflorescence on the brick masonry, the decision was made to install a layer of lime-based mortar on the interior of the wall. This was performed in the beginning of May 2018, which is visible as an increased relative humidity in Fig. 7. The mortar acts sacrificially to prevent the brick from deteriorating but does not stop efflorescence. Consequently, after the mortar was applied, the efflorescence continued, along with the degradation of the interior surface by the salt deposition. The salt crystals are continuously brushed off the wall and the mortar need to be regularly inspected to not deteriorate and expose the brick masonry. It is also important to make sure that the mortar is attached to the load-bearing part of the brick masonry so that no pockets of air can be formed between the layers where the salt efflorescence can continue to deteriorate the brick masonry.

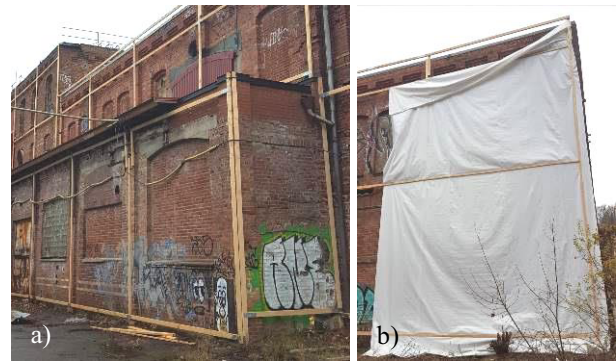
**Fig. 8.** (a) Exterior of the building prepared to be covered in plastic wrapping. (b) Part of the building covered in plastic, from November 2019.

The long-term durability of the building and the load-bearing structure need to be secured. As the heating in the buildings is detrimental to the brick mortar, and the cold and humid climate is as well, measures are needed. A solution that was implemented in November 2019, was to add a plastic wrapping around the entire building, see Fig. 8. The roof was already, from the start of the study, covered by a weather protection tent to prevent water leakage from rain into the building. The measurements will continue also after the plastic wrapping has been installed and the hygrothermal performance of the brick masonry is continuously monitored.
