# Deterioration in brick buildings: hygrothermal performance and measures to save them

Pär Johansson<sup>1,\*</sup> and Paula Wahlgren<sup>1</sup>

<sup>1</sup>Chalmers University of Technology, Department of Architecture and Civil Engineering, SE-412 96 Gothenburg, Sweden

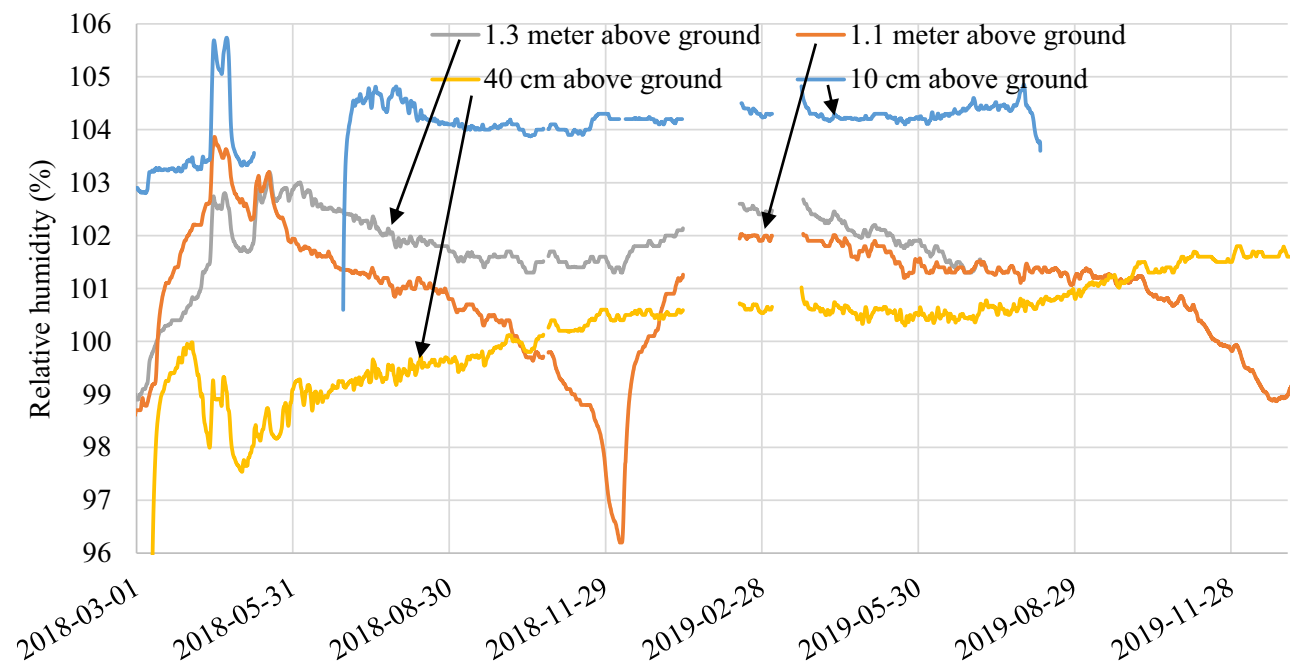
**Fig. 7.** Relative humidity in the middle of the wall at different heights, from March 2018 to January 2020, sliding 24-hour average.

According to the measurements, the temperature is highest further up in the wall, where it can be expected that the impact of the surrounding ground is smaller. The relative humidity is above 100% in the measurements. This is due to the interpretation of the measurement results in the sensor itself. The relative humidity is highest close to the slab while it varies between the measurement positions in the upper part of the wall. This could be caused by a crack in the mortar or bricks, as well as whether the sensor is in contact with brick or mortar inside the wall.

Due to the detrimental effects by the salt efflorescence on the brick masonry, the decision was made to install a layer of lime-based mortar on the interior of the wall. This was performed in the beginning of May 2018, which is visible as an increased relative humidity in Fig. 7. The mortar acts sacrificially to prevent the brick from deteriorating but does not stop efflorescence. Consequently, after the mortar was applied, the efflorescence continued, along with the degradation of the interior surface by the salt deposition. The salt crystals are continuously brushed off the wall and the mortar need to be regularly inspected to not deteriorate and expose the brick masonry. It is also important to make sure that the mortar is attached to the load-bearing part of the brick masonry so that no pockets of air can be formed between the layers where the salt efflorescence can continue to deteriorate the brick masonry.
