## **A material degradation study of novel FeCrAl alloys, stainless steels and nickel base alloy in fluidized bed heat exchangers of a waste-fired CFB**

Lindmark, H., Phother Simon, J., Olausson, M. et al (2023). A material degradation study of novel FeCrAl alloys, stainless steels and nickel base alloy in fluidized bed heat exchangers of a waste-fired CFB boiler. Fuel, 338.  
<http://dx.doi.org/10.1016/j.fuel.2022.127299>

# A material degradation study of novel FeCrAl alloys, stainless steels and nickel base alloy in fluidized bed heat exchangers of a waste-fired CFB boiler

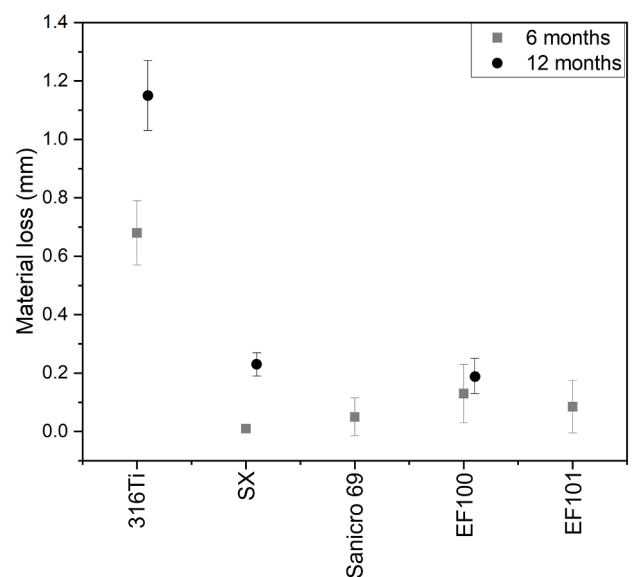
A summary of the results of material losses after 6 and 12 months of exposure is shown in Fig. 2. Material loss data of San69 and EF101 after 12 months of exposure could not be retrieved. A general trend was observed, showing that the material loss increased as a function of exposure time. After 12 months of exposure, 316Ti exhibited the highest measured material loss (1.15 mm/year). The FeCrAl alloy EF100 outperformed 316Ti after 12 months of exposure, obtaining a material loss of 0.19 mm/year, which was similar to SX (0.22 mm/year). Although material losses for 12 months could not be retrieved for San69 and EF101, they exhibited significantly low material losses after 6 months, roughly 0.08 mm and 0.1 mm, respectively.

**Fig. 2.** Material losses after 6 and 12 months of exposure.

316Ti presented the highest material loss after 6 and 12 months of exposure compared to the other materials (see Fig. 2). The material was subjected to a large degree of intergranular corrosion and the severity of the corrosion attack was increased as a function of time exposed to the present environment (see Fig. 3). In mild environments, austenitic stainless steels, such as, e.g., 347H, 304L, and 316Ti, are expected to form a chromium-rich and protective oxide [23]. In environments rich in alkali chlorides, this group of materials is readily attacked by both alkali and chlorine forming alkali chromates and metal with a corrosion product layer often consisting of an outward-growing hematite ( $\text{Fe}_2\text{O}_3$ ) and an inward-growing (mixed) spinel oxide layer ( $\text{Me}_3\text{O}_4$ ) [24]. In this study, only the inward-growing spinel oxide (rich in Cr and Ni, see Fig. 3, remains on the sample, whereas the outward-growing hematite as well as the deposited layer, have been lost. It is expected that the presence of alkali in the environment has destroyed the protective properties of the initial chromium-rich oxide [13,23]. Furthermore, an intergranular attack in the form of a steel grain boundary (GB) attack can be seen. In a recent study, the attack is associated with small levels of chlorine in

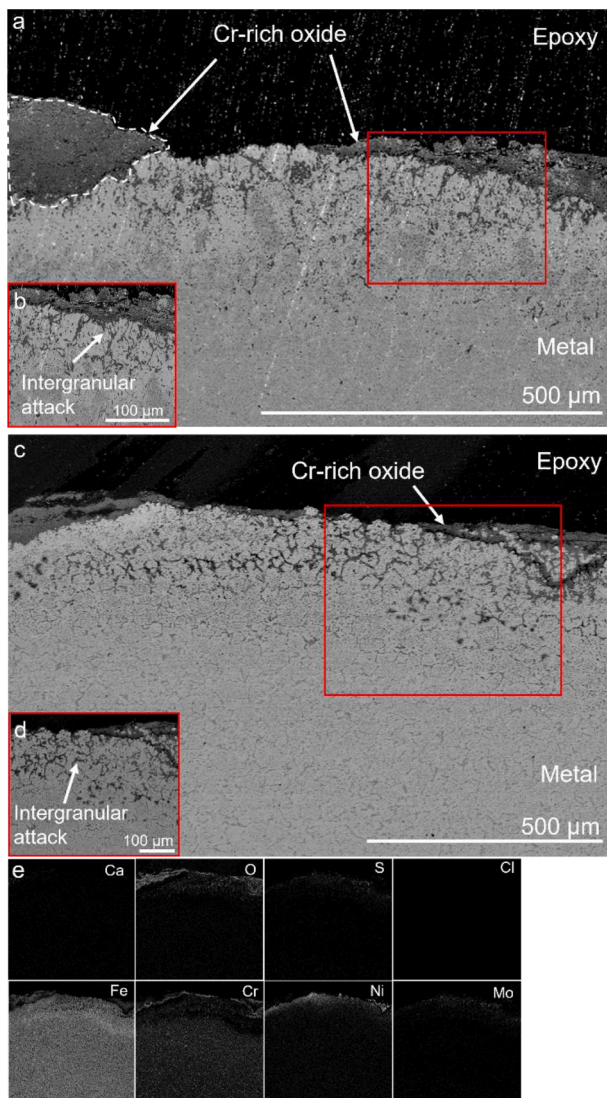
The cross-section images after 6 and 12 months of exposure for 316Ti are shown in Fig. 3a and c. Similar features were observed for both samples, and thus, chemical analysis via EDX mapping is only shown for the sample exposed for 12 months. For 316Ti, the cross-section showed little or no deposit layer as well as a minor indication of the formation of an outer corrosion product layer. Instead, the cross-sections revealed signs of intergranular corrosion attacks (see Fig. 3b and 3d). Compared to the FeCrAl alloys, the material loss was considerably higher, as the 6-month 316Ti sample exhibited a material loss roughly 7 times higher than the FeCrAl alloys (see Fig. 2).

Fig. 3e shows the EDX mapping of 316Ti exposed for 12 months. A thin outer layer of oxide was observed on top of the sample consisting mainly of Cr and trace amounts of Fe. 316Ti suffered from an intergranular corrosion attack after 6 months of exposure (see Fig. 3b). This attack progressed with increased severity as a function of exposure time. The corrosion products formed in the steel grain boundaries consisted mainly of a Cr-rich oxide. In addition, from the EDX map analysis it was confirmed that no sign of any chlorine species was detected throughout

the sample. Below the metal/oxide surface, a roughly 150  $\mu\text{m}$  thick Cr-depleted region had been formed throughout the sample (See Fig. 3e).

**Fig. 3.** SEM BSE cross-section image of 316Ti (a) 6 months of exposure. (b) Insert of intergranular attack after 6 months. (c) 12 months of exposure. (d) Insert of intergranular attack after 12 months. (e) EDX mapping of (c).

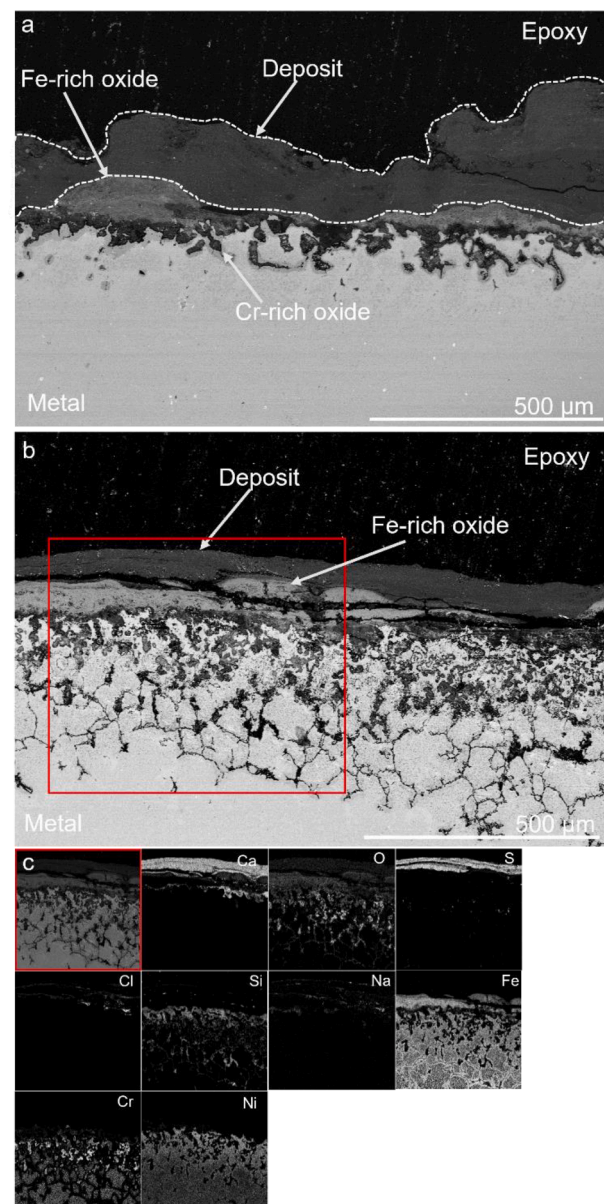
Fig. 4a and b show the cross-sections of the SX samples exposed for 6 and 12 months. Similar features were observed for both samples, and thus, chemical analysis via EDX mapping is only shown for the sample exposed for 12 months. A homogenous deposit layer was observed on both samples and consisted mainly of Ca, S, O, and traces of Na. In addition, minor traces of Cl were detected in the inner regions of the deposit. The thickness of the deposit was in the order of 60–150  $\mu\text{m}$  for 12 and 6 months, respectively. SX formed an adherent outer corrosion product layer composed mainly of a Fe-rich oxide (see Fig. 4c). The outer oxide layer became less adherent with time, which is displayed in Fig. 4b, where large cracks after 12 months of exposure were observed. As with 316Ti, intergranular attacks were noticeable after 6 months of exposure and became more severe with time (compare Fig. 4a with 4b). The internal oxidation at the metal/oxide interphase consisted mainly of a Cr and Si-rich oxide and was propagating via grain boundaries through the material. After 12 months of exposure, at roughly 60  $\mu\text{m}$  below the metal/oxide interphase, the chemical composition in the grain boundary

**Fig. 4.** SEM BSE cross-section image of SX after (a) 6 months of exposure. (b) 12 months of exposure. (c) EDX mapping of SX from the highlighted area in (b).

region changed, and a Cr-depleted region were obtained with the formation of Si-rich oxide in the grain boundary together with Fe-enrichments at the border of the grain boundaries (see Fig. 4c).

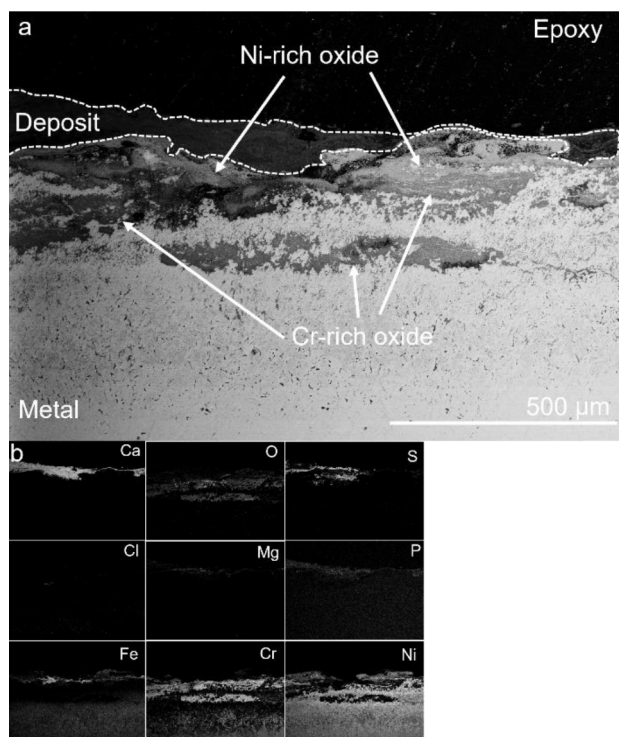
Fig. 5a shows the cross-section image of the San69 sample after 6 months of exposure. An approximately 50  $\mu\text{m}$  thick deposit layer was observed containing mainly S, Ca, and O with traces of P and Mg (see Fig. 5b). No significant amount of deposit was identified in the formed oxide scale. A Ni-rich oxide was formed underneath the deposited layer, and at the metal/oxide interphase, an oxide containing a high amount of Cr was observed. In addition, a Cr-rich oxide was also detected further into the metal as an internal oxidation region approximately 80  $\mu\text{m}$  below the corrosion product layer. This feature is presumably a 3D effect of this 2D cross-section imaging. The EDX mapping shows that the metal is mainly depleted of Cr, while nickel remains the main alloy element in the material matrix close to the corrosion front. The material loss measurement of San69 was negligible after 6 months of exposure. However, based on the SEM/EDX analysis, the internal corrosion attack can be seen up to 0.3 mm into the metal.

Fig. 5. SEM BSE cross-section image of San69 (a) after 6 months of exposure. (b) EDX mapping of (a).

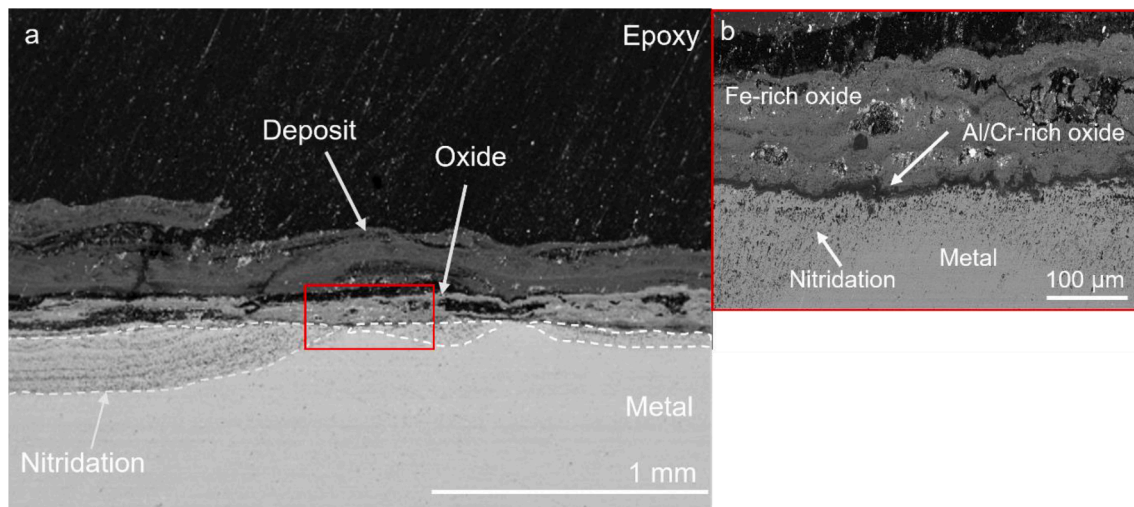
A SEM cross-sectional view of the EF100 sample exposed for 6 months is shown in Fig. 6a. An approximately 250  $\mu\text{m}$  thick deposit was observed, consisting primarily of S, Ca, and O. Beneath the deposited layer, an approximately 100  $\mu\text{m}$  thick iron oxide had formed. The oxide contained small cracks and displayed void formations, whereas it was difficult to distinguish regions of inward and outward oxide layer formation. A roughly 10  $\mu\text{m}$  Al/Cr-rich thin oxide layer was detected across the metal/oxide interphase (see Fig. 6b). The SEM analysis revealed no indications of internal oxidation for this material. However, a nitridation zone could be seen below the metal/oxide interphase. The thickness of the region varied greatly (between 0 and 200  $\mu\text{m}$ ) and was observed in a patch-wise fashion throughout the cross-section of the sample.

**Fig. 6.** (a) SEM BSE cross-section image of EF100 after 6 months of exposure. (b) Higher magnification of the marked area in (a).

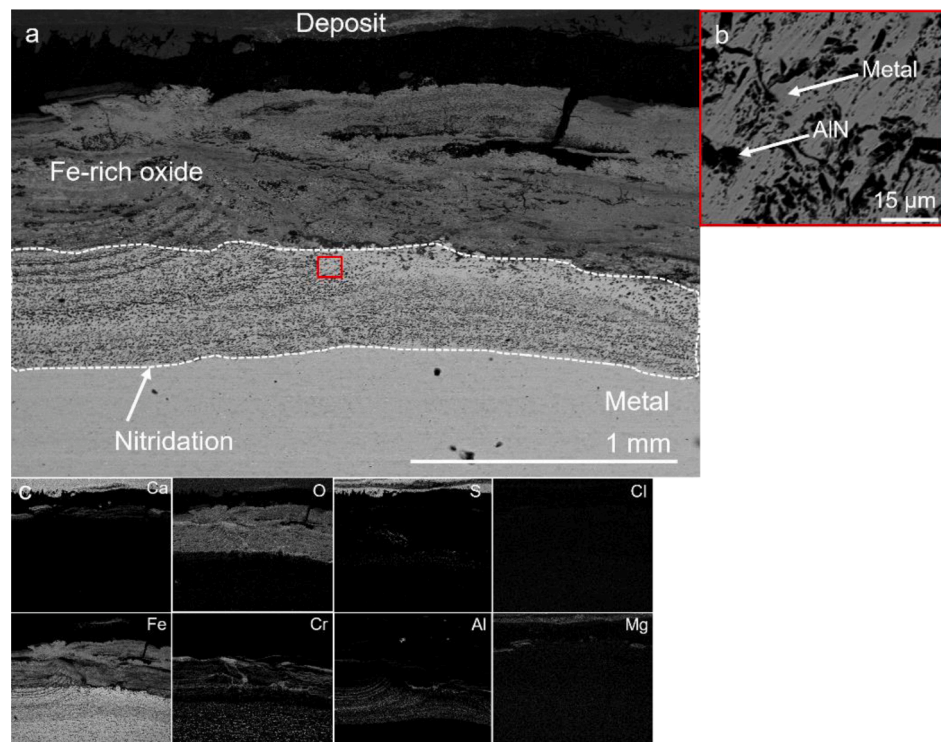
(compare Fig. 6a and Fig. 7a). However, for the sample exposed for 12 months, most of the deposited layer had spalled off. This may however be an effect of sample outtake and subsequent sample preparation for post-analysis measurements. A Fe-rich oxide was observed (about 600  $\mu\text{m}$  in thickness) containing voids and cracks as well as traces of Cr and Al (see Fig. 7a and c). The nitridation zone had also grown larger compared to after 6 months of exposure (about 400  $\mu\text{m}$  in thickness) and was observed throughout the cross-section of the sample in a homogeneous fashion. The EDX analysis confirmed that the dark particles shown in the nitridation zone consisted of Alumina Nitrides (AlN) precipitates embedded in a Fe-rich alloy matrix (see Fig. 7b). The observed microstructures and corrosion attacks agree well with the measured material losses. The material loss for EF100 after 6 and 12 months was 0.13 and 0.19 mm, respectively. The SEM/EDX analysis after 12 months of exposure also shows that a region (roughly 125  $\mu\text{m}$  thick) depleted in Cr was detected at the nitridation/metal interphase (see Fig. 7c). This Cr-depletion zone was homogenous and observed throughout the sample. No Cl was detected in the corrosion front or the deposit. Regardless of exposure time, the sample was covered by corrosion products and, for the 6-month exposed sample, deposit. Thus, it is suggested that the material loss is primarily driven by a corrosion process rather than erosion.

**Fig. 7.** SEM BSE cross-section image of EF100 (a) after 12 months of exposure. (b) Higher magnification of the marked area in (a). (c) EDX mapping of (a).

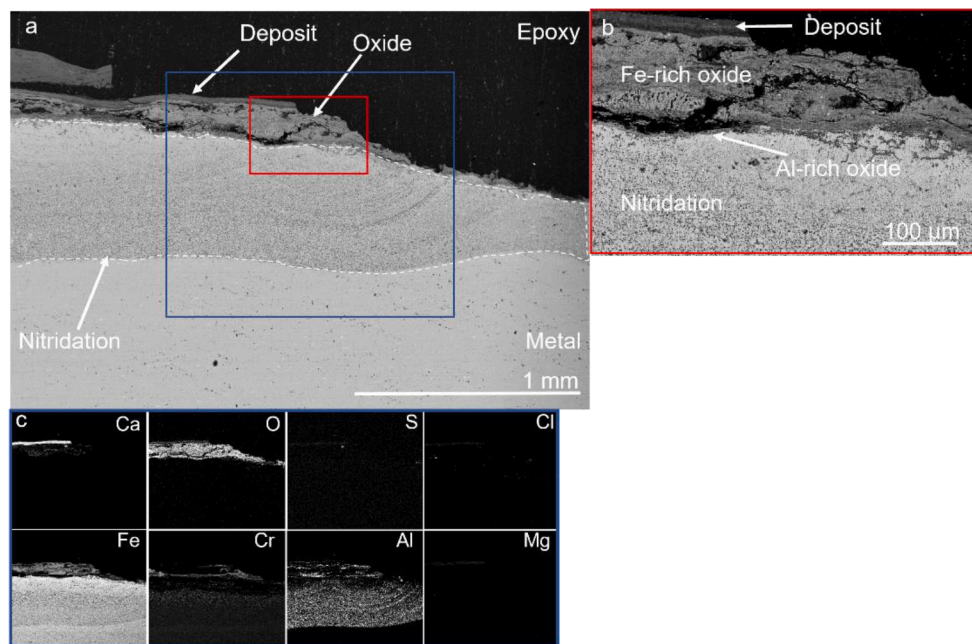
EF101 displayed similar features as EF100 after 6 months of exposure (see Fig. 8a). The EDX map analysis of EF101 shows that a thin deposit layer (about 25  $\mu\text{m}$  in thickness) had formed above the oxide layer containing large amounts of Ca (see Fig. 8c). The oxide scale was composed of a Fe-rich oxide containing cracks and voids (see Fig. 8b). Traces of a Cr rich oxide were also observed but to a lower extent. Below the Fe-rich oxide a roughly 8  $\mu\text{m}$  thin Al-rich oxide layer was observed. In addition, below the metal/oxide interface, a Cr-depleted zone of approximately 100  $\mu\text{m}$  was seen. Compared to EF100, the EF101 sample exhibited a more pronounced nitridation zone. The thickness of the nitridation zones was 450  $\mu\text{m}$  and 200  $\mu\text{m}$  for EF101 and EF100, respectively, after 6 months. For EF101, the SEM analysis revealed no or small amounts of deposit components. In addition, no traces of chlorine-containing species were observed in the cross-section (see Fig. 8c).

**Fig. 8.** SEM BSE cross-section image of (a) EF101 after 6 months of exposure. (b) Higher magnification of the small marked red area in (a). (c) EDX mapping of the sizeable, marked area in (a). (For interpretation of the references to colour in this figure legend, the reader is referred to the web version of this article.)

The EF101 obtained a thicker nitridation zone after 6 months of exposure compared to EF100 (compare Fig. 6a and 8a). The resistance towards nitridation can be due to several factors, such as the concentration of Cr in the alloy, the integrity of the alumina scale including micro defects in the oxide, which allows the nitrogen to diffuse through the deposit and oxide scale. The nitridation is, from a corrosion point of view, not desirable as the aluminum in the alloy is tied up locally in the formation of AlN rather than forming a protective alumina scale. Despite this, the newly developed FeCrAl alloys showed good material performance in this environment, and the material losses of the investigated materials were rather low.
