A material degradation study of novel FeCrAl alloys, stainless steels and nickel base alloy in fluidized bed heat exchangers of a waste-fired CFB

Lindmark, H., Phother Simon, J., Olausson, M. et al (2023). A material degradation study of novel FeCrAl alloys, stainless steels and nickel base alloy in fluidized bed heat exchangers of a waste-fired CFB boiler. Fuel, 338.
<http://dx.doi.org/10.1016/j.fuel.2022.127299>

A material degradation study of novel FeCrAl alloys, stainless steels and nickel base alloy in fluidized bed heat exchangers of a waste-fired CFB boiler

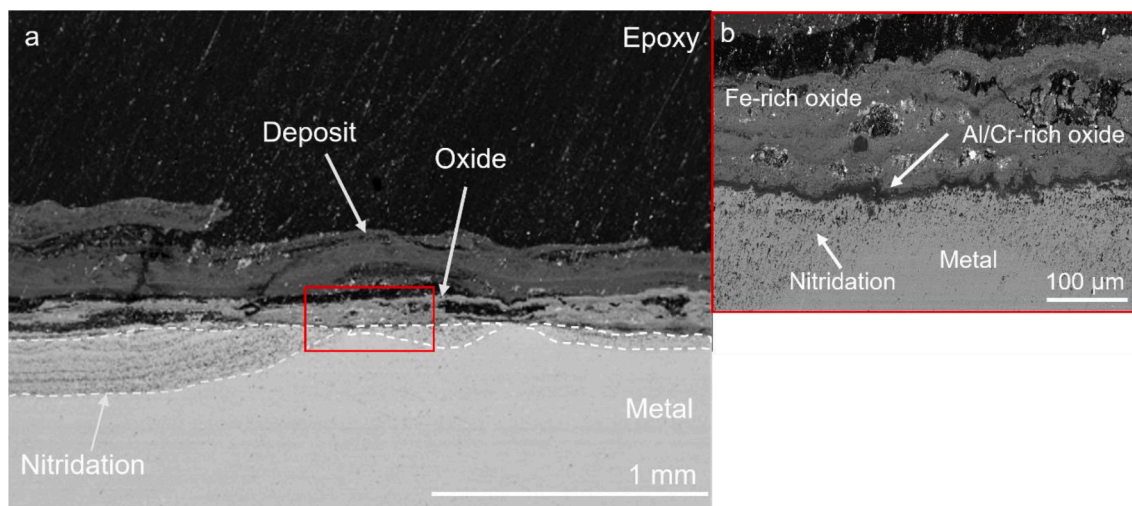
A SEM cross-sectional view of the EF100 sample exposed for 6 months is shown in Fig. 6a. An approximately 250 μm thick deposit was observed, consisting primarily of S, Ca, and O. Beneath the deposited layer, an approximately 100 μm thick iron oxide had formed. The oxide contained small cracks and displayed void formations, whereas it was difficult to distinguish regions of inward and outward oxide layer formation. A roughly 10 μm Al/Cr-rich thin oxide layer was detected across the metal/oxide interphase (see Fig. 6b). The SEM analysis revealed no indications of internal oxidation for this material. However, a nitridation zone could be seen below the metal/oxide interphase. The thickness of the region varied greatly (between 0 and 200 μm) and was observed in a patch-wise fashion throughout the cross-section of the sample.

Fig. 6. (a) SEM BSE cross-section image of EF100 after 6 months of exposure. (b) Higher magnification of the marked area in (a).

The EF101 obtained a thicker nitridation zone after 6 months of exposure compared to EF100 (compare Fig. 6a and 8a). The resistance towards nitridation can be due to several factors, such as the concentration of Cr in the alloy, the integrity of the alumina scale including micro defects in the oxide, which allows the nitrogen to diffuse through the deposit and oxide scale. The nitridation is, from a corrosion point of view, not desirable as the aluminum in the alloy is tied up locally in the formation of AlN rather than forming a protective alumina scale. Despite this, the newly developed FeCrAl alloys showed good material performance in this environment, and the material losses of the investigated materials were rather low.

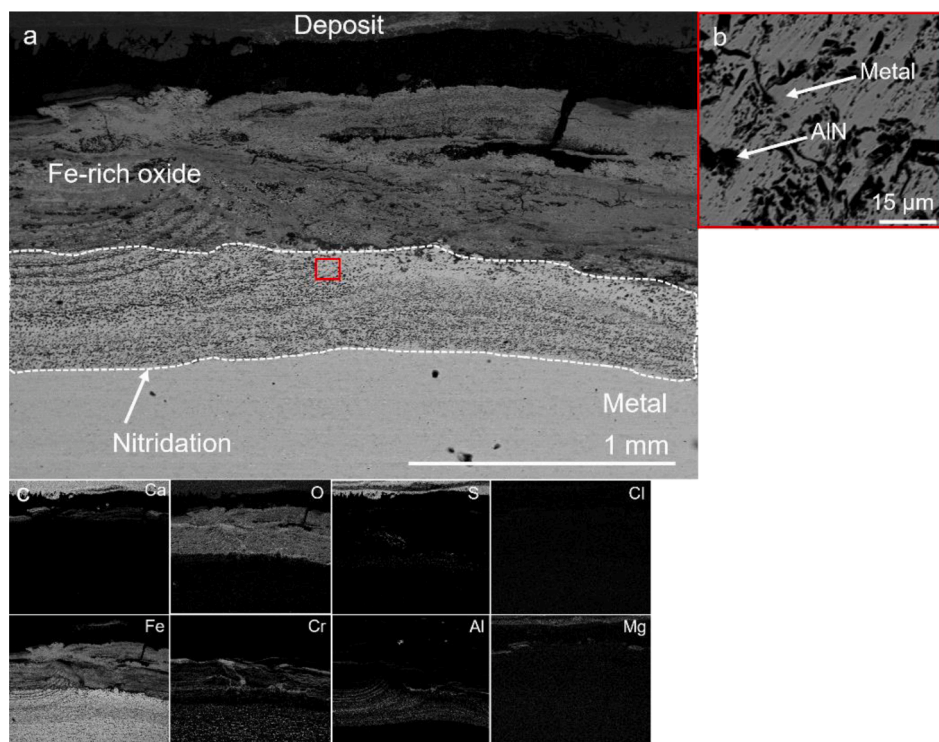
(compare Fig. 6a and Fig. 7a). However, for the sample exposed for 12 months, most of the deposited layer had spalled off. This may however be an effect of sample outtake and subsequent sample preparation for post-analysis measurements. A Fe-rich oxide was observed (about 600 μm in thickness) containing voids and cracks as well as traces of Cr and Al (see Fig. 7a and c). The nitridation zone had also grown larger compared to after 6 months of exposure (about 400 μm in thickness) and was observed throughout the cross-section of the sample in a homogeneous fashion. The EDX analysis confirmed that the dark particles shown in the nitridation zone consisted of Alumina Nitrides (AlN) precipitates embedded in a Fe-rich alloy matrix (see Fig. 7b). The observed microstructures and corrosion attacks agree well with the measured material losses. The material loss for EF100 after 6 and 12 months was 0.13 and 0.19 mm, respectively. The SEM/EDX analysis after 12 months of exposure also shows that a region (roughly 125 μm thick) depleted in Cr was detected at the nitridation/metal interphase (see Fig. 7c). This Cr-depletion zone was homogenous and observed throughout the sample. No Cl was detected in the corrosion front or the deposit. Regardless of exposure time, the sample was covered by corrosion products and, for the 6-month exposed sample, deposit. Thus, it is suggested that the material loss is primarily driven by a corrosion process rather than erosion.

Fig. 7. SEM BSE cross-section image of EF100 (a) after 12 months of exposure. (b) Higher magnification of the marked area in (a). (c) EDX mapping of (a).

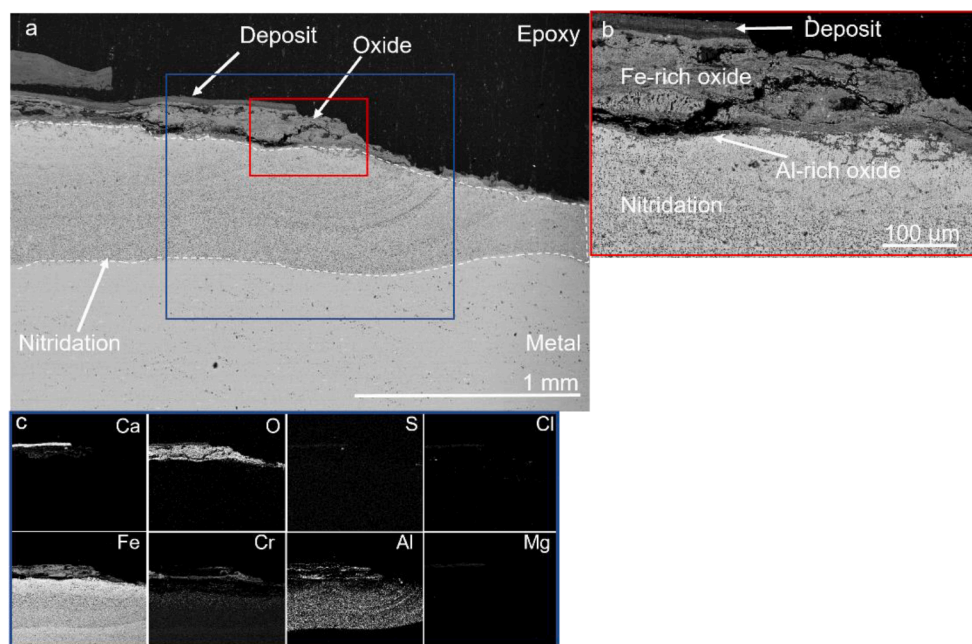
EF101 displayed similar features as EF100 after 6 months of exposure (see Fig. 8a). The EDX map analysis of EF101 shows that a thin deposit layer (about 25 μm in thickness) had formed above the oxide layer containing large amounts of Ca (see Fig. 8c). The oxide scale was composed of a Fe-rich oxide containing cracks and voids (see Fig. 8b). Traces of a Cr rich oxide were also observed but to a lower extent. Below the Fe-rich oxide a roughly 8 μm thin Al-rich oxide layer was observed. In addition, below the metal/oxide interface, a Cr-depleted zone of approximately 100 μm was seen. Compared to EF100, the EF101 sample exhibited a more pronounced nitridation zone. The thickness of the nitridation zones was 450 μm and 200 μm for EF101 and EF100, respectively, after 6 months. For EF101, the SEM analysis revealed no or small amounts of deposit components. In addition, no traces of chlorine-containing species were observed in the cross-section (see Fig. 8c).

Fig. 8. SEM BSE cross-section image of (a) EF101 after 6 months of exposure. (b) Higher magnification of the small marked red area in (a). (c) EDX mapping of the sizeable, marked area in (a). (For interpretation of the references to colour in this figure legend, the reader is referred to the web version of this article.)
