## **Concluding destructive investigation of a nine-year-old marine-exposed cracked concrete panel**

Geiker, M., Robuschi, S., Lundgren, K. et al (2023). Concluding destructive investigation of a nine-year-old marine-exposed cracked concrete panel. Cement and Concrete Research, 165.  
<http://dx.doi.org/10.1016/j.cemconres.2022.107070>

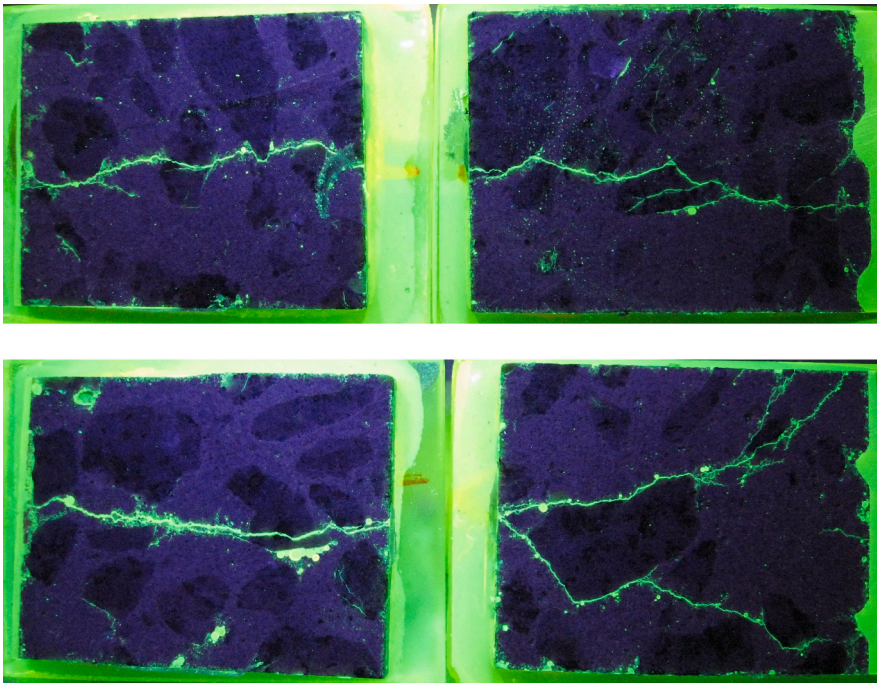
Fig. 6 shows impregnated pieces cut off after thin sectioning prepared from cores from the tidal (C2) and submerged (C5) exposure zones of the panel. Open cracks are observed to reach the reinforcement level in both cores.

One crack is seen in core C2 from the surface of the concrete to the imprint of the rebar. The crack traverses aggregate and occasionally splits into smaller cracks. The main crack has a width of 60–80  $\mu$ m at the surface and narrows to 15  $\mu$ m at the rebar. The cracks are generally open, but the main crack is bridged by calcite for the last 0.2 mm up to the surface.

The initially introduced crack in core C5 is seen from the surface of the concrete to the imprint of the rebar. An empty crack, possibly formed when the rebar was removed from the concrete, has been generated along this crack. The initial crack traverses aggregate and occasionally splits into smaller brittle cracks. The main crack has a width of 200  $\mu$ m at the surface and narrows to 13  $\mu$ m at the rebar. The initial cracks are generally open, but the main crack is bridged by calcite for the last 3 mm up to the surface.

**Fig. 6.** Fluorescent impregnated thin sections (two per core) showing impregnated (green) cracks in cores C2 (tidal exposure) and C5 (submerged). The exposed surface is to the left in the left-hand thin sections, and the imprint after the rebar is to the right in right-hand thin sections. The dimensions of the fluorescent impregnated pieces cut off from the thin sections are 30 × 45 mm<sup>2</sup>.

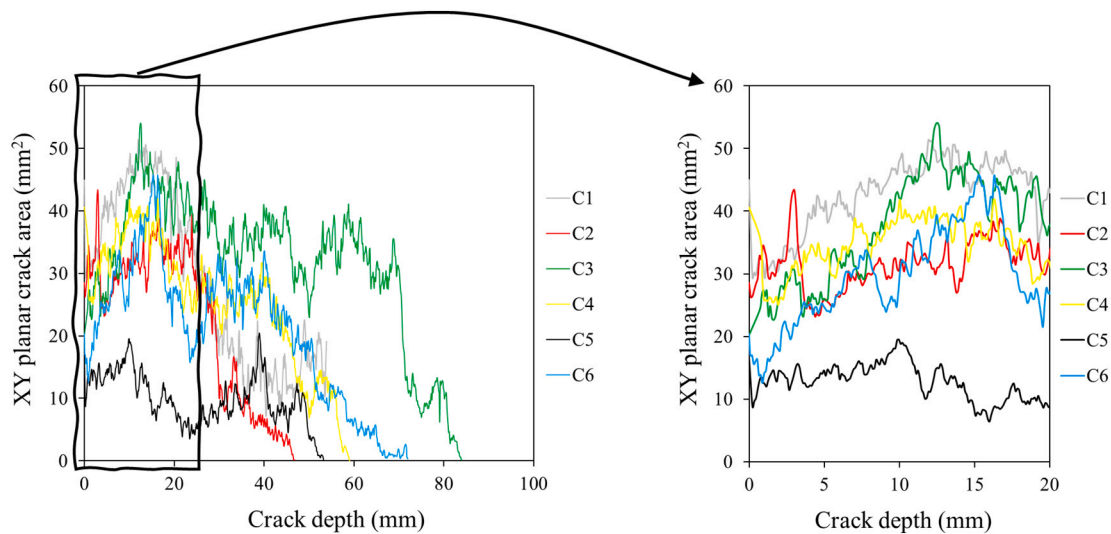
The distribution of XY planar crack area across the crack depth is given in Fig. 7 for all six cores of Series 1. The results indicate fluctuations for all cores, among which C5 showed the lowest maximum crack area. A common trend is observed from the exposed surface to the greatest depths for all cores investigated:

- The crack in the top part of the cores ( $\sim 0$ –10 mm crack depth) exhibits an initial increase in the XY planar crack area (i.e., the crack widens) from the exposed surface and down.
- The trend of growing crack area with crack depth reverses at depths beyond approximately 10 mm.
- The crack is narrow (or below the detection limit) in the vicinity of the rebar (large crack depths). This behaviour is generally to be anticipated since the cracks were initially introduced due to bending in the concrete slab.

**Fig. 7.** Measured XY planar crack area distribution across the crack depth for each core investigated using  $\mu$ -CT. (For interpretation of the references to colour in this figure legend, the reader is referred to the web version of this article.)

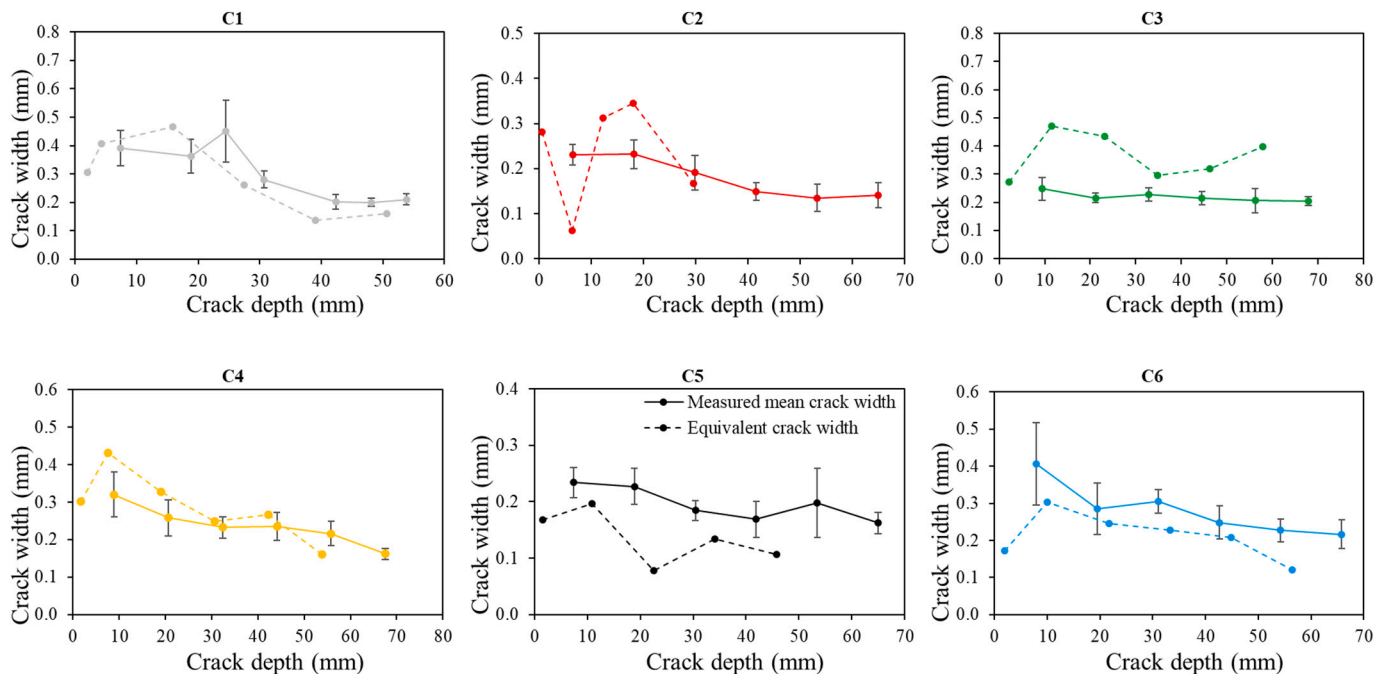
The results enable a comparison of the crack geometry between all six cores investigated, cancelling the effect of crack location in the core. Except for core C2, an increase in equivalent crack width is observed during the transition from the exposed surface down to 10 mm of crack depth, which agrees with the results shown in Fig. 7. While fluctuations are also present, a general trend of decreasing crack width values is observed beyond 10 mm crack depth. Fig. 8 compares the two different methodologies adopted. Good agreement can be observed, considering the limitations related to the resolution.

**Fig. 8.** Comparison between the two methodologies adopted to quantify crack widths from  $\mu$ -CT scans.

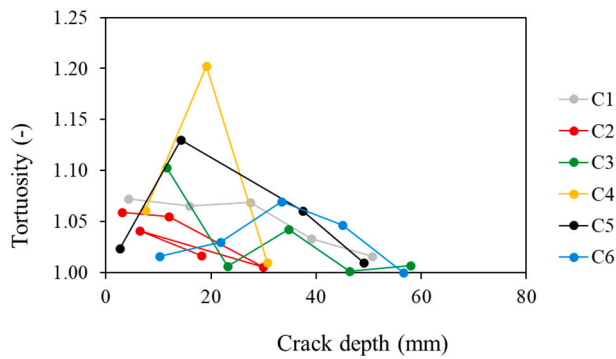
Finally, crack tortuosity was also investigated using the available  $\mu$ -CT image dataset. Representative 2D XY plane projections (five per core) were used to calculate the effective and the nominal crack length (Section 2.4) in the XY plane. The results are illustrated in Fig. 9. Numbers close to 1.00 might be explained by self-healing, closing part of the crack and reducing the effective crack length.

**Fig. 9.** Crack tortuosity distribution across crack depth for all six cores investigated using  $\mu$ -CT. (For interpretation of the references to colour in this figure legend, the reader is referred to the web version of this article.)

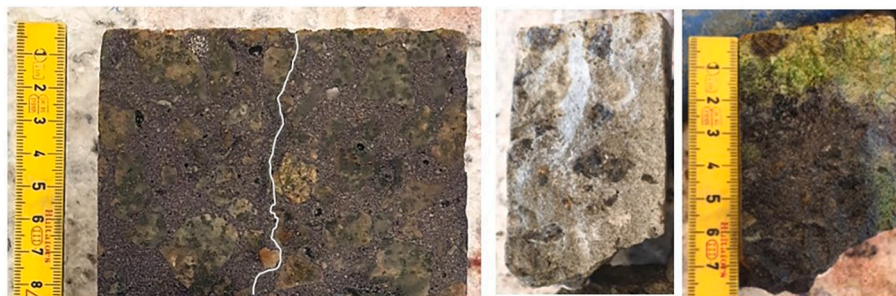
At the cut surface, the concrete did not show visual/macroscopic signs of carbonation (Fig. 10, left), which is similar to the petrographic analysis showing only shallow (1–2 mm) carbonation. The concrete surface colour was violet to blue, indicating a pH between 11 and 13. However, a carbonation front of about 20–30 mm was detected when the concrete was split along the crack face. This is also in line with the observations made in the petrographic analysis that showed carbonation along the crack face to a depth of 20 mm for core C2 (tidal exposure). The colour of the concrete was green in the outer 20–30 mm, indicating a pH of around 9 (Fig. 10, right). Furthermore, the carbonation of the upper part of the crack face coincided with a white precipitate. The carbonation depth appeared deeper along the cylindrical outer surface of the core (Fig. 10, right), suggesting carbonation during storage (approximately six weeks wrapped in plastic and stored at 5 °C). However, this is not in agreement with the lack of/limited carbonation on the exposed surface (Fig. 10, left), so it is assumed to be an artefact. Note that the petrographic analysis showed less carbonation along the crack face (to a depth of 8 mm) for the submerged exposed core (C5) than for the core from tidal exposure (C2). The petrographic analysis also showed shallow carbonation of part of the rebar imprint in core C5 (submerged exposure), which was not observed in the visual/macroscopic investigation. Similar observations were made for core C1 (tidal exposure) and C4 (submerged exposure).

**Fig. 10.** Carbonation detection on core C1. Left: freshly cut concrete core sprayed with rainbow indicator; Right: crack face sprayed with a rainbow indicator (left side: cut surface; right side: outer cylinder surface). (For interpretation of the references to colour in this figure legend, the reader is referred to the web version of this article.)

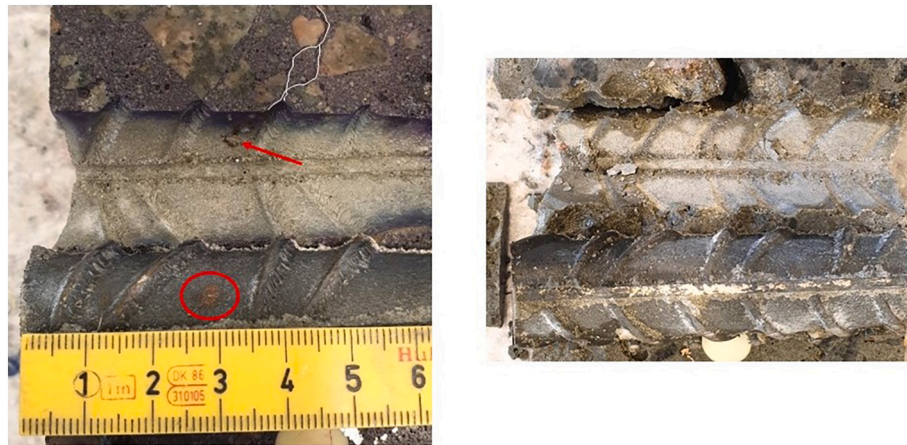
there were no indications of corrosion at the rebar–concrete interface. The bond between rebar and concrete appeared good, and the reinforcement condition generally appeared very good. One minor corrosion spot was found on the reinforcement of core C1 close to the crack (Fig. 11). The corrosion spot appeared only superficial and had a length of about 5 mm. Furthermore, a white precipitate was found on one side of the reinforcement surface in core C1 (Fig. 11, right).

**Fig. 11.** Minor corrosion spot detected in C1; Red circle: Spot on reinforcement bar; Red arrow: Spot in the concrete imprint; Crack marked in white. (For interpretation of the references to colour in this figure legend, the reader is referred to the web version of this article.)

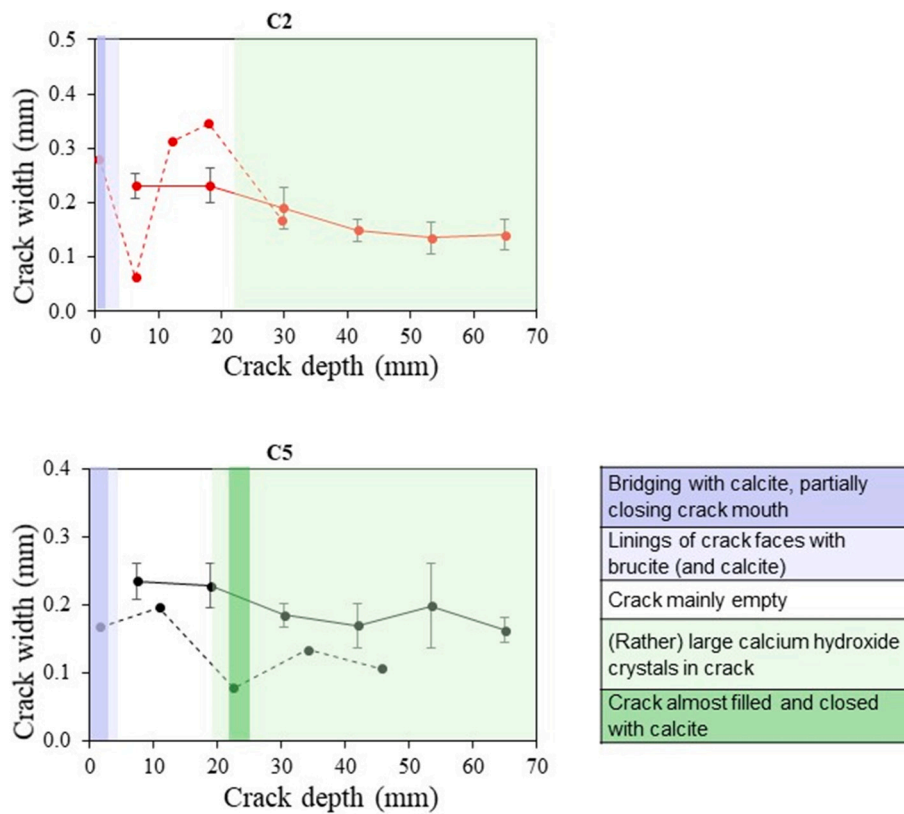
**Fig. 12.** Comparison of crack characterization using  $\mu$ -CT (equivalent crack width (dotted line) and measured mean crack width (solid line), data from Fig. 8) and zones identified using petrography (data from Table 8) for cores C2 (tidal exposure) and C5 (submerged exposure). (For interpretation of the references to colour in this figure legend, the reader is referred to the web version of this article.)

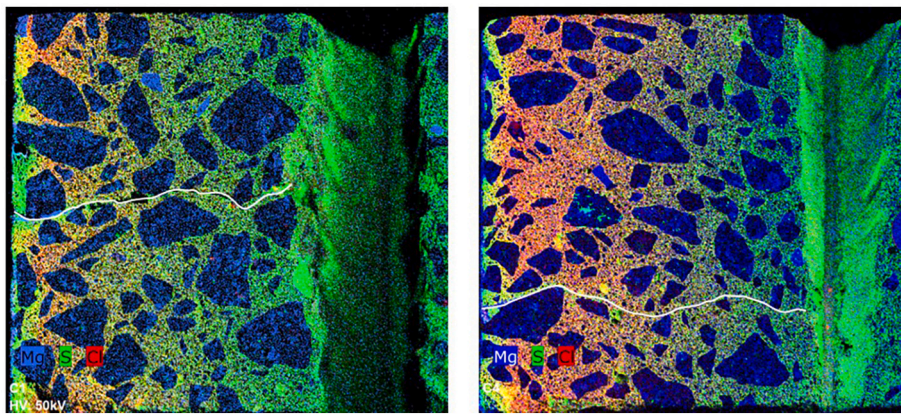
The petrographic study showed that the first 5 mm of the paste was fully de-calcified with increased porosity in the tidal and submerged zones. If the elemental maps of Mg, S and Cl obtained by  $\mu$ -XRF (Fig. 13)

**Fig. 13.** Elemental zonation of Mg (blue), S (yellow) and Cl (red) in core C1 (left) and C4 (right). Cracked and exposed surfaces of panels to the left and imprints of rebars to the right in both figures. Mg is visible within the first 10 mm of the crack. Note that the apparent high S content in part of the steel–concrete interface of core C1 is an artefact due to mechanical damage during sample preparation. (For interpretation of the references to colour in this figure legend, the reader is referred to the web version of this article.)

are combined, a clear elemental zonation as reported by Jakobsen et al. [22] can be observed, with a thin Mg-rich surface layer, followed by a layer of about 0.5 cm enriched in S, followed by Cl. Fig. 13 shows that precipitation of Mg-rich phases was detected within the first 10–15 mm in both cracks. This is in line with observations reported of cracked concrete beams after 25 years of marine exposure in northern Norway [20].

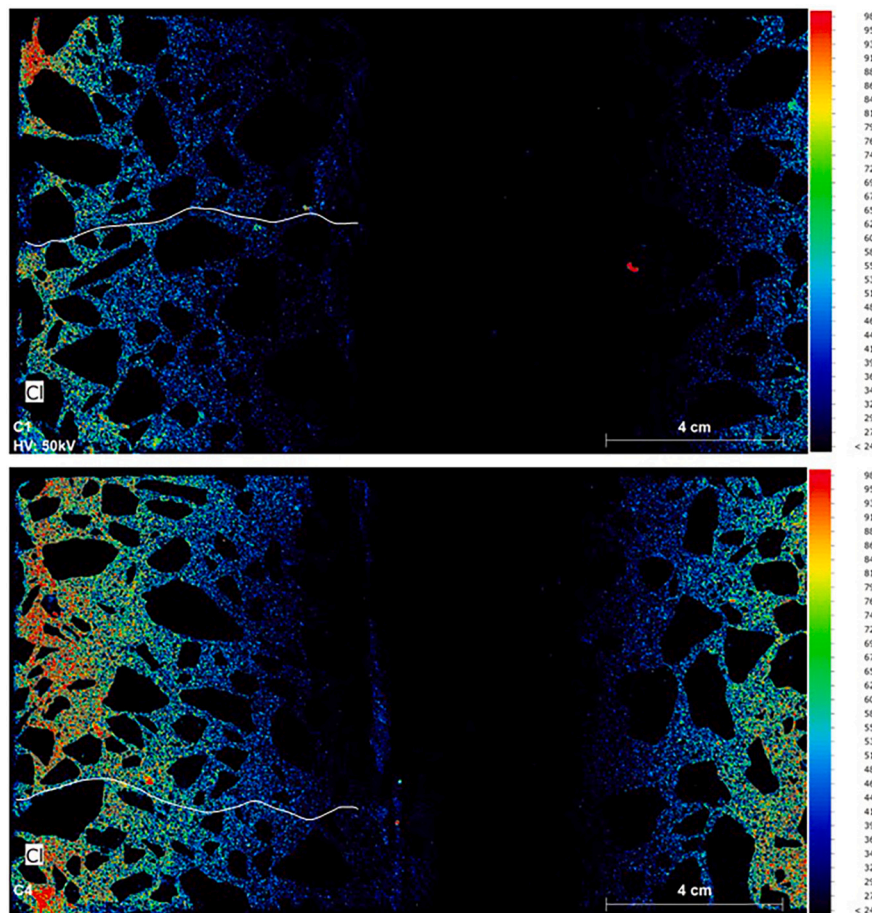
**Fig. 14.** Map visualizing chloride ingress depth in relative intensities: core C1 (tidal exposure) at the top and core C4 (submerged) at the bottom. The cracked surface of the panel is to the left. Cracks are marked in white. (For interpretation of the references to colour in this figure legend, the reader is referred to the web version of this article.)
