Yuan, M., Karamchedu, S., Fan, Y. et al (2023). A Case Study for a Worn Tool Steel in the Hot Stamping Process. *Journal of Materials Research and Technology*, 22: 1065-1075.  
<http://dx.doi.org/10.1016/j.jmrt.2022.12.006>

# A case study for a worn tool steel in the hot stamping process

A good understanding of failure mechanisms can help us improve the lifetime of the dies. This paper presents a case study investigating the wear behaviour of a QRO90 die insert utilized for stamping uncoated boron-alloyed high-strength steel sheets. Topography and microstructure were characterized by means of scanning electron microscopy (SEM), energy-dispersive X-ray spectroscopy (EDS), hardness measurement and X-ray photoelectron spectroscopy (XPS). Severe galling due to accumulated layers transferred from the boron-alloyed steel workpieces occurred on the die surface. Material softening was detected in the sublayer of the tool steel (up to ~200  $\mu\text{m}$ ). In addition, white layers with a thickness of 1–2  $\mu\text{m}$  were frequently observed on the surface of the round corner of the tool. The main wear mechanisms are discussed. Galling caused by surface softening and the spallation o

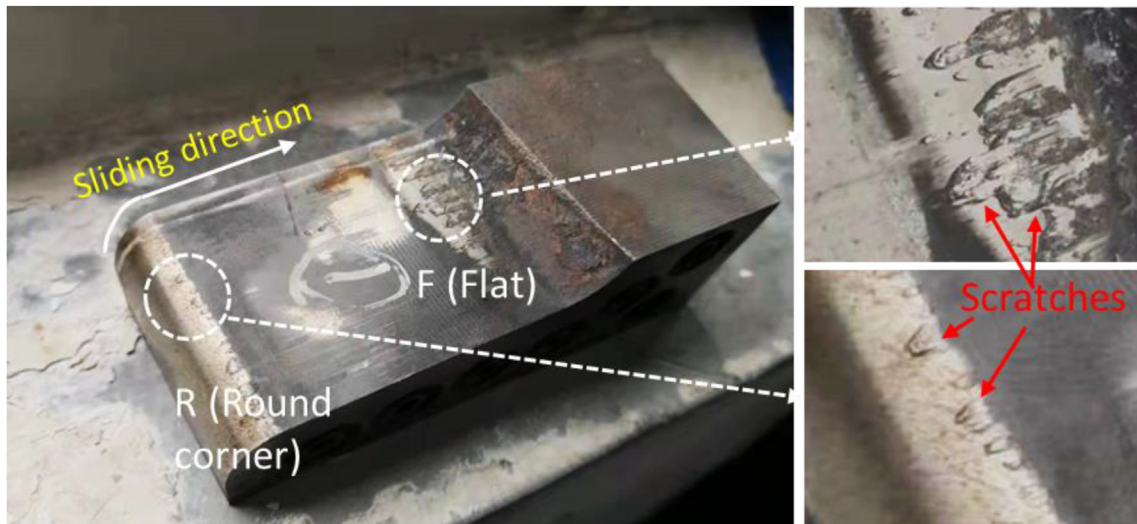
A failed die insert for hot stamping, as shown in Fig. 1, was considered for analysis. The main worn areas on the die insert are displayed in Fig. 1. The area on the round corner is marked

**Fig. 1 – The main worn areas on the die insert.**

as “R” and the flat part is marked as “F”. Specimens were extracted from these two areas for investigation.

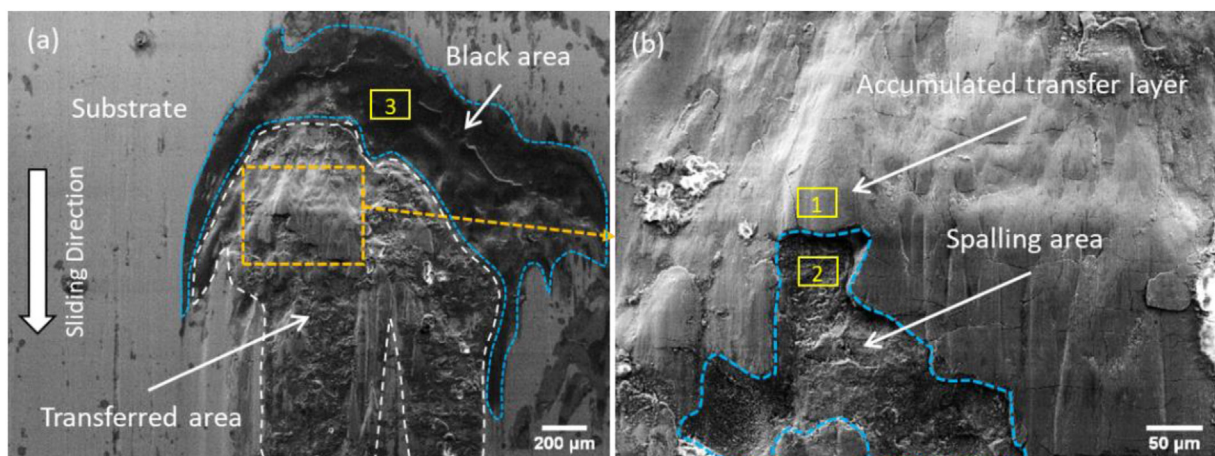
**Fig. 2 – SEM images showing the transferred materials on the flat part. The sliding direction (S.D.) is marked in the figure.**

a scratches was thoroughly examined by SEM, as shown in Fig. 2. A large area of transferred materials was found on the top of the scratch. The transferred material showed a glazed surface. The extremely low concentration of Cr and Mo and high concentration of O at Site 1 (see Fig. 2b), as revealed by EDS analysis in Table 2 indicated that this transferred material was from the workpiece which was oxidized with a remarkable oxide layer thickness in the micrometer level. The oxide was mainly iron oxide. A spalling area was found on the top of the transferred material, implying that the transferred material was accumulated during the stamping process. EDS analysis conducted on the spalling area (Site 2) showed a relatively lower O concentration compared to the un-spalled zone (Fig. 2b and Table 2), indicating less oxidation of the transferred material in this region. In addition, a black/dark area (upper area indicated in Fig. 2a) was also observed in front of this big scratch. The EDS (Site 3 in Table 2) result shows that this area has an even higher O content than that of Site 1. The material in this area was suspected to be mainly iron oxides with some contamination.

The adjacent protrusion prevented this black area in Fig. 2a from being in contact with the hot workpieces, and thereby its surface was exposed to a high temperature for a relatively long time and was thus heavily oxidized. Notice a significant amount of Si was observed in this region. It could be resulted from the selective oxidation of Si from the steel at high temperatures during processing due to the high affinity of Si with oxygen or the residue from the coolant. The observation of Mo here is a surprise. On the other hand, the protrusion can scrape the hot workpiece, and therefore the transferred layer could be accumulated on the top, as observed in Fig. 2.

During the hot stamping process, transferred material with a top oxide layer was stacked on the tool steel layer by layer in an accumulated manner. This type of accumulated and compacted layer has commonly been observed in other high-temperature reciprocating sliding systems [9,15]. An interesting phenomenon observed was the varied bonding strength at different locations. At the head of scratches (Fig. 4a), there was a strong bonding between the transferred materials and the slopy surface of tool steel. It was attributed to the high partial normal load  $F_1$  on the local surface (the slopy region) of the tool steel, as schematically drawn in Fig. 4a. Meanwhile, the transferred material was at high temperatures with high ductility. Consequently, it could form a good bonding with the underlying tool steel. On the other hand, at the tail of scratches (Fig. 4a and b), much lower normal stress led to a weak bonding between the transferred materials and the tool steel. As a result, the spalling of transferred materials could happen in such region, as shown in Fig. 2b.

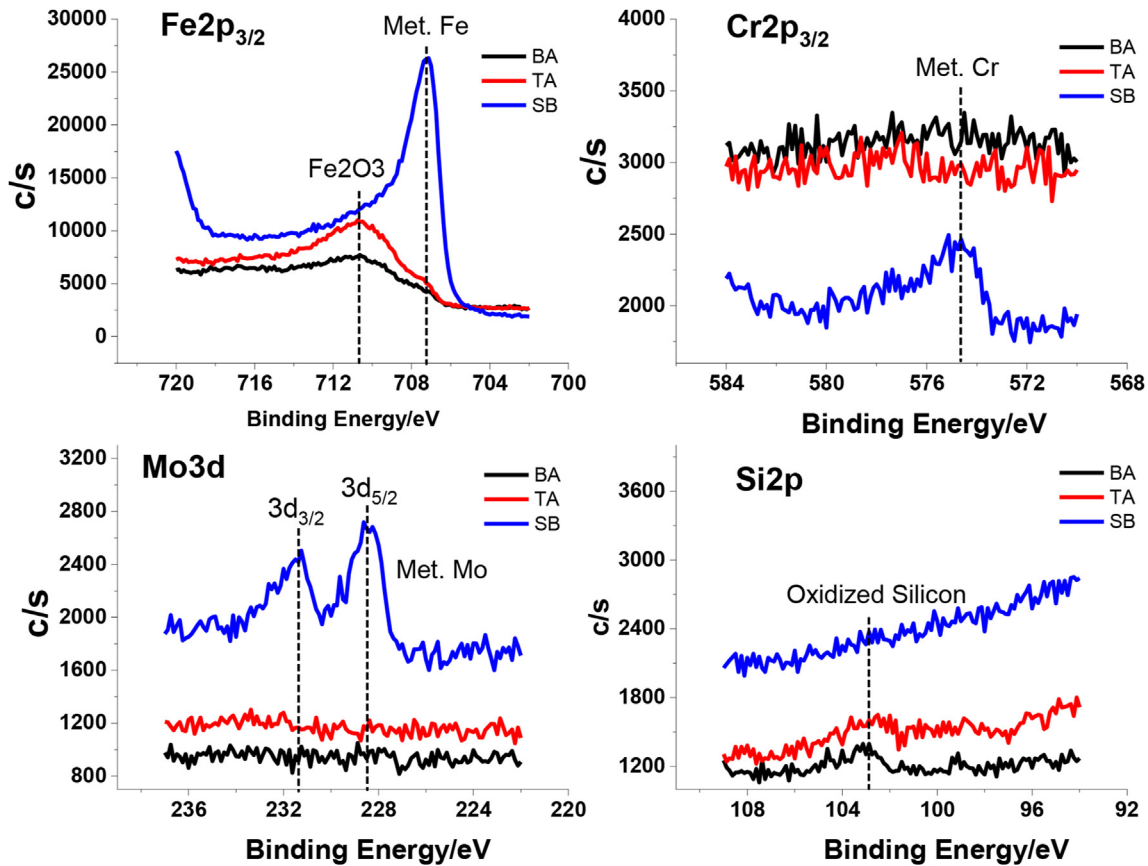
In order to further characterize the chemistry of the oxide, XPS was conducted on the black area (BA), transferred area (TA) and substrate (SB), as indicated in Fig. 2a. The surface was slightly etched by argon ions prior to the measurement to remove some contamination and the native oxide. As shown in Fig. 3, the substrate possessed strong peaks of Fe, Cr and Mo in metallic form. However, Fe was identified to be present as  $\text{Fe}_2\text{O}_3$  in both the black area and transferred material area, indicating significantly thicker oxide compared to the substrate. This was consistent with the EDS results in Table 2. Molybdenum was not observed at the surface of BA and TA regions. High silicon content in BA and TA regions is also agree with the EDS results in Table 2. The area with transferred material had the strongest oxidized Fe peak, indicating that  $\text{Fe}_2\text{O}_3$  was dominant on the surface of this area.

Fig. 3 – The XPS spectra of the concerned elements on the scratch in Fig. 2. BA: black area, TA: transferred area, SB: substrate.

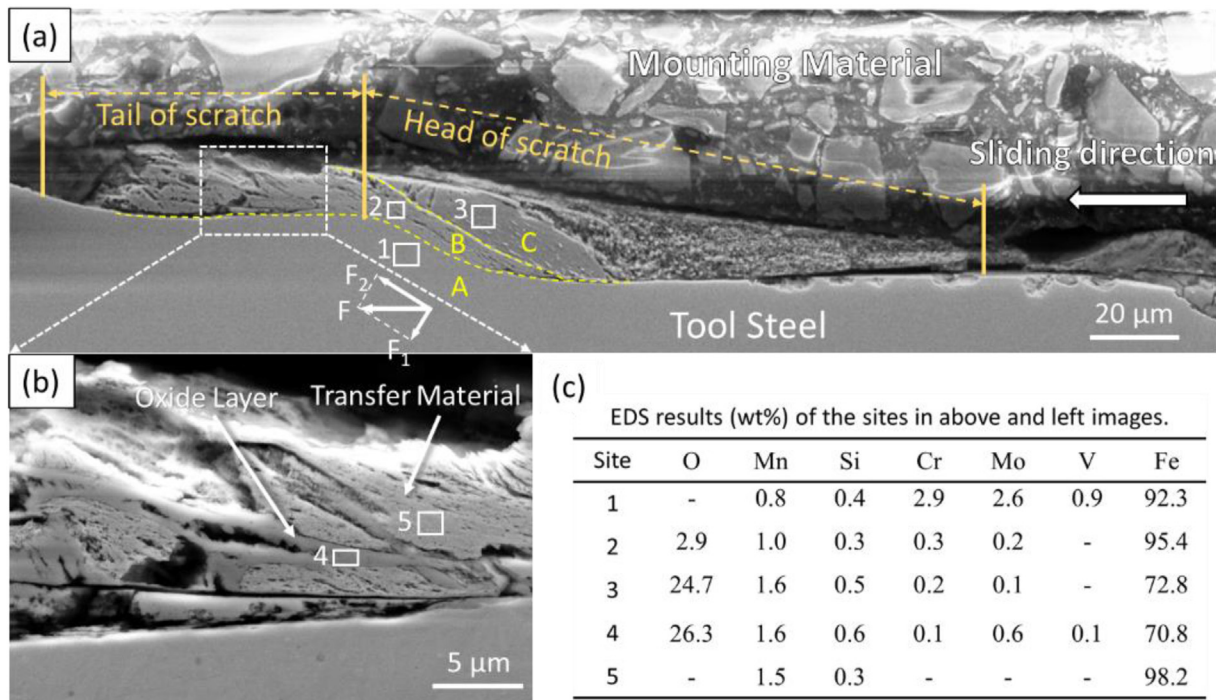
Fig. 4a shows the morphology of the polished longitudinal cross-section from the flat region (see Fig. 1) with some

transferred materials on the top. EDS analysis was carried out on different areas, and the results are presented in Fig. 4c. Here “A” (Site 1 in Fig. 4a) represents the tool steel and shows a typical composition of die material (QRO 90 tool steel). The regions “B” and “C” should be material that differ from the tool steel considering their unique morphology. According to the EDS results shown in Fig. 4c, the “C” layer (Site 3) reveals a much higher O content, and the composition is similar to that of Site 1 in Fig. 2, indicating that the material in this layer is the  $\text{Fe}_2\text{O}_3$ .

The composition of site 2 in the “B” layer was consistent with the nominal composition of the boron steel, indicating it was the transferred material from the boron steel workpiece. The small content of O (2.9 wt%) in the “B” layer suggests that the material was slightly oxidized. In another location of the “B” layer, as shown in Fig. 4b, multi-layers consisting of alternating denser layers (Site 4) and the ones with some black pores (Site 5) were observed. EDS (Fig. 4c) conducted on these different layers shows that the composition of the more porous layers (e.g., Site 5) was consistent with that from site 2 of the “B” layer, while the denser layers (Site 4) had almost the same composition as the “C” layer, suggesting the formation of  $\text{Fe}_2\text{O}_3$  due to oxidation of the transferred material. However, Mo was detected in both “B” and “C” layers. It was not expected because Mo is not present in the workpieces of the boron steel. One possible reason for this could be that the smearing of the tool steel might occur, which introduces some material from the tool steel into the transferred layer. The mixture of tool steel and transferred materials was also observed in other sliding wear tests [9]. This occurs at the surface of the workpiece, which explains why Mo was only found in the oxide but not the bulk transferred boron steel bulk in the “B” layer.

Fig. 4 – (a) SEM image from the longitudinal cross-section (parallel to the sliding direction) of the flat part, (b) Magnified image presenting transferred material in a multilayer form, (c) The corresponding EDS analysis results.

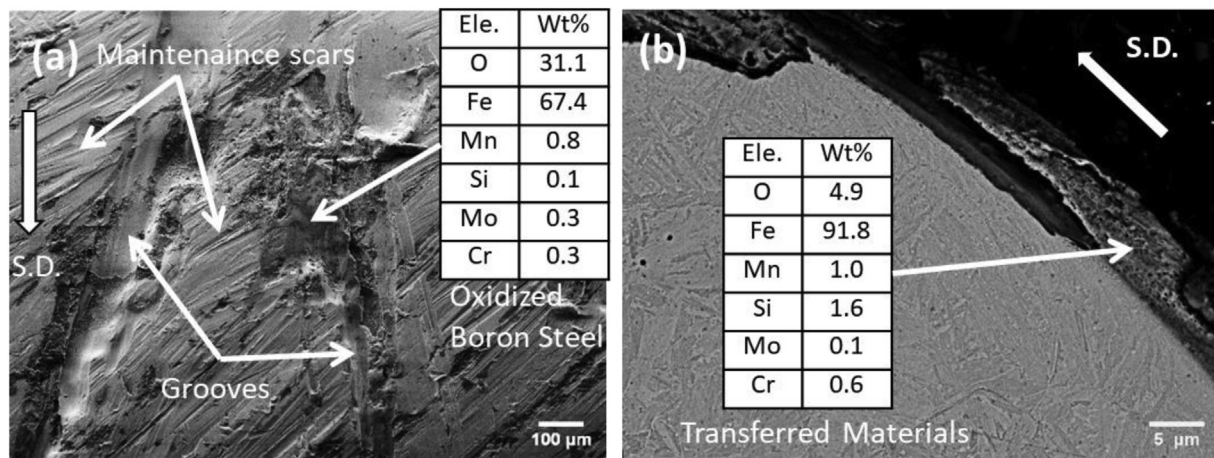
**Fig. 5 – Material transfer observed at the round corner: (a) the micrograph of worn surface, (b) cross-section illustrating the transferred material.**

(31.1 wt%). This meant the oxide layer on the surface was nearly pure  $\text{Fe}_2\text{O}_3$  with a remarkable thickness ( $>1 \mu\text{m}$ ). In the central area of the round corner surface, transferred materials were found as well by cross-section observation (Fig. 5b).

During the service of hot stamping, abrasive wear was not as serious as the galling phenomenon in the current study. However, ploughing grooves were still found on both round corner and flat part, as shown in Figs. 5a and 2a. The slanted scratch in Fig. 5a was caused by the maintenance. The ploughing grooves on the round corner were relatively deep. It was reasonable because the round corner experienced higher shear stress than that of the flat area. The round corner was the place where abrasive wear most frequently happened. Therefore, some deep grooves were found in the central area of the round corner (one of them was shown in Fig. 6). The groove was parallel to the sliding direction and was filled with debris (Fig. 6b). The high content of O, Cr and Mo revealed by EDS point analysis (Fig. 6c) inferred that it came from the oxidized tool steel. The oxidation and detachment of debris from the tool steel surface took place during the service. Notice these oxidized debris were compacted and trapped in the deep grooves.

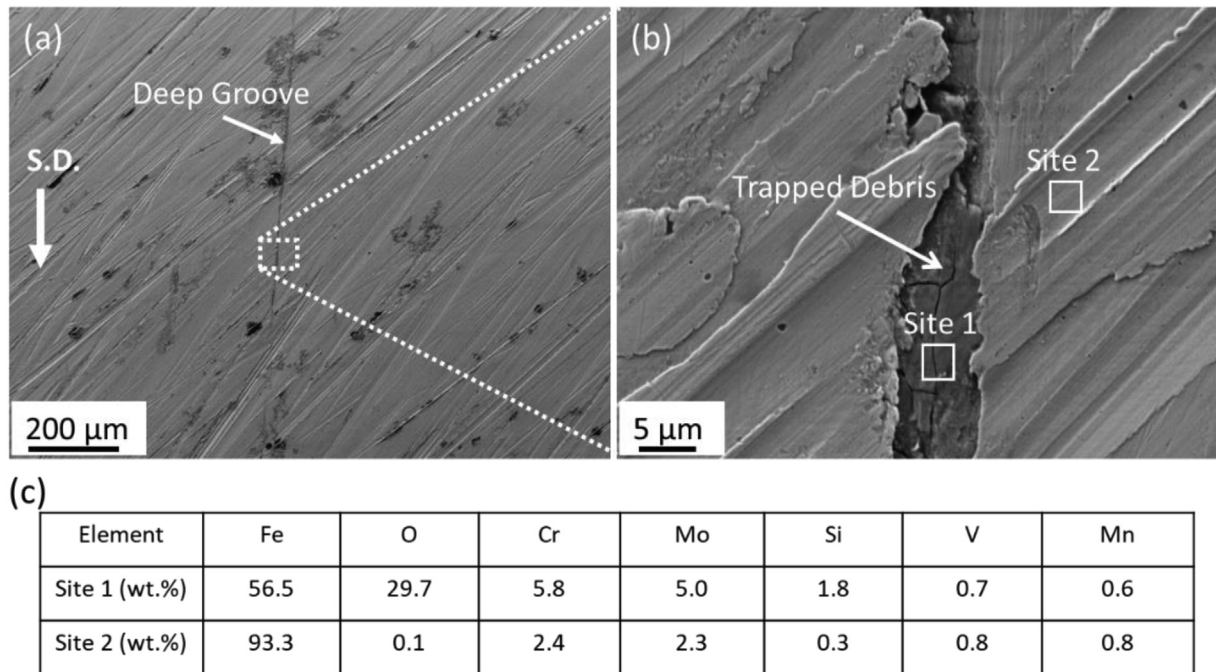
Fig. 6 – (a) Deep groove was found on the round corner surface. (b) Trapped debris found in magnified SEM image. (c) EDS analysis shows the trapped material is the oxidized debris from the tool steel.

could be easily oxidized due to their relatively high specific area and develop into debris consisting of a mixture of metal and oxides. The trapped materials in Fig. 6 are suspected to be this kind of debris.

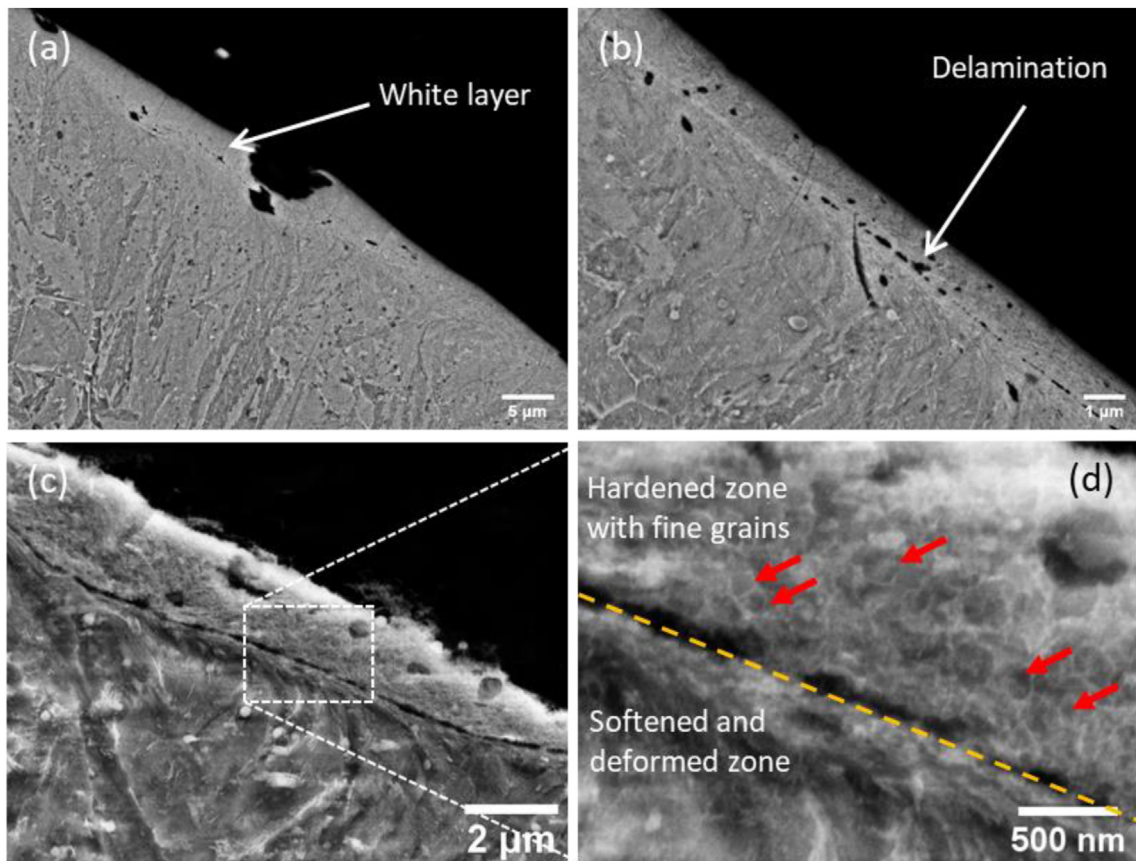
Fig. 7 shows SEM images from the cross-section at the center of round corner. Delamination was found in some local areas near the surface of the round corner. The thickness of these layers is about 1–5  $\mu\text{m}$ . A discontinuous line (Fig. 7b) appeared between the surface layer and substrate. Above the line, in the SEM image, the layer was brighter than that of the substrate and it was thus named as “white layer” in this paper. EDS analysis conducted on the white layer showed a similar composition to the substrate. At some places, as revealed in Fig. 7a, fracture found in the white layer suggested that it had experienced remarkable tensile stress during the hot stamping service. In addition, the delamination implied a weak bonding between this white layer and substrate, which could probably lead to spallation under a load of shear stress.

Secondary electron imaging SEM having high-resolution was used to reveal some detailed features. As shown in Fig. 7c and d, the white layer (above the delamination line) had an ultra-fine structure, implying that it probably had higher hardness than the region below the line. As can be seen in these images, the region below the line had severe plastic deformation caused by shear stress while no distinct deformation was found in the white layer, although the regions below and above the line were subjected to similar shear stress. This suggested that the hardness of the white layer may be much higher than that of the substrate. The formation of the white layer will be discussed further in Section 4.2.

Fig. 7 – Back scattered SEM images from the cross-section reveal the microstructure of the round corner center, (a) fractured “white” layer, and (b) delamination below the white layer. Secondary electron SEM images (c) and (d) detailed features near the surface.

The formation of the white layer shown in Fig. 7 is the consequence of thermal cycles experienced by the tool steel. During hot stamping, the top surface of the die will be heated up to a peak temperature above 800 °C by the hot workpiece. According to Ref. [14], the austenitizing start temperature of the die material, i.e., QRO 90 tool steel, is about 800 °C. Therefore, partial austenitizing of tool steel occurs within a shallow depth (1–3 μm). The subsequent rapid cooling caused by the water-cooling channels in the die results in the hardening of this surface region owing to martensite formation. During the service, it is expected that the top surface layer of the tool steel is subjected to a repeated austenitizing and quenching, leading to the formation of a layer with ultra-fine grains on the top surface. Hosseini [20] reported a similar white layer on high carbon 100Cr6 steel after fast turning. This layer would have a relatively high hardness due to the quenching process and will not be easily deformed. However, the substrate material, whose peak temperature was below the austenitizing temperature, will not experience austenitizing and just be softened. Hence, plastic deformation could take place easily in these regions, as can be seen in Fig. 7. Different deformation capability makes the white layer and substrate incompatible. This could be one of the reasons for delamination.

Another observation in Fig. 7b is that the black voids near the delamination line have been elongated. The assumption proposed by Suh [19] can interpret it properly. During the deformation, massive dislocations could be accumulated around the hard particles and voids develop. With the growth of the voids, they could be elongated and linked together to form a discontinuous line, as shown in Fig. 7. Further growth of the voids leads to the delamination.

expansion. However, as the temperature of the die decreases by the cooling channels, the surface layer tends to contract, and the substrate opposes it. The internal stresses change direction and turn to tensile stress. Beside this, austenitizing process in the white layer could also be one of the reasons causing tensile stresses. When the temperature in the white layer exceeds the austenitizing temperature, there is a volume contraction, because austenite ( $\gamma$ -Fe) with fcc structure has a higher atomic packing density than that of the martensite/ferrite phase. Hence, austenitizing will cause a sudden increase in density. The resultant volume contraction will also produce tensile stress in the white layer. As mentioned previously, the white layer with a high hardness has limited ductility. Therefore, fracture could happen in the white layer, as shown in Fig. 7a.

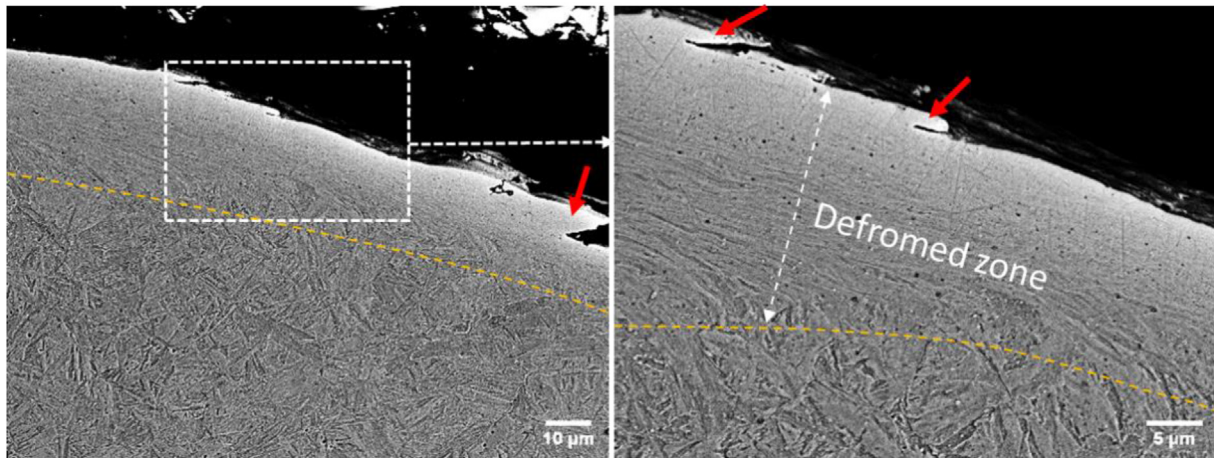
At the die exit of the round corner, severe shear deformation was also found in the region close to the surface (Fig. 8). The sites of exit refer to Fig. 9a. In the lower part of Fig. 8a, a typical tempered martensitic structure was observed. In the deformation zone having a depth of 10–20  $\mu\text{m}$ , this structure was stretched along the sliding direction. In Fig. 8b, the grain size reduction was seen in the severe deformed zone. In hot stamping, the die was repeatedly subjected to the shear and normal load at high temperatures. High shear stress can lead to not only the elongation of the grain but also break down the original grains into extremely fine size. As a consequence, the deformed zone showed a different microstructure from the matrix. For other sub-surface regions, the deformation depth

**Fig. 8** – Back scattered SEM images from the cross-section of the round corner exit (refer to Fig. 9a), showing severe plastic deformation of the sub-surface of die material. Solid arrows in the images indicate the initiation of wear fragments.

was only about 2–3  $\mu\text{m}$  due to lower shear stress (Fig. 7). Another interesting observation was the initiation of fragments from the uneven surface (marked as red arrows in Fig. 8), which also contributed to the wear in the current study. These fragments could be evolved as well into the third body particles that caused abrasive wear.

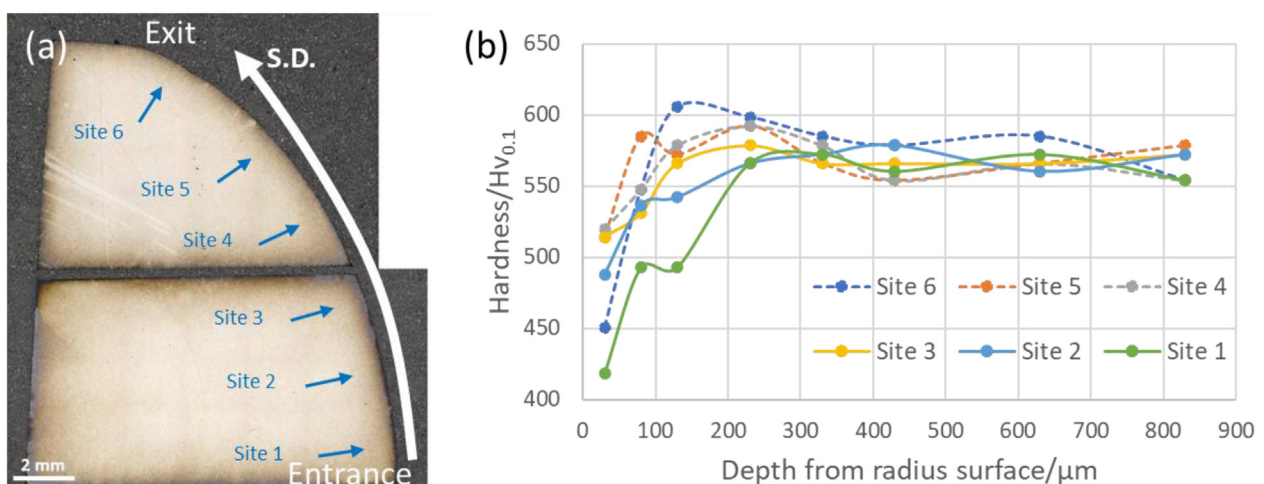
Hardness measurements of the sub-surface on the cross section of the round corner revealed the softening phenomenon of QRO 90 tool steel during the hot stamping process, as shown in Fig. 9. Microhardness test ( $\text{HV}_{0.1}$ ) was chosen in order to reduce the size of indentation and reveal the trend of hardness variation with the distance to the surface. As we can see, the hardness of the sub-surface was significantly lower than that of the bulk ( $\sim 570 \text{ HV}_{0.1}$ ). The softening of the sub-surface was believed to be related to the heating effect from the hot workpieces. The heat transferred from the workpieces decomposed the martensite into ferrite and carbides. With

time, the carbides were coarsened at high temperatures and the dislocation density in the material would be decreased greatly, leading to the softening of tool steel. As shown in Fig. 9b, the softening phenomenon became weaker and weaker from the entrance (Site 1) to exit (Site 6) of the round corner. Moreover, the softening depth of the sub-surface also decreased from  $\sim 250 \mu\text{m}$  to  $\sim 150 \mu\text{m}$ . This could be explained by the decrease in temperature when the boron steel workpieces travelled from the entrance to the exit of the round corner.

**Fig. 9** – The hardness on the cross-section of the round corner shows the softening of the sub-surface, (a) test sites, and (b) hardness profiles of various sites.

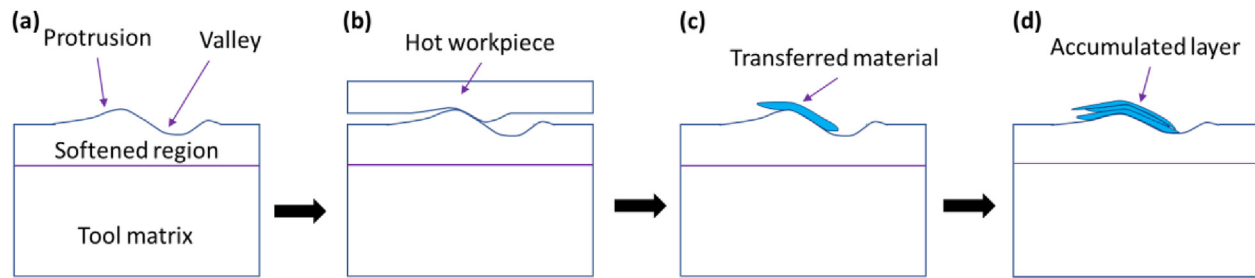
**Fig. 10 – The schematic diagram of the galling phenomenon. (a) Formation of protrusion, (b) Scratching the hot workpiece, (c) Transferred material stuck on the tool surface, (d) Accumulated layer (galling) on the tool surface.**

The galling process is schematically shown in Fig. 10. During the initial period, the working condition of the tool is good due to the unsoftened substrate and smooth surface. With the ongoing service (few thousands of cycles), the sub-surface of the tool is softened, as shown in Fig. 9. On the other hand, the already formed workpieces generally have a high hardness (around 500 HV) due to quenching in hot stamping. During the process of unloading, the hardened workpiece could generate some scratches (the valley in Fig. 10a) on the softened tool surface, leaving some protrusions at the edge of the scratches. In the next cycle of forming, these protrusions could scratch the hot and soft workpiece surface of boron steel (Fig. 10b). Consequently, some material could be transferred from the boron steel workpieces to the tool surface (Fig. 10c). Under the forming force and high temperature from the hot workpiece, the adhesive force between the transfer material and tool steel would be high. According to Ref. [17], the adhesive force is largely dependent on the real contact area (atomic level) of two solid materials. The adhesive force between ductile materials will be enhanced with the increased contact area by plastic deformation. In addition, a large adhesive force is often the case when combining similar materials. In the present study, the workpiece and tool are both made of steels. Considering the possible austenitizing at the surface of tool due to heating from the hot workpieces, both types of steel would have an fcc structure in the surface region when forming. This would further enhance the adhesive force. Hence, the transferred material can easily stick to the tool. Notably, this process can be repeated in the stamping processes, which results in the formation of accumulated layers (galling, Fig. 10d) until they are removed as part of daily maintenance. However, the root cause for galling is the softening of the sub-surface, which could lead to the easy formation of scratches and consequently the initiation of material transfer. This is consistent with Heinrichs' work [18]. From the perspective of this investigation, increasing the softening resistance of tool steel or performing hard facing on

the tool could be potential ways to mitigate the galling that happens in the hot stamping process.
