## **Investigation on Pollution-Induced Flashovers of In-Service Insulators in Ethiopian Power Transmission Lines**

# Investigation on Pollution-Induced Flashovers of In-Service Insulators in Ethiopian Power Transmission Lines

Berhanu Zelalem Desta <sup>1,2,\*</sup>, Mengesha M. Wogari <sup>2</sup> and Stanislaw M. Gubanski <sup>3</sup>

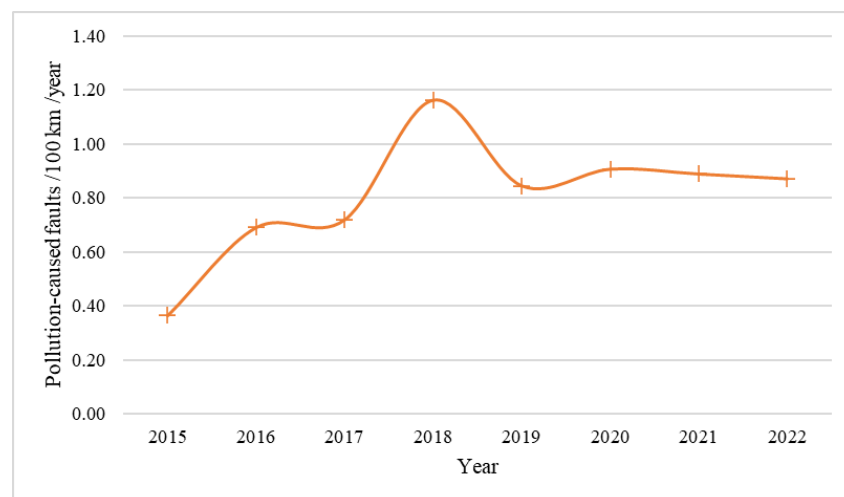
Scrutiny of the identified pollution-induced faults revealed that yearly trends in their appearance varied from one year to another—it had an increasing trend, peaking in 2018, as shown in Figure 7. Since 2019, it has become constant due to pollution saturation (an equilibrium condition between the pollution deposit rate and insulator cleaning rate) [1]. The reason for the increasing trend could be attributed to changes in environmental and meteorological conditions, issues related to the selection and dimensioning of insulators, infrastructure aging, and ineffective maintenance procedures. Further study is required to elucidate the reason for this trend and develop strategies to mitigate future fault occurrences.

**Figure 7.** Annual variation in pollution-induced faults in Ethiopian power grid.

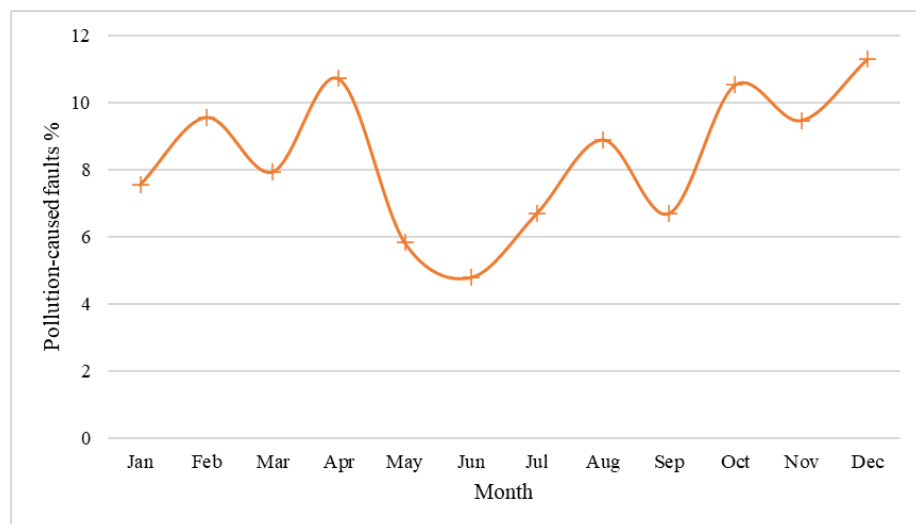
The seasonal pattern of fault incidence is depicted in Figure 9, exhibiting a maximum fault during the dry months of October to February and March to May, peaking in December and April. A relatively lower number of faults occur from May to September, except for August, which falls during the main rainy season in most parts of Ethiopia. The seasonal trend of fault occurrence follows the rainfall patterns in the country.

**Figure 9.** Seasonal trend of pollution-induced flashover faults in the Ethiopian power network.

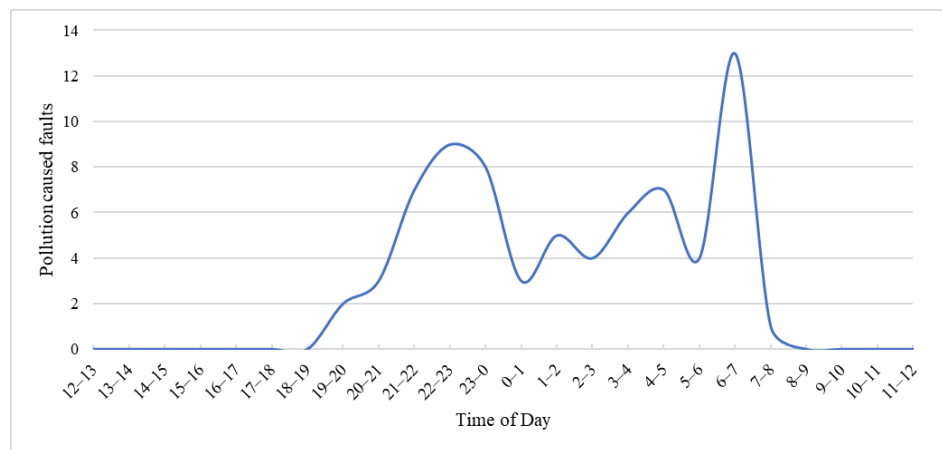
The time-of-the-day curve depicted in Figure 15 reveals that most of these faults occurred close to midnight, from 22:00 to 23:00, and early in the morning, between 6:00 to 7:00. Figure 16 indicates that the majority of faults occurred between November and February, attributed to dew formation on the glass insulator surface, and from March to May (due to light precipitation), respectively, corresponding to the dry and light rainfall seasons in the area. Most faults were concentrated during spring ploughing, winter crop harvesting, and burning. The bird streamer mechanism may contribute to the faults occurring in October and November, during the autumn season. The described conditions are consistent with type A and type B pollution-flashover mechanisms.

**Figure 15.** Daily distribution of pollution-induced faults of the Bahir Dar II—Debre Markos—Sululta 400 kV line.

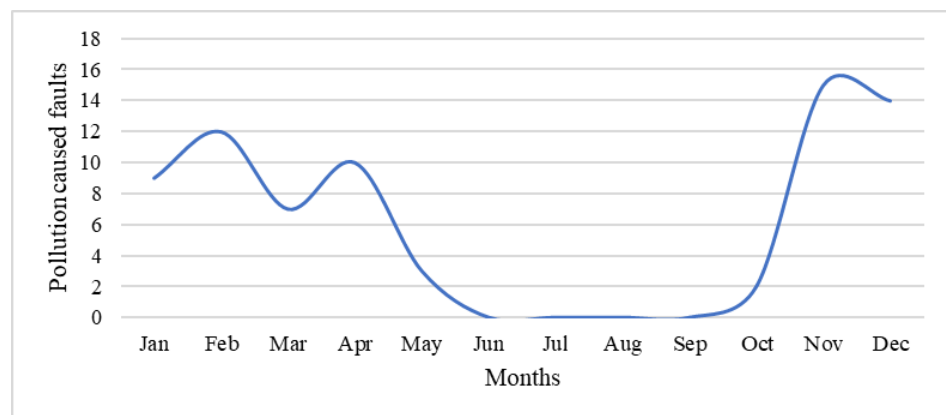
**Figure 16.** Monthly distribution of pollution-induced faults of the Bahir Dar II—Debre Markos—Sululta 400 kV line.
