Investigation on Pollution-Induced Flashovers of In-Service Insulators in Ethiopian Power Transmission Lines

Zelalem Desta, B., Wogari, M., Gubanski, S. (2024). Investigation on Pollution-Induced Flashovers of In-Service Insulators in Ethiopian Power Transmission Lines. *Energies*, 17(9). <http://dx.doi.org/10.3390/en17092007>

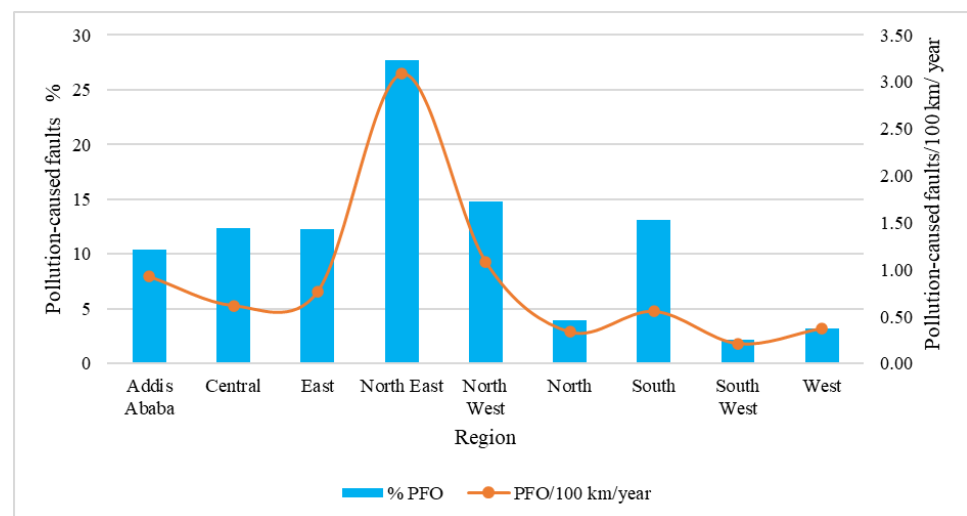
The distribution of pollution-induced faults in each grid region of EEP between 2015 and 2022 is presented in Figure 4. Among these regions, the Northeast region suffered 290 (27.8%) faults, the highest frequency of interruptions with 3.1 faults/100 km/year, followed by the Northwest region which endured 155 (14.8%) faults and 1.1 faults/100 km/year. The Addis Ababa, East, Central and South grid regions also experienced a higher number of interruptions during this period with more than 100 faults and 0.55 faults/100 km/year each. The Southwest region suffered 23 (2.2%) faults, the lowest number of incidents with 0.2 faults/100 km/year.

Figure 4. Distribution of pollution-induced flashover faults across EEP grid regions from 2015–2022.

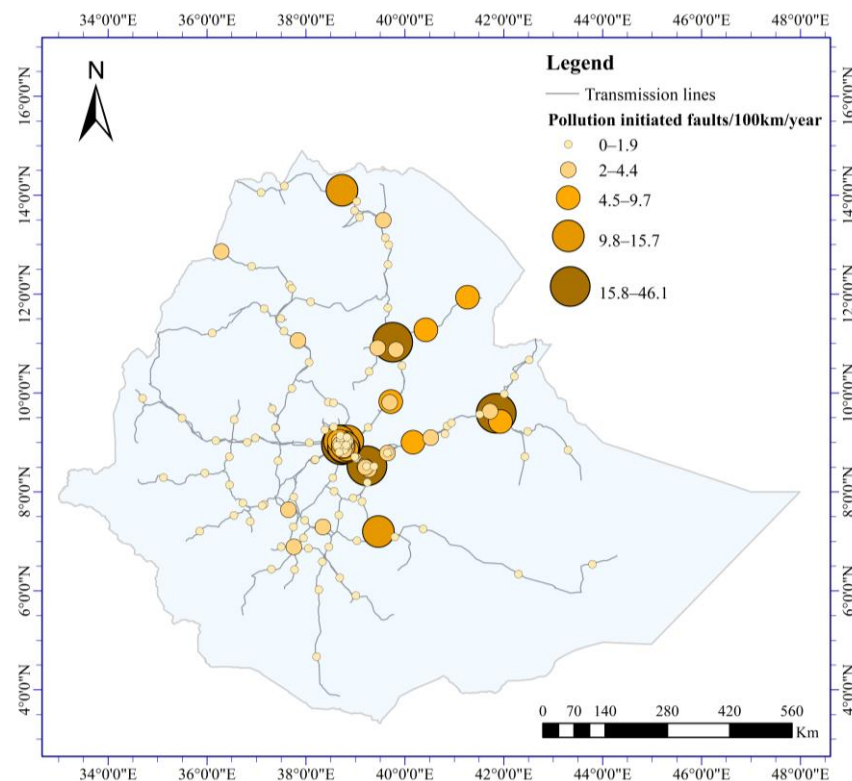
Figure 5. Geographical distribution of pollution induced faults across Ethiopia from 2015–2022.

Pollution flashover faults were found in 152 circuits, with an average of 3.0 faults per 100 km per year. In terms of geographical variations, the majority of these circuits were concentrated in the Northeast, Eastern, and Central part of Ethiopia as shown in Figure 5.

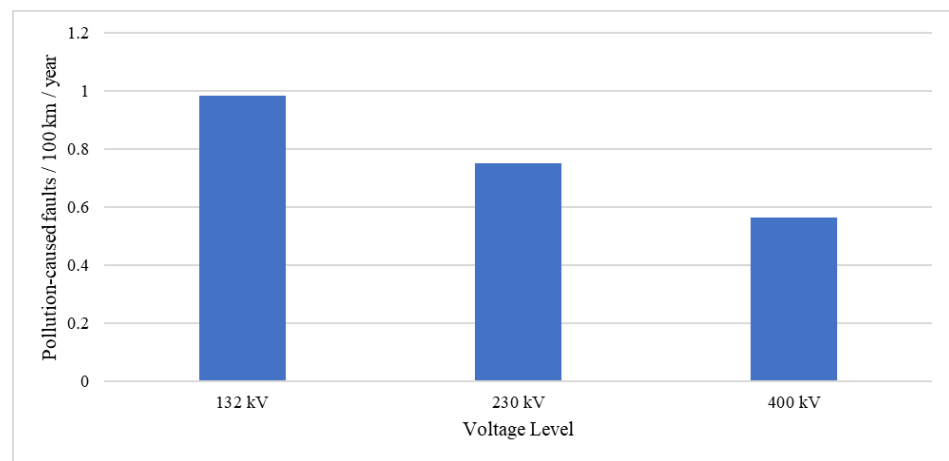
Figure 6. Frequency of pollution-induced faults for 132 kV, 230 kV, and 400 kV lines.

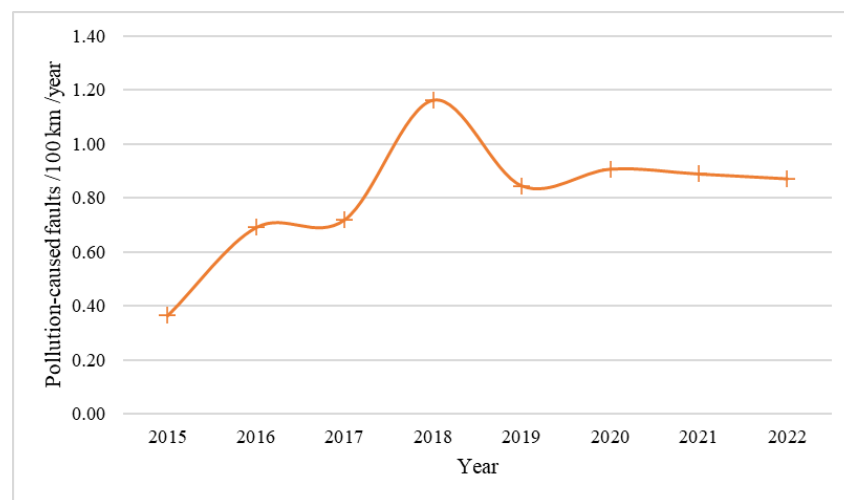
Scrutiny of the identified pollution-induced faults revealed that yearly trends in their appearance varied from one year to another—it had an increasing trend, peaking in 2018, as shown in Figure 7. Since 2019, it has become constant due to pollution saturation (an equilibrium condition between the pollution deposit rate and insulator cleaning rate) [1]. The reason for the increasing trend could be attributed to changes in environmental and meteorological conditions, issues related to the selection and dimensioning of insulators, infrastructure aging, and ineffective maintenance procedures. Further study is required to elucidate the reason for this trend and develop strategies to mitigate future fault occurrences.

Figure 7. Annual variation in pollution-induced faults in Ethiopian power grid.

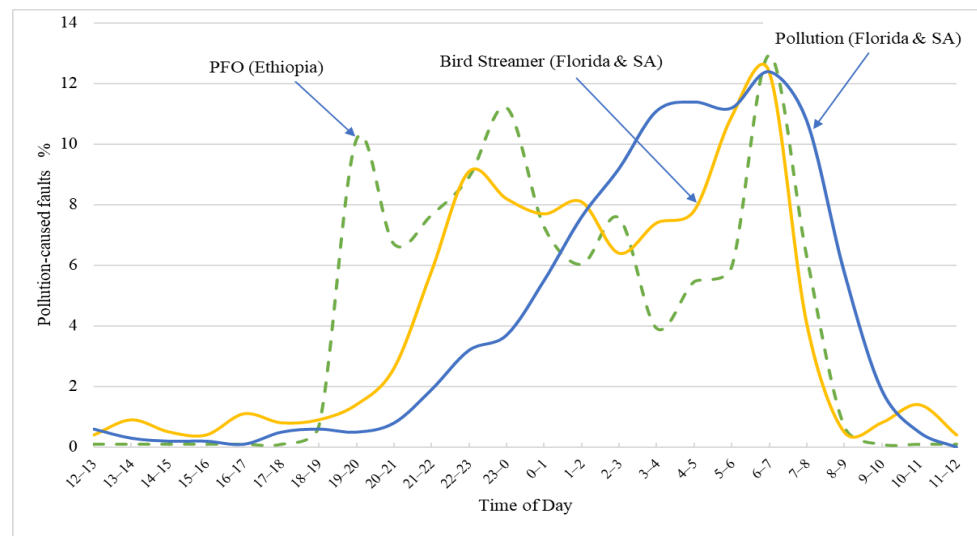
The time-of-the-day curve of pollution induced faults (PFO) is shown in Figure 8. It exhibits a pattern characterized by three peaks. The number of faults rises quickly after sunset between 19:00–20:00, and after showing a decrease, it again rises around midnight, mainly due to pollution wetting that can be associated with light precipitation, dew formation, and moisture adsorption during the night. At around 06:00 in the early morning, there is again a rapid increase in the fault number, likely due to a combination of wetting and bird steamers, the latter usually occurring during the spring season in areas populated by large birds. Thereafter, the number of faults drops close to zero and remains at this level practically for the whole day. This pattern has a good correlation with the

patterns for bird streamer and pollution-caused faults in Florida and in South Africa, as shown in Figure 8.

Figure 8. Pollution-induced faults within the Ethiopian network, in comparison with the typical time-of-day fault profiles attributed to pollution and bird streamers observed in Florida, USA, and South Africa [2,19].

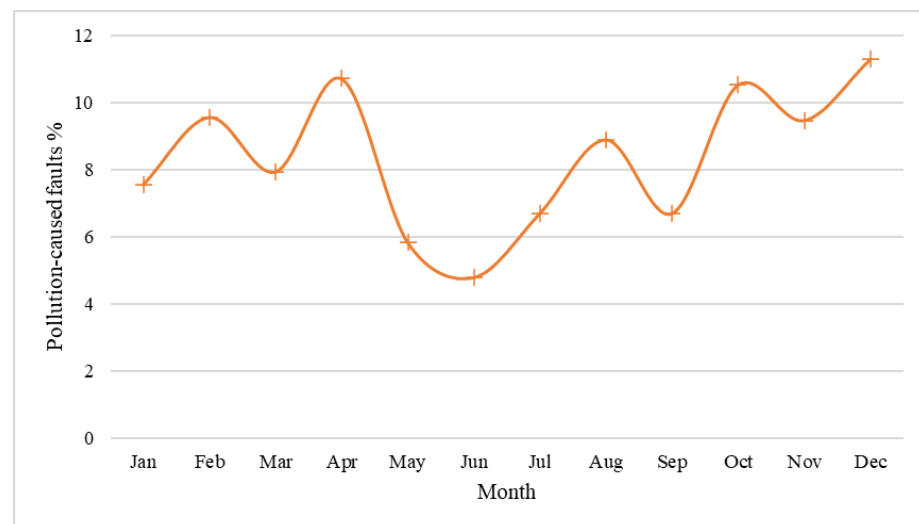
The seasonal pattern of fault incidence is depicted in Figure 9, exhibiting a maximum fault during the dry months of October to February and March to May, peaking in December and April. A relatively lower number of faults occur from May to September, except for August, which falls during the main rainy season in most parts of Ethiopia. The seasonal trend of fault occurrence follows the rainfall patterns in the country.

Figure 9. Seasonal trend of pollution-induced flashover faults in the Ethiopian power network.

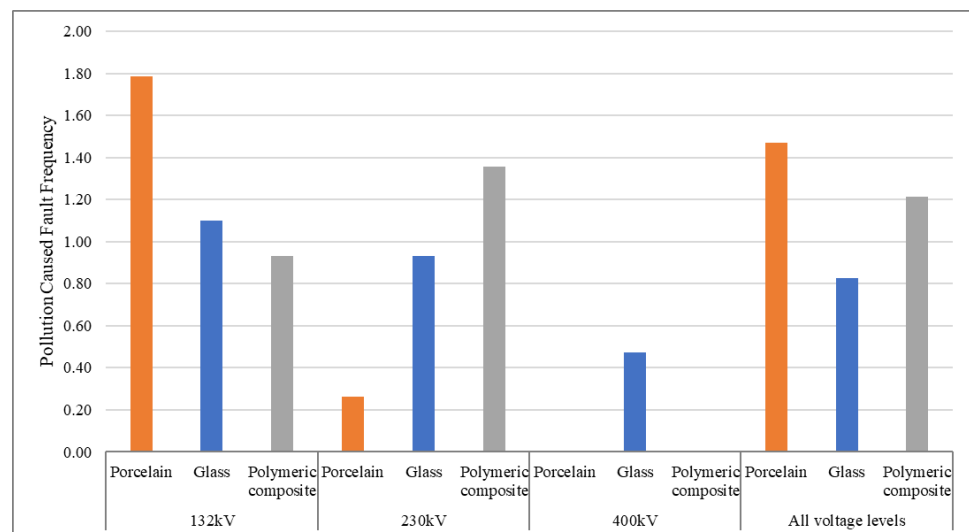
The analysis result indicates that, out of the total 1045 pollution-induced faults, 77 (7.3%) occurred on porcelain strings, 542 (51.9%) on glass strings, and the remaining 426 (40.8%) occurred on polymeric composite long rods. Most of the faults occurred on glass and polymeric insulators which, respectively, represent 61% and 34% of the total insulators installed in the system, while porcelain insulators strings represent only 5%. Figure 10 compares the pollution flashover intensity for each voltage level and for insulator types, covering eight consecutive years from 2015 to 2022. For 132 kV lines, the intensity of pollution-induced flashovers was highest on strings assembled from porcelain cap-and-pin insulators, with the intensity of 1.79 faults/year/1000 units, followed by glass insulator strings with 1.10 faults/year/1000 units and polymeric long rod insulator, which suffered the least number of faults with less than 0.93 faults/year/1000 units. For 230 kV lines, the intensity of pollution-induced flashovers was highest on strings of polymeric composite insulators with the intensity of 1.36 faults/year/1000 units and followed by glass insulator strings with 0.93 faults/year/1000 units. Here, porcelain insulators had the lowest intensity of faults with less than 0.26 faults/year/1000 units. In 400 kV lines, glass insulator strings are exclusively used and experienced the fault intensity of 0.47 faults/year/1000 units.

Figure 10. Distribution of PFO intensity by type of insulator (2015 to 2022).

For the three voltage levels, porcelain insulator strings had the highest pollution-induced flashover intensity of 1.47 faults/year/1000 units, followed by polymeric composite long rod insulators with an intensity of 1.21 faults/year/1000 units and glass insulator strings with the lowest fault intensity of 0.83 faults/year/1000 units. The percentage distributions of individual insulator types and a comparison to the intensities of pollution-induced flashovers for all voltage levels are summarized in Table 3.

As already indicated, the combined intensity of pollution flashovers was highest on strings assembled from ceramic (porcelain and glass) insulators, mainly due to their hydrophilic surface properties. Moreover, the other reason which additionally contributes to the poor pollution performance of these insulators can be attributed to aging, as these lines were built 30–40 years ago. Various environmental stresses erode and degrade their end fittings and surfaces. These include exposure to high-temperature variations during long, dry periods and vandalism. This conclusion is also supported by the reported service experience.

We therefore recommend that EEP improves its practice towards selection and dimensioning of outdoor insulators by defining guidelines for monitoring, maintenance, and inspection procedures for new and existing lines. One of the major uncertainties when selecting outdoor insulators can be linked with estimation of the actual values of the pollution severity level of installation sites. Field monitoring of pollution severity at critical line locations and establishing test stations for carrying intensive measurement campaigns is a prerequisite for improving the present state. Ultimately, creating a comprehensive pollution severity map covering the entire country can provide invaluable information for optimal insulator selection. Moreover, pollution performance tests and acceptance criteria should be included as requirements in the purchase specifications for outdoor insulators.

In addition, EEP should implement scheduled maintenance plans and palliative practices to compensate for the design failures, thereby reducing maintenance costs and mitigating premature failures of outdoor insulators. These plans should be based on detailed evaluations of environmental factors, alongside considerations of technical, economic, and logistical viability. Potential maintenance and preventative strategies to mitigate pollution flashover-caused outages include washing substation and line insulators, using creepage extenders, replacing hydrophilic insulators with hydrophobic alternatives, and application of RTV silicone coatings. The selection of these measures should depend upon their economic and technical feasibility [1,2,12,14].

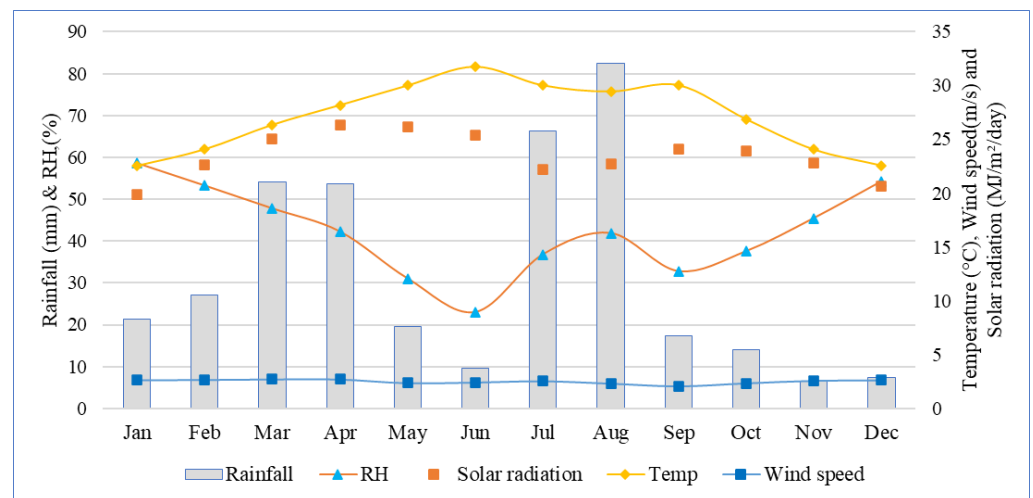
which has a desert and semi-arid climatic conditions, characterized by having limited rainfall throughout the year. It is near the Danakil desert and Red Sea and is exposed to direct salt sprays, salty dusts, and salty fog carried by strong winds. It also is exposed to mining contamination from the desert and saline lakes in the region and is thus subject to a combination of type A and type B pollutants. The line is insulated with long-rod HTV silicone rubber composite insulators and is known from service experience to have poor performance. A total of 105 pollution-induced flashovers were identified on this line from 2015 to the end of 2022, an average of 13.1 faults per year. Figure 11 shows the monthly average meteorological parameters across the entire length of the line. The line receives an average rainfall of less than 48 mm from March to August. The yearly average values of relative humidity (above 42%), temperature (above 27 °C), and windspeed (2.5 m/s) fit the conditions for pollution accumulation and wetting.

Figure 11. Monthly average meteorological parameters across the entire length of the Combolcha II—Semera—Dicheto 230 kV line [28].

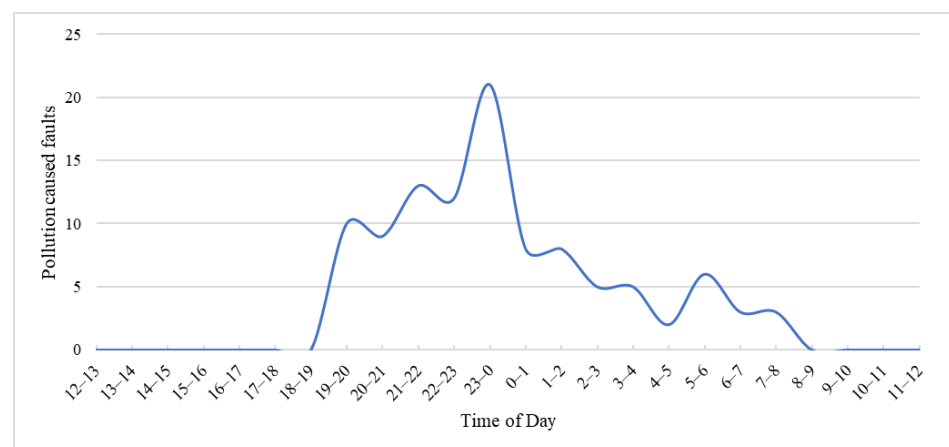
Figures 12 and 13 indicate that the pollution-induced faults mainly occurred on the line during the night from 19:00 to early morning (5:00–6:00), peaking at midnight (23:00–1:00) and especially in April and August. This is the rainy season in the region, having relatively low rainfall levels, when insulator surfaces are wetted by light precipitation during the evening hours and dew formation at sunrise.

Figure 12. Daily distribution of pollution-induced faults of the Combolcha II—Semera—Dicheto 230 kV line.

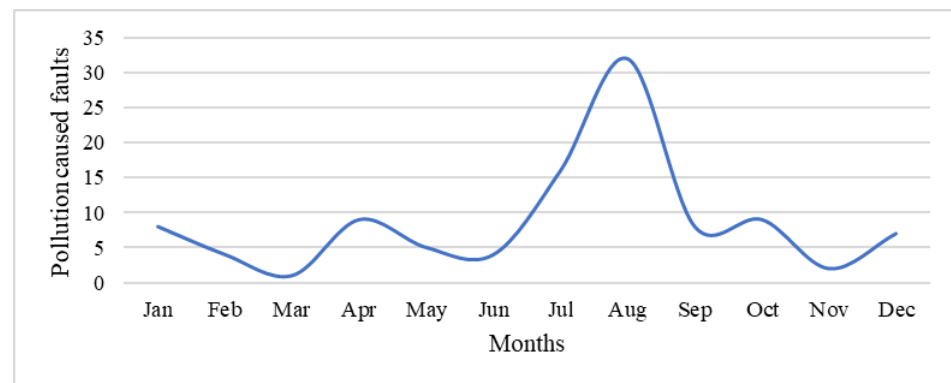
Figure 13. Monthly distribution of pollution-induced faults of the Combolcha II—Semera—Dicheto 230 kV line.

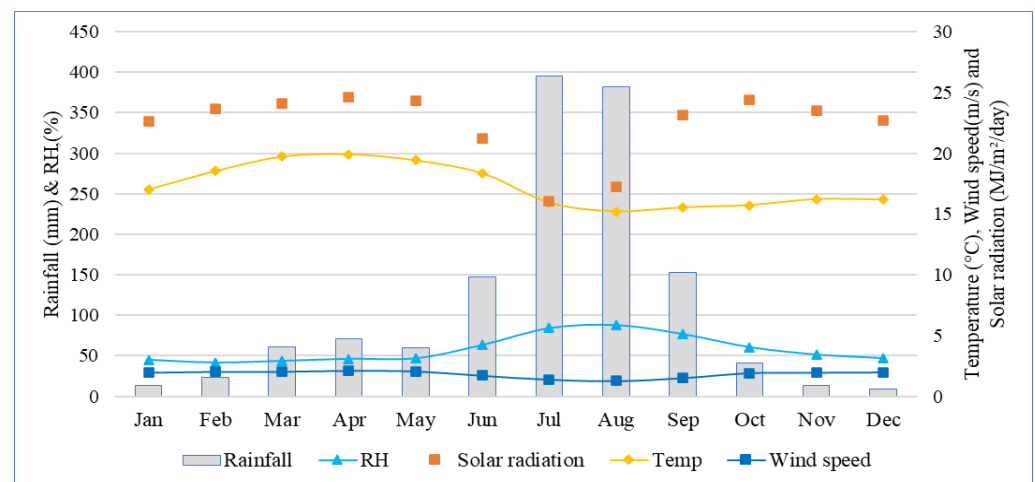
The Bahir Dar II—Debre Markos—Sululta 400 kV line spans 410 km, extending from the northwestern highlands of Ethiopia to Addis Ababa, crossing subtropical highland and tropical savanna climatic conditions. The environmental conditions along the route of the line are characterized by a mixture of desert, industrial, and agricultural pollutants. The main sources of pollution in the area are from transportation, construction, quarry sites, naturally occurring dust from local soils, cement factories, and agricultural activities such as ploughing, fertilizers, crop spraying, and harvesting. The line is insulated with glass-cap and pin strings. The line is known for having a high number of unexplained outages, and the performed analysis identified a total of 72 pollution induced faults on it for the period between 2015 to 2022, an average of 9 faults per year. Figure 14 shows the monthly average meteorological parameters across the entire length of the line. The line receives an average rainfall of about 270 mm from June to September and an average relative humidity above 58%, temperature above 17 °C and windspeed 1.8 m/s for the whole year.

Figure 14. Monthly average meteorological parameters across the entire length of the Bahir Dar II—Debre Markos—Sululta 400 kV line [28].

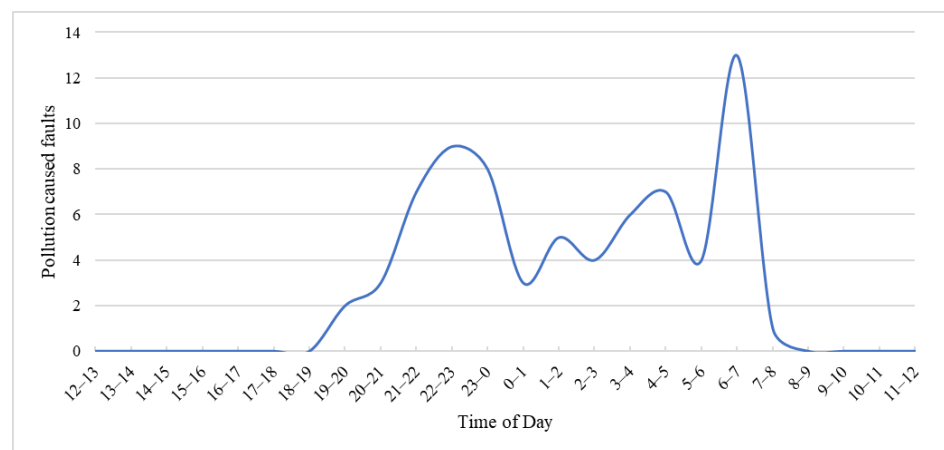
The time-of-the-day curve depicted in Figure 15 reveals that most of these faults occurred close to midnight, from 22:00 to 23:00, and early in the morning, between 6:00 to 7:00. Figure 16 indicates that the majority of faults occurred between November and February, attributed to dew formation on the glass insulator surface, and from March to May (due to light precipitation), respectively, corresponding to the dry and light rainfall seasons in the area. Most faults were concentrated during spring ploughing, winter crop harvesting, and burning. The bird streamer mechanism may contribute to the faults occurring in October and November, during the autumn season. The described conditions are consistent with type A and type B pollution-flashover mechanisms.

Figure 15. Daily distribution of pollution-induced faults of the Bahir Dar II—Debre Markos—Sululta 400 kV line.

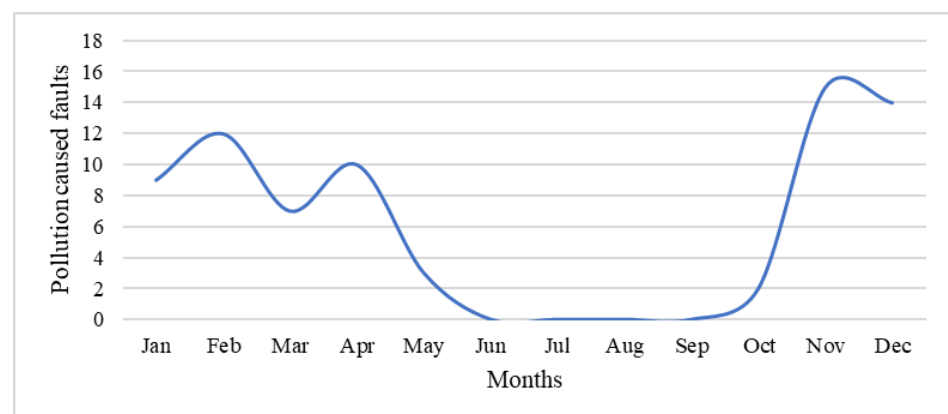
Figure 16. Monthly distribution of pollution-induced faults of the Bahir Dar II—Debre Markos—Sululta 400 kV line.

Moreover, the reduction in flashover voltage (above 10%), because of the lowered air density by high altitude (~2000 m) and nearly constant temperature along the route of the line, could also contribute to the increased outage rate [1]. Therefore, there is a good
