## Hydrogen embrittlement at elevated temperature during low cycle fatigue of AISI 321 stainless steel

Anilkumar, V., Wanjura, S., Kulawinski, D. et al (2026). Hydrogen embrittlement at elevated temperature during low cycle fatigue of AISI 321 stainless steel. Engineering Failure Analysis, 184. http://dx.doi.org/10.1016/j.engfailanal.2025.110307

### **Engineering Failure Analysis**

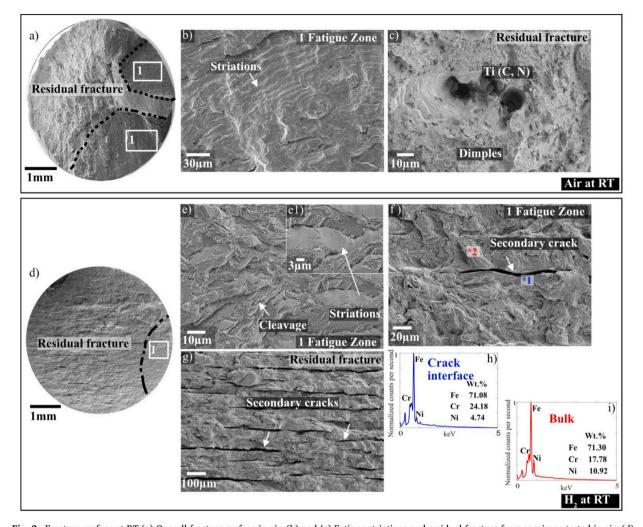
At RT, in the fatigue zone of specimen tested in air, striations were observed pointing away from the crack initiation site, as marked in Fig. 3b. The dimples in the residual fracture, especially the pull outs of Ti(C,N), denoted the ductile nature of fracture (Fig. 3c) here. In contrast, the fatigue zone of the specimen tested in  $H_2$  at RT exhibited a predominantly striation-free fracture (Fig. 3e-f), though sparsely distributed small areas of striations could be observed occasionally. This fatigue zone featured secondary cracks with surrounding cleavage (Fig. 3f). The difference in the fatigue zone correlates to the drop in LCF performance. To understand the secondary cracks in the fatigue zone, EDX point analyses were performed at bulk and at the crack interface, as shown in Fig. 3h and Fig. 3i. The higher chromium (Cr) and lower nickel (Ni) content at the interface, where cracking occurred, confirmed the presence of  $\delta$ -ferrite. Cracking along the  $\delta$ -ferrite phase boundaries in the fatigue zone, as shown in (Fig. 3f), suggests that such phase boundaries could serve as potential crack initiation and propagation paths during cyclic loading. Additionally, in Fig. 3g, an increase in secondary cracks of the same nature is seen in the residual fracture zone with no dimple formation. Although the residual fracture in tension after the test interruption can also be an indication of the effect of H, it should not be mixed up with the fatigue zone.

Fig. 3. Fracture surface at RT (a) Overall fracture surface in air; (b) and (c) Fatigue striations and residual fracture from specimen tested in air; (d) Overall fracture surface in  $H_2$ ; (e), (e1) and (f) Cleavage fracture, scarce presence of striations and secondary cracks in fatigue zone of  $H_2$  tested specimens; (g) Secondary cracking in residual fracture; (h-i) EDX point analysis of bulk and near the cracks in fatigue zone of  $H_2$  tested specimens as marked in (f). note: regions marked '1' in (a) and (d) represent fatigue zone.

At room temperature, the fatigue zone of specimens tested in air exhibits typical striations indicative of a ductile behaviour in the alloy (Fig. 3b). However, after prolonged thermal pre-charging (350 °C for 672 h) and subsequent testing in  $H_2$  environment at RT, the fracture surface dramatically changes. Cleavage is the dominant fracture mode (Fig. 3e). Furthermore, the fatigue zone in these  $H_2$  tested specimens shows secondary cracking along  $\delta$ -ferrite interfaces (Fig. 3f). It should be mentioned that a few isolated and sparsely distributed striation zones exist (Fig. 3e1). In addition, slip bands could be observed in some of the untransformed austenite grains from band contrast image of RT  $H_2$  tested specimen shown in Fig. 5e. These features suggest a combination of HEDE and HELP mechanisms. When tested in  $H_2$  at RT, the possible activation of HELP mechanism can lead to highly localized slip deformation transforming austenite into martensite at the crack front. This provides H diffusion pathways that may lead to a local increase in H content [29]. Furthermore, H accumulates at the austenite/martensite interfaces, as newly formed martensite saturates and rejects excess H, promoting preferential crack propagation by weakening the cohesive strength of these boundaries via HEDE [8]. Thus the observed cleavage fracture at RT in  $H_2$  could be in fact a combination of HELP and HEDE mechanisms [30]. Crucially, the observation of secondary cracks along the  $\delta$ -ferrite phase boundaries (Fig. 3f) indicates that these interfaces are prone to H-assisted weakening by a similar mechanism [14]. Accordingly, at RT, the concurrent presence of DIM and  $\delta$ -ferrite correlates with accelerated fatigue crack initiation and propagation via HEDE and HELP mechanisms.

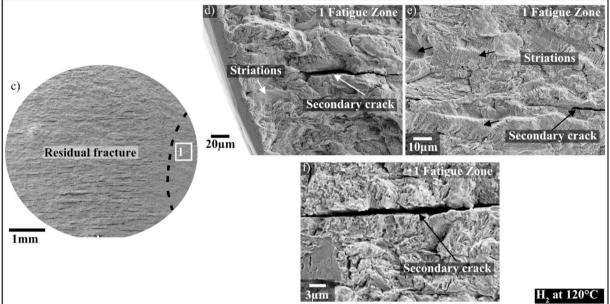
At 120 °C, a pronounced drop in life due to H uptake was also found, and there were some changes in the fracture surface characteristics (Fig. 4) compared to RT counterparts (Fig. 3). When tested in air at this temperature, a ductile nature of fracture was seen with fatigue striations in the fatigue zone (Fig. 4b) and dimples in the residual fracture (Fig. 4a). This was like the specimen tested in air at RT. When tested in H<sub>2</sub>, cleavage was observed, and the fatigue zone featured relatively more striation zones compared to the specimen tested at RT (Fig. 3e). Here parallel cracking associated with  $\delta$ -ferrite interphase boundaries was seen as well (Fig. 4d-f). Interestingly, the regions close to  $\delta$ -ferrite interphase boundaries featured fracture without striations (cleavage like) as shown in Fig. 4f. The residual fracture zone was observed with secondary cracks along  $\delta$ -ferrite phase boundaries, as shown in Fig. 4d and Fig. 4g. In this study, no secondary cracks are observed to be associated with grain boundaries of austenite either from fracture surfaces or from cross sections of fatigue zone (Fig. 3e-d, Fig. 4d-f, & Fig. 6b).

Fig. 4. Fracture surface at 120 °C (a) Overall fracture surface in air; (b) Fatigue striations from specimen tested in air in fatigue zone; (c) Overall fracture surface in  $H_2$ ; (d-e) Presence of striations and secondary cracks along δ-ferrite phase boundaries; (f) lack of striations around δ-ferrite phase boundaries.

At 120 °C, DIM formation is not favoured. Specimens tested in air exclusively display striations and no indications of brittle behaviour (Fig. 4b). Conversely, specimens tested in H<sub>2</sub> environment exhibits secondary cracks along the δ-ferrite interfaces (Fig. 4d-f). Here fracture mode close to δ-ferrite interface is cleavage (Fig. 4f). Under cyclic loading, crack tip blunting may be inhibited close to these interfaces, and the crack tip may remain relatively sharp. In addition, new cracks could be formed as seen from secondary cracks along these interfaces in the fatigue zone (Fig. 4d-f). Notably, when tested in H<sub>2</sub>, the specimens show more striation-rich regions (Fig. 4e) compared to their RT counterparts (Figs. 3e-e1). The lack of DIM at 120 °C could be the reason for the presence of striations in H<sub>2</sub> tested specimens. Moreover, multiple slipping occurs in austenite in presence of H (Fig. 6b). The combined action of HEDE and HELP mechanisms is thus believed to be responsible for the observed HE at this elevated temperature. Likely, the weight of HELP could be higher than in its RT counterpart. The operative HE processes apparently involve δ-ferrite/austenite phase boundaries. The inherent strain partitioning between  $\delta$ -ferrite and austenite leads to strain localization in austenite (Fig. 6e), with and without the presence of H [31]. Although differences in plastic strain accumulation in these two cases complicate direct comparison of dislocation mobility in austenite, it is known that H promotes dislocation motion through the HELP mechanism [27,28]. Consequently, strain partitioning occurs earlier, accelerating strain localization in austenite at lower LCF cycles. This is confirmed by the extensive slipping in Fig. 6b. Interestingly, as presented in Fig. 6e, slip bands terminate at the  $\delta$ -ferrite phase boundary, indicating impeded dislocation motion there. Meanwhile, a higher dislocation density, evidenced by regions of increased brightness in Fig. 6e, imply dislocation pile up and consequently stress concentration in front of the  $\delta$ -ferrite phase boundary. These interfaces are also preferential sites for H accumulation [32], leading to potential reduction in cohesive strength. The combination of localized increase in interfacial stresses owing to strain localization in austenite (via HELP) and H-induced reduction in interfacial cohesion (via HEDE), could promote faster crack initiation and propagation along  $\delta$  phase boundaries. Nonetheless, the strain localization observed in specimens without the presence of H did not lead to secondary cracking along the phase boundaries (Fig. 4a). Indeed, it is the synergistic effect of hydrogen accumulation and strain localization that lead to secondary cracks and adjacent cleavage-like regions. (Fig. 4f). In summary, at 120 °C in the absence of DIM, our observations are consistent with HELP and HEDE mechanisms acting at  $\delta$ -ferrite/austenite boundaries, which likely contribute to accelerated crack initiation and propagation and reduced LCF life. The presence of δ-ferrite worsens fatigue life, though alternative HE pathways cannot be excluded.

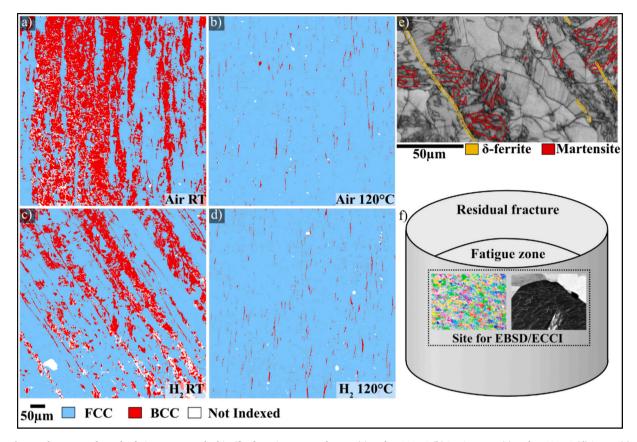
To distinguish martensite from  $\delta$ -ferrite, "Classify" data analysis mode in Aztec Crystal software was used in image quality (IQ) maps. The result is given in Fig. 5e. Deformation-induced martensite was distinguished based on morphology and IQ maps. It typically exhibited lower IQ values, appearing as darker regions. The difference in grain morphology of martensite and  $\delta$ -ferrite further aids in the classification. Compared to martensite, as mentioned earlier, the  $\delta$ -ferrite phase displays a characteristic 'string-like' morphology, often extending across multiple austenite grains aiding in its identification. Notice that Fig. 5e serves as a representative example of the identification technique and not all DIM and  $\delta$ -ferrite regions are explicitly marked in this figure. The amount of DIM can be quantified by image analysis, as presented in Table 3. At room temperature, approximately 31 % DIM was observed in specimens tested in air, whereas  $\sim$  14.7 % was detected in specimens tested in H<sub>2</sub>. At 120 °C, formation of martensite was not observed in either air or H<sub>2</sub> tested specimens, see Fig. 5b, Fig. 5d and Table 3. Under these conditions, the BCC phase detected was  $\delta$ -ferrite, which can be readily

distinguished from austenite based on its distinct morphology. These findings confirm that at 120  $^{\circ}$ C and 0.45 % strain amplitude, austenite is stable against DIM formation.

Fig. 5. Phase maps from the fatigue zone marked in (f) of specimens tested at RT (a) and at 120  $^{\circ}$ C (b) in air; at RT (c) and at 120  $^{\circ}$ C (d) in H<sub>2</sub>; (e) Distinguishing  $\delta$ -ferrite and martensite from IQ map with the "Classify" data analysis mode in AztecCrystal software.

In the current study, it was observed that austenite remained stable in specimens tested at 120 °C, with no signs of DIM formation, as shown in Fig. 5b and Fig. 5d. This is attributed to the test temperature being above the  $M_d$  temperature of the alloy [10]. The absence of DIM explains the enhancement in the number of cycles to crack initiation by 56 % in air at 120 °C, compared to room temperature. Similar observations have been made by Grosse et al. [15] who reported that martensite formation follows an exponential decay with increasing LCF testing temperatures in AISI 321. The lack of DIM eliminates its detrimental effect on strain-controlled LCF performance, as martensite formation causes higher cyclic stress response [26].

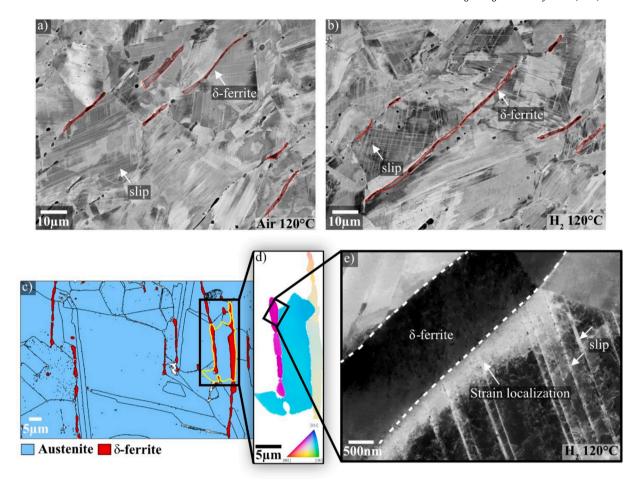
It is well known that electron channelling contrast (ECC) is the strongest under two-beam diffraction conditions, enabling observation of crystal defects, such as dislocations, stacking faults, twins in an SEM [23]. At the same locations previously analysed by EBSD in Fig. 5, post-mortem microstructural analysis of specimens tested at 120 °C using controlled-electron channelling contrast imaging (cECCI) is shown in Fig. 6. At 120 °C no DIM formation was observable (see Fig. 5b and Fig. 5d). This indicates that this temperature is above the  $M_{\rm d}$  temperature of the alloy, where DIM formation is not feasible. The deformation is primarily accommodated by slip, as evident from the slip traces observed in austenite irrespective of testing environment in Fig. 6a and Fig. 6b. The presence of  $\delta$ -ferrite is also highlighted in the image.

Controlled-electron channelling contrast imaging can also be used to elaborate the role of  $\delta$ -ferrite interphase. An EBSD phase map, as shown in Fig. 6c, was first acquired near the fatigue zone, as indicated schematically in Fig. 5. Austenite and  $\delta$ -ferrite are the two phases observed here (note: electrochemical polishing removed Ti(C,N) precipitates). Randomly oriented austenite grains with adjacent  $\delta$ -ferrite were selected for detailed analysis, as highlighted in Fig. 6c and its orientation is shown in Fig. 6d. The corresponding cECCI analysis, presented in Fig. 6e, reveals strain localization at the austenite- $\delta$ -ferrite phase boundary, evidenced by regions of increased brightness signifying a higher dislocation density. Additionally, the presence of slip bands and their termination at the  $\delta$ -ferrite phase boundary can be observed in Fig. 6e, highlighting the role of phase boundaries in impeding the dislocation motion.

H was complicated. Nevertheless, the accumulation of H along the phase boundaries when combined with the strain localization could worsen the interface strength, leading to decohesion of the boundaries. This will be discussed in detail in next section.

Fig. 6. Deformation of austenite through slip at 120 °C in air (a) and in  $H_2$  (b); (c) EBSD phase map showing the presence of austenite and δ-ferrite; (d) EBSD orientation map of selected grain as highlighted in (c); (e) Image of the same region revealing the strain localization at the austenite-δ-ferrite phase boundary.
