## **The Impact of High-Productivity Processing on the Fatigue Failure of an Additive Manufactured Superalloy HAYNES 282**

Shaikh, A., Jabir Hussain, A., Mishurova, T. et al (2026). The Impact of High-Productivity Processing on the Fatigue Failure of an Additive Manufactured Superalloy HAYNES 282. *Advanced Engineering Materials*, 28(8).  
<http://dx.doi.org/10.1002/adem.202502048>

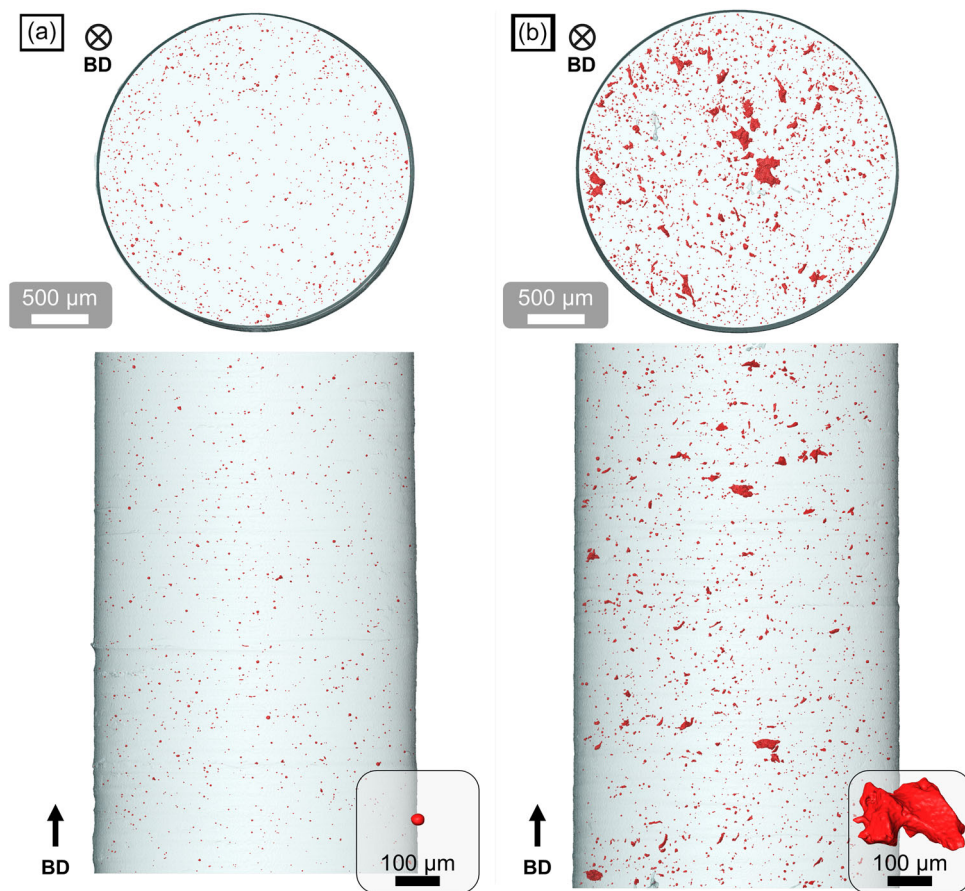
Analysis of the porosity by XCT revealed a major difference between the 40 and 80  $\mu\text{m}$  282 alloy conditions. A 3D rendering of the XCT reconstructions is presented in Figure 6, where red coloring indicates the absence of dense material, i.e., porosity/defects. As can be seen from the reconstruction, the 40  $\mu\text{m}$

sample showed small spherical pores, whereas the 80 μm sample showed small spherical pores as well as larger pores with a higher aspect ratio. The insets in Figure 6 show magnified versions of typical pores found in the samples. The large pores found in the 80 μm sample tend to have their major dimension oriented perpendicular to the build direction, which suggests that these are lack of fusion defects [8, 38]. The volume fraction of porosity was calculated to be 0.004% for the 40 μm sample and 0.036% for the 80 μm sample. While both these values are small in absolute terms, the difference in porosity between the process parameters is significant.

**FIGURE 6** | 3D rendering of samples and porosity obtained by XCT in (a) 40  $\mu\text{m}$  282 alloy; and (b) 80  $\mu\text{m}$  282 alloy. Insets show isolated defects from each condition.

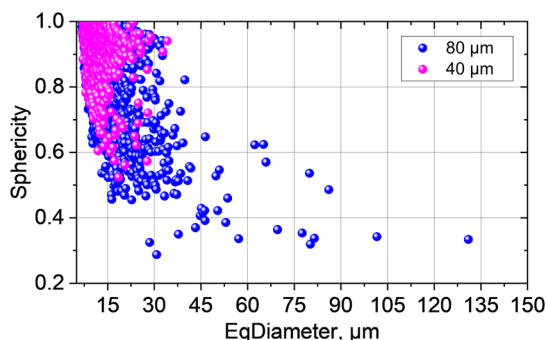
A quantitative representation of the comparative sphericity and size of the porosity distributions is shown in Figure 7. The 40 μm sample had pores which were no larger than 40 μm (in equivalent spherical diameter) and tended to have high sphericity. Such

pores are also present in the 80 μm sample, however, the distribution for the 80 μm sample was extended towards large defect sizes, with equivalent spherical diameters up to 130 μm. Note that a low sphericity for a pore implies that the maximum dimension of the defect is much larger than the equivalent spherical diameter. For the 80 μm sample the larger pores were also less spherical, further supporting the understanding that these are lack of fusion defects [30]. The increased propensity to porosity and lack of fusion defects in larger layer thickness PBF-LB processing is consistent with the literature and has been correlated to increased melt pool instability, more spatter generation, and reduced remelting of underlying material when layer thickness is high [14, 16, 39, 40]. Further detailed analysis of the cause of porosity and optimization of PBF-LB process parameters is beyond the scope of the present investigation.

**FIGURE 7** | Distribution of defects detected by XCT in 40 and 80  $\mu\text{m}$  282 alloy in terms of sphericity and equivalent spherical diameter.

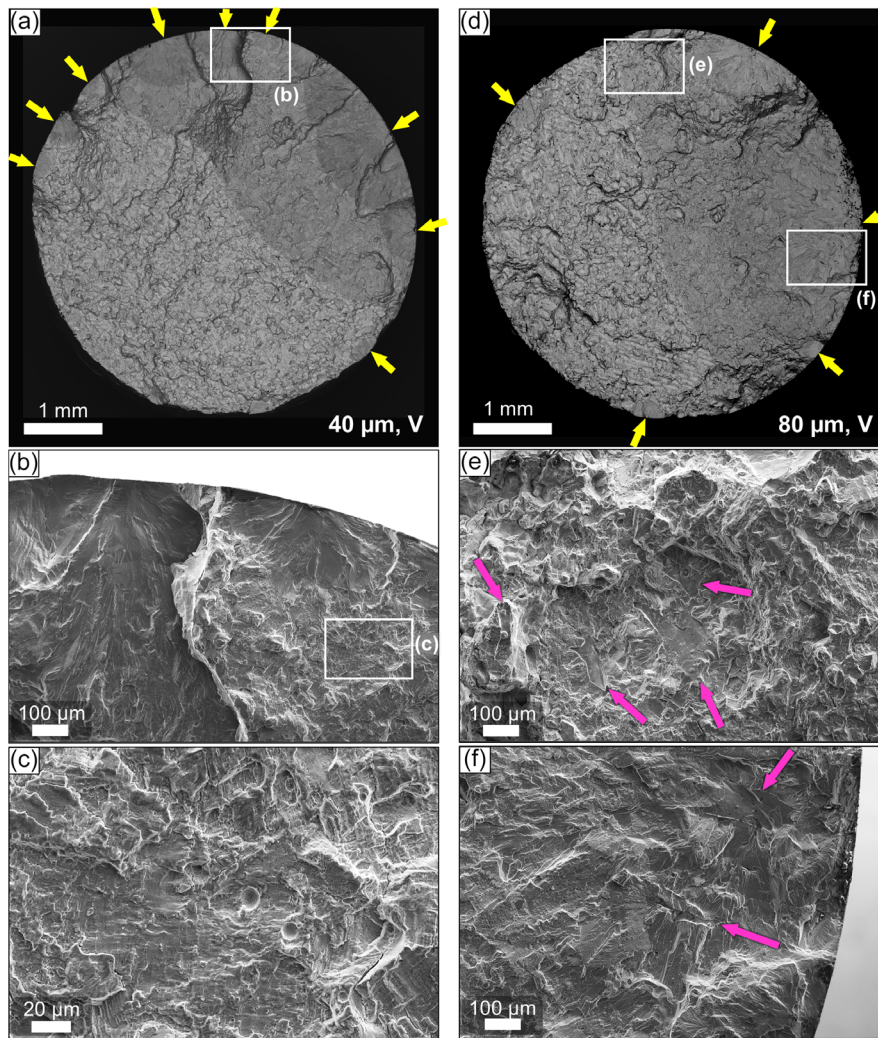
For the 40  $\mu\text{m}$  vertical sample, multiple initiation points can be seen in Figure 8a,b, however, no defects were found at or near the initiation points. Rather rough morphology of the fracture surface indicates complex crack propagation, starting from multiple initiation points at the sample surface. The transgranular fracture surface can be seen in Figure 8c, as well as two spherical pores, which are typical for the 40  $\mu\text{m}$  282 alloy, as discussed in section 3.4 above.

The fractured 80  $\mu\text{m}$  vertical sample seen in Figure 8d,e, also showed several initiation points. However, several lack of fusion defects could be observed on the fracture surface, as seen in Figure 8e, which contributed to initiation and acceleration of the crack propagation through the specimen. Large lack of fusion defects were also observed near to the surface - see Figure 8f. These defects have maximum dimensions exceeding 200  $\mu\text{m}$  and sharp features, suggesting they could act as stress concentrators. The observation of feathering marks on the fracture surface adjacent to these defects suggests that these defects acted as crack

**FIGURE 8** | Fracture surfaces of failed vertical LCF specimens from (a) to (c) 40  $\mu\text{m}$  282 alloy; and (d) to (f) 80  $\mu\text{m}$  282 alloy. Yellow arrows indicate fatigue crack initiation points, and pink arrows indicate lack of fusion defects.

initiation sites. It is notable that the 80  $\mu\text{m}$  vertically oriented samples showed the lowest LCF life of all conditions.

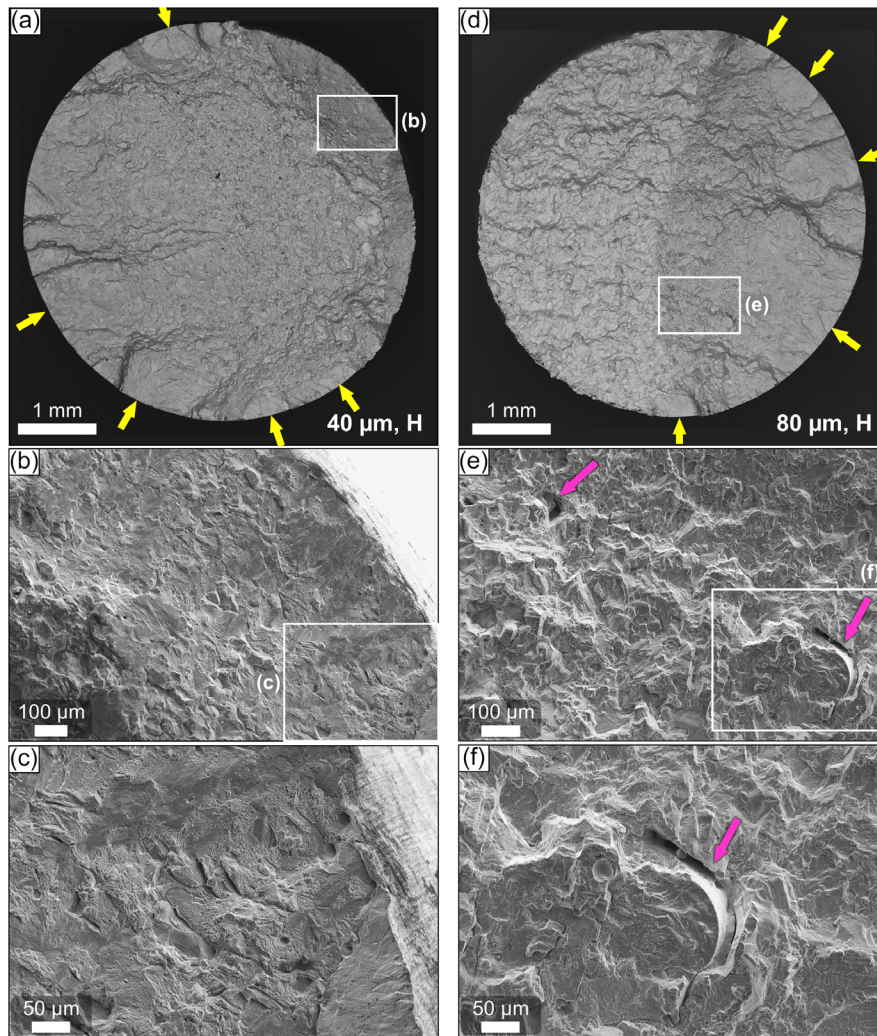
The fracture surface for a 40  $\mu\text{m}$  horizontally oriented LCF specimen can be seen in Figure 9a–c. Similar to the vertically oriented sample, multiple initiation points at the surface were observed, along with a transgranular fracture surface. No large defects were observed on the fracture surface, nor near the crack initiation points. Conversely, the 80  $\mu\text{m}$  horizontally oriented specimen showed large lack of fusion defects with their major axis oriented perpendicular to the direction of crack growth (parallel to the direction of applied stress) at locations within the specimen bulk. Such defects can be seen in Figure 9e,f. As these defects are not cohesive, they would be expected to negatively impact the fatigue life. However, since they are oriented parallel to the stress axis, their effective cross-sectional area is lower relative to the lack of fusion defects seen in Figure 8f, decreasing their harmful effect on fatigue life. No indications were found that they acted as initiation points in the 80  $\mu\text{m}$  horizontally oriented specimens.

**FIGURE 9** | Fracture surfaces of failed horizontal LCF specimens from (a) to (c) 40  $\mu\text{m}$  282 alloy; and (d) to (f) 80  $\mu\text{m}$  282 alloy. Yellow arrows indicate fatigue crack initiation points, and pink arrows indicate lack of fusion defects.

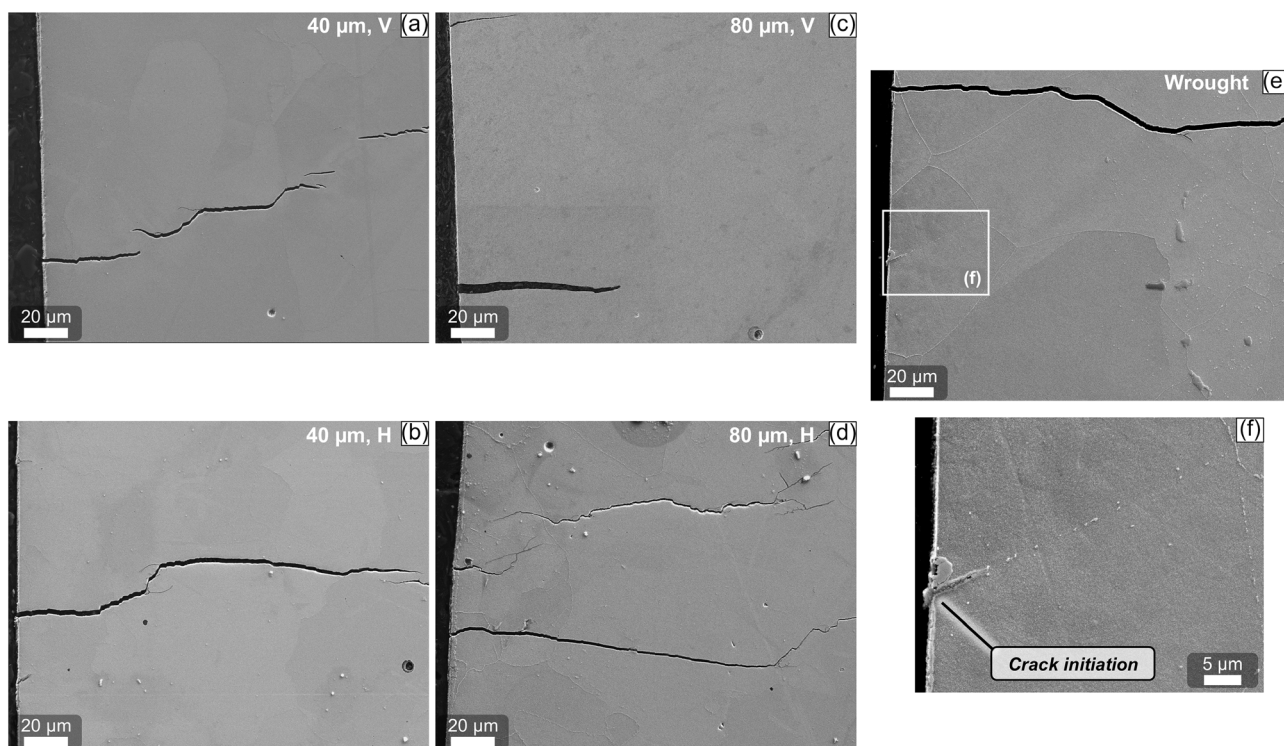
Cross-sections of the failed specimens were examined to further clarify the crack initiation and propagation in different conditions of AM 282. Several large secondary cracks were observed for the specimens in all conditions (see Figure 10) but no

correlation of secondary cracks with defects could be found at cross-sections. This suggests that cracks initiated on the surface of specimens from microstructural features, for example, see Figure 10e,f where a crack can be seen initiating on the surface of the wrought specimen from a feature which is probably a twin boundary—an initiation mechanism which is commonly reported in the literature [2, 42]. However, in the cross-section of the failed 80  $\mu\text{m}$  vertical specimen a number of small cracks could be observed around lack of fusion defects oriented perpendicular to the BD (and the axis of applied stress). Some examples of these defects are shown in Figure 11. While these cracks were small relative to the specimen cross-sectional area, their occurrence only in the 80  $\mu\text{m}$  horizontal specimen agrees with the observations from fractography (Figure 8d–f) where lack of fusion defects could be seen on the path of the fatigue crack.

**FIGURE 10** | Secondary cracks in cross-sections of failed LCF specimens tested at 760 °C; (a) 40 μm vertical; (b) 40 μm horizontal; (c) 80 μm vertical; (d) 80 μm horizontal; (e) wrought; and (f) suspected crack initiation at twin boundary in failed wrought specimen.

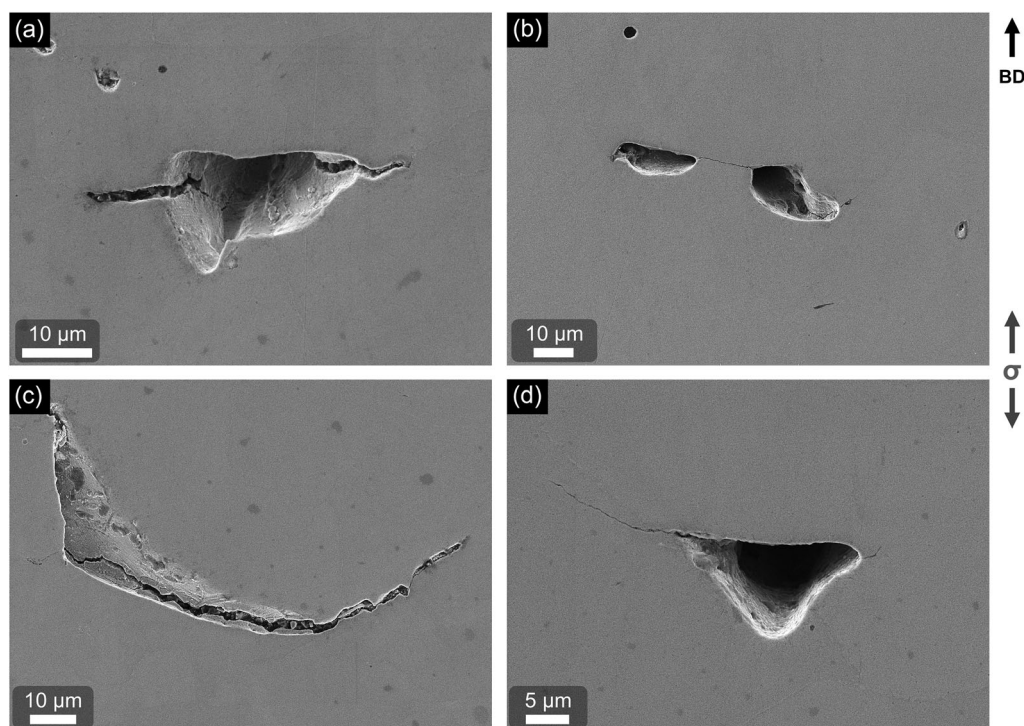
**FIGURE 11** | Cracks observed around lack of fusion defects in a cross-section of the failed horizontal 80 μm LCF specimen. Defects (and cracks originating from them) appear to be oriented perpendicular to the axis of applied stress.

area of defects over the load bearing cross-section being maximized due to their orientation. Therefore, both initiation and propagation stages are accelerated in the 80 μm vertical specimens, which accounts for their average  $N_f$  being the lowest of all

tested conditions. The detrimental effect of lack of fusion defects orientated perpendicular to the loading direction on fatigue life has previously been noted by other researchers as well [50–53].
