Railway wheel failure caused by flange crack, part 1: Background and failure analysis

Downloaded from: <https://research.chalmers.se>, 2026-04-15 15:39 UTC

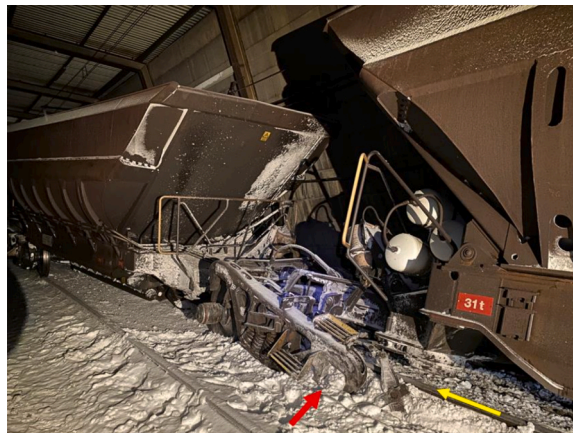
Fig. 1. The wagon with the fractured wheel to the left. Note the detached bogie where also the wheelset with the fractured wheel is detached (red arrow). The travel direction is indicated by the yellow arrow. Picture CCBY 2.5 SE, Statens haverikommission [2].

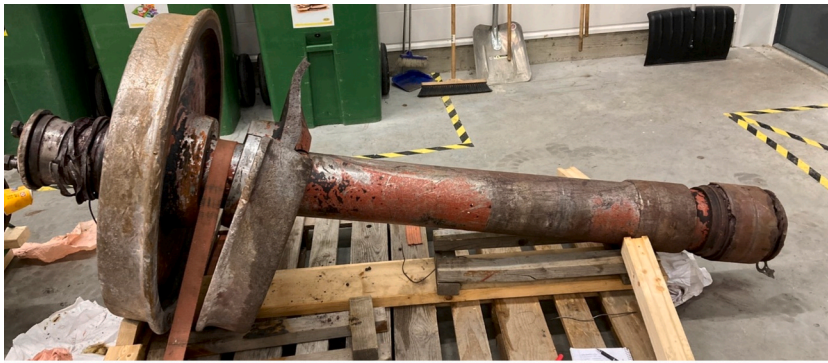
Fig. 2. The fractured wheel shifted along the axle.

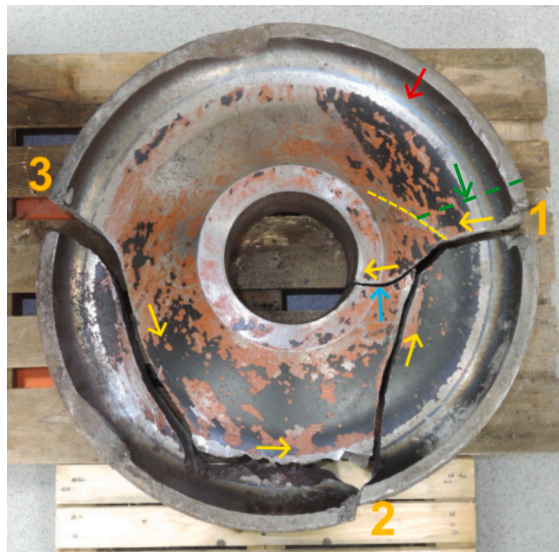
Fig. 3. The fractured wheel restored from salvaged parts. Yellow arrows show fracture directions, dashed yellow line a non-fracturing crack branch. Red arrow points at blue colour shift, light blue arrow indicates position of replica casting. Green dashed line and arrow show approximate position and direction of view of cross section in figures 7, 8 and 10.

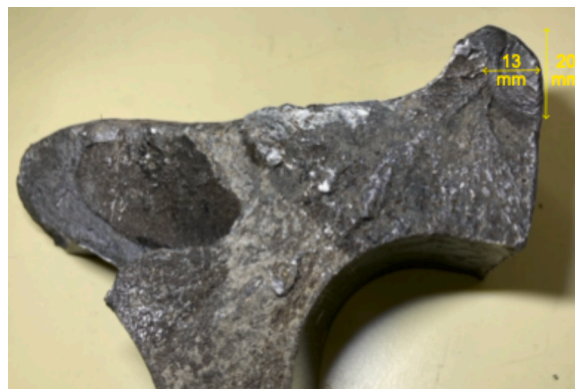
Fig. 4. Fracture in position 1 of figure 2 with primary fatigue crack in flange indicated.

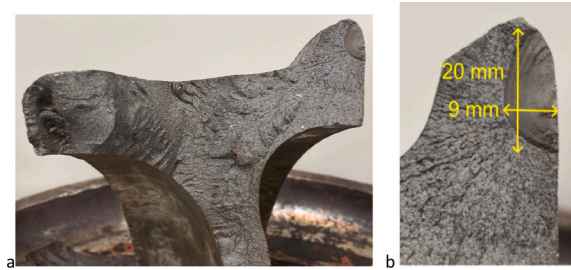
Fig. 5. Fracture in position 2 of figure 3. a) Overview of fracture surface. b) Detailed view of the fatigue crack.

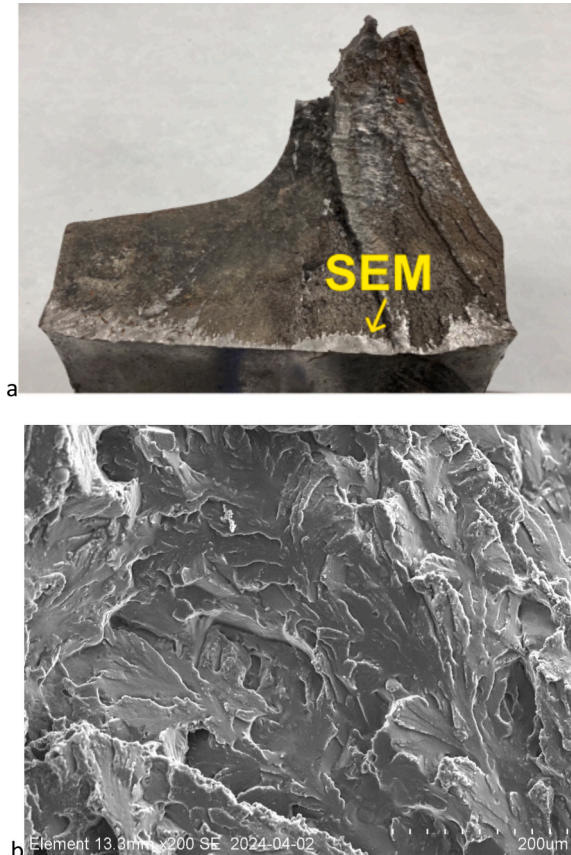
Fig. 6. a) replica of fracture area at the hub (position indicated by light blue arrow in figure 3), web upwards. b) SEM picture at position indicated by yellow arrow in figure 6a, hub upwards.

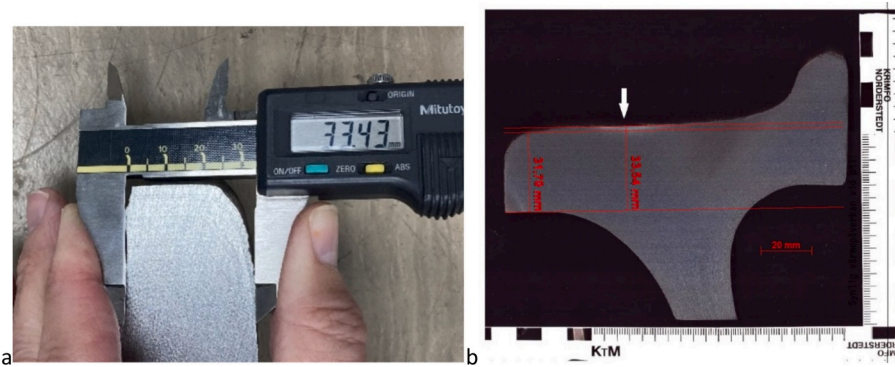
Fig. 7. a) rim thickness measurement using a caliper, and b) wheel rim dimensions from image analysis.

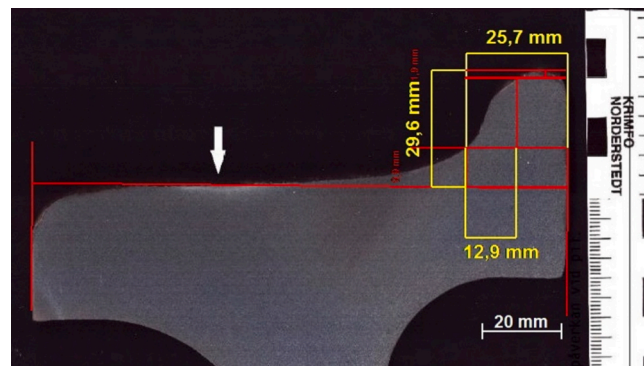
Fig. 8. Flange thickness (25.7 mm), height (29.6 mm) and q_r (12.9 mm).

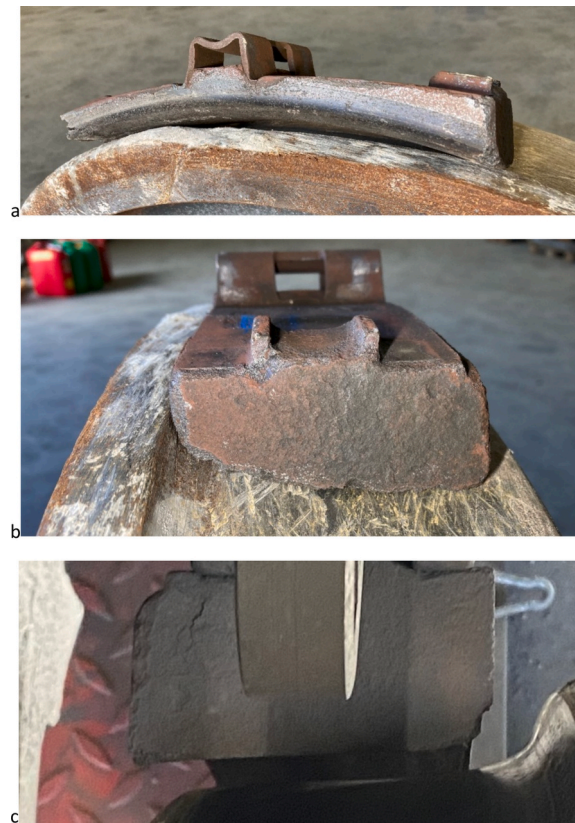
Fig. 9. Brake block found where track damage began. a) Longitudinal profile. b) Transverse profile matched towards the opposite wheel on the axle. c) Less worn brake block from another wagon.

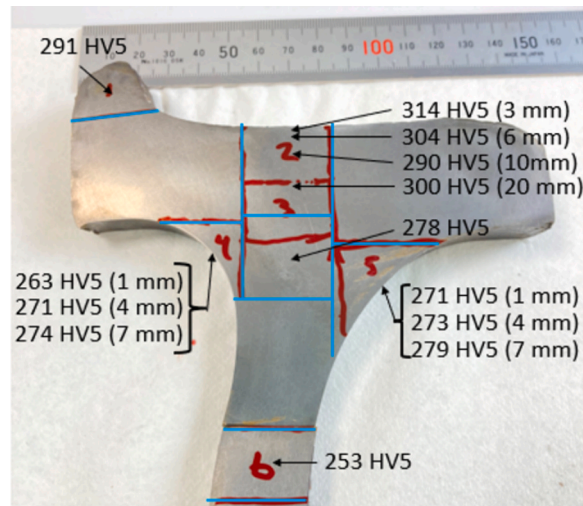
Fig. 10. Hardness mapping of the wheel cross section. Blue lines mark the location of the six micro-sections, reported values are averages of three hardness tests at indicated depth below surface.

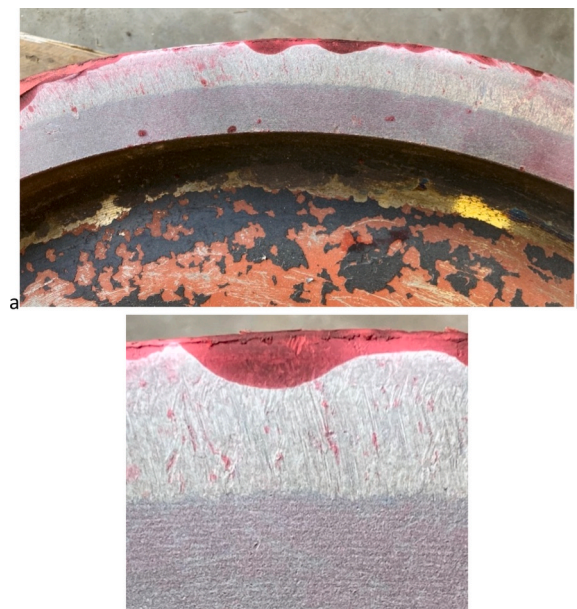
Fig. 11. a) inside of flange on the wheel opposite the fractured wheel. b) detail of radial scratch pattern on inside of flange. Pictures taken during testing with red penetrant.

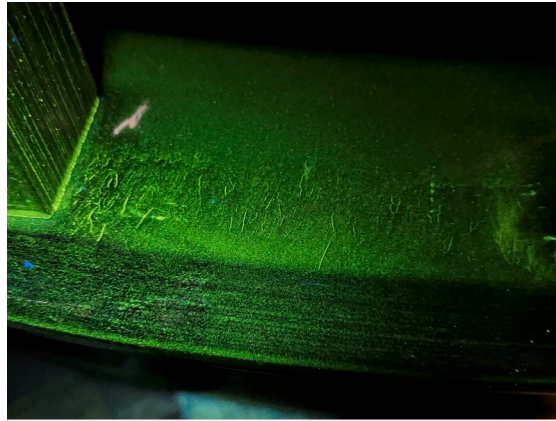
Fig. 12. Magnetic particle inspection showing indications of microcracks on the inside of the flange.
