# Concluding destructive investigation of a nine-year-old marine-exposed cracked concrete panel

Geiker, M., Robuschi, S., Lundgren, K. et al (2023). Concluding destructive investigation of a nine-year-old marine-exposed cracked concrete panel. Cement and Concrete Research, 165. http://dx.doi.org/10.1016/j.cemconres.2022.107070

This study undertaken on a nine-year-old cracked concrete panel further investigates the impact of cracks on the corrosion performance of conventional steel reinforcement in marine-exposed concrete to explain observed monitoring data. The present data covers seven 1.80 m long (12.6 m) reinforcing bars embedded in good quality concrete (w/b = 0.40 and cover >75 mm). Each bar was crossed by two horizontal cracks (surface crack widths 0.20–0.30 mm). The investigation showed no corrosion on the surface of the reinforcing bars, in either cracked or uncracked areas. Two of the seven reinforcing bars were instrumented in the vicinity of the cracks. Extensive corrosion was found in the interior of all instrumented parts of these bars. This may explain the monitoring data despite the lack of corrosion on the exterior surface of the two instrumented rebars. However,

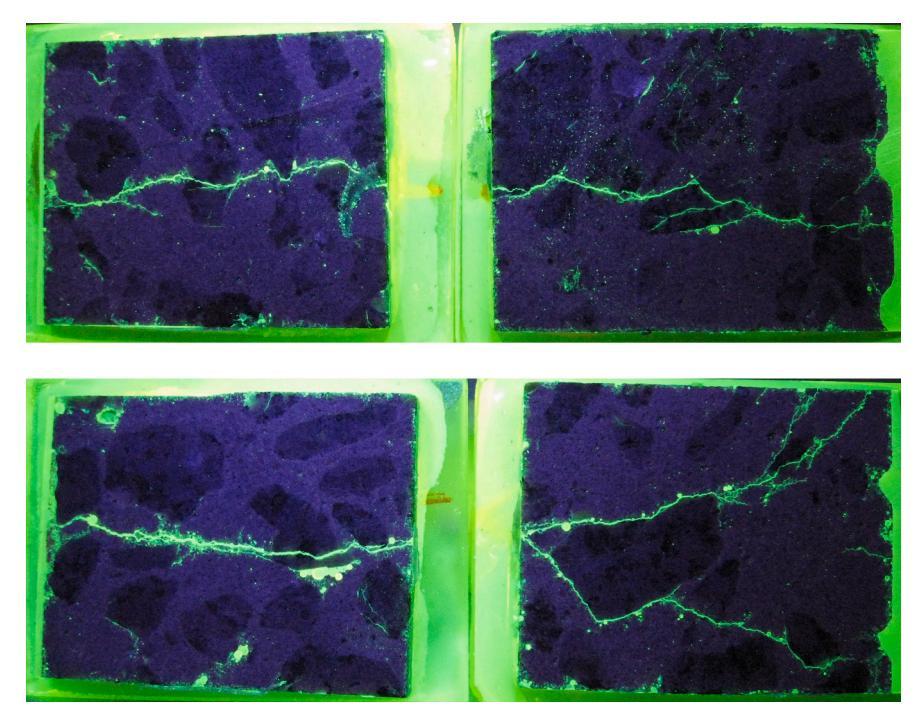
Fig. 6 shows impregnated pieces cut off after thin sectioning prepared from cores from the tidal (C2) and submerged (C5) exposure zones of the panel. Open cracks are observed to reach the reinforcement level in both cores.

One crack is seen in core C2 from the surface of the concrete to the imprint of the rebar. The crack traverses aggregate and occasionally splits into smaller cracks. The main crack has a width of 60–80  $\mu$ m at the surface and narrows to 15  $\mu$ m at the rebar. The cracks are generally open, but the main crack is bridged by calcite for the last 0.2 mm up to the surface.

The initially introduced crack in core C5 is seen from the surface of the concrete to the imprint of the rebar. An empty crack, possibly formed when the rebar was removed from the concrete, has been generated along this crack. The initial crack traverses aggregate and occasionally splits into smaller brittle cracks. The main crack has a width of 200  $\mu m$  at the surface and narrows to 13  $\mu m$  at the rebar. The initial cracks are generally open, but the main crack is bridged by calcite for the last 3 mm up to the surface.

The petrographic investigations indicate that the cracks are still open, as seen in fluorescent light mode (Fig. 6), but various deposits are seen on the crack faces and in the crack. These deposits were identical in the two tidal (C2) and submerged (C5) exposed cores and were as follows from the exposed surface and inwards in the crack: calcite, followed by brucite, and deeper inside the cracks, first portlandite (calcium hydroxide, Ca(OH)<sub>2</sub>) and then ettringite. These observations are similar to observations made on cores from the cracked beams of three different types of infrastructure concrete after 25 years of marine exposure [20]. Table 8 summarizes the findings from the petrographic study and shows the depths from the surface to which the deposits were observed. The petrographic study also showed shallow and uneven carbonation of the outer exposed surfaces (C2: 0–1.2 mm, C5: 0–2 mm), as well as shallow carbonation along the crack faces at greater depths from the exposed surfaces (C2: 0.8–20 mm, C5: 3–8 mm) and carbonation in part of the

**Fig. 6.** Fluorescent impregnated thin sections (two per core) showing impregnated (green) cracks in cores C2 (tidal exposure) and C5 (submerged). The exposed surface is to the left in the left-hand thin sections, and the imprint after the rebar is to the right in right-hand thin sections. The dimensions of the fluorescent impregnated pieces cut off from the thin sections are  $30 \times 45 \text{ mm}^2$ .

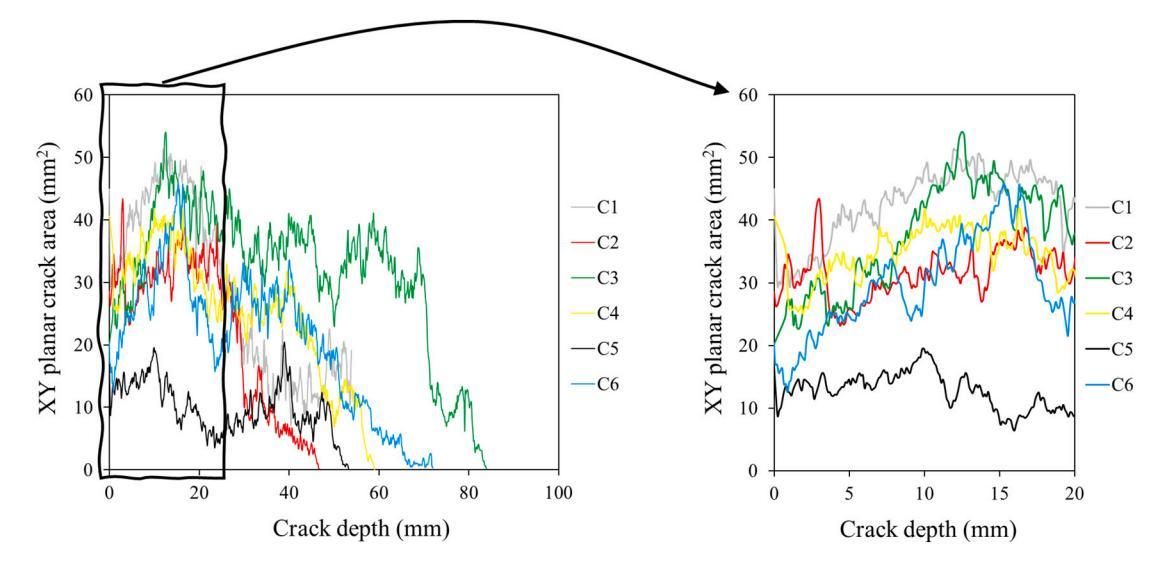
The distribution of XY planar crack area across the crack depth is given in Fig. 7 for all six cores of Series 1. The results indicate fluctuations for all cores, among which C5 showed the lowest maximum crack area. A common trend is observed from the exposed surface to the greatest depths for all cores investigated:

- The crack in the top part of the cores (~0–10 mm crack depth) exhibits an initial increase in the XY planar crack area (i.e., the crack widens) from the exposed surface and down.
- The trend of growing crack area with crack depth reverses at depths beyond approximately 10 mm.
- The crack is narrow (or below the detection limit) in the vicinity of the rebar (large crack depths). This behaviour is generally to be anticipated since the cracks were initially introduced due to bending in the concrete slab.

Fig. 7. Measured XY planar crack area distribution across the crack depth for each core investigated using  $\mu$ -CT. (For interpretation of the references to colour in this figure legend , the reader is referred to the web version of this article.)

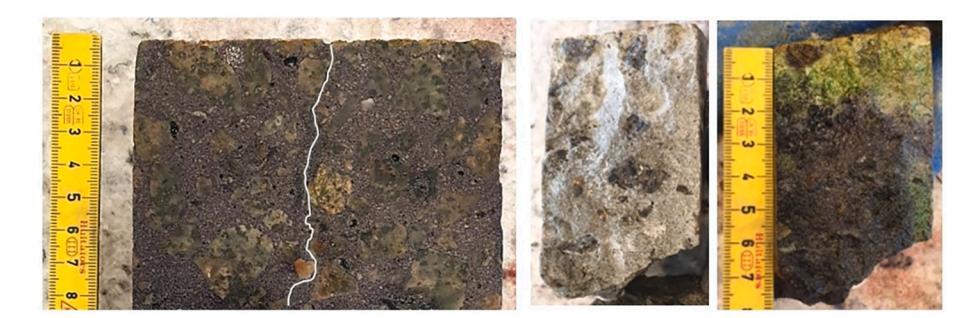
At the cut surface, the concrete did not show visual/macroscopic signs of carbonation (Fig. 10, left), which is similar to the petrographic analysis showing only shallow (1-2 mm) carbonation. The concrete surface colour was violet to blue, indicating a pH between 11 and 13. However, a carbonation front of about 20-30 mm was detected when the concrete was split along the crack face. This is also in line with the observations made in the petrographic analysis that showed carbonation along the crack face to a depth of 20 mm for core C2 (tidal exposure). The colour of the concrete was green in the outer 20–30 mm, indicating a pH of around 9 (Fig. 10, right). Furthermore, the carbonation of the upper part of the crack face coincided with a white precipitate. The carbonation depth appeared deeper along the cylindrical outer surface of the core (Fig. 10, right), suggesting carbonation during storage (approximately six weeks wrapped in plastic and stored at 5 °C). However, this is not in agreement with the lack of/limited carbonation on the exposed surface (Fig. 10, left), so it is assumed to be an artefact. Note that the petrographic analysis showed less carbonation along the crack face (to a depth of 8 mm) for the submerged exposed core (C5) than for the core from tidal exposure (C2). The petrographic analysis also showed shallow carbonation of part of the rebar imprint in core C5 (submerged exposure), which was not observed in the visual/macroscopic investigation. Similar observations were made for core C1 (tidal exposure) and C4 (submerged exposure).

Fig. 10. Carbonation detection on core C1. Left: freshly cut concrete core sprayed with rainbow indicator; Right: crack face sprayed with a rainbow indicator (left side: cut surface; right side: outer cylinder surface). (For interpretation of the references to colour in this figure legend, the reader is referred to the web version of this article.)

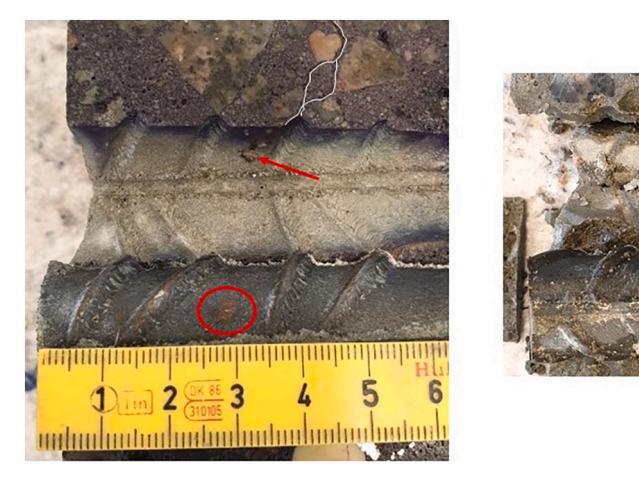
there were no indications of corrosion at the rebar–concrete interface. The bond between rebar and concrete appeared good, and the reinforcement condition generally appeared very good. One minor corrosion spot was found on the reinforcement of core C1 close to the crack (Fig. 11). The corrosion spot appeared only superficial and had a length of about 5 mm. Furthermore, a white precipitate was found on one side of the reinforcement surface in core C1 (Fig. 11, right).

Fig. 11. Minor corrosion spot detected in C1; Red circle: Spot on reinforcement bar; Red arrow: Spot in the concrete imprint; Crack marked in white. (For interpretation of the references to colour in this figure legend, the reader is referred to the web version of this article.)

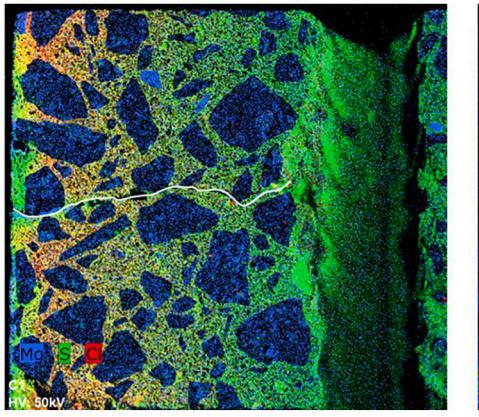
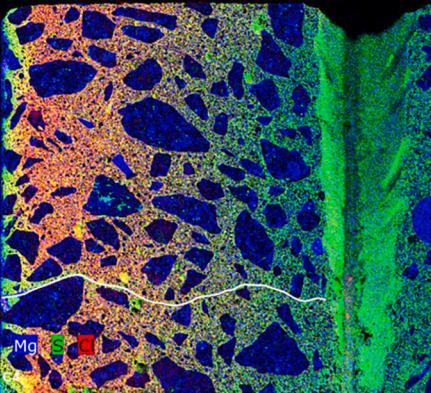
The petrographic study showed that the first 5 mm of the paste was fully de-calcified with increased porosity in the tidal and submerged zones. If the elemental maps of Mg, S and Cl obtained by  $\mu$ -XRF (Fig. 13)

**Fig. 13.** Elemental zonation of Mg (blue), S (yellow) and Cl (red) in core C1 (left) and C4 (right). Cracked and exposed surfaces of panels to the left and imprints of rebars to the right in both figures. Mg is visible within the first 10 mm of the crack. Note that the apparent high S content in part of the steel–concrete interface of core CI is an artefact due to mechanical damage during sample preparation. (For interpretation of the reafer is referred to the web version of this article.)

are combined, a clear elemental zonation as reported by Jakobsen et al. [22] can be observed, with a thin Mg-rich surface layer, followed by a layer of about 0.5 cm enriched in S, followed by Cl. Fig. 13 shows that precipitation of Mg-rich phases was detected within the first 10–15 mm in both cracks. This is in line with observations reported of cracked concrete beams after 25 years of marine exposure in northern Norway [20].

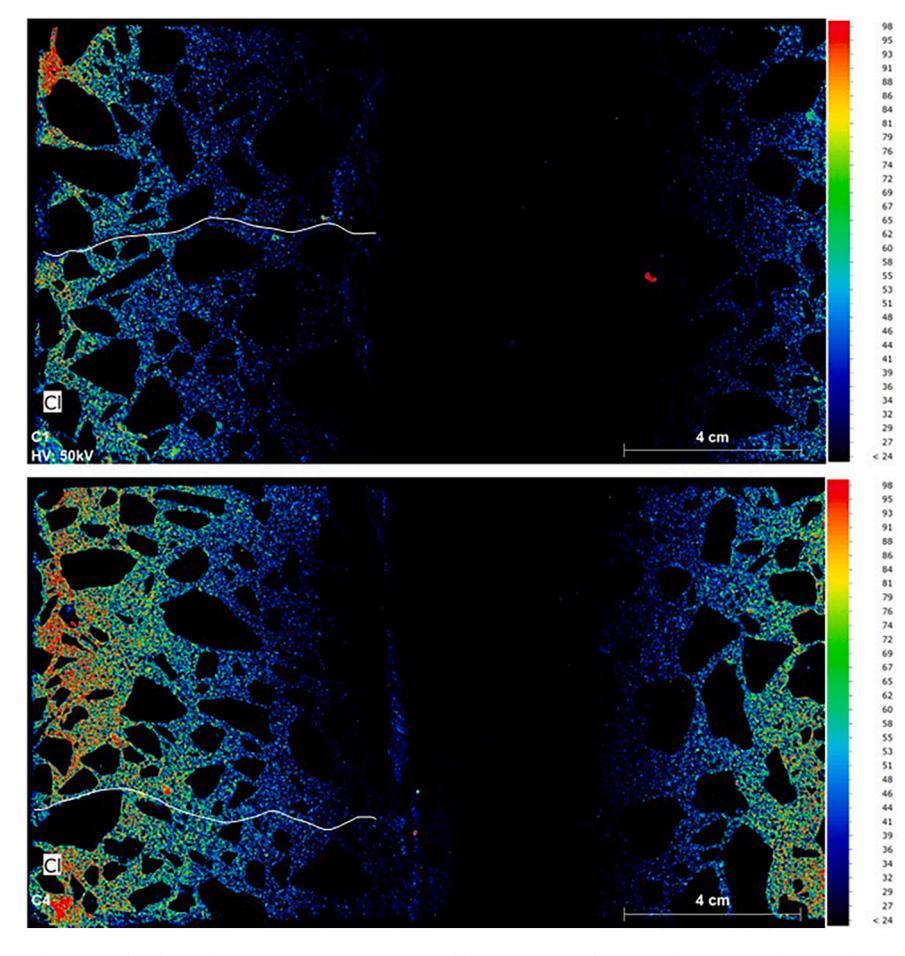
Fig. 14. Map visualizing chloride ingress depth in relative intensities: core C1 (tidal exposure) at the top and core C4 (submerged) at the bottom. The cracked surface of the panel is to the left. Cracks are marked in white. (For interpretation of the references to colour in this figure legend, the reader is referred to the web version of this article.)
