A Case Study for a Worn Tool Steel in the Hot Stamping Process

A case study for a worn tool steel in the hot stamping process

Keywords: Hot stamping die Failure mechanism Surface softening Transfer materials

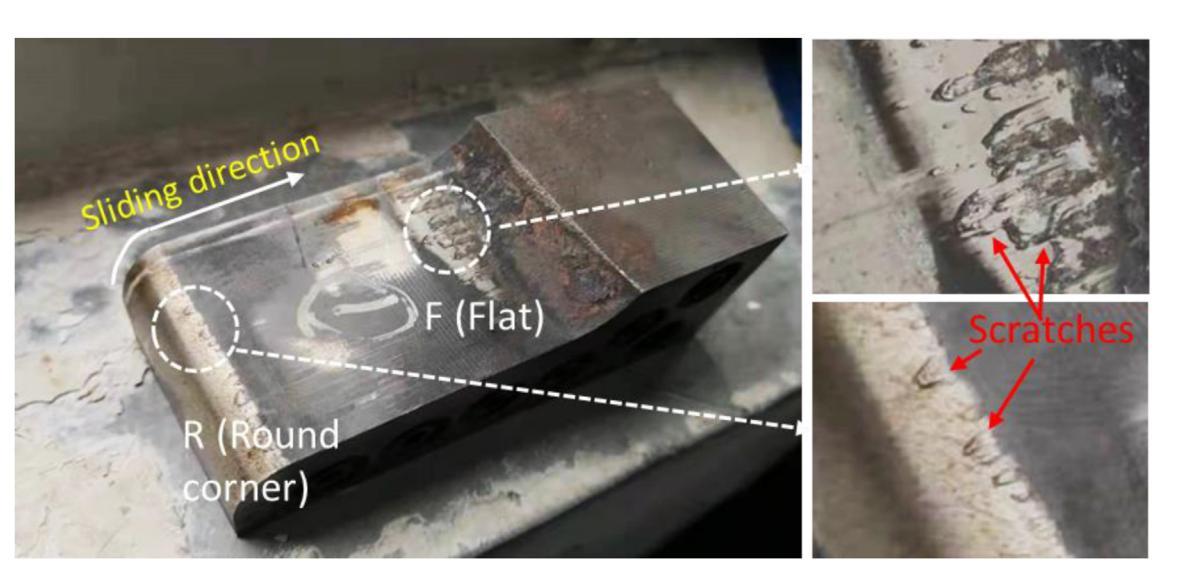
A failed die insert for hot stamping, as shown in Fig. 1, was considered for analysis. The main worn areas on the die insert are displayed in Fig. 1. The area on the round corner is marked

Fig. 1 - The main worn areas on the die insert.

as "R" and the flat part is marked as "F". Specimens were extracted from these two areas for investigation.

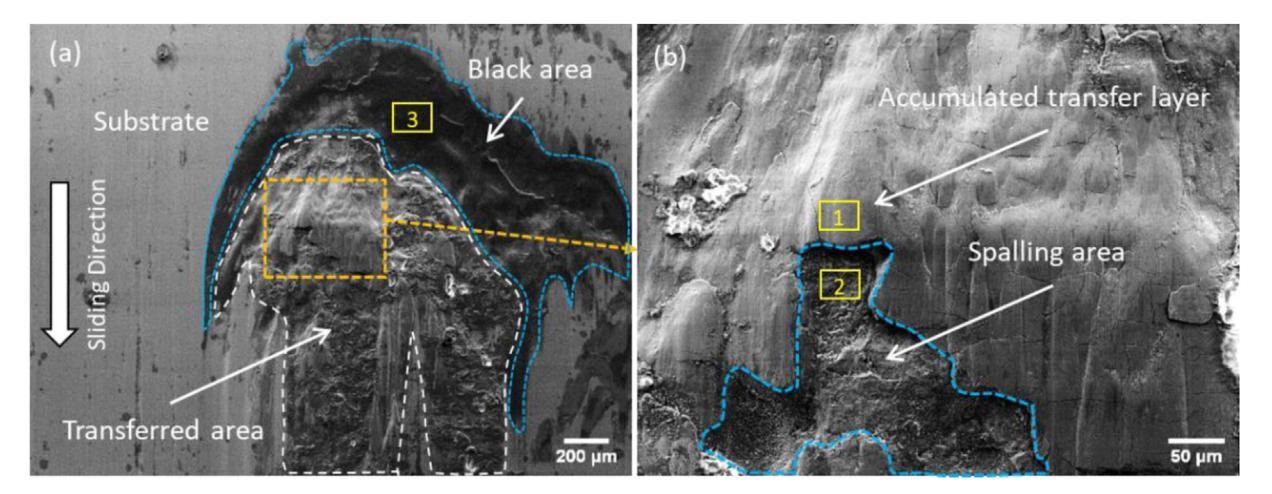
Fig. 2 – SEM images showing the transferred materials on the flat part. The sliding direction (S.D.) is marked in the figure.

a scratches was thoroughly examined by SEM, as shown in Fig. 2. A large area of transferred materials was found on the top of the scratch. The transferred material showed a glazed surface. The extremely low concentration of Cr and Mo and high concentration of O at Site 1 (see Fig. 2b), as revealed by EDS analysis in Table 2 indicated that this transferred material was from the workpiece which was oxidized with a remarkable oxide layer thickness in the micrometer level. The oxide was mainly iron oxide. A spalling area was found on the top of the transferred material, implying that the transferred material was accumulated during the stamping process. EDS analysis conducted on the spalling area (Site 2) showed a relatively lower O concentration compared to the un-spalled zone (Fig. 2b and Table 2), indicating less oxidation of the transferred material in this region. In addition, a black/dark area (upper area indicated in Fig. 2a) was also observed in front of this big scratch. The EDS (Site 3 in Table 2) result shows that this area has an even higher O content than that of Site 1. The material in this area was suspected to be mainly iron oxides with some contamination.

The adjacent protrusion prevented this black area in Fig. 2a from being in contact with the hot workpieces, and thereby its surface was exposed to a high temperature for a relatively long time and was thus heavily oxidized. Notice a significant amount of Si was observed in this region. It could be resulted from the selective oxidation of Si from the steel at high temperatures during processing due to the high affinity of Si with oxygen or the residue from the coolant. The observation of Mo here is a surprise. On the other hand, the protrusion can scrape the hot workpiece, and therefore the transferred layer could be accumulated on the top, as observed in Fig. 2.

In order to further characterize the chemistry of the oxide, XPS was conducted on the black area (BA), transferred area (TA) and substrate (SB), as indicated in Fig. 2a. The surface was slightly etched by argon ions prior to the measurement to remove some contamination and the native oxide. As shown in Fig. 3, the substrate possessed strong peaks of Fe, Cr and Mo in metallic form. However, Fe was identified to be present as Fe_2O_3 in both the black area and transferred material area, indicating significantly thicker oxide compared to the substrate. This was consistent with the EDS results in Table 2. Molybdenum was not observed at the surface of BA and TA regions. High silicon content in BA and TA regions is also agree with the EDS results in Table 2. The area with transferred material had the strongest oxidized Fe peak, indicating that Fe_2O_3 was dominant on the surface of this area.

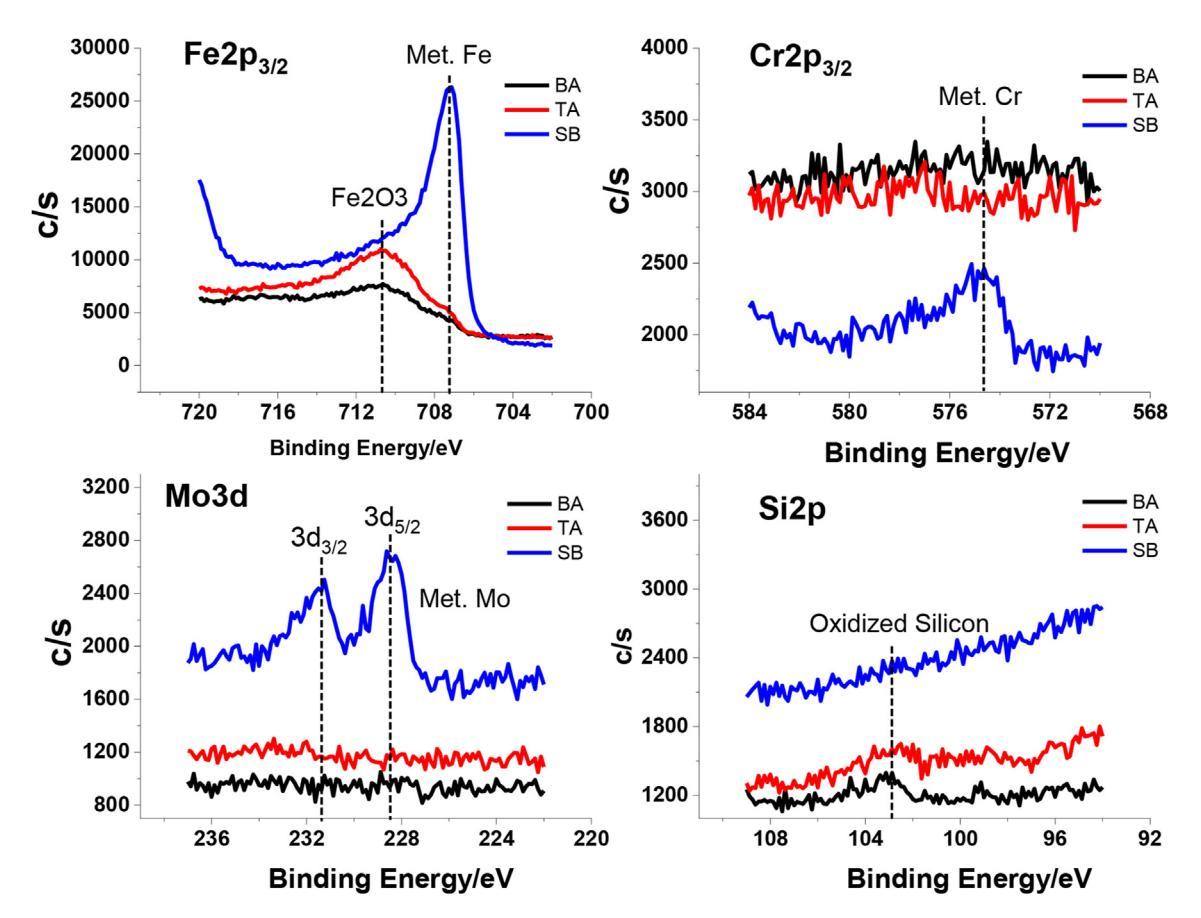
Fig. 3 – The XPS spectra of the concerned elements on the scratch in Fig. 2. BA: black area, TA: transferred area, SB: substrate.

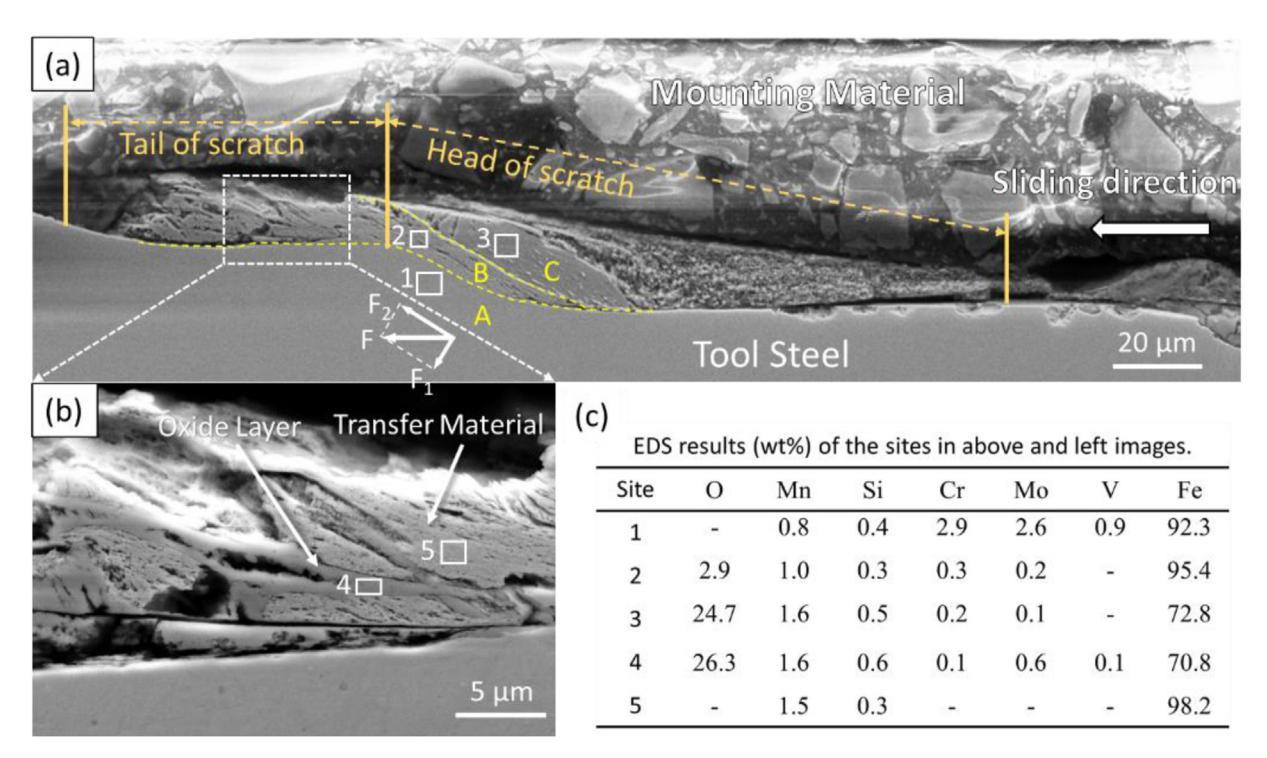
transferred materials on the top. EDS analysis was carried out on different areas, and the results are presented in Fig. 4c. Here "A" (Site 1 in Fig. 4a) represents the tool steel and shows a typical composition of die material (QRO 90 tool steel). The regions "B" and "C" should be material that differ from the tool steel considering their unique morphology. According to the EDS results shown in Fig. 4c, the "C" layer (Site 3) reveals a much higher O content, and the composition is similar to that of Site 1 in Fig. 2, indicating that the material in this layer is the Fe₂O₃.

The composition of site 2 in the "B" layer was consistent with the nominal composition of the boron steel, indicating it was the transferred material from the boron steel workpiece. The small content of O (2.9 wt%) in the "B" layer suggests that the material was slightly oxidized. In another location of the "B" layer, as shown in Fig. 4b, multi-layers consisting of alternating denser layers (Site 4) and the ones with some black pores (Site 5) were observed. EDS (Fig. 4c) conducted on these different layers shows that the composition of the more porous layers (e.g., Site 5) was consistent with that from site 2 of the "B" layer, while the denser layers (Site 4) had almost the same composition as the "C" layer, suggesting the formation of Fe₂O₃ due to oxidation of the transferred material. However, Mo was detected in both "B" and "C" layers. It was not expected because Mo is not present in the workpieces of the boron steel. One possible reason for this could be that the smearing of the tool steel might occur, which introduces some material from the tool steel into the transferred layer. The mixture of tool steel and transferred materials was also observed in other sliding wear tests [9]. This occurs at the surface of the workpiece, which explains why Mo was only found in the oxide but not the bulk transferred boron steel bulk in the "B" layer.

During the hot stamping process, transferred material with a top oxide layer was stacked on the tool steel layer by layer in an accumulated manner. This type of accumulated and compacted layer has commonly been observed in other hightemperature reciprocating sliding systems [9,15]. An interesting phenomenon observed was the varied bonding strength at different locations. At the head of scratches (Fig. 4a), there was a strong bonding between the transferred materials and the slopy surface of tool steel. It was attributed to the high partial normal load F_1 on the local surface (the slopy region) of the tool steel, as schematically drawn in Fig. 4a. Meanwhile, the transferred material was at high temperatures with high ductility. Consequently, it could form a good bonding with the underlying tool steel. On the other hand, at the tail of scratches (Fig. 4a and b), much lower normal stress led to a weak bonding between the transferred materials and the tool steel. As a result, the spalling of transferred materials could happen in such region, as shown in Fig. 2b.

Fig. 4 – (a) SEM image from the longitudinal cross-section (parallel to the sliding direction) of the flat part, (b) Magnified image presenting transferred material in a multilayer form, (c) The corresponding EDS analysis results.

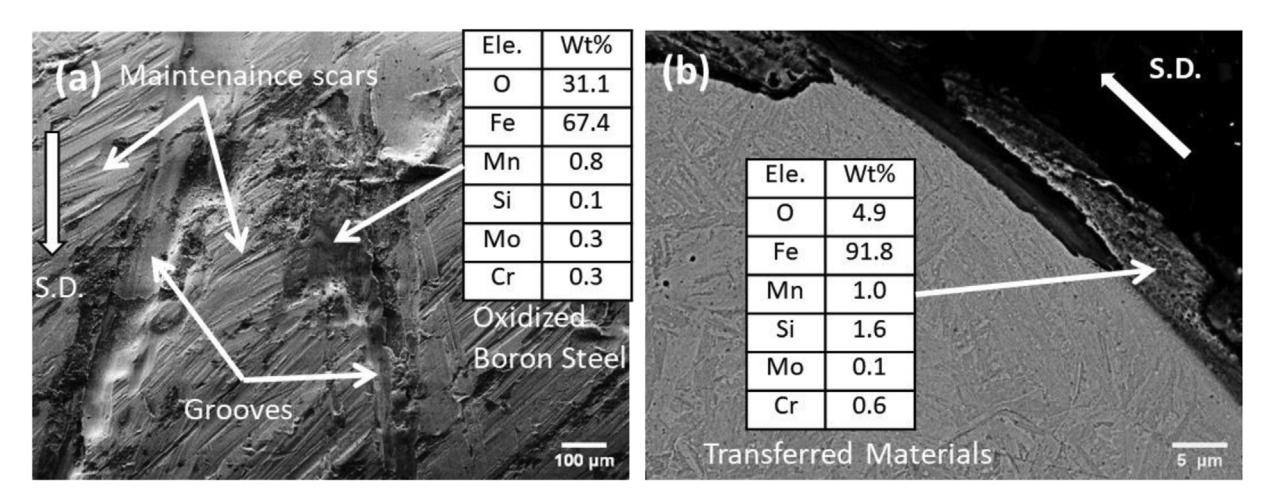
The surface of the round corner was an ideal place to analyze the wear behaviour because the friction mainly occurred here. Unfortunately, the wear morphology of the round corner was destructed during daily maintenance by grinding using sandpaper. Fig. 5a shows some wear scars left there. Transferred materials were also found on the edge of the groove. EDS analysis (inserted in Fig. 5a) confirmed that the transferred material was an oxide with a high content of O

Fig. 5 – Material transfer observed at the round corner: (a) the micrograph of worn surface, (b) cross-section illustrating the transferred material.

(31.1 wt%). This meant the oxide layer on the surface was nearly pure Fe_2O_3 with a remarkable thickness (>1 µm). In the central area of the round corner surface, transferred materials were found as well by cross-section observation (Fig. 5b).

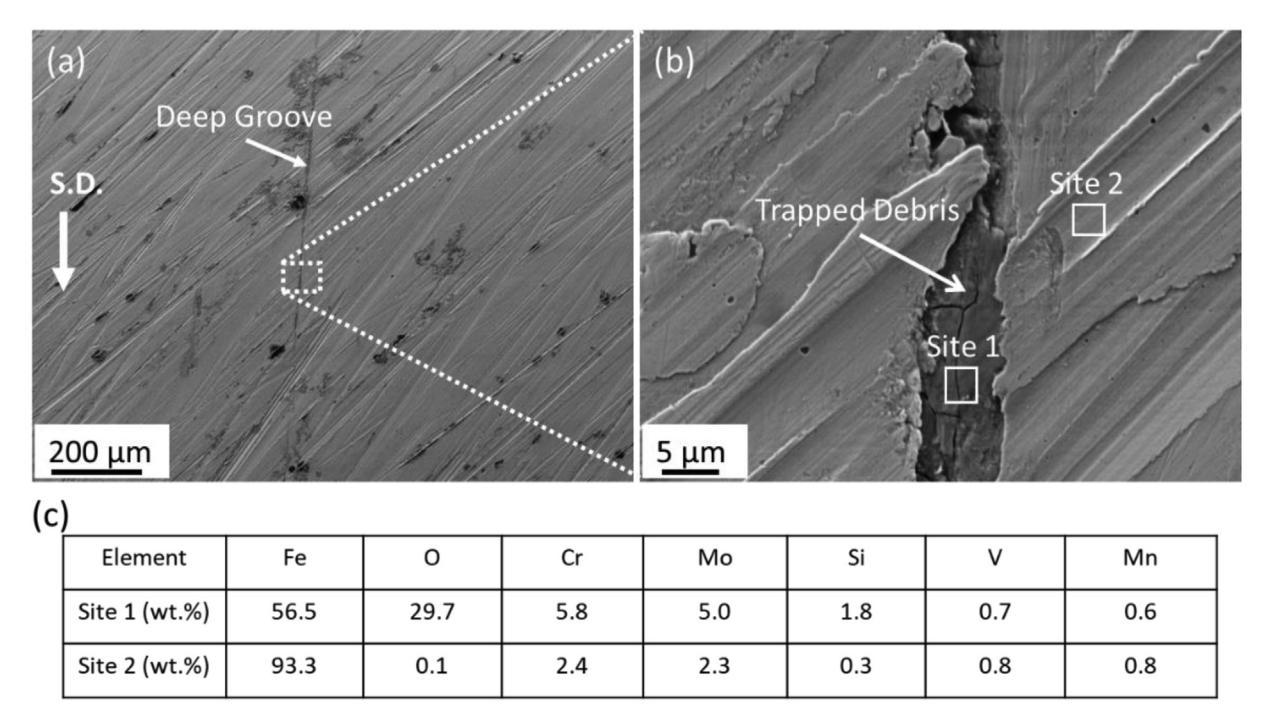
During the service of hot stamping, abrasive wear was not as serious as the galling phenomenon in the current study. However, ploughing grooves were still found on both round corner and flat part, as shown in Figs. 5a and 2a. The slanted scratch in Fig. 5a was caused by the maintenance. The ploughing grooves on the round corner were relatively deep. It was reasonable because the round corner experienced higher shear stress than that of the flat area. The round corner was the place where abrasive wear most frequently happened. Therefore, some deep grooves were found in the central area of the round corner (one of them was shown in Fig. 6). The groove was parallel to the sliding direction and was filled with debris (Fig. 6b). The high content of O, Cr and Mo revealed by EDS point analysis (Fig. 6c) inferred that it came from the oxidized tool steel. The oxidation and detachment of debris from the tool steel surface took place during the service. Notice these oxidized debris were compacted and trapped in the deep grooves.

Fig. 6 – (a) Deep groove was found on the round corner surface. (b) Trapped debris found in magnified SEM image. (c) EDS analysis shows the trapped material is the oxidized debris from the tool steel.

could be easily oxidized due to their relatively high specific area and develop into debris consisting of a mixture of metal and oxides. The trapped materials in Fig. 6 are suspected to be this kind of debris.

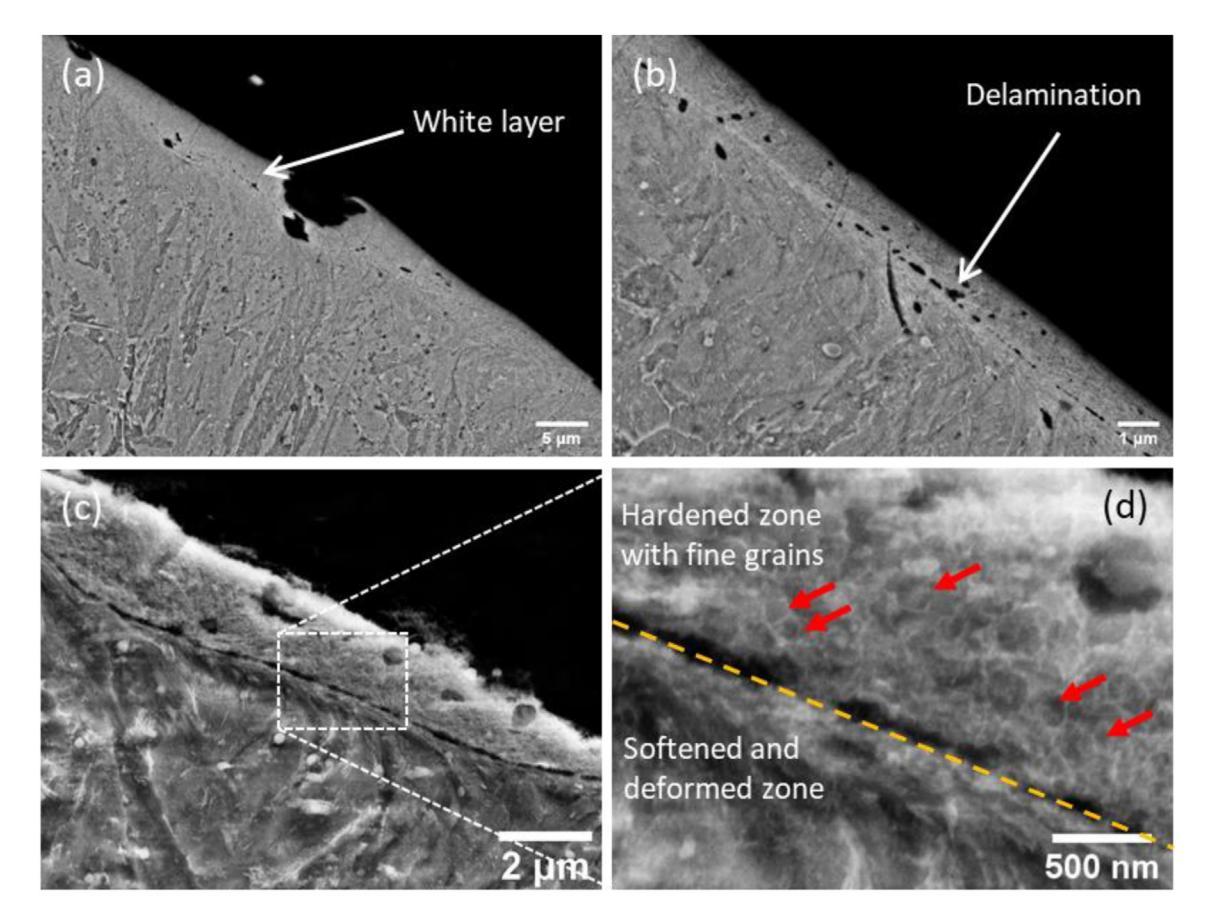
Secondary electron imaging SEM having high-resolution was used to reveal some detailed features. As shown in Fig. 7c and d, the white layer (above the delamination line) had an ultra-fine structure, implying that it probably had higher hardness than the region below the line. As can be seen in these images, the region below the line had severe plastic deformation caused by shear stress while no distinct deformation was found in the white layer, although the regions below and above the line were subjected to similar shear stress. This suggested that the hardness of the white layer may be much higher than that of the substrate. The formation of the white layer will be discussed further in Section 4.2.

Fig. 7 – Back scattered SEM images from the cross-section reveal the microstructure of the round corner center, (a) fractured "white" layer, and (b) delamination below the white layer. Secondary electron SEM images (c) and (d) detailed features near the surface.

The formation of the white layer shown in Fig. 7 is the consequence of thermal cycles experienced by the tool steel. During hot stamping, the top surface of the die will be heated up to a peak temperature above 800 °C by the hot workpiece. According to Ref. [14], the austenitizing start temperature of the die material, i.e., QRO 90 tool steel, is about 800 °C. Therefore, partial austenitizing of tool steel occurs within a shallow depth (1–3 μm). The subsequent rapid cooling caused by the water-cooling channels in the die results in the hardening of this surface region owing to martensite formation. During the service, it is expected that the top surface layer of the tool steel is subjected to a repeated austenitizing and quenching, leading to the formation of a layer with ultra-fine grains on the top surface. Hosseini [20] reported a similar white layer on high carbon 100Cr6 steel after fast turning. This layer would have a relatively high hardness due to the quenching process and will not be easily deformed. However, the substrate material, whose peak temperature was below the austenitizing temperature, will not experience austenitizing and just be softened. Hence, plastic deformation could take place easily in these regions, as can be seen in Fig. 7. Different deformation capability makes the white layer and substrate incompatible. This could be one of the reasons for delamination.

Another observation in Fig. 7b is that the black voids near the delamination line have been elongated. The assumption proposed by Suh [19] can interpret it properly. During the deformation, massive dislocations could be accumulated around the hard particles and voids develop. With the growth of the voids, they could be elongated and linked together to form a discontinuous line, as shown in Fig. 7. Further growth of the voids leads to the delamination.

Tensile stress which causes the fracture of the white layer can be interpreted by the cyclic heating and cooling of the martensite. Once martensite is transformed from austenite at the surface, volume expansion could cause a compressive stress in this layer because the substrate below opposes the expansion. However, as the temperature of the die decreases by the cooling channels, the surface layer tends to contract, and the substrate opposes it. The internal stresses change direction and turn to tensile stress. Beside this, austenitizing process in the white layer could also be one of the reasons causing tensile stresses. When the temperature in the white layer exceeds the austenitizing temperature, there is a volume contraction, because austenite (γ -Fe) with fcc structure has a higher atomic packing density than that of the martensite/ ferrite phase. Hence, austenitizing will cause a sudden increase in density. The resultant volume contraction will also produce tensile stress in the white layer. As mentioned previously, the white layer with a high hardness has limited ductility. Therefore, fracture could happen in the white layer, as shown in Fig. 7a.

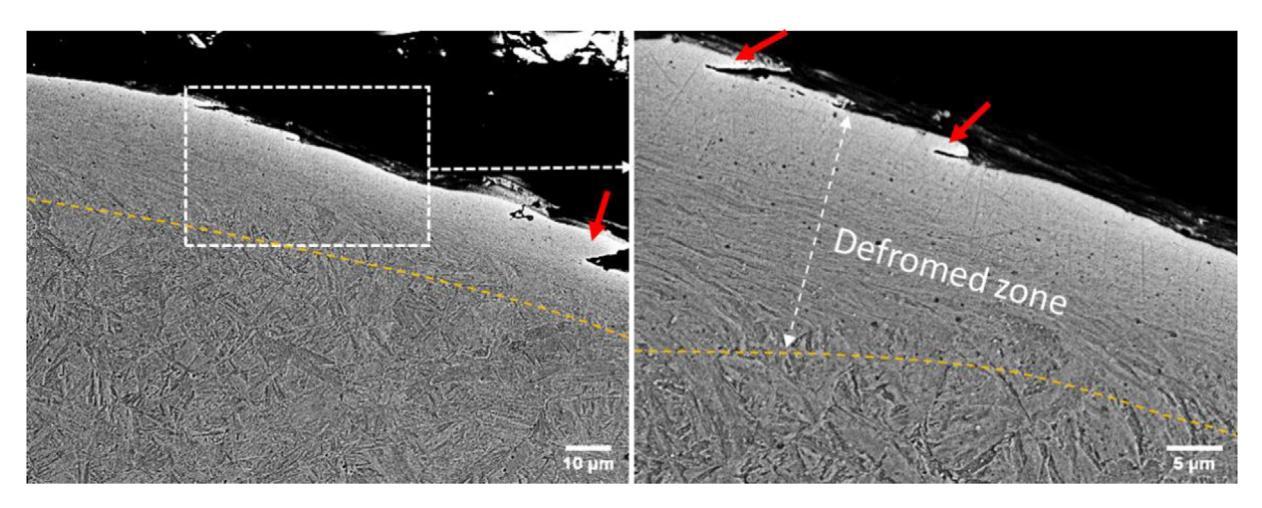
At the die exit of the round corner, severe shear deformation was also found in the region close to the surface (Fig. 8). The sites of exit refer to Fig. 9a. In the lower part of Fig. 8a, a typical tempered martensitic structure was observed. In the deformation zone having a depth of $10-20 \ \mu m$, this structure was stretched along the sliding direction. In Fig. 8b, the grain size reduction was seen in the severe deformed zone. In hot stamping, the die was repeatedly subjected to the shear and normal load at high temperatures. High shear stress can lead to not only the elongation of the grain but also break down the original grains into extremely fine size. As a consequence, the deformed zone showed a different microstructure from the matrix. For other sub-surface regions, the deformation depth

Fig. 8 – Back scattered SEM images from the cross-section of the round corner exit (refer to Fig. 9a), showing severe plastic deformation of the sub-surface of die material. Solid arrows in the images indicate the initiation of wear fragments.

was only about $2-3 \mu m$ due to lower shear stress (Fig. 7). Another interesting observation was the initiation of fragments from the uneven surface (marked as red arrows in Fig. 8), which also contributed to the wear in the current study. These fragments could be evolved as well into the third body particles that caused abrasive wear.

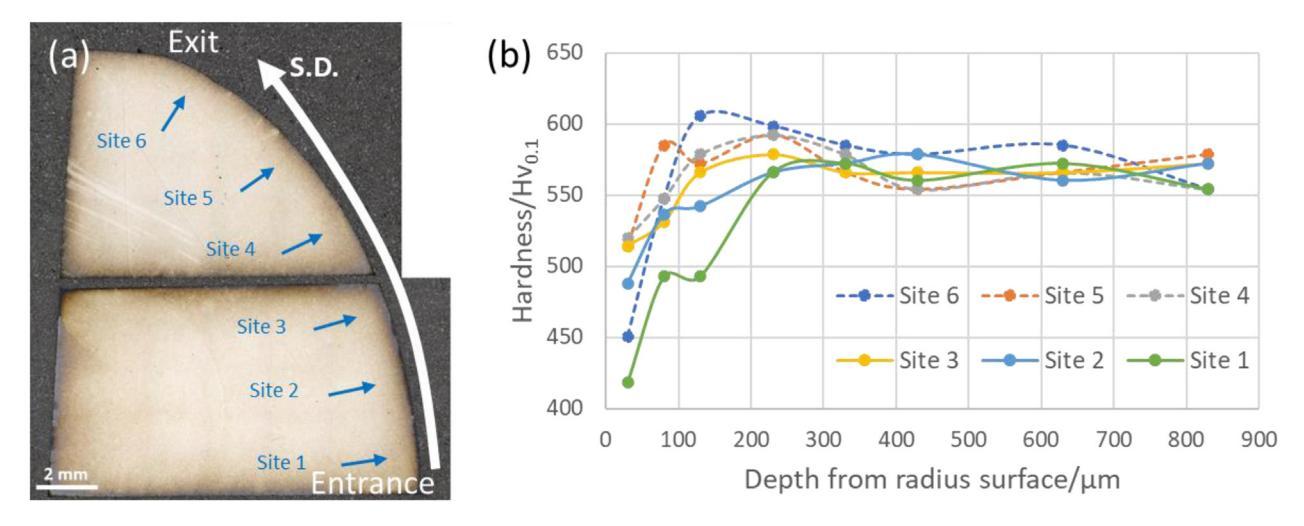
Hardness measurements of the sub-surface on the cross section of the round corner revealed the softening phenomenon of QRO 90 tool steel during the hot stamping process, as shown in Fig. 9. Microhardness test ($HV_{0.1}$) was chosen in order to reduce the size of indentation and reveal the trend of hardness variation with the distance to the surface. As we can see, the hardness of the sub-surface was significantly lower than that of the bulk (~570 HV_{0.1}). The softening of the subsurface was believed to be related to the heating effect from the hot workpieces. The heat transferred from the workpieces decomposed the martensite into ferrite and carbides. With time, the carbides were coarsened at high temperatures and the dislocation density in the material would be decreased greatly, leading to the softening of tool steel. As shown in Fig. 9b, the softening phenomenon became weaker and weaker from the entrance (Site 1) to exit (Site 6) of the round corner. Moreover, the softening depth of the sub-surface also decreased from ~250 μ m to ~150 μ m. This could be explained by the decrease in temperature when the boron steel workpieces travelled from the entrance to the exit of the round corner.

Fig. 9 - The hardness on the cross-section of the round corner shows the softening of the sub-surface, (a) test sites, and (b) hardness profiles of various sites.

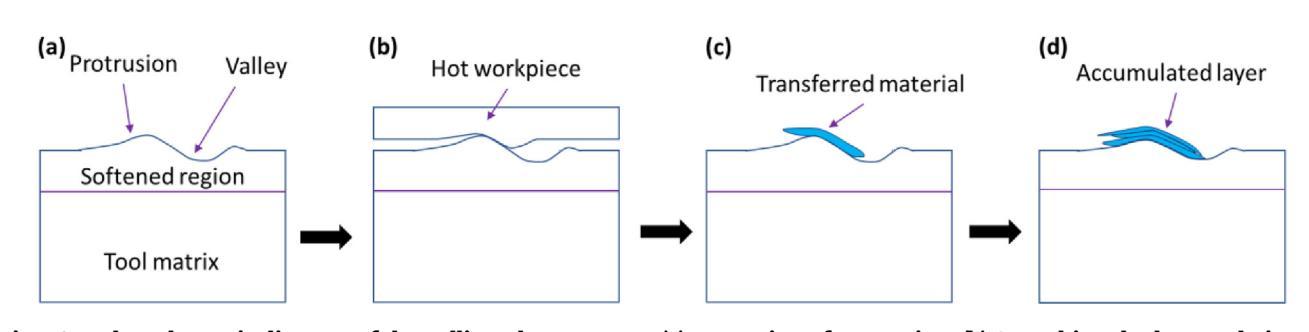
Fig. 10 — The schematic diagram of the galling phenomenon. (a) Formation of protrusion, (b) Scratching the hot workpiece, (c) Transferred material sticked on the tool surface, (d) Accumulated layer (galling) on the tool surface.

The galling process is schematically shown in Fig. 10. During the initial period, the working condition of the tool is good due to the unsoftened substrate and smooth surface. With the ongoing service (few thousands of cycles), the subsurface of the tool is softened, as shown in Fig. 9. On the other hand, the already formed workpieces generally have a high hardness (around 500 HV) due to quenching in hot stamping. During the process of unloading, the hardened workpiece could generate some scratches (the valley in Fig. 10a) on the softened tool surface, leaving some protrusions at the edge of the scratches. In the next cycle of forming, these protrusions could scratch the hot and soft workpiece surface of boron steel (Fig. 10b). Consequently, some material could be transferred from the boron steel workpieces to the tool surface (Fig. 10c). Under the forming force and high temperature from the hot workpiece, the adhesive force between the transfer material and tool steel would be high. According to Ref. [17], the adhesive force is largely dependent on the real contact area (atomic level) of two solid materials. The adhesive force between ductile materials will be enhanced with the increased contact area by plastic deformation. In addition, a large adhesive force is often the case when combining similar materials. In the present study, the workpiece and tool are both made of steels. Considering the possible austenitizing at the surface of tool due to heating from the hot workpieces, both types of steel would have an fcc structure in the surface region when forming. This would further enhance the adhesive force. Hence, the transferred material can easily stick to the tool. Notably, this process can be repeated in the stamping processes, which results in the formation of accumulated layers (galling, Fig. 10d) until they are removed as part of daily maintenance. However, the root cause for galling is the softening of the sub-surface, which could lead to the easy formation of scratches and consequently the initiation of material transfer. This is consistent with Heinrichs' work [18]. From the perspective of this investigation, increasing the softening resistance of tool steel or performing hard facing on the tool could be potential ways to mitigate the galling that happens in the hot stamping process.
