Anchorage in naturally corroded specimens taken from existing structures

Tahershamsi, M., Zandi, K., Lundgren, K. et al (2012). Anchorage in naturally corroded specimens taken from existing structures. Proceeding of the Fourth International Symposium on Bond in Concrete 2012: Bond, Anchorage, Detailing, Brescia, Italy, 17-20 June 2012, Editors: John w. Cairns, Giovanni Metelli, Giovanni A. Plizzari, 1, General Aspects of Bond: 345-349

ABSTRACT: In an on-going project, the anchorage capacity of naturally corroded steel reinforcement was investigated experimentally. The beam specimens were taken from edge beams of Stallbacka Bridge in Sweden. The specimens showed different extent of corrosion induced damage; from no sign of corrosion to extensive cracking and spalling of the concrete cover. After consideration of different possible test setups, a four point bending test indirectly supported with suspension hangers was chosen. The beams were strengthened with transverse reinforcement around the suspension hangers to avoid a premature failure. Eight successful tests have been carried out so far; in all these, a diagonal shear crack preceded an anchorage failure. The anchorage behavio

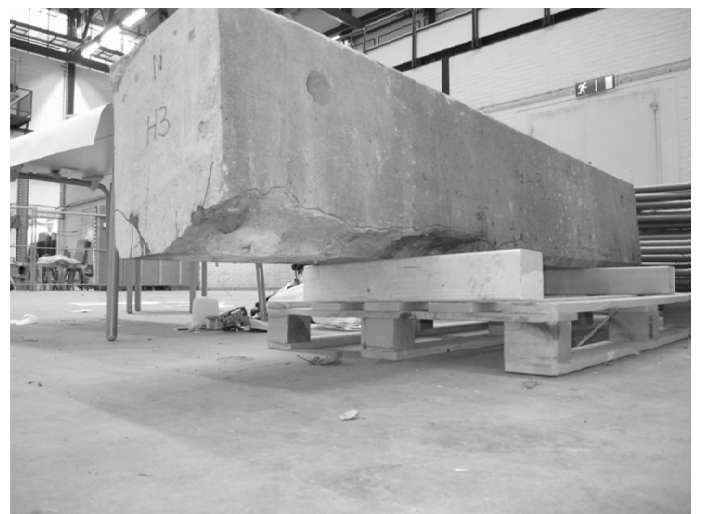
Figure 2. Photos of some of the test specimens before testing.

(a) Medium Damaged M2

(b) Highly Damaged H1

(c) Highly Damaged H3

In Figure 1(a), the geometry of the edge beams is shown. They were 350 x 400 mm in cross-section, with a small inclination of the upper surface. The longitudinal reinforcement consisted of four bars Ø16 Ks60 bundled in pairs in the upper part, and two bars Ø16 Ks60 at the bottom. The transverse reinforcement consisted of Ø10 s300 Ks40. The longitudinal reinforcement bars closest to the upper inclined surface of the edge beams were more damaged than the other longitudinal bars as they were most exposed to de-icing salt. Therefore, they were considered to be more interesting in the investigation of bond and anchorage behaviour. The edge beams show different extent of corrosion-induced damage, from no sign of corrosion to extensive cover cracking resulting in spalling of concrete cover. Based on the damage patterns; the test specimens were categorized into three different groups: Reference (R) specimens, and Medium (M) and Highly (H) damaged specimens. The edge beams were reinforced, both longitudinally and transversally, with deformed bars, i.e. ribbed bars. In Figure 2, some examples of test specimens before testing are shown.

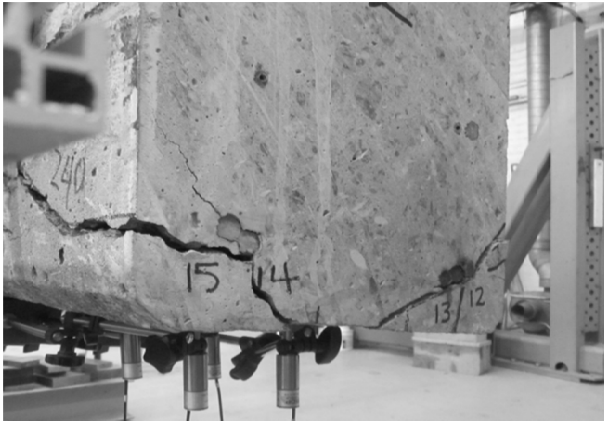
Figure 3. Failure and crack pattern of some of the beams after testing.

The free-end of the tensile bars began to slip at a load level of about 190-200 kN and the final anchorage failure took place, on average, at a load level of 275 kN for the reference beams (R) and 240 kN for the damaged beams at both levels (M and H), see Table 2. As can be seen from the values of the failure loads in Table 2, the scatter was larger for the highly damaged beams. Photos of some of the beams after they were tested are shown in Figure 3; as can be seen splitting cracks occurred around the main bars at failure.

(a) Reference specimen R2

(b) Medium Damaged M2

(c) Highly Damaged H3
