Anchorage capacity of naturally corroded reinforcement in an existing bridge

Berg, F., Johansson, D., Lundgren, K. et al (2012). Anchorage capacity of naturally corroded reinforcement in an existing bridge. Proceedings of the Sixth International Conference on Bridge Maintenance, Safety and Management, IABMAS 2012, Stresa, Lake Maggiore, 8-12 July 2012: 2800-2807. <http://dx.doi.org/10.1201/b12352-428>

F. Berg & D. Johansson

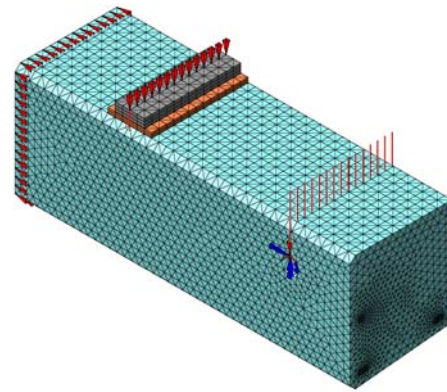
An example of a finite element model in three dimensions is illustrated in Figure 3. Due to symmetry, only a half-member was analyzed. Several simplifications were made, such as not including the deterioration of corrosion and frost. Deviations of the position and the varying amount of the longitudinal and transverse reinforcement were also not accounted for. Note that these simplifications were only used in the preliminary analyses used to design the test set-up. In later work, analyses of the tests will be done to better evaluate the results; then these simplifications will be reassessed and probably not used.

Figure 3. An example of a finite element model in three dimensions.

The longitudinal tensile reinforcement were modeled using solid elements. The compressive and transverse reinforcement were modeled as embedded in the concrete elements, i.e. assuming perfect bond between the reinforcement and the concrete.

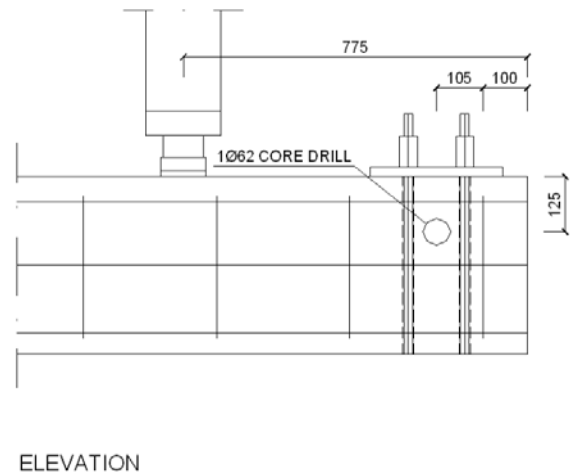
The experience gained from the first beam test led to a modification of the strengthening, shown in Figure 4. The strengthening bars from the first test were replaced by bars of prestressing steel (dywidags) with a diameter of 20 mm. The high yield reinforcing steel bars, fully threaded, were anchored at the top of the beam with hexagonal nuts and flat steel plates. The mechanical docking of the bars, by means of threaded coupling, was considered to provide the additional anchorage needed. The bars were bonded to the concrete with epoxy, the same technique used in the first test. Epoxy was also applied in between the flat steel plate and the concrete beam in order to obtain even pressure.

Figure 4. Details of second test set-up with improved anchorage of the strengthening bars.

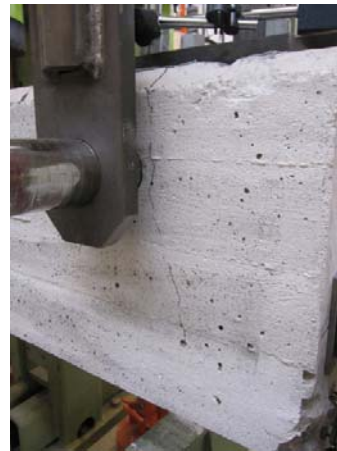
Figure 5. Photo taken before testing, at the end where failure later took place. Second test specimen, low corrosion

The specimen used in the second test was almost undamaged; i.e. only small cracks due to corrosion were visible before the test. The specimen used in the third test had severe damages due to corrosion, with cover spalling. Photos of the test specimens before testing are shown in Figures 5 and 6.

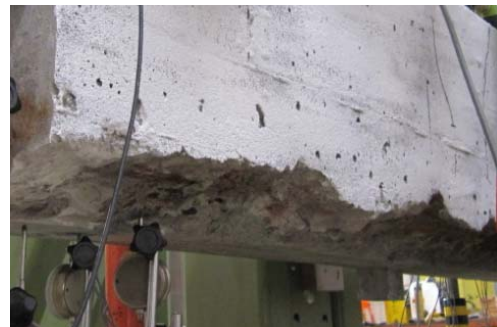
Figure 6. Photo taken before testing, at the end where failure later took place. Third test specimen, high corrosion with cover spalling.

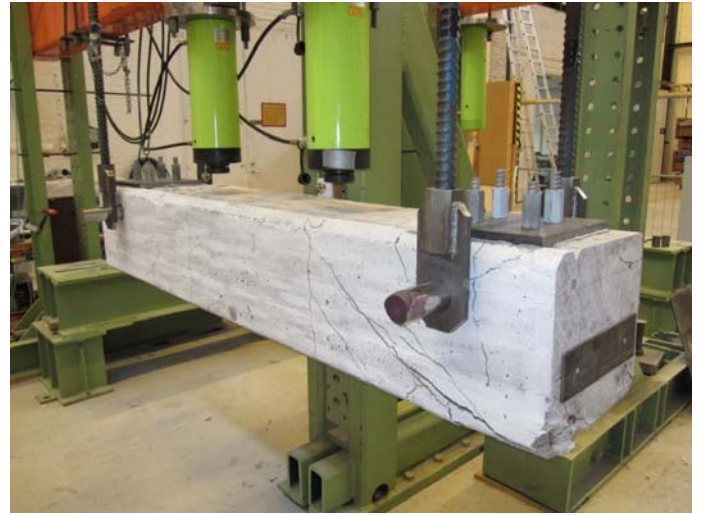
Figure 9. Second test specimen (low corrosion) after testing

Figure 8 shows the average load versus the free end slip in the second test (with low corrosion). The corresponding result in the test with high corrosion degree is similar. As can be seen in Figure 8, all the main bars had a considerable slip of 0.1 mm in the pre-peak stage, which indicates that anchorage failure took place. Photos showing the crack patterns can be found in Figures 9 and 10.

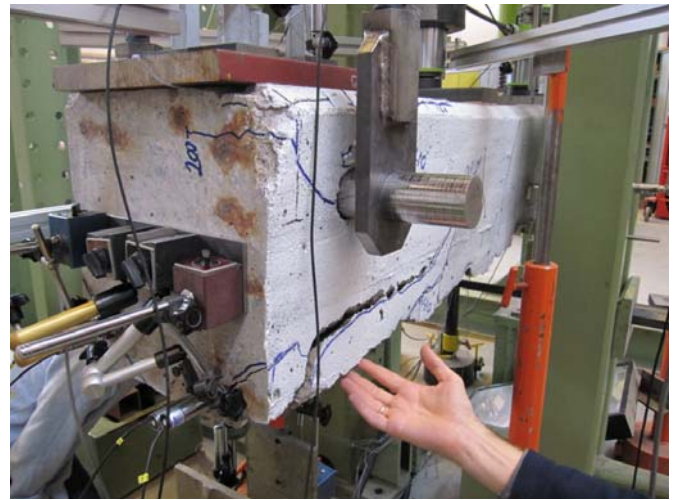
Figure 10. Third test specimen (high corrosion with cover spalling) at failure.
