Anchorage capacity of naturally corroded reinforcement in an existing bridge

Proceedings of the Sixth International Conference on Bridge Maintenance, Safety and Management,

# Anchorage capacity of naturally corroded reinforcement in an existing bridge

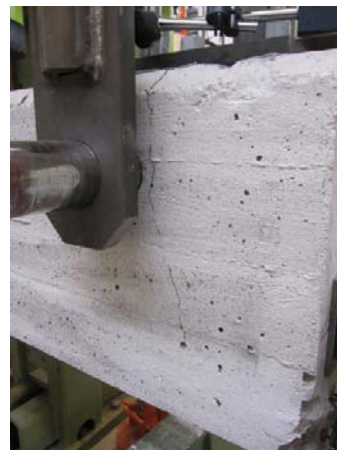
The specimen used in the second test was almost undamaged; i.e. only small cracks due to corrosion were visible before the test. The specimen used in the third test had severe damages due to corrosion, with cover spalling. Photos of the test specimens before testing are shown in Figures 5 and 6.

Figure 5. Photo taken before testing, at the end where failure later took place. Second test specimen, low corrosion

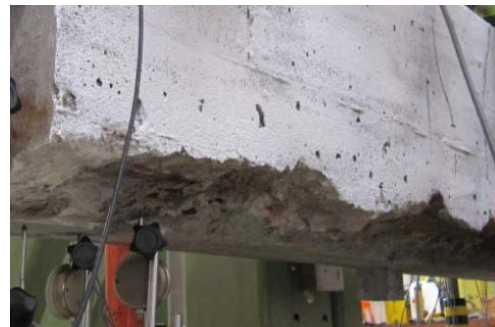
Figure 6. Photo taken before testing, at the end where failure later took place. Third test specimen, high corrosion with cover spalling.

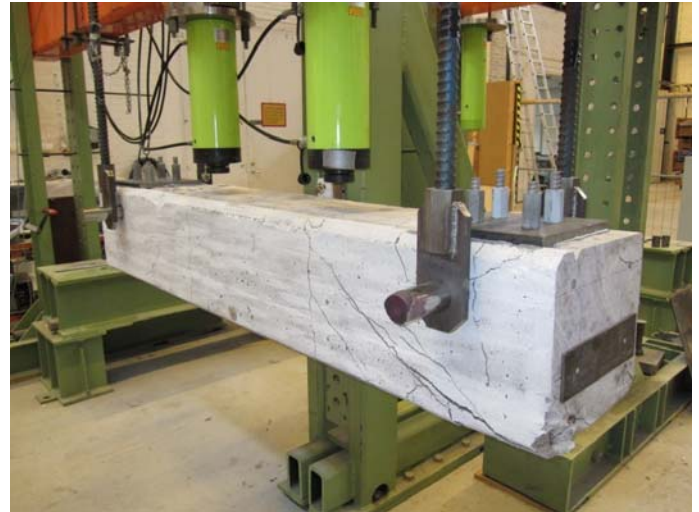
Figure 9. Second test specimen (low corrosion) after testing

Figure 8 shows the average load versus the free end slip in the second test (with low corrosion). The corresponding result in the test with high corrosion degree is similar. As can be seen in Figure 8, all the main bars had a considerable slip of 0.1 mm in the pre-peak stage, which indicates that anchorage failure took place. Photos showing the crack patterns can be found in Figures 9 and 10.

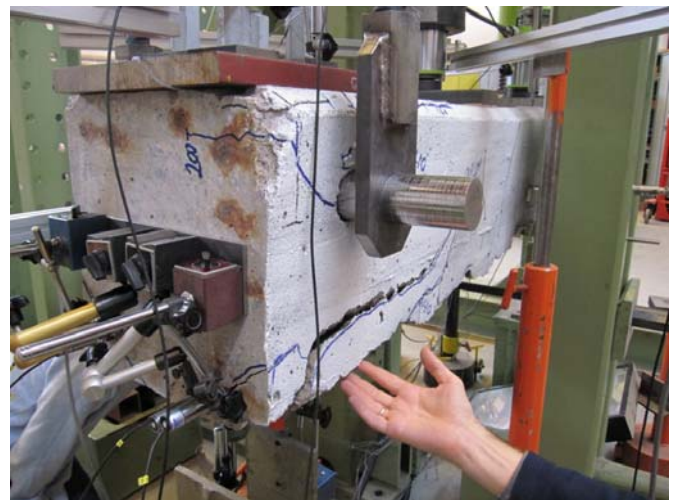
Figure 10. Third test specimen (high corrosion with cover spalling) at failure.
