Anchorage capacity of naturally corroded reinforcement in an existing bridge

Berg, F., Johansson, D., Lundgren, K. et al (2012)

Proceedings of the Sixth International Conference on Bridge Maintenance, Safety and Management,

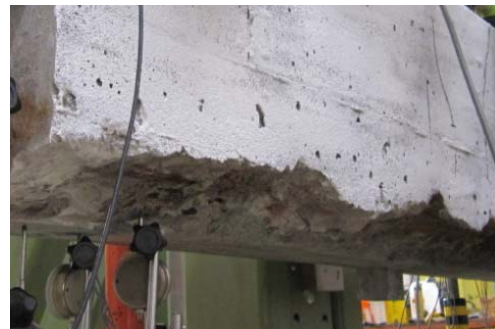
Figure 6. Photo taken before testing, at the end where failure later took place. Third test specimen, high corrosion with cover spalling.

The specimen used in the second test was almost undamaged; i.e. only small cracks due to corrosion were visible before the test. The specimen used in the third test had severe damages due to corrosion, with cover spalling. Photos of the test specimens before testing are shown in Figures 5 and 6.

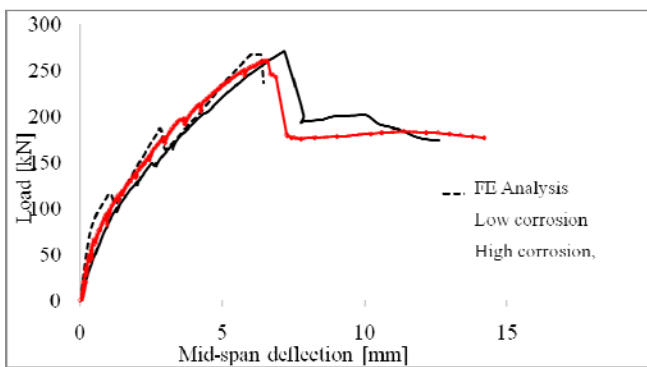
The second and third beam tests resulted in anchorage failure as wanted and had a good correspondence to the finite element analysis. This can be seen in Figure 7, where the average load of the two hydraulic jacks is plotted against the mid-span deflection, for both the two tests and the analysis. The maximum load in the specimen with low corrosion was about 270 kN, corresponding very well to the one resulting from the finite element analysis. In the

test with a severely corroded specimen, the maximum load was almost as high: 255 kN. The three-dimensional simulation showed a slightly stiffer behavior in the pre-peak stage. The experiments showed a considerable residual load-bearing capacity of about 70-75%; this could not be followed in the analysis. The sudden drop in the post-peak stage, from the maximum load down to the more or less constant branch representing the residual capacity, indicates that the failure was not completely stable.

Figure 7. Results from second test: a) Average load versus mid span deflection, and b) Average load versus end slip.

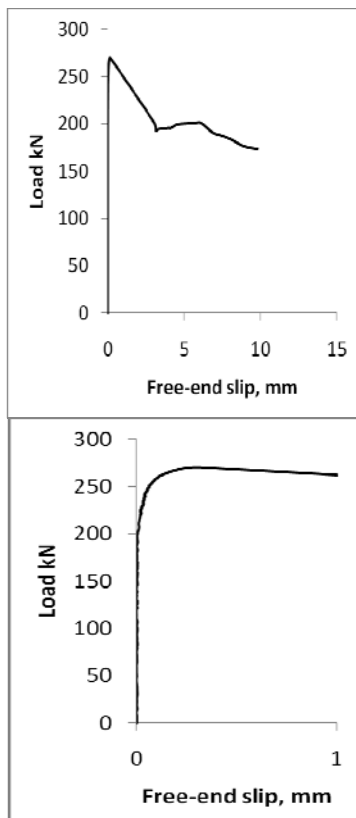
Figure 8 shows the average load versus the free end slip in the second test (with low corrosion). The corresponding result in the test with high corrosion degree is similar. As can be seen in Figure 8, all the main bars had a considerable slip of 0.1 mm in the pre-peak stage, which indicates that anchorage failure took place. Photos showing the crack patterns can be found in Figures 9 and 10.

Figure 8. Average load versus end slip in second test, with low corrosion. b) is an enlargement of a).

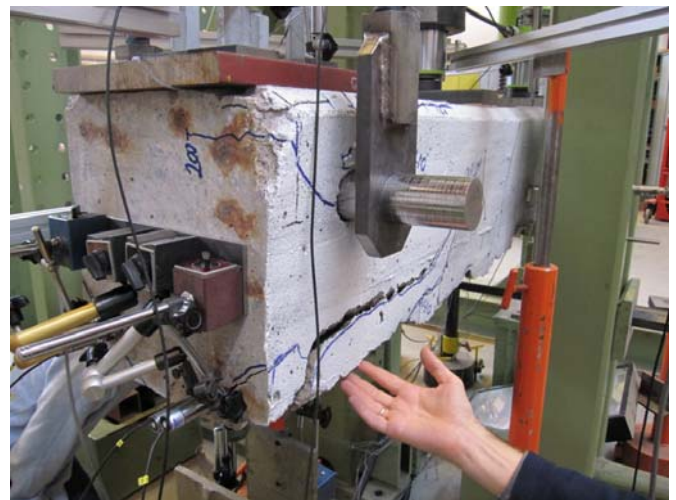
Figure 10. Third test specimen (high corrosion with cover spalling) at failure.
