## Vacuum insulation panels (VIP) in refrigerator room, freezing room & fridge

Samuel Brunner<sup>a,\*</sup>, Karim Ghazi Wakil<sup>a</sup> and Pär Johansson<sup>b</sup>

<sup>a</sup> Empa, Laboratory for Building Science and Technology, Swiss Federal Laboratories for Materials Science and Technology, Ueberlandstrasse 129, CH-8600 Dübendorf, Switzerland

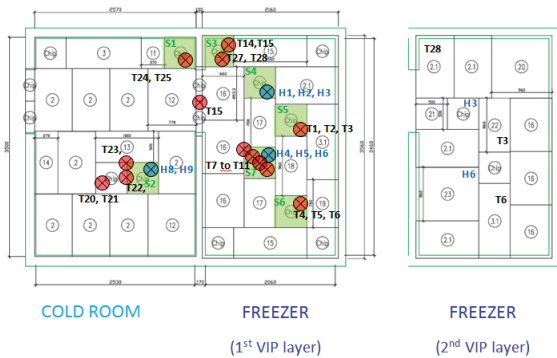
Fig 2: Layout of the VIP's in the refrigerating (single layer) and in the freezing room (double layer). Temperature and humidity sensor are labeled with T and H. Panels with integrated pressure sensor are highlighted in green (or light gray in b&w). Numbers in circle had been from the dimensional planning. Cold storage room CR, Freezer room FR.

for a combined cooling / freezing chamber with partition wall could be changed to include a full VIP floor insulation of both the cold (5 °C) and the freezing (-20 °C) section of the double chamber (figure 5). The thickness of the VIP layers was 25 mm in the cooling and 2 x 20 mm (double layer) in the freezing section, and the area about 9 m<sup>2</sup> each. Further details including first year results had already been presented at IVIS2007 including vertical section through the floor [7]

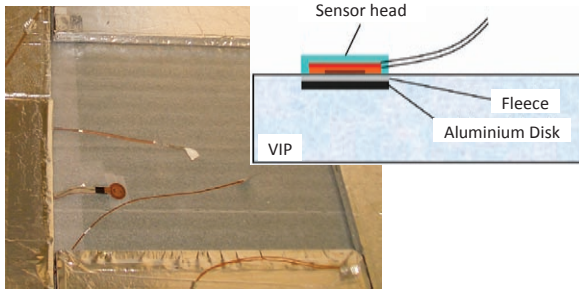
Fig. 3: Principle of the in-situ measurement of the internal pressure (technique va-q-perm, developed by VIP producer va-Q-tec, Würzburg, Germany [8,9]).

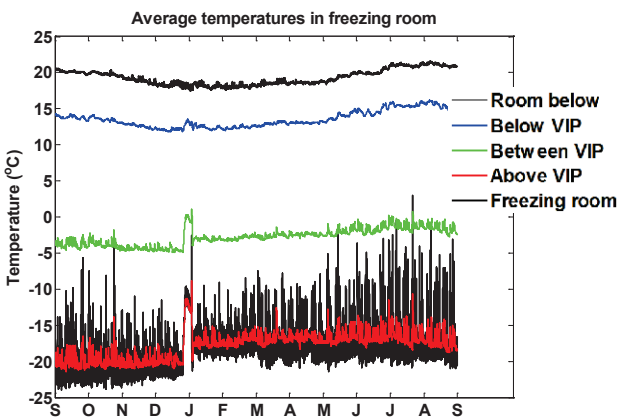
Fig. 4: Average temperature in the freezing room and cold storage room respectively during the period 1 September, 2007 to 31 August, 2008

The every 12 minutes logged data in Fig.4 showed late Dec. 2007 a jump up, that did not occur a year later on next X-mas.

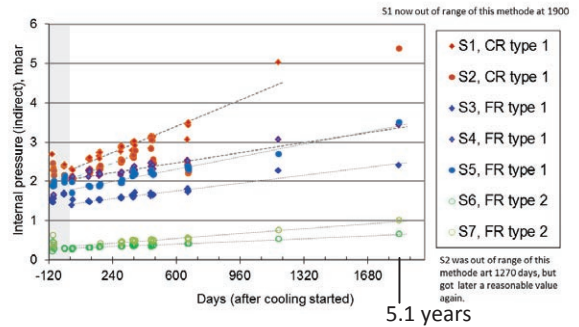
Fig. 5: In-situ measured internal pressure of VIP floor insulation in the cooling / freezing room. The dotted lines indicate the respective linear trends.

The present contribution deals with the evolution of the internal pressure of VIPs subjected to low and freezing temperature for a period of 5 years confirming the prediction made earlier on its linear increase 0.6 mbar/year in the refrigerator room and 0.10 to 0.26 mbar/year in freezer room depending on the VIP type.

According to [9] a measurement range between 0.02 and 10 mbar can be covered with this fleece type. Here the data between 0.2 and 4 mbar well on the linear trend. Values above are less well on the line, and artifacts from the method and not real internal pressure is likely the causation for this.

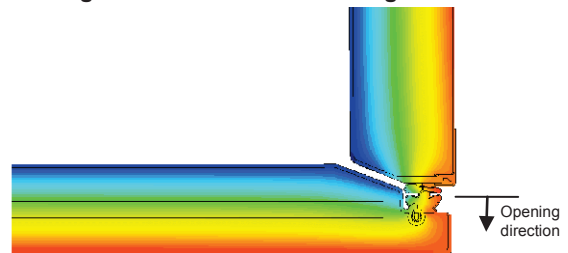
Fig. 6: 2D-Thermal simulation of VIP in a freezer door.

Further, a refrigerator with different VIP configuration was analysed with respect to their energy performance by means of thermal bridge analysis and possibilities to reduce them.
