## **Sustainable and Balanced Energy Efficiency and Preservation in Our Built Heritage**

Norrström, H. (2013). Sustainable and Balanced Energy Efficiency and Preservation in Our Built Heritage. *Sustainability*, 5(6): 2623-2643. <http://dx.doi.org/10.3390/su5062623>

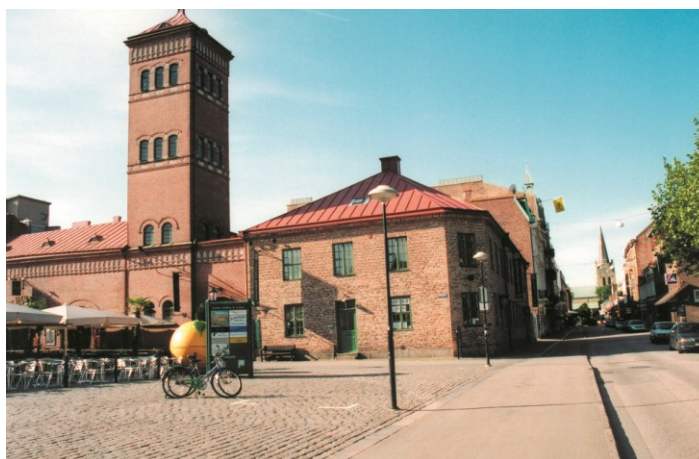
Figure 1 below shows the expressive brick façade of Fattighuset and the hose tower, once used for drying the fire brigade's hoses after use. The results from the conservation work are considered good, with well-preserved authenticity and patina, but, in short, preservation issues in Fattighuset have been given foremost priority, at the expense of the indoor comfort and energy issues.

**Figure 1.** Fattighuset's North façade, facing Lilla Torg in Halmstad. Photo Eva Gustafsson, Heritage Halland at the Regional Museum Halland.

Fattighuset has mainly been used by the fire brigade. Both buildings have a solid red 1 ½-stone brick construction, and partitions and floors are wooden. The buildings are made of local materials, worked by skilled craftsmen. They have well preserved original forms, expressive exteriors, and preserved interior furnishing. Most of the old doors, windows, stairs, floor, and roof cornices *etc.* have preserved old features. The almost intact floor plans have a general character, which enables different activities to take place within them, and as such possesses high architectural quality. The buildings, and

The new mechanical continuous exhaust ventilation is placed in a separate room in the attic and the ducts are visible in the corridors. Fresh air is supplied through vents in the brick wall. The tenants experience poor comfort levels. It is cold during winter, especially in areas near the fresh air vents and around windows and doors. On the interior walls, by the fresh air vents, the temperature was measured as 9 °C, and simultaneously the temperature outdoors was measured as 0 °C. In the oldest part of the building, on the ground floor, there is a boiler room where the exchanger for district heating is situated. There is also a problem with the foundation. Fungus growth in the stone foundation occurred in the beginning of 2001 and was then excavated, and a dehumidifier with continuous measuring and control was installed. When the conservation was carried out the earlier roof garrets were replaced with roof windows, and 175 mm of insulation was added to the interior side of the roof. During the summer, the offices on the attic floor are overheated despite this. The conservation work was carried out in 1996. After its completion, Fattighuset was let out to shopkeepers and offices.

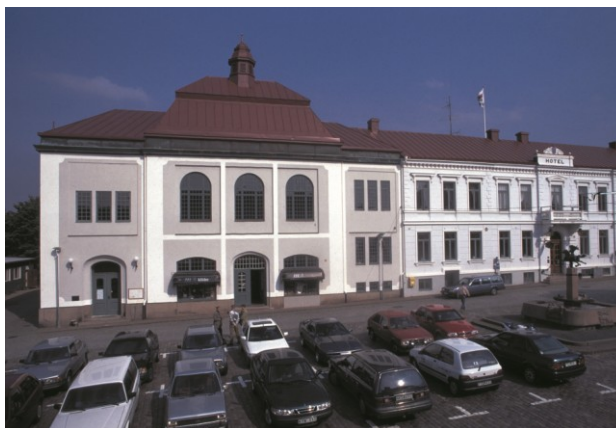
The authenticity in the building's appearance is high although it lacks some of the patina of 1913, mostly due to the 1950s refurbishment as seen in the building's façade in Figure 2 below. The energy efficiency measures have been nicely adapted to the building and are not experienced as disturbing.

**Figure 2.** The South façade of Teatern, facing Hästtorget in Laholm. Photo Eva Gustafsson, Heritage Halland at the Regional Museum Halland.

Teatern is the local theatre and has a solid 2 ½-stone brick construction with a plastered façade. Partitions and floors are wooden, except for the auditorium's added inner roof construction of steel. In Teatern the original interior of the foyer, the auditorium, and the official restroom, for refreshments and use between acts were restored to their former state with lime plaster and gold. The plastered façade was altered in the 1950s, but was not restored during the conservation work in 1995. Still, Teatern is one of the most dominant buildings at Hästtorget in the old town, Gamleby, and has classification 1 in the city's preservation plan: a building of great cultural and historic value.

Teatern was restored in 1995 within the Halland Model. During the conservation work, 300 mm insulation was added to the inner vaulted steel roof over the auditorium, and ventilation with both exhaust/supply air and a heat exchanger for heat recovery was installed. The vaulted windows in the auditorium were reproduced and partly mounted with three window-panes. These were the main energy efficiency actions carried out in Teatern. The measured energy consumption for heat and electricity is 108 MWh/year and per area  $A_{temp}$ . The area heated to 10 °C or more,  $A_{temp}$ , for Teatern is 884 m<sup>2</sup>. The key figure for energy consumption is 122 kWh/m<sup>2</sup> and per year. This is considered low for an old building in this category, type code 826, according to the comparative key figure given, statistic interval 123–185 kWh/m<sup>2</sup> and per year, when calculating the energy performance of the building at Boverket's web site [12]. Teatern is heated by a gas boiler and the calculated CO<sub>2</sub> emissions are 20.53 tons/year.

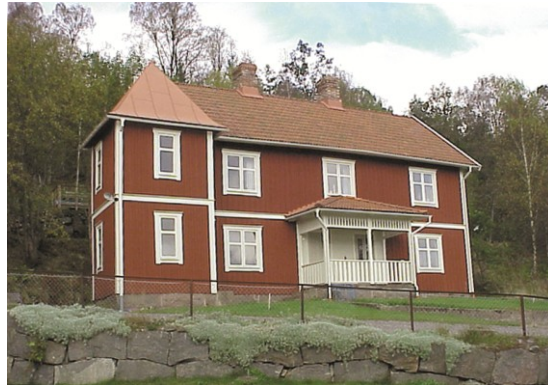
**Figure 3.** Tyreshill's façade, towards Southeast. Photo Eva Gustafsson, Heritage Halland at the Regional Museum Halland.

Tyreshill has a solid timber construction and was planned as a private house for three families, but was remodelled in 1949 for five families. According to the local preservation plan, it is the oldest house in the industrial community Rydö Bruk. Tyreshill has a typical red wooden panel façade with white corners, and it was quite dilapidated in the 1990s. The owner at that time wanted it to be demolished, but the building committee did not allow it. It was renovated in 1997–1998 and most of the exterior façade is intact, despite the otherwise poor condition. The interior was totally refurbished and even parts of the construction on the ground floor had to be reproduced. The construction details of the interior woodwork had to be produced by working from old models. The attic was insulated with 200 mm mineral wool during the restoration, and 45 mm was added to the interior side of the walls. Low emission glass was selected for the inner panes of the windows. Two wood stoves were installed, one on each floor, using the original chimneys, along with a boiler for wood-pellets with storage in a shed on the property with a culvert into the house. The building has floor heating and natural ventilation. Today one family lives on the first floor and they have a workshop and a pottery on the ground floor.

The result of the restoration is a very comfortable house, warm, with no draughts. It has a modern kitchen, bathrooms, space for laundry, and all the facilities needed in a household of today. The two houses' appearance is original but lacks all patina in the interior. Their cultural value is considered moderate but Tyreshill has high value in its context, visibly exposed and located on the hillside as shown in Figure 3 below, and as part of the young community's history. Usability, comfort, and energy issues were prioritized at the expense of the original authenticity and patina, due to its poor original condition.
