Norrström, H. (2013). Sustainable and Balanced Energy Efficiency and Preservation in Our Built Heritage. *Sustainability*, 5(6): 2623-2643. <http://dx.doi.org/10.3390/su5062623>

Sustainable and Balanced Energy Efficiency and Preservation in Our Built Heritage

Heidi Norrström

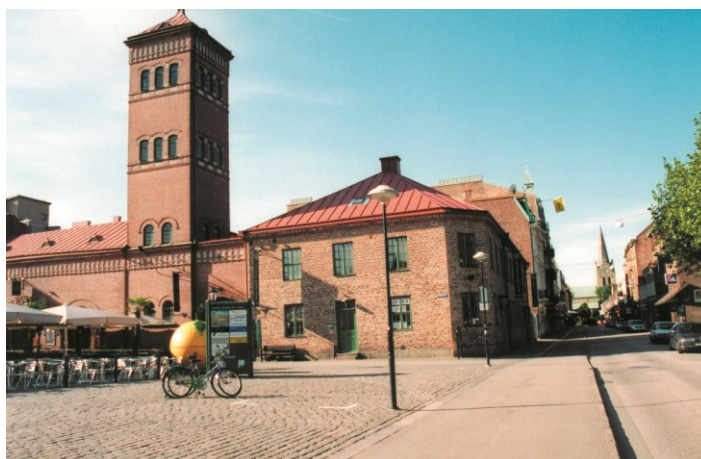
Figure 1 below shows the expressive brick façade of Fattighuset and the hose tower, once used for drying the fire brigade's hoses after use. The results from the conservation work are considered good, with well-preserved authenticity and patina, but, in short, preservation issues in Fattighuset have been given foremost priority, at the expense of the indoor comfort and energy issues.

Figure 1. Fattighuset's North façade, facing Lilla Torg in Halmstad. Photo Eva Gustafsson, Heritage Halland at the Regional Museum Halland.

Fattighuset has mainly been used by the fire brigade. Both buildings have a solid red 1 ½-stone brick construction, and partitions and floors are wooden. The buildings are made of local materials, worked by skilled craftsmen. They have well preserved original forms, expressive exteriors, and preserved interior furnishing. Most of the old doors, windows, stairs, floor, and roof cornices *etc.* have preserved old features. The almost intact floor plans have a general character, which enables different activities to take place within them, and as such possesses high architectural quality. The buildings, and

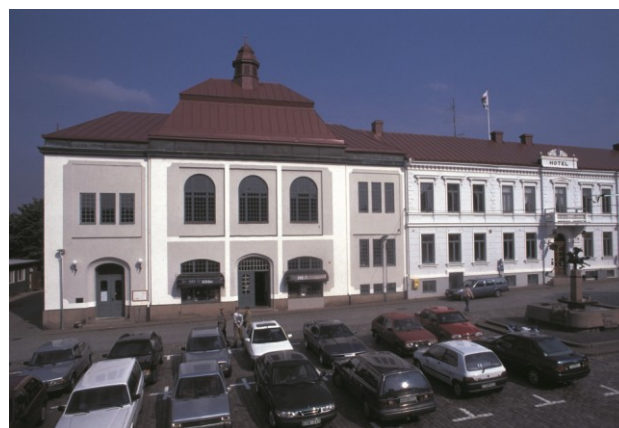
Figure 2. The South façade of Teatern, facing Hästtorget in Laholm. Photo Eva Gustafsson, Heritage Halland at the Regional Museum Halland.

The authenticity in the building's appearance is high although it lacks some of the patina of 1913, mostly due to the 1950s refurbishment as seen in the building's façade in Figure 2 below. The energy efficiency measures have been nicely adapted to the building and are not experienced as disturbing.

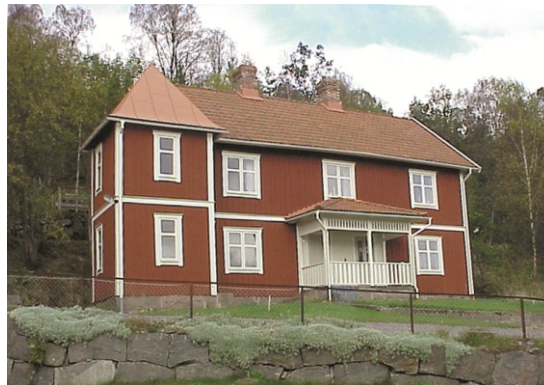
Figure 3. Tyreshill's façade, towards Southeast. Photo Eva Gustafsson, Heritage Halland at the Regional Museum Halland.

The result of the restoration is a very comfortable house, warm, with no draughts. It has a modern kitchen, bathrooms, space for laundry, and all the facilities needed in a household of today. The two houses' appearance is original but lacks all patina in the interior. Their cultural value is considered moderate but Tyreshill has high value in its context, visibly exposed and located on the hillside as shown in Figure 3 below, and as part of the young community's history. Usability, comfort, and energy issues were prioritized at the expense of the original authenticity and patina, due to its poor original condition.
