## **The effect of fibres on steel bar corrosion and flexural behaviour of corroded RC beams**

Berrocal, C., Lövgren, I., Lundgren, K. (2018). The effect of fibres on steel bar corrosion and flexural behaviour of corroded RC beams. *Engineering Structures*, 163: 409-425.  
<http://dx.doi.org/10.1016/j.engstruct.2018.02.068>

# The effect of fibres on steel bar corrosion and flexural behaviour of corroded RC beams

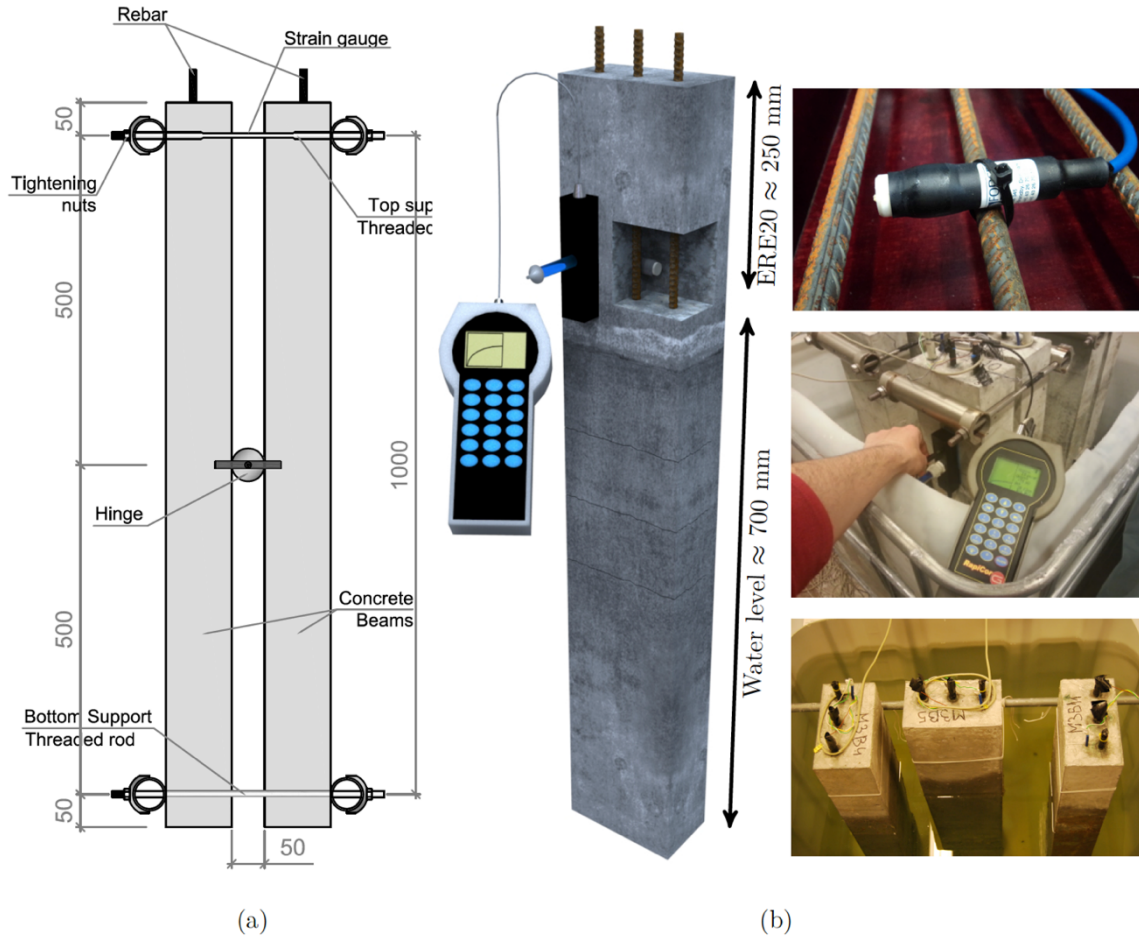
**Figure 3. (a) Schematic illustration of the sustained loading setup and (b) 3D representation of the corrosion monitoring setup and images of the ERE 20, RapiCor device and beams during immersion in chloride solution. Note that the cut-out in the beam is only included to illustrate the position of the ERE20. All measurements are in mm.**

A MnO<sub>2</sub> reference electrode from Force Technology (ERE20) was embedded into all beams, placed at 250 mm from one of the beam ends. The reference electrode was used to monitor the corrosion potential of two of the three reinforcing bars in each beam and determine the duration of the corrosion initiation phase. In addition to corrosion potential measurements, the corrosion rate during the propagation phase was measured using a handheld device named RapiCor, the accuracy of which has been tested on laboratory specimens as well as on on-site structures [55]. The RapiCor is based on the galvanostatic pulse technique [56], which was chosen for this investigation due to the reduced time required to perform a measurement compared to other polarization techniques such as linear polarization resistance, cf. [57]. The corrosion rate was measured on the same two bars where corrosion potential readings were performed, placing the sensor of the device on the surface of the beams at roughly the same location

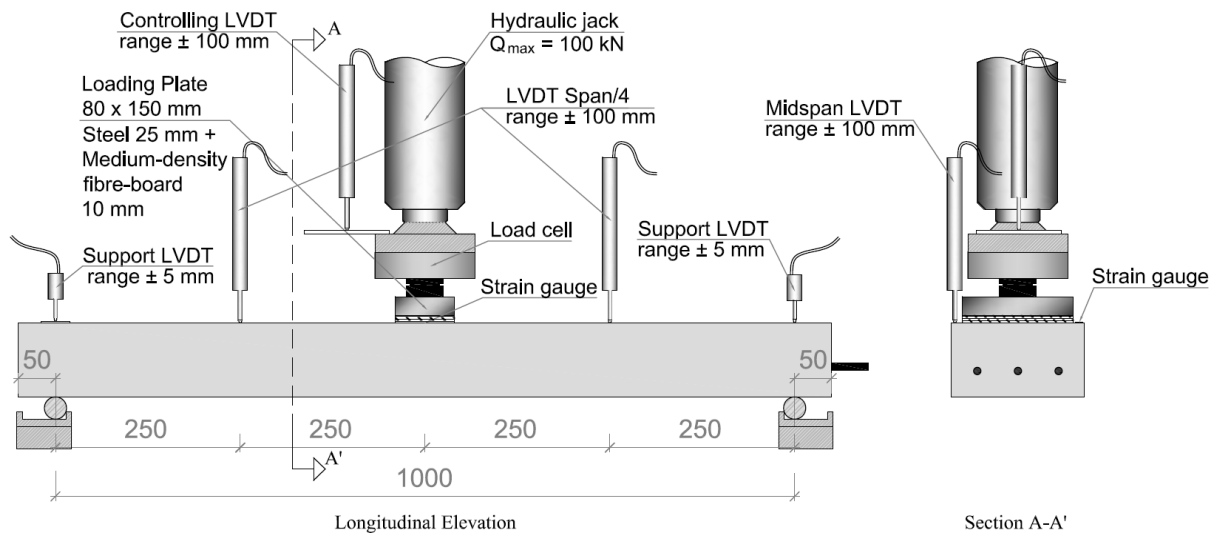
**Figure 4. Three-point bending test setup used to test the flexural capacity of the beam specimens after the corrosion experiments. Measurements are in mm.**

A three-point loading configuration was used both to precrack, and to test the flexural capacity of the beam specimens after the exposure period. The distance between the end supports was 1000 mm, and the load was applied at the mid-span. Loading was performed using a double-effect hydraulic jack with a maximum load capacity of 100 kN. The applied load was measured using a load-cell that was placed between the jack piston and the loading plate. Beam displacements were measured using five linear variable displacement transducers (LVDTs) placed on the top surface of the concrete beam, one at the mid-span section next to the loading plate, two more at span quarters and the remaining two, one over each support. Additionally, a 65 mm strain gauge was also glued on the top surface of the concrete, next to the loading plate, to monitor the compressive strain at the mid-span section.

The loading procedure was performed under displacement control at a displacement rate of 1 mm/min up to a mid-span displacement of 10 mm. Thereafter the displacement rate was increased gradually up to 3 mm/min for the remainder of the tests until failure of the beam specimens occurred.

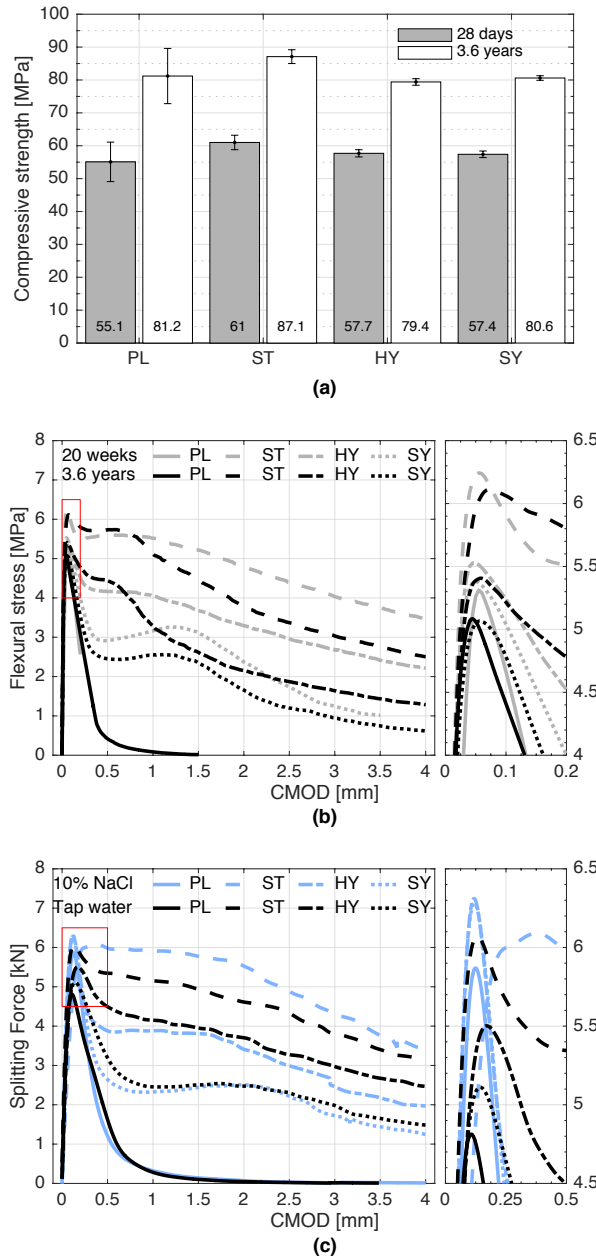
**Figure 6. Material characterization tests: (a) compressive strength, average and standard deviation for three specimens; (b) three-point bending tests of notched beams, average for six specimens; and (c) wedge splitting tests, average for three specimens. A zoomed area is shown for (b) and (c) to show the region of the peak values in detail.**

The results from the material characterization tests, presented in Fig. 6(a)-(c), illustrate the influence of the concrete age and chloride exposure on the mechanical performance of plain and fibre reinforced concrete. As observed in Fig. 6(a), the initial compressive strength of all the studied mixes measured at 28 days was increased by approximately 40% after 3.6 years stored in potable water. This increase of strength is attributed to the refinement of the pore network caused by the continued hydration of unreacted cement occurring during the storage period.

Regarding the results obtained from the three-point bending tests, presented in Fig. 6(b), no significant difference due to ageing was observed in the flexural strength for any of the mixes irrespective of the fibre addition. However, for CMOD's greater than 1 mm, three years ageing reduced the post-cracking flexural stress about 1 MPa in mixes containing steel and hybrid fibres. Also the mixes with synthetic fibres had a slightly reduced post-cracking flexural stress for aged specimens. The unaltered flexural strength, which seems to contradict the compressive strength results, could be explained by the fact that the initial three-point bending tests were carried out at 20 weeks, instead of 28 days, thus considerably later. Moreover, the beams tested after 3.6 years, unlike the cylinders used for compressive strength tests, were stored in dry conditions under part of the storage period due to a water leakage in the storage container that went unnoticed. These two factors, might have limited the relative increase of strength due to late hydration of cement, particularly near the surface of the beams. On the other hand, the loss of post-cracking stress at large crack openings for specimens with steel fibres, is attributed to a change in the failure mode of steel fibres, from fibre pull-out to fibre breakage, due to an increased bond capacity between the fibres and the concrete matrix, as previously reported by others, see e.g. [61]. The reason for the increased bond capacity of the fibres was not specifically investigated but a possible explanation could be attributed to a small pressure on the fibres due to shrinkage, which could have increased the frictional component of the bond. This effect was less apparent for the mix with synthetic fibres, where fibre breakage was already detected in the initial tests at 20 weeks.

The results from the wedge splitting tests presented in Fig. 6(c) show that prolonged immersion (3 years) in 10% chloride solution, compared to potable water, had no adverse effect on the mechanical performance of either plain or fibre reinforced concrete. In fact, a positive effect on the peak splitting force was consistently observed for all the mixes stored in chloride solution. The binding of chloride ions as Friedel's salts or Kuzel's salts [62] is a process of expansive nature that generally leads to a decreased concrete strength [63]. However, the effect of NaCl is lower compared to other salts like  $\text{CaCl}_2$  and  $\text{MgCl}$  [64]. Moreover, since the formation of such salts depends mainly on the  $\text{C}_3\text{A}$  content of the cement, which in this study was low (<3% compared to ~6-7% for ordinary Portland cement), the increased strength observed in the wedge splitting tests could, possibly, be explained by a limited

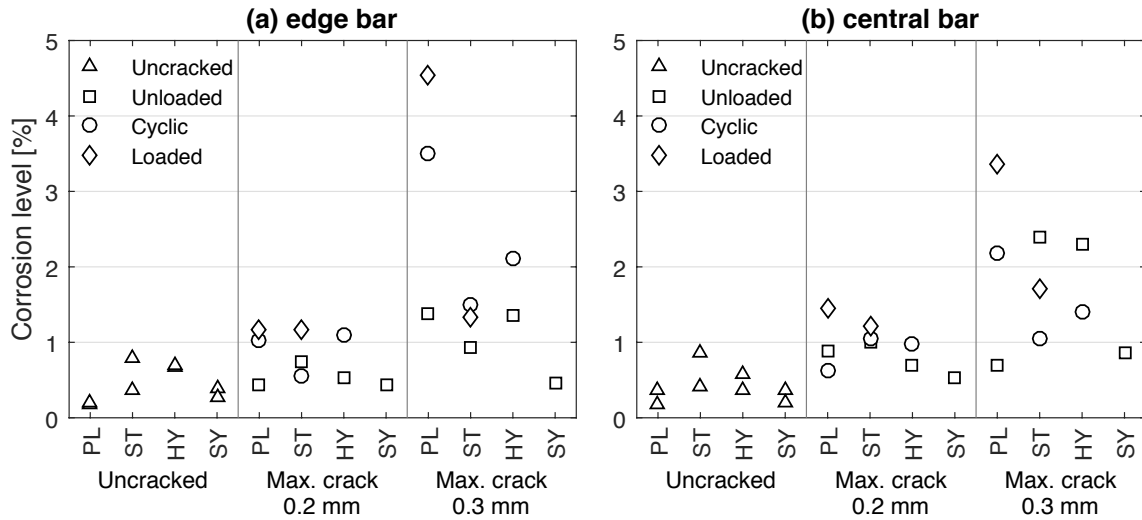
**Figure 7. Corrosion level calculated according to Eq. (2) based on the corrosion rate measurements obtained with the RapiCor device.**

a local corrosion level was calculated for each rebar according to Eq. (2), which is presented in Fig. 7 for all the series and loading conditions investigated. For the correct interpretation of these results, however, some aspects must be taken into consideration.

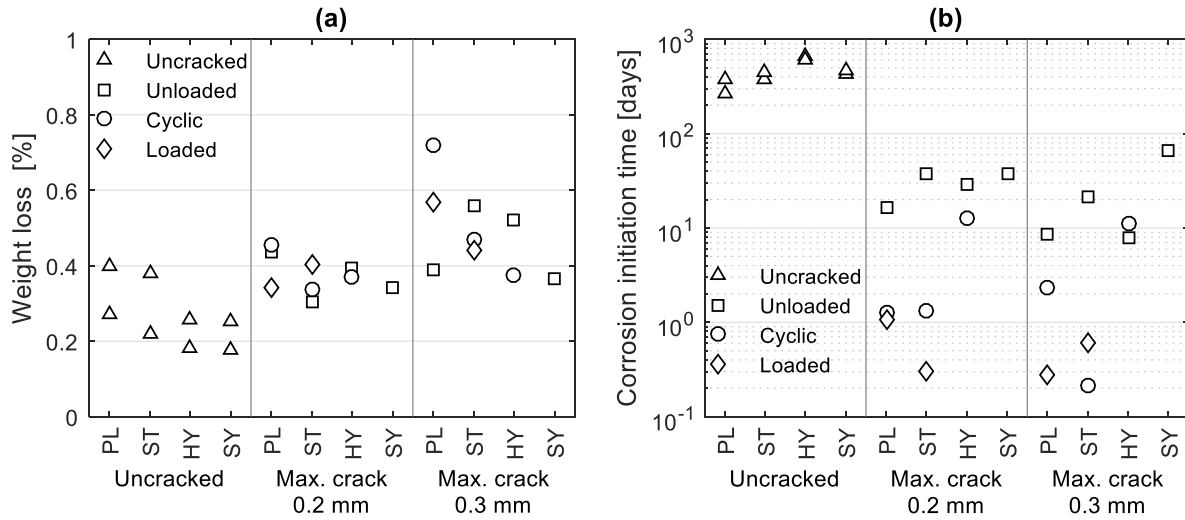
**Figure 8. (a) General corrosion level expressed as weight loss, calculated according to Eq. (1). Each marker represents the average of the corrosion level determined for the three bars of the same beam. (b) Time to corrosion initiation determined from half-cell potential measurements. Each marker represents the average of the two monitored bars for each beam.**

The general corrosion level calculated from the weight loss according to Eq. (1), is presented in Fig. 8(a) as an average corrosion level of the three bars embedded in each beam whereas in Fig. 8(b) the time to corrosion initiation is presented as an average of the two bars monitored. The first thing that should

be highlighted from Fig. 8(a) is the low corrosion levels ( $< 1\%$ ) obtained for all specimens. This finding is a consequence of the concentration of corrosion into very limited regions, giving rise to localisation of deep pits and an extensive bar surface proportion free from corrosion.

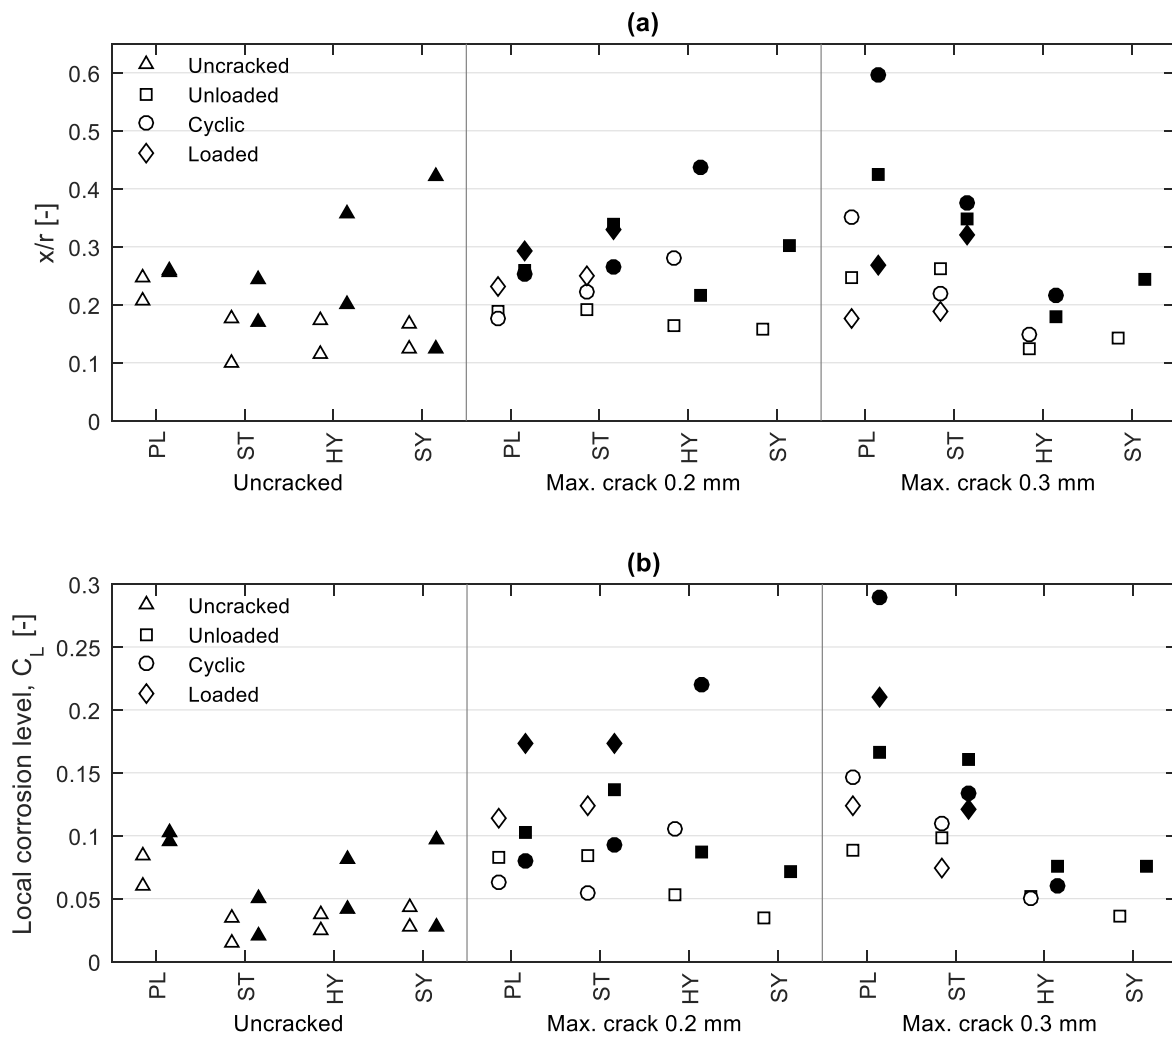
**Figure 11. Penetration depth normalized to the reinforcement bar radius,  $x/r$  (a) and local corrosion level,  $C_L$ , based on the cross-sectional loss according to Eq. (2) (b). White markers ( $\square$ ) indicate average values and black markers ( $\blacksquare$ ) indicate maximum values of measurements carried out at various pit locations in each beam.**

Looking at the average values in Fig. 11(a) it can be observed that the addition of fibres had a clearly positive effect in reducing the penetration depth in uncracked specimens. In cracked specimens, however, only hybrid and synthetic series displayed a generally beneficial effect whereas steel series had a rather limited impact, being slightly unfavourable in some cases. Similar results are shown in Fig. 11(b) for the cross-sectional loss, although in the latter case the steel fibre series showed a modest improvement with respect to corrosion penetration depth. These findings support the previous results indicating that corrosion of reinforcement in fibre reinforced concrete features a larger number of pits

On the other hand, the maximum values presented in Fig. 11 (a) and (b) appeared more scattered with no apparent general trend. For uncracked beams and beams with target crack widths equal to 0.2 mm, a seemingly random distribution of the penetration depth and cross-sectional loss maxima was observed. For beams with target crack widths equal to 0.3 mm, the addition of fibres showed a clearly positive effect. In the light of these results, fibre reinforcement, at low dosages, did not seem to have any particular influence by itself on the pit growth. It is, therefore, reasonable to think that the local conditions at each pit play a more important role in the local corrosion development than the presence of fibres. Those conditions may include damage at the steel-concrete interface, e.g. slip and separation caused by mechanical loading, which have been shown to be influenced by the addition of fibres at large crack widths [47]; hence a positive effect of the fibres on the penetration depth and cross-sectional loss could be observed when a certain crack width threshold is exceeded.
