Department of Architecture and Civil Engineering
Division of Building Technology
CHALMERS UNIVERSITY OF TECHNOLOGY
Gothenburg Sweden 2018

Driving Rain Tightness, Intrusion Rates and Phenomenology of Leakages in Defects of
Façades: A New Calculation Algorithm

LARS OLSSON

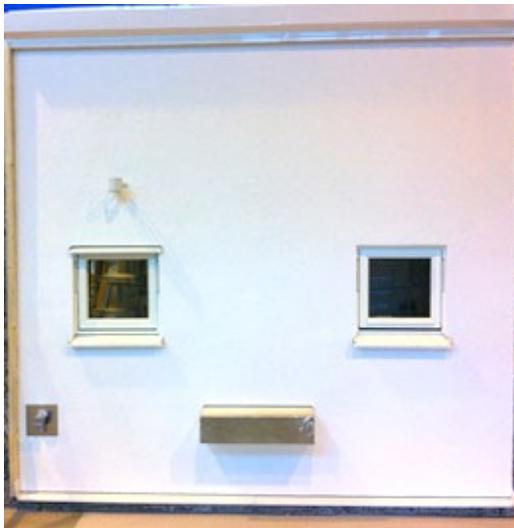
Figure 3. Example of a commercial test wall (size 3 x 3 m) with façade details; windows, balcony, and two fixings (marquis and downpipe fastener).

Rain leakage was detected by using indicators that consisted of absorption paper and thin electrodes for resistance measurement, in the study of compilation of over 100 commercial tests. As façades usually consist of multiple façade details, the façade details are important in the testing of commercial façades, see Figure 3 and **Paper I**.

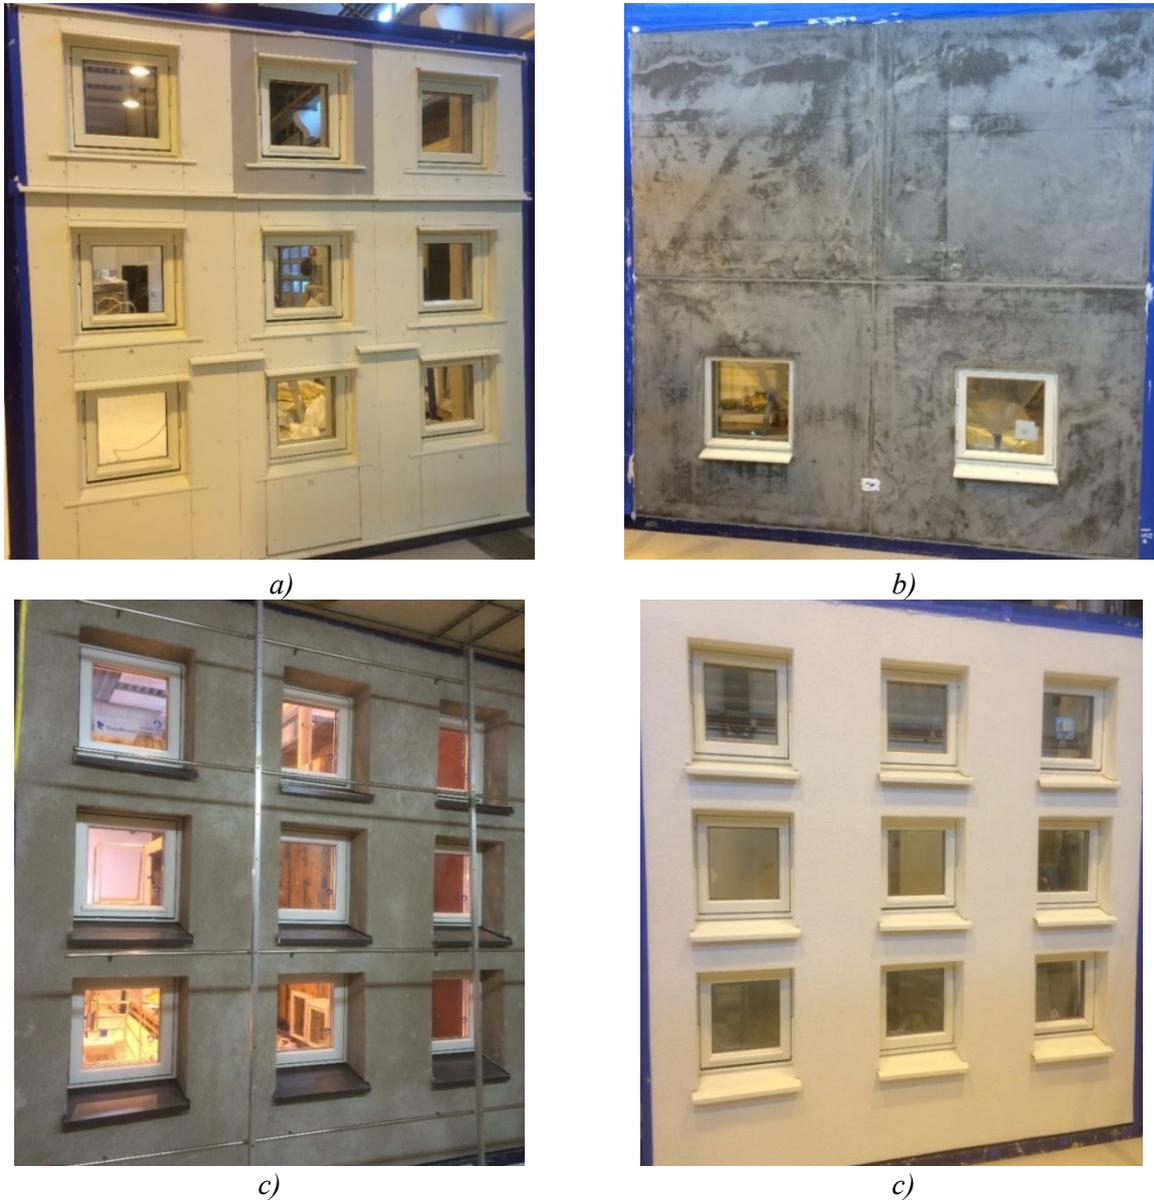
Figure 4. (a) Ventilated façade with polymer composite boards, (b) 15 mm thin prefabricated high-performance concrete sandwich element with elastic joints, (c) 20 mm plaster façade with 200 mm mineral wool with drainage possibility and weather barrier (second line of defence), (d) 8 mm plaster on 100 mm EPS with drainage possibility and weather barrier. Water spray racks are shown in (c).

The additional tests on windows in four different types of façades with 29 window connections, see Figure 4, showed similar results. Window-wall interfaces leakage occurred in around 60 % of the windows connections (window-wall interfaces), see **Paper III**. The three largest point water leakages were within 0.01-0.03 l/min, with the water load as set out

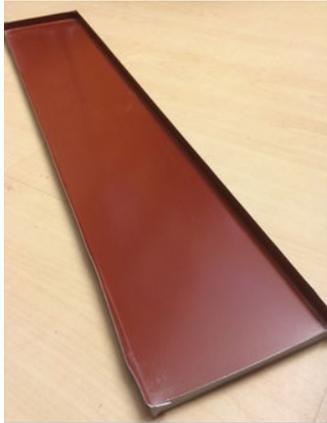
Figure 5. (a) Photo of a collection tray that was placed in the gap under the window frame (the gap was air sealed on inside with transparent tape). (b) Photo of catchment chutes positioned on the outside of the weather barrier, between the façade (to be mounted) and the weather barrier, the smaller just below the exterior window sill and the larger placed approximately 30 cm above the bottom of the wall. To the right of the image, you can see the installation of EPS-insulation in progress.

Within the walls, under the bottom of window frame, collecting trays were installed for measuring the water leakage amount and a little further down, collecting chutes were installed under the details etc. and led with a hose to a closed collecting container, to measure the water leakage flows, see Figure 5.

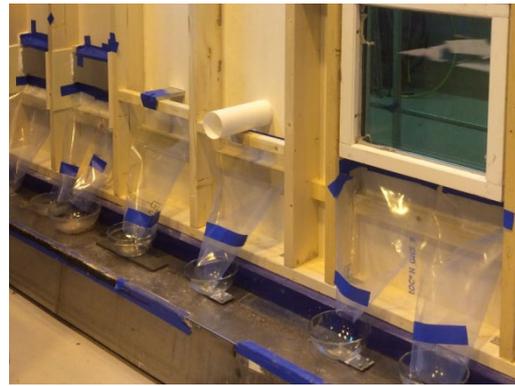
Figure 6. (a) Photo of the front of the wall element with the defects in the details numbered according to Table 1 in Chapter 4.2, (b) Photo of the rear of the experiment wall with collection funnels and bowls.

At the rear of the façade layer collecting channels were installed that led to glass bowls, see Figure 6b and **Paper IV**.

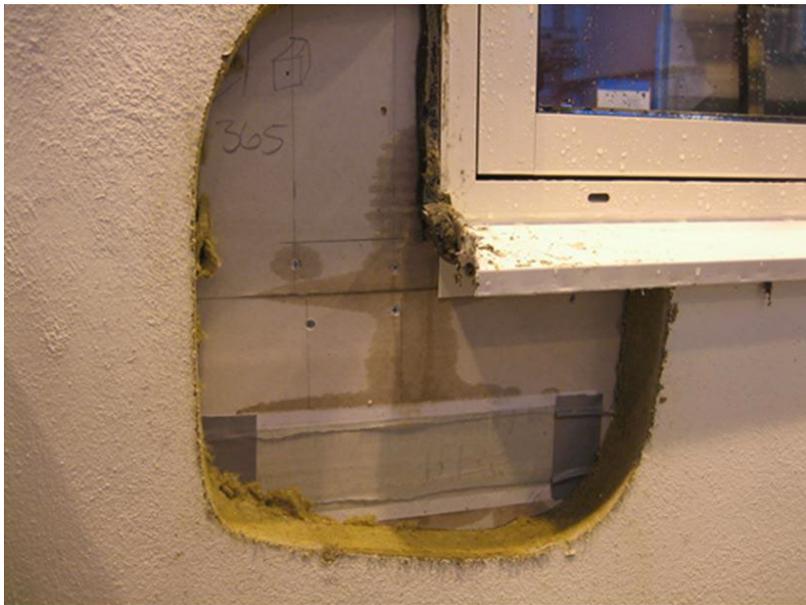
Figure 11. Rain leakage at the corner of the window-wall interface in an ETICS façade (photo from after the measurements were finished and the wall was opened). The material behind the plaster and insulation board is in this case moisture retaining, which should be avoided.

The windows-wall interfaces were particularly difficult to get raintight despite the fact that they are one of the most common details in façades, see Figure 11.
