## **Performance of insulation materials for historic buildings: case-studies comparing super insulation materials and hemp-lime**

# Performance of insulation materials for historic buildings

Case studies comparing a super insulation material and hemp-lime

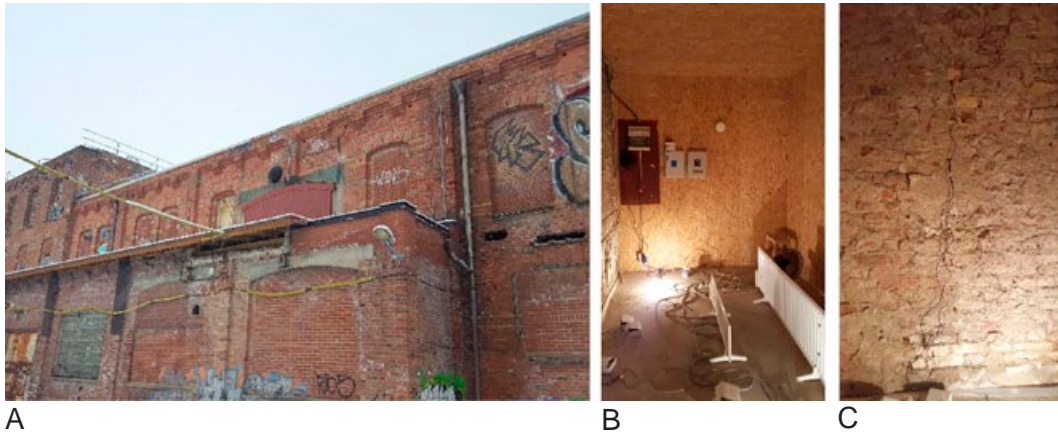
Figure 3. A) Industrial building from 1896 south of Gothenburg to be insulated on the interior with VIP, B) The test room inside the industrial building, C) Sensors in the external brick wall. Photos: Pär Johansson.

An old industrial brick building, see Figure 3, south of Gothenburg is planned to be equipped with VIP on the interior of the wall during 2018. The walls are made of 500 mm thick non-insulated homogenous brick masonry which gives a calculated U-value of 1.0 W/m<sup>2</sup>K. The building was constructed in 1896 and has been reconstructed several times since then.

There are several challenges to renovate the building where the thermal performance of the walls is one example. The cultural values of the building have been evaluated and one of the features that is considered important is the brick façade. Therefore, interior insulation is considered to be a possible solution to reach sufficient energy performance [19]. Inside a part of the deserted building, a small room (2.1 x 2.6 x 4.0 m) has been constructed which consist of floor, walls and roof insulated with 170 mm mineral wool, and the exposed brick wall, see Figure 3. The room is heated to around 22 °C and ventilated by natural ventilation with 0.5 h<sup>-1</sup> air exchange rate. The air in the room is circulated by a fan to create homogenous temperature and moisture conditions in the entire room. The exterior wall is divided in three parts where VIP will be tested and compared to a non-insulated reference. The wall is equipped with hygrothermal sensors that every hour registers the temperature and relative humidity in the middle of the wall and at the interior surface. A weather station monitors the outdoor temperature, relative humidity, wind speed and rain intensity.

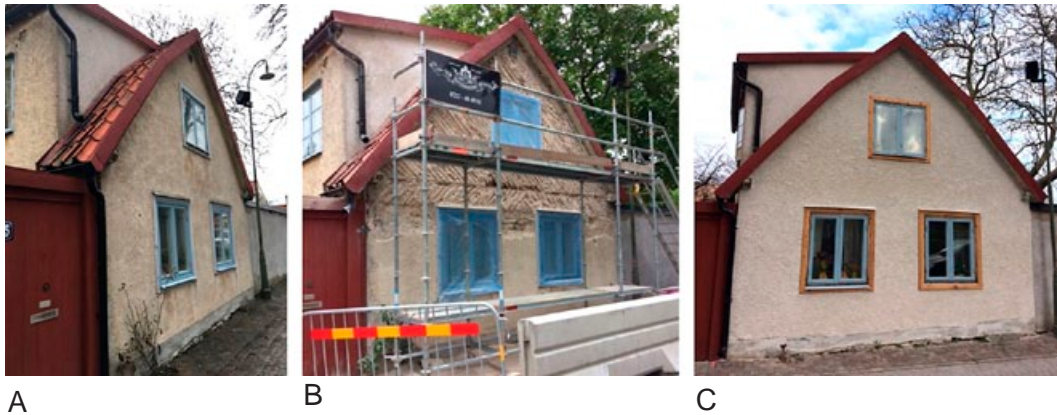
Figure 4. Detached historic single family house in Visby renovated with hemp-lime, A) Before renovation, B) During renovation, C) After renovation. Photos: Paulien Strandberg.

One gable section of a detached single family house in Visby's historic centre was renovated with hemp-lime render in September 2017, see Figure 4. The house was built in the mid-1800s and rebuilt to a large extent in the 1930's. It is built with a mix of construction techniques; the gable section of the eastern wall is built with wooden planks and the lower part of the same wall is built with lime stone. All façades are covered with lime rough-cast. The preservation of the

When the old render on the façade of the building was removed, the original wooden slats, placed diagonally on the timber for carrying the render, were exposed. These slats were kept for carrying the hemp-lime render. Since the space between the slats was only a few centimetres, some slats were removed to create some space between the slats for applying hemp-lime. A layer of hemp-lime of approximately 50 mm (the original thickness of the lime render) was put on the façade and finished with a 15 mm layer of traditional lime render on the outside. The hemp-lime was allowed to dry for a few weeks before a new lime render was applied. The mixing ratio of the hemp-lime was 1 part by volume air hardening lime for 2.5 parts by volume hemp shiv. Sensors to monitor temperature and relative humidity were placed in different locations and depths in the wall. Monitoring started in September 2017 and continues for one year. The results will give a better understanding of moisture levels and moisture flows in the walls. It will also give some indication regarding the temperature flows and insulating properties of the wall after renovation with hemp-lime.

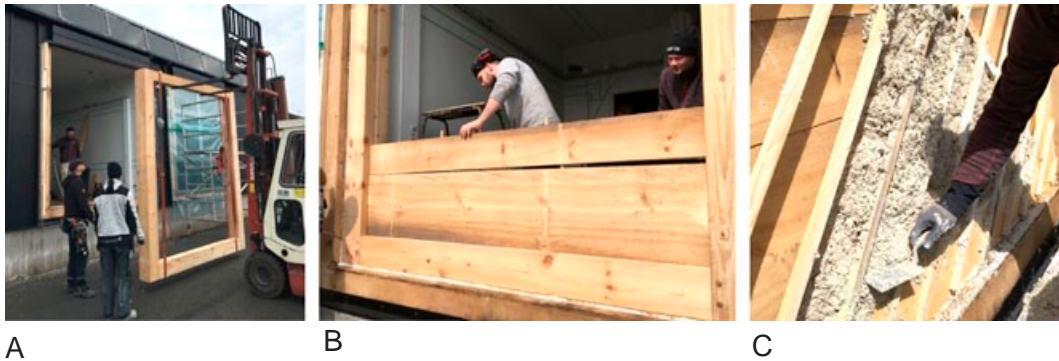
Figure 5. Construction of two full-scale test walls at Lund University, A) Construction of post-and-plank walls, B) Timber planks mounted between the posts, C) Application of hemp-lime on the post-and-plank wall. Photos: Paulien Strandberg.

At Lund University, two façades have been built at the laboratory of the Division of Energy and Building Design, see Figure 5. One façade resembles a traditional post-and-plank construction with a thick lime render about 80 mm. The other façade resembles a traditional post-and-plank construction that is renovated using hemp-lime (~100 mm) as additional external insulation. Behind each façade there is a room (3x3 m) that is insulated at all sides (floor, walls, ceiling). Therefore, the only heat loss that takes place will be through the façade. The energy use for heating the rooms behind the façades is monitored to evaluate the thermal performance of both façades. This way, a historic façade with a lime

render can be directly compared to a façade that is renovated with hemp-lime. The façades were constructed in April/May 2017, monitoring started in September 2017 and continues for one year. The façades are exposed to the outdoor climate. Moisture conditions (RH and moisture content) and temperature are being monitored at four depths inside the wall. The aim of the study is to compare the walls with regards to their energy performance. Therefore, the energy use (kWh/m<sup>2</sup>, year) is measured and recorded continuously.

The preliminary results from the laboratory show a lower energy use for heating in the room behind the hemp-lime façade. The room behind the hemp-lime façade uses 60–70 % of the energy use that is required by the room with the lime façade. The temperature variations are also less apparent in the insulated room.
