Performance of insulation materials for historic buildings

Case studies comparing a super insulation material and hemp-lime

P. Johansson¹, A. Donarelli², P. Strandberg³

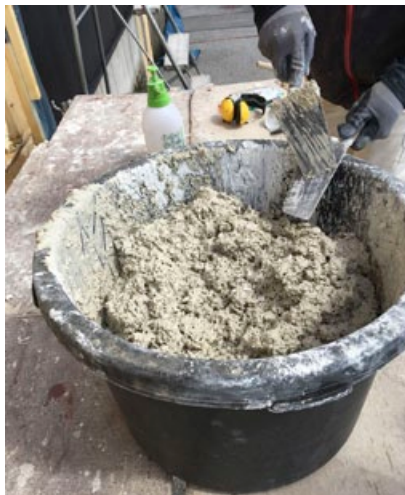
A

Figure 1. A) Hemp-lime mix, B) VIP with fumed silica core material and metalized film envelope. Photos: Paulien Strandberg, Pär Johansson.

The materials used in this research were hemp-lime and VIP. Figure 1 shows hemp-lime after mixing and a VIP with the core material and air tight barrier visible.

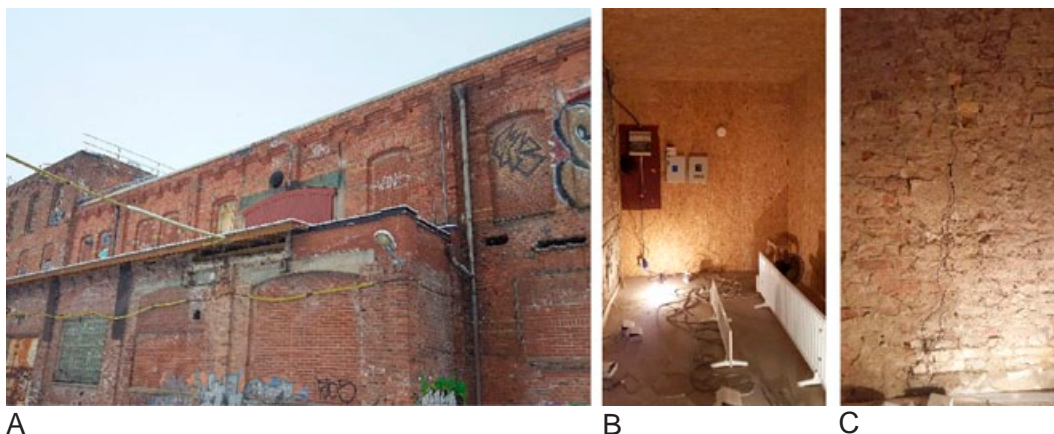
Figure 3. A) Industrial building from 1896 south of Gothenburg to be insulated on the interior with VIP, B) The test room inside the industrial building, C) Sensors in the external brick wall. Photos: Pär Johansson.

An old industrial brick building, see Figure 3, south of Gothenburg is planned to be equipped with VIP on the interior of the wall during 2018. The walls are made of 500 mm thick non-insulated homogenous brick masonry which gives a calculated U-value of $1.0 \text{ W/m}^2\text{K}$. The building was constructed in 1896 and has been reconstructed several times since then.

There are several challenges to renovate the building where the thermal performance of the walls is one example. The cultural values of the building have been evaluated and one of the features that is considered important is the brick façade. Therefore, interior insulation is considered to be a possible solution to reach sufficient energy performance [19]. Inside a part of the deserted building, a small room ($2.1 \times 2.6 \times 4.0 \text{ m}$) has been constructed which consist of floor, walls and roof insulated with 170 mm mineral wool, and the exposed brick wall, see Figure 3. The room is heated to around 22°C and ventilated by natural ventilation with 0.5 h^{-1} air exchange rate. The air in the room is circulated by a fan to create homogenous temperature and moisture conditions in the entire room. The exterior wall is divided in three parts where VIP will be tested and compared to a non-insulated reference. The wall is equipped with hygrothermal sensors that every hour registers the temperature and relative humidity in the middle of the wall and at the interior surface. A weather station monitors the outdoor temperature, relative humidity, wind speed and rain intensity.

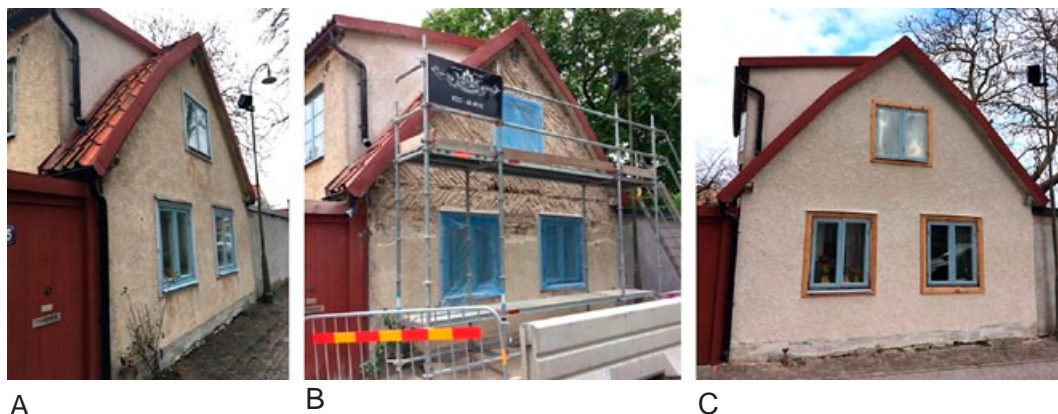
Figure 4. Detached historic single family house in Visby renovated with hemp-lime, A) Before renovation, B) During renovation, C) After renovation. Photos: Paulien Strandberg.

One gable section of a detached single family house in Visby's historic centre was renovated with hemp-lime render in September 2017, see Figure 4. The house was built in the mid-1800s and rebuilt to a large extent in the 1930's. It is built with a mix of construction techniques; the gable section of the eastern wall is built with wooden planks and the lower part of the same wall is built with lime stone. All façades are covered with lime rough-cast. The preservation of the

When the old render on the façade of the building was removed, the original wooden slats, placed diagonally on the timber for carrying the render, were exposed. These slats were kept for carrying the hemp-lime render. Since the space between the slats was only a few centimetres, some slats were removed to create some space between the slats for applying hemp-lime. A layer of hemp-lime of approximately 50 mm (the original thickness of the lime render) was put on the façade and finished with a 15 mm layer of traditional lime render on the outside. The hemp-lime was allowed to dry for a few weeks before a new lime render was applied. The mixing ratio of the hemp-lime was 1 part by volume air hardening lime for 2.5 parts by volume hemp shiv. Sensors to monitor temperature and relative humidity were placed in different locations and depths in the wall. Monitoring started in September 2017 and continues for one year. The results will give a better understanding of moisture levels and moisture flows in the walls. It will also give some indication regarding the temperature flows and insulating properties of the wall after renovation with hemp-lime.
