THESIS FOR THE DEGREE OF LICENTIATE OF ENGINEERING

Anchorage of naturally-corroded, plain bars in  
Reinforced Concrete structures

SAMANTA ROBUSCHI

CHALMERS UNIVERSITY OF TECHNOLOGY

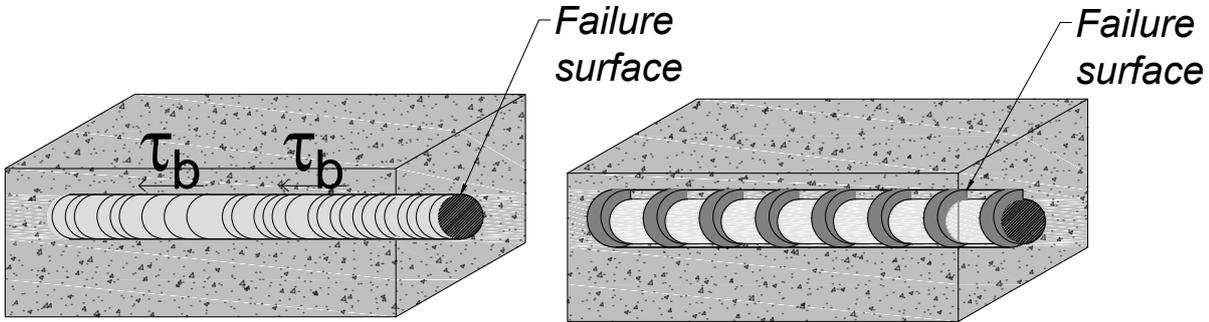
**Figure 2.1:** *Failure surface: plain bars (left) and deformed bars (right) at pull-out.*

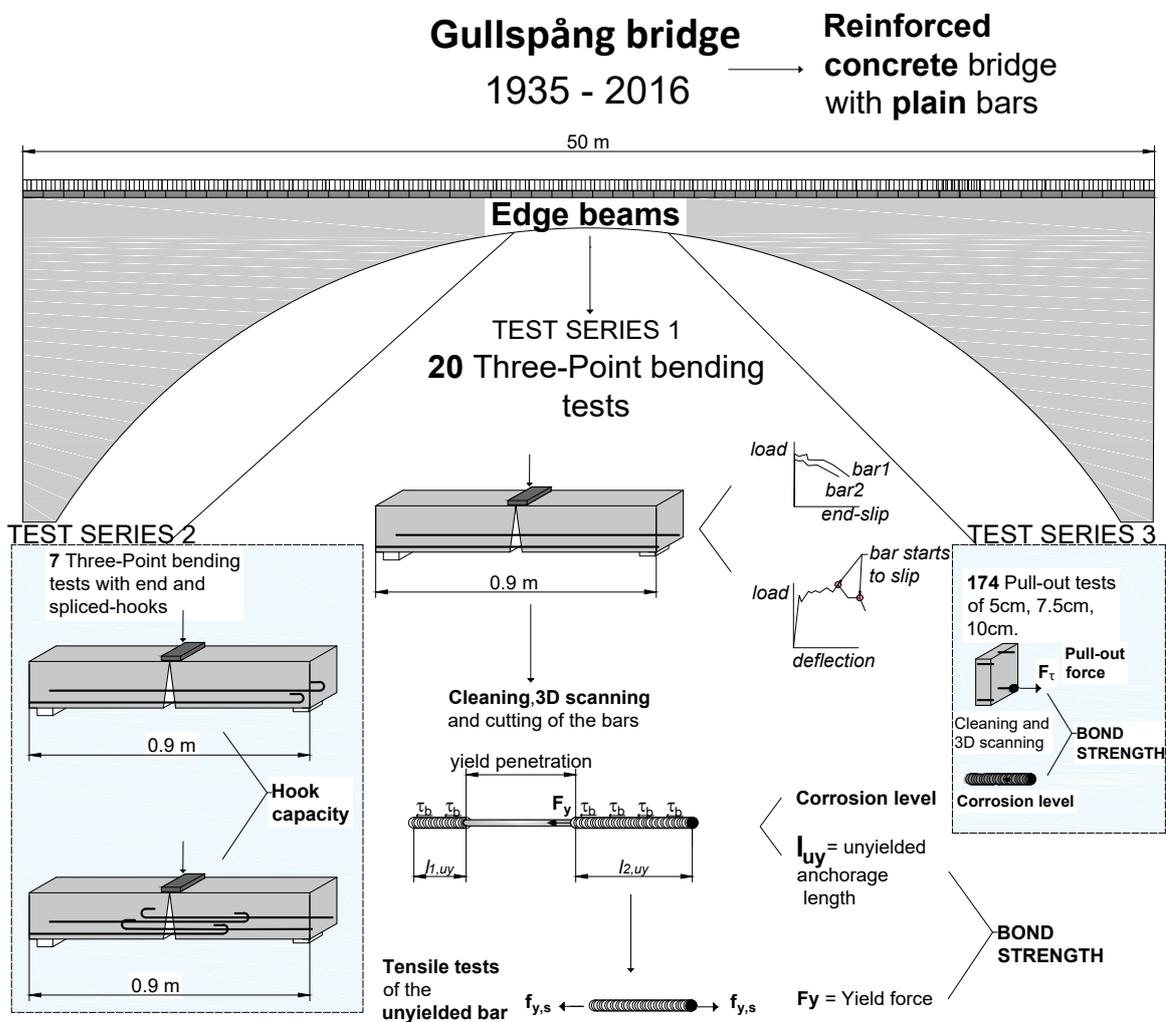
Figure 3.1: Overview of the tests planned from the edge beams of Gullspång bridge.

Three different test series were planned:

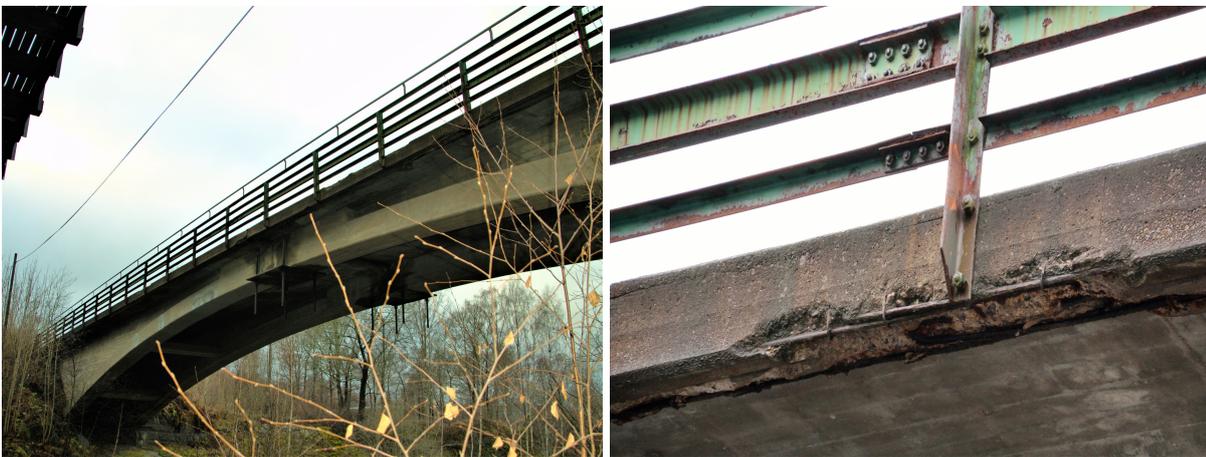
**Figure 3.2:** *Gullspång bridge: view of the bridge before demolition (left) and exposed tensile reinforcement bars and spalling in an edge beam (right).*

Gullspång bridge (Fig.3.2) was built in 1935 and torn down in 2016 due to heavy corrosion damages. The edge beams were carefully taken out, cut in segments and designated to be used for research. Having been exposed for 81 years to weather conditions that include snow, freezing-thawing cycles and wind, as well as to de-icing salts and traffic loads, the beams presented different cracks on their surface, and spalling strongly affected the geometry in some locations (Fig.3.2). Signs of corrosion were clearly visible, but not uniformly distributed.

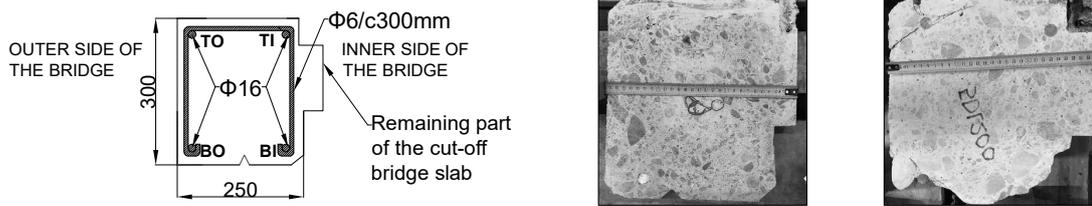
**Figure 3.3:** *The beam cross-section geometry (according to the original drawings) is shown on the left. Photographs of two beam cross-sections are shown on the right. Bar naming convention is as follows: TO= Top-Outer, TI= Top-Inner, BO= Bottom-Outer and BI= Bottom-Inner. The remaining part of the slab-deck is clearly visible to the right. All dimensions are in mm.*

The edge beams were characterized by  $\phi 6$  stirrups, open on the bottom side with respect to the original position on the bridge and  $2\phi 16$  plain reinforcement bars, top and bottom (Fig.3.3). The concrete cover varied approximately between 20 and 55 mm, but was reported equal to 34 mm in the original drawings.

Average cross-section dimensions were 300x250 mm. All specimens contained approximately a 50 mm part of the slab deck. Spacing of the stirrups ranged between 100 and 450mm, in contrast to the typical 300mm spacing referenced on the drawings.

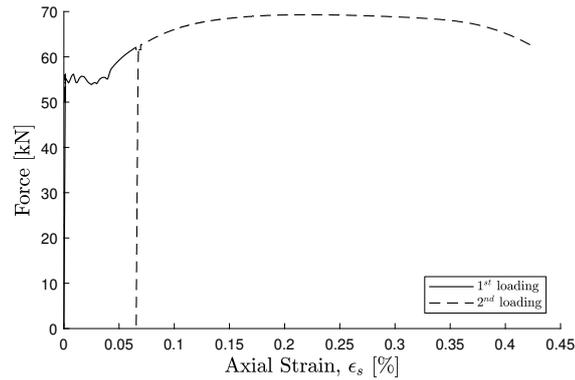
**Figure 3.4:** Example of tensile test of an uncorroded reinforcement bar from Gullspång bridge: the same bar was loaded in two different stages to better capture the mechanical properties of the steel.

Two bars were subjected to additional tests so as to characterize the material properties of the steel. The bars were uncorroded and extracted from an untested segment of the bridge. Each bar was loaded first in tension until indication of strain hardening and then unloaded. The bars were then reloaded until rupture. Fig. 3.4 shows good agreement with the hypothesis of isotropic hardening, meaning that, by testing the already hardened bar in tension, it was possible to estimate, with good confidence, the force reached in the bar when the first test was interrupted.

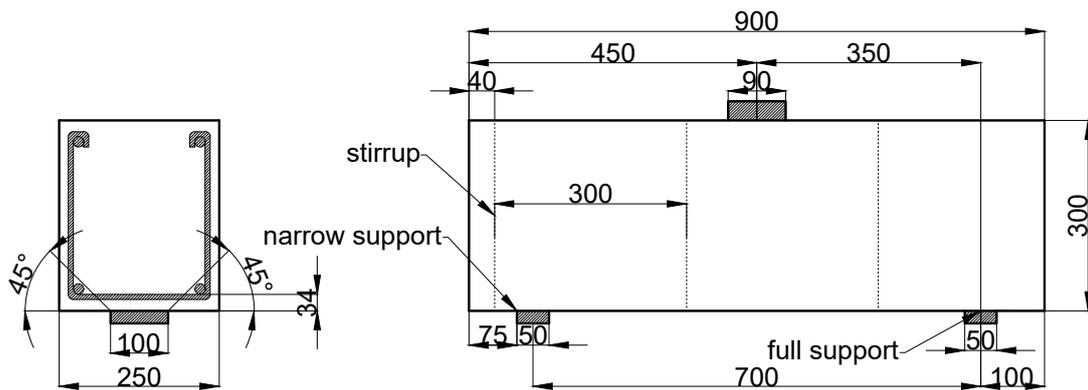
**Figure 3.5:** *Experimental set-up and view of the narrow support for a beam tested upside-down compared to its position on the bridge.*

Twenty beam specimens were tested. Figure 3.5 gives details on the beam geometry and the 3-point bending test configuration. The tested beams were 900 mm long, with a theoretical span of 700 mm. They were supported on one side by a narrow support (50x100 mm) and a full support (50x250mm) on the opposite side. Both the load plate and the two supports consisted of a steel block and a thin wood-fibre layer inserted between steel and concrete. The aim of the narrow support was to minimize the effect of support pressure. To meet this objective, a smaller support plate was positioned in the middle of the beam (between the bars) and specifically located on the side expected to have anchorage failure. The specimen was specifically cut to have a stirrup external to the narrow support to help redistribute the higher concentrated stresses generated by the support. On the opposite end, at the location of the full support, the ends of the reinforcing bars were restrained from anchorage failure by means of a bolt/washer configuration. However, out of the first four tests, two beams showed bending of the washers and unwanted slipping of the restrained tensile reinforcements. It was opted not to restrained the reinforcement bars, but to monitor the end-slip on both sides for subsequent beams.

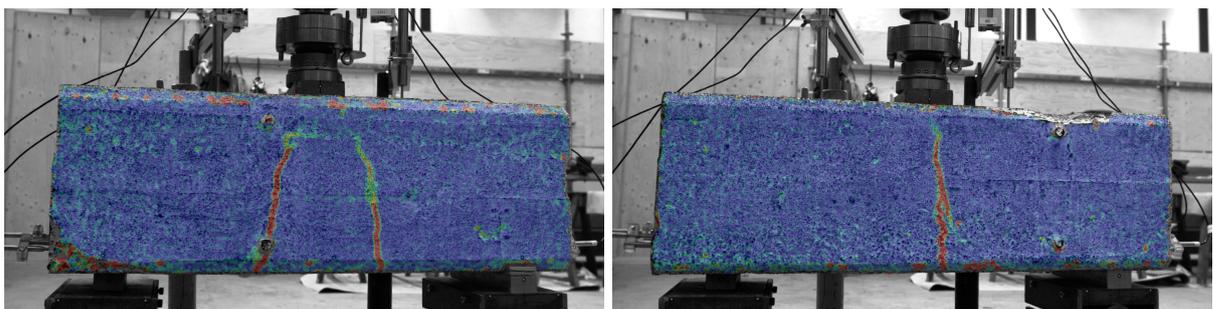
**Figure 3.6:** *Beam 17H (Left) and Beam 9B (Right): example of typical crack patterns, as captured by Digital Image Correlation (DIC) cameras.*

Due to the high cracking and low bending moment in the cross section of the beams, it became necessary to include the effect of bar yielding on the anchorage of the tensile reinforcements. Yielding of the reinforcement bars took place in all but one of the 20 beams tested<sup>1</sup>, the low yield strength of the tensile reinforcement resulting in the bars reaching yield stress near the time of opening of the first bending crack. Yielding, by reducing the diameter of the bar, results in a local loss of bond strength. Slipping of the tensile reinforcement took place after the opening of one or two major bending cracks and yielding of the tensile reinforcements. In Fig.3.6, the typical crack patterns exhibited by the specimens are shown. With the given design of the beams and the condition of the specimen, it was not possible to initiate shear failure before anchorage failure.

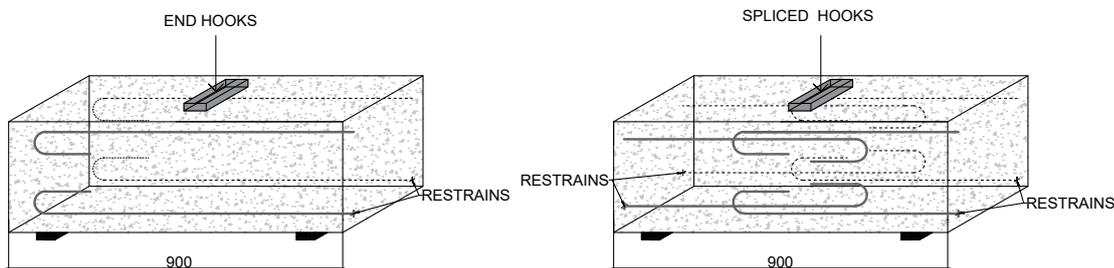
**Figure 3.7:** Test set-up for beams with end hooks (left) and spliced hooks (right). All measurements in mm.

The test configuration is similar to that used for the beams without hooks. One exception is that all rebars were restrained at the ends through use of a nut/washer fixture. The objective was to assess the anchorage capacity of the hooks and not the end-slip of the straight reinforcement. At the time of printing of this thesis, the beams were already tested, but data on the corrosion level of the bars are still to be obtained. The tensile reinforcement bars are to be cleaned and 3D scanned, and the results are to be processed. The two categories of beams exhibited different failure modes in the structural tests. The 3 beams with spliced hooks failed in shear. The 4 beams with end-hooks failed in bending. Failure of the hooks was not observed in any of the tests.

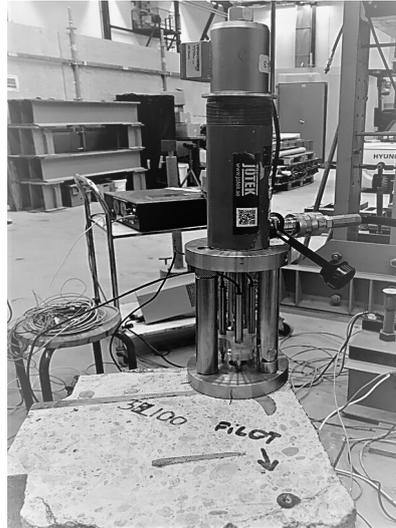
**Figure 3.8:** *Pull-out test set-up*

The third series of tests was designed to avoid the situation of reinforcement reaching the yield point. Direct pull-out tests were performed using cut sections (50, 75 and 100 mm in thickness ) from untested segments of the edge beams from Gullspång bridge. The test set-up required drilling, threading, and inserting a threaded rod in the individual rebars. Thereafter, each individual rebar was pulled out using a hydraulic load cell. A special rig was designed and produced (See Fig.3.8). This consisted of three legs, two of which could be length-adjusted to account for any skew angle between bar and cut concrete surface. The need of avoiding yielding of bars gave an upper limit of 100 mm embedment length. The lower limit was set to 50 mm, for feasible cutting of concrete slices and drilling (20 mm deep) not to affect the major part of the length. Based on these arguments,

embedment lengths of 50, 75, and 100 mm were chosen. There was a total of 174 bars, of which 104 were in concrete without visible damage, 35 had cracks, and 35 had some spalling of the concrete cover. At the time of printing of this thesis, all the reinforcement bars were tested, extracted from the cross-sections, and are in the process of being cleaned and 3D scanned. A rough first approximation of the bond stress at peak shows value comparable to the flexural tests in the first test series and a large scatter.

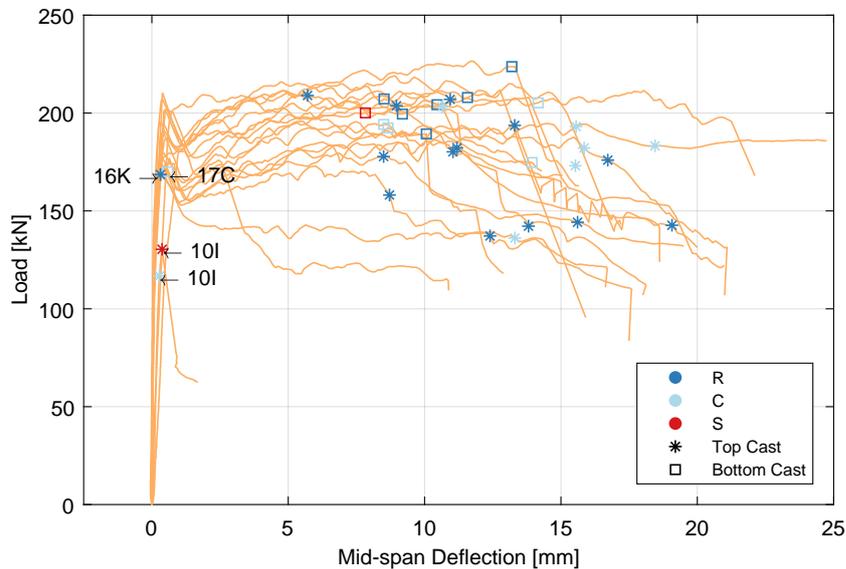
**Figure 4.1:** Load-Mid-span deflection curves for the 3-point bending tests. The markers show where each bar started to slip; colours indicate the level of damage in the anchorage zone. The influence of the cast position is shown by asterisk for top-cast and squares for bottom-cast bars. The names of the beams where end-slip of one or more bars took place without yielding are marked.

In Fig.4.1, mid-span deflection is plotted as a function of the applied load. The applied load was sourced from the hydraulic load cell and the mid-span deflection was extrapolated from data obtained with Digital Image Correlation. The initiation of slip of the reinforcement bars, for each test specimen, is marked. Colors are used to differentiate the observed external damage respective to the concrete surrounding the individual rebars and the marker symbol indicates top-cast and bottom-cast positioning.

All the beams were characterized by the opening of one, or maximum two, major bending cracks localized in the mid span. In most cases, yielding of tensile reinforcement was noted shortly after cracking; though, anchorage failure did occur for 4 bars in three beams preceding tensile yielding. In all other bars, the force was increased beyond strain-hardening condition of the reinforcement before the eventual slip of rebars and loss of load. Thus, the bars started to slip at a point when other failure mechanisms had already initiated. The anchorage capacity did not limit the load-carrying capacity of the specimen. Thus, the anchorage was enough to carry the yield force. End-slip was observed at a later stage, when yielding of the reinforcements locally decreased the bond strength. The deformation capacity was therefore affected by the anchorage failure.

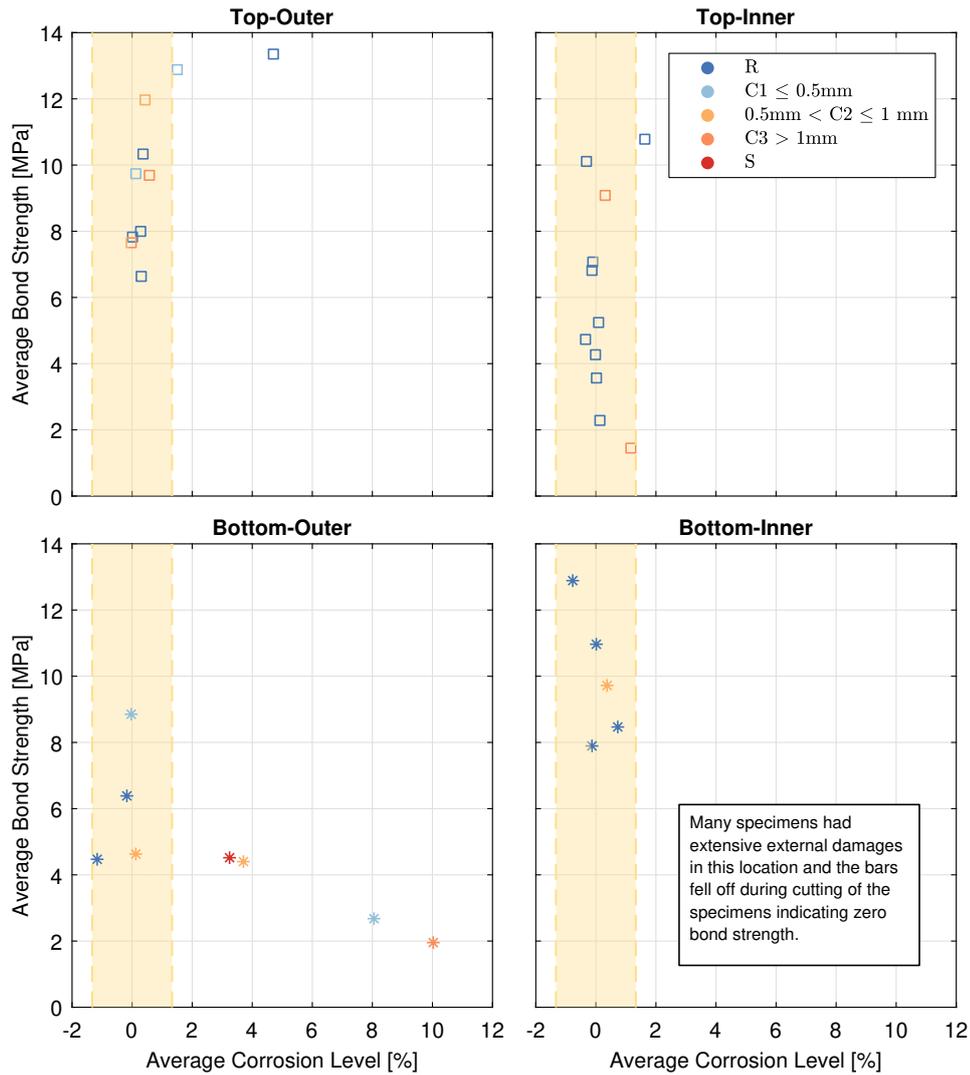
**Figure 4.2:** The average bond strength in the unyielded zone is plotted against the average corrosion level. Different colours are used to indicate the level of damage in the anchorage zone visible before the test. Results from different positions in the cross section are displayed separately: top-outer (left, top), top-inner (right, top), bottom-outer (bottom, left), bottom-inner (bottom, right). The shadowed area represents the accuracy in the evaluation of the corrosion level at zero, due to the uncertainties in the reference area of the uncorroded bars

In Fig.4.2, the average corrosion level of the bars is presented and plotted against the calculated bond strength in the unyielded zone. Different colours denote the deterioration classification introduced in Section 3.1, based on visual inspection of the beams prior to testing. Separating the results by bar position highlights the influence of casting position on the bond strength. This showed to be a critical factor relative to maximum average bond strength.

Considering first the bars with no relevant corrosion amounts, top-cast bars were found to have a lower bond strength than bottom-cast bars. This is believed to be due to different densities of the surrounding concrete, where lower density concrete provides less confining pressure and thus reduced friction. Considering top-cast bars with small amounts of corrosion product, the bond strength is found to increase up to values comparable with the bond strength of bottom-cast bars without corrosion. Top-cast bars present as well less external cracks than bottom-cast bars for the same corrosion level. Bottom-cast bars are shown to lose bond strength with increasing corrosion levels.

It is interesting to note that the average bond strength calculated from the results of the experiment was significantly higher than data available in literature. This conclusion even acknowledges the high scatter in the results. The average bond strength of the bars was calculated as 7.39 MPa, with a standard deviation of 3.33 MPa; in contrast, Cairns et al. [6] presents measured bond strengths between 1 and 3 MPa. One explanation for the different outcomes between this study and the literature is that no previous study made use of naturally

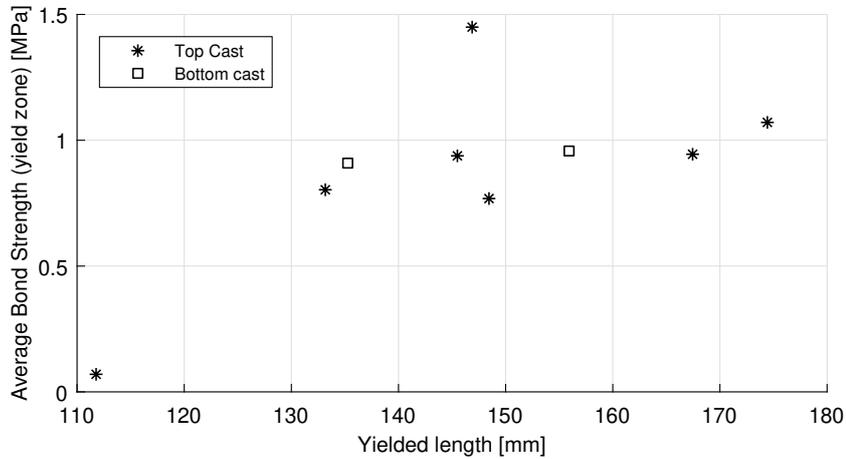
**Figure 4.3:** *The average bond strength in the yielded zone is plotted against the length of the yielded zone in the tested bar. The influence of the cast position is shown by asterisk for top-cast and squares for bottom-cast bars.*

In Fig. 4.3, the average corrosion level of the bars is presented and plotted against the calculated bond strength in the yielded area. The results presented a rather small scatter, with an average of about 1 MPa. They also show a noticeable

loss of bond strength after yielding (about 90% loss compared to the bond strength in the unyielded zone of the same rebar). However, less data were available due to damages in the extraction process of the bars.

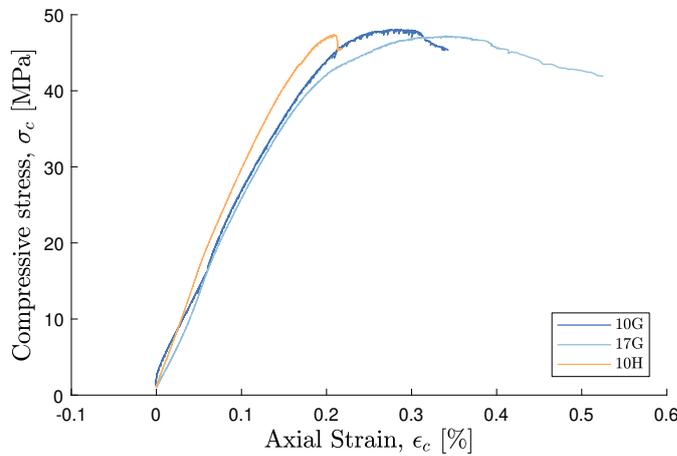
**Figure A.1:** *Stress-strain curves of tested cores 17G, 10H, and 10G.*

Two of the three tested cores showed a change in the elastic slope at low stresses. This is not usual, however, there are two possible explanations to this behaviour. A change of stiffness in the ascending branch of the stress-strain curve often indicates frost-damage in the concrete sample [18]. This is likely linked to the presence of randomly oriented micro-cracks prior testing, resulting from freeze-thaw cycles. Large strains at peak stresses and a more ductile behavior are generally as well
