Microstructural Characteristics of Vehicle-Aged Heavy-Duty Diesel Oxidation Catalyst and Natural Gas Three-Way Catalyst

Keywords: catalyst deactivation; diesel; natural gas; SEM; TEM; poisoning

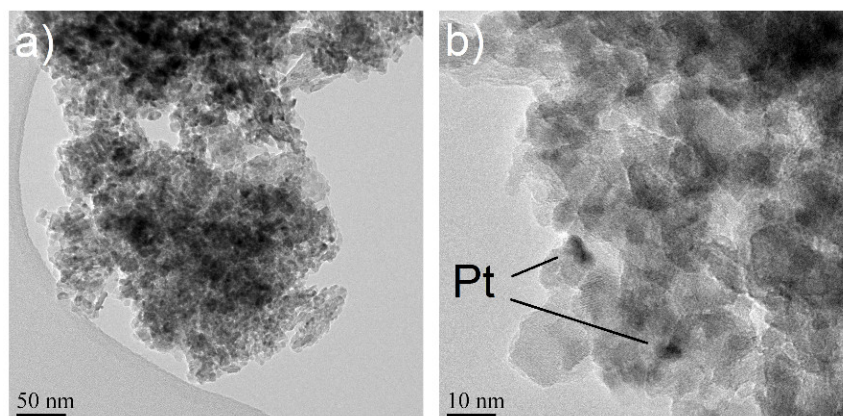
Figure 3. TEM images from the fresh diesel oxidation catalyst with (a) lower and (b) higher magnification.

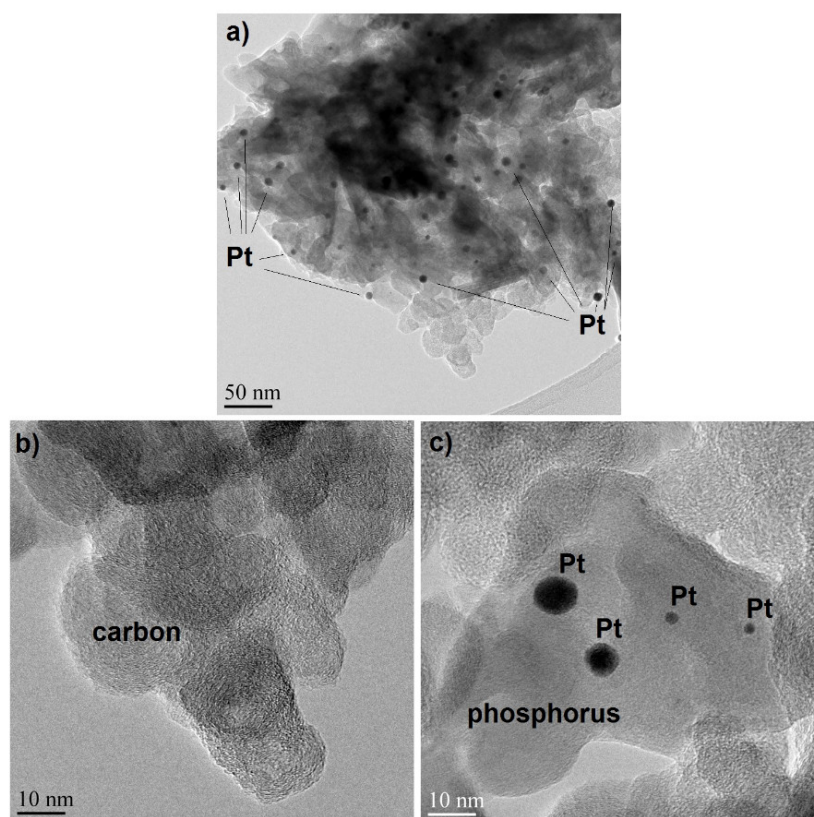
The EDS analyses from the TEM samples supported the SEM-EDS analyses (Figure 2). Detected poisons in the aged diesel oxidation catalyst samples, from both the inlet and outlet, were S, P, K, Ca and Zn, sulphur clearly with the highest percentage. These are typical poisons in diesel engines originating from fuels, lubricants and detergents [4]. TEM images from the fresh diesel oxidation catalyst sample (Figure 3a,b) show the fine structure of the washcoat with small Pt particles. The size of the Pt particles was <5 nm measured from the STEM images. In the used inlet sample (Figure 4a,c), the size of the platinum particles was 7.0 ± 1.9 nm (100 particles measured). Thus, the particle size increased slightly in the vehicle ageing. In addition, carbon (soot) and phosphorus were detected

regularly (Figure 4b,c). Phosphorus exposure is known to cause such growth and shape effects in the noble metals [11,12].

Figure 4. TEM images from (a) the vehicle-aged diesel inlet catalyst. (b) and (c) showing the carbon and phosphorus poisoned areas, respectively.

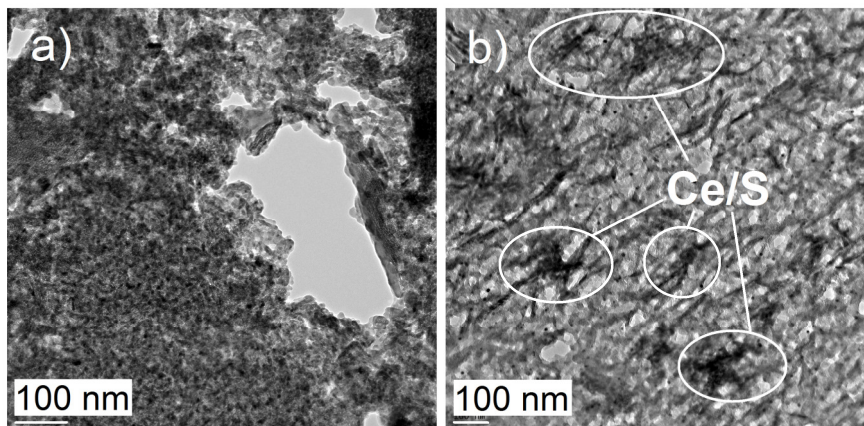
The cross-sectional TEM images from the fresh and vehicle-aged diesel oxidation catalysts are presented in Figure 5. The cross-sectional TEM–EDS map images from selected elements for the used inlet diesel sample are shown in Figure 6. In the studied sample, sulphur and phosphorus were the only poisons with a sufficient amount to be included in the EDS map. As seen in Figure 6, ceria and sulphur cover the same area in the analysed cross-section, as also indicated in the SEM-EDS line analyses (Figure 2). These Ce- and S-rich areas are clearly detectable as darker areas in the TEM images in Figure 5b. Phosphorus covers the washcoat more evenly, following the contents of aluminium and

Figure 5. The cross-sectional TEM images of (a) the fresh diesel oxidation catalyst and (b) the vehicle-aged inlet diesel oxidation catalyst.

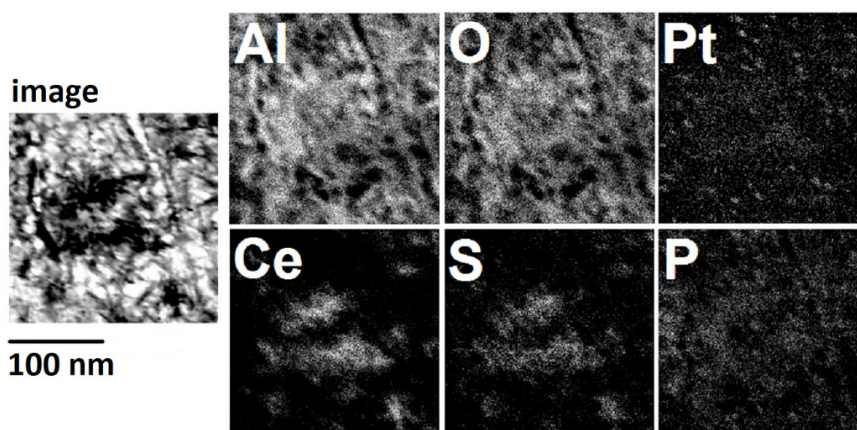
oxygen (Figure 6), as seen in the SEM-EDS line analyses (Figure 2). Overall, the platinum particles have grown in use, and there seem to be larger Pt particles outside the Ce/S-rich area than inside this area. A possibility of the Ce/S effect on the Pt particle sintering could be an interesting topic for future investigations, while such a phenomenon has not been extensively reported.

Figure 6. Cross-sectional TEM-EDS map from the vehicle-aged diesel (inlet) catalyst.

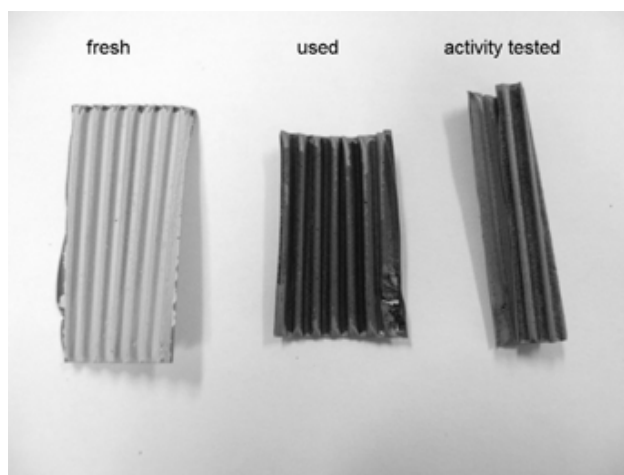
Figure 11. The sections of the diesel oxidation catalyst sheets: fresh, vehicle-aged and performance-tested.

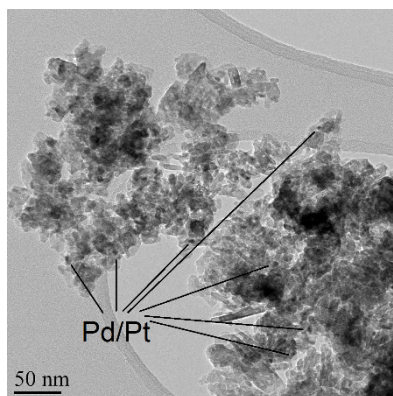
The fine structure of the fresh NG catalyst washcoat is presented in Figure 14. Detected poisons in the TEM-EDS spot analyses from aged natural gas catalyst samples (Figure 15) were S, P, K, Zn, Si, Ca and Cu in various amounts. Copper was not calculated in these analyses, since the powder sample holder is made of copper and thus gives an additional copper signal to the spectrum. The used outlet catalyst showed few or no structural changes or poisonous impurities after use (Figure 15b).

Figure 14. TEM image from the fresh natural gas catalyst.

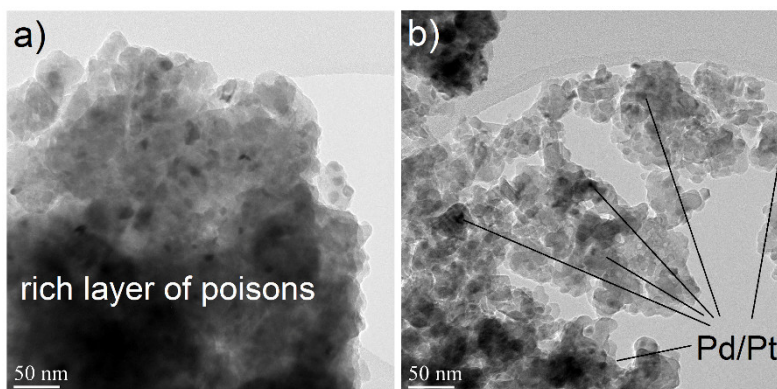
Figure 15. TEM images from the vehicle-aged natural gas catalyst (a) inlet, (b) outlet.

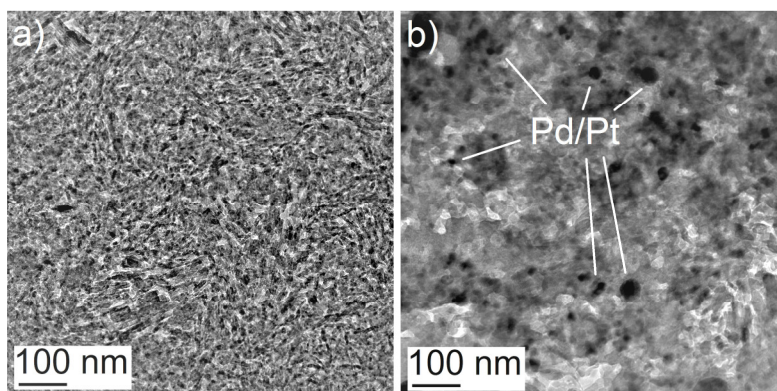
In the NG catalyst inlet part, significant noble metal particle growth was observed after the use, as seen in the cross-sectional TEM images in Figure 16a,b. In the fresh catalyst, the metal particle size was <5 nm, and after use it was 54 ± 23 nm as measured from the STEM images (100 particles measured). The structure of the used inlet catalyst had become more heterogeneous and dense compared to the fresh structure due to heavy sintering during use.

Figure 16. The cross-sectional TEM image of (a) the fresh natural gas catalyst and (b) the vehicle-aged inlet natural gas catalyst.

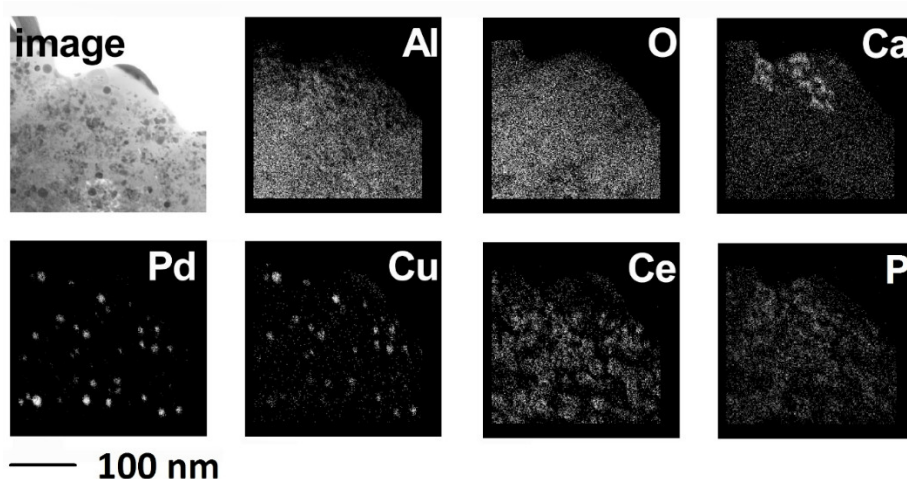
Three main poisoning elements, Ca, Cu and P, were included in the cross-sectional TEM-EDS map (Figure 17) of the inlet NG sample. One possible origin for copper can be the lubricant oil of the natural gas engine. In addition, copper seems to be mainly found together with noble metal particles (Figure 17). The presence of copper in the used catalysts needs further investigations in order to verify the occurrence of the phenomenon. High local concentrations of calcium were detected in both the EDS spot and map analyses. Pt was not included in the EDS map of the used sample due to its low amount. Again, phosphorus was spread quite evenly across the sample. The phosphorus detection has some uncertainties, due to the overlapping of Pt and Zr peaks.

Figure 17. The cross-sectional TEM-EDS map of the inlet natural gas sample.

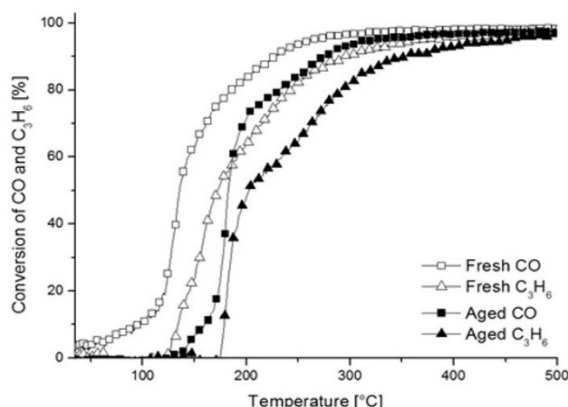
The studied gases in the catalyst performance tests were CO and C_3H_6 . The results of the performance test are presented in Figure 20. For the natural gas catalyst, the fresh one was more active

than the aged catalyst, as expected. Poisons and palladium crystal growth had affected the active sites of the catalyst, increasing the light-off temperature.

Figure 20. The conversion curves of CO and C₃H₆ for the fresh and aged natural gas catalysts.

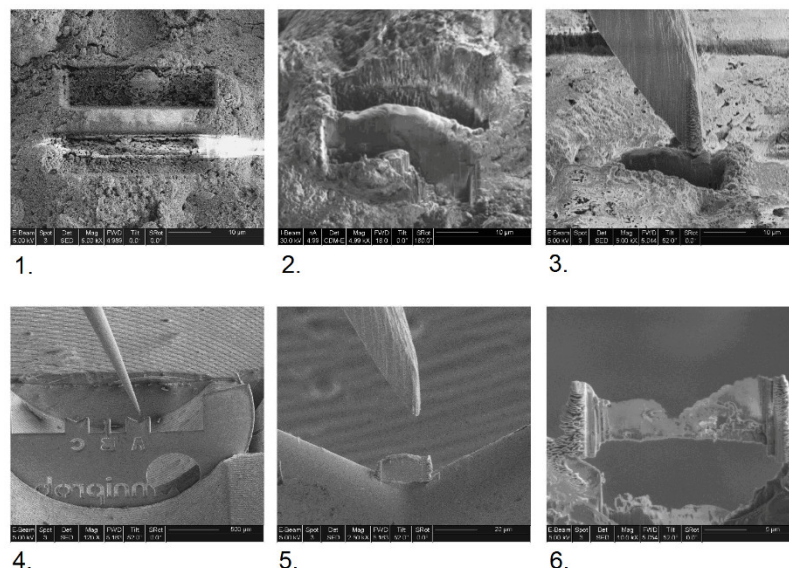
the materials, it was difficult to achieve a homogeneous thickness over large areas. Figure 21 presents SEM images of different steps of the FIB sample preparation. Image of the final stage of the preparation (step 6) shows the sample used in the TEM analyses.

Figure 21. Focused Ion Beam sample preparation steps 1–6. Steps 1 and 2 are from the milled trenches on the surface of the catalyst. Steps 3–5 are from the lift-out and mounting procedure. Step 6 is the final thinned sample.
