Effect of Running-In (Load and Speed) on Surface Characteristics of Honed Gears

Mallipeddi, D., Norell, M., Sosa, M. et al (2019). Effect of Running-In (Load and Speed) on Surface Characteristics of Honed Gears. Tribology Transactions, 62(3): 412-418.
<http://dx.doi.org/10.1080/10402004.2019.1565849>

Dinesh Mallipeddi, Mats Norell, Mario Sosa & Lars Nyborg

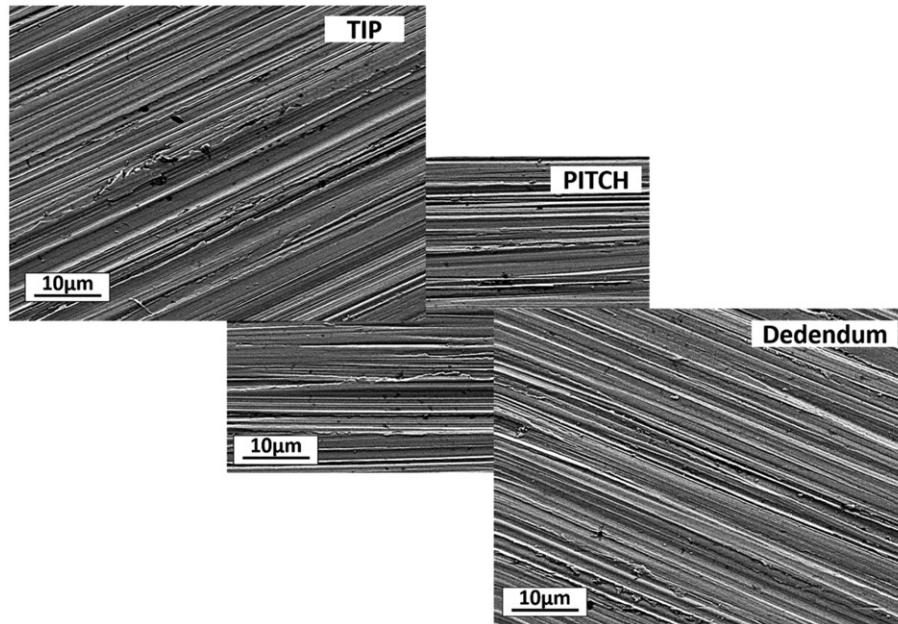
**Figure 1.** Surface topography of as-honed gear.

The surface topography of as-honed gears is shown in Fig. 1. The surface lay orientation is different between regions of the gear flank. At pitch, the lay is perpendicular to the profile direction, like that of a ground gear. At both the tip and dedendum, the lay is oriented at an angle with respect to the pitch surface but with orientations in opposite directions. This is because the honing tool motion is cross-axed to the gear surface. Irrespective of orientation, the surface lay consists of adjacent peaks and valleys with irregular asperities. These surface microfeatures determine the contact area during the initial cycles.

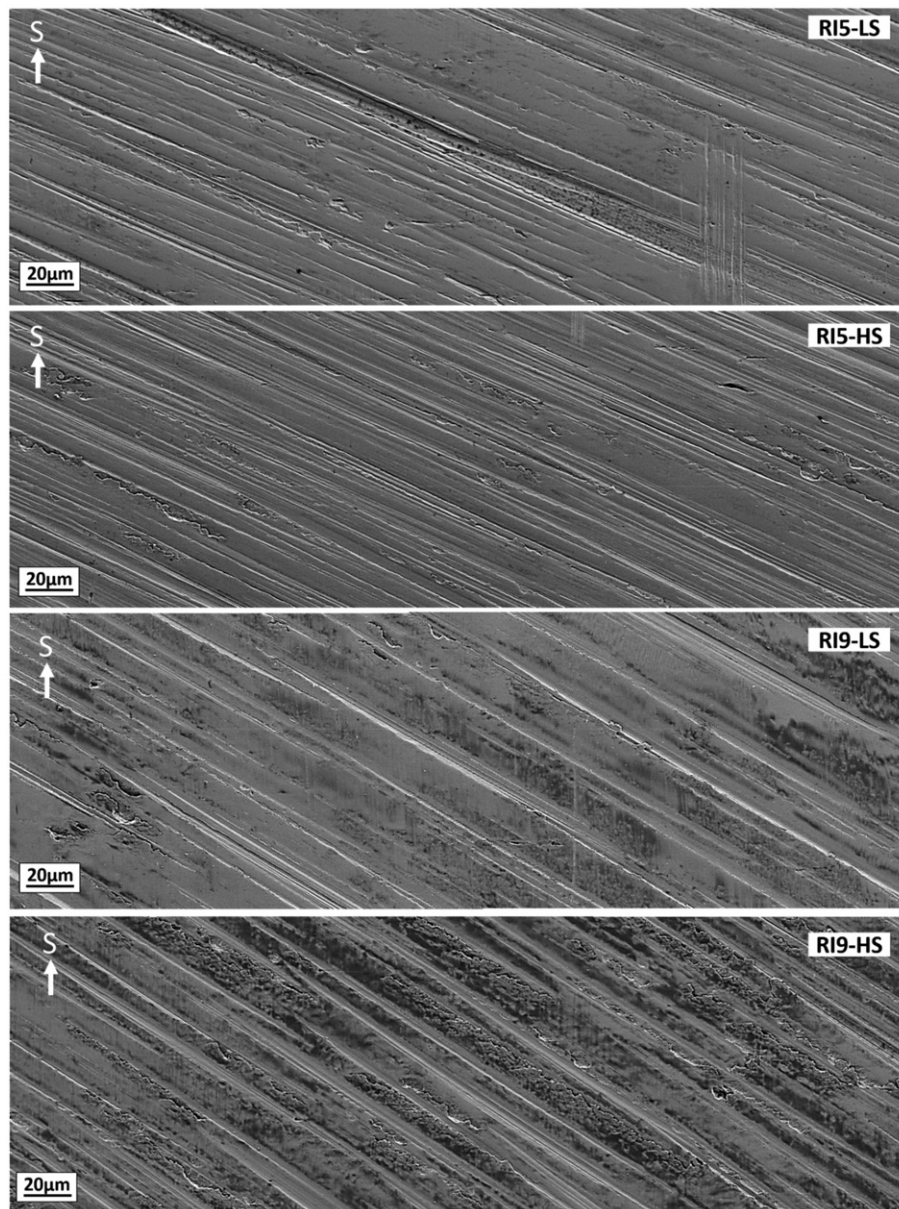
Figure 2. Surface topography of dedendum surfaces (close to the end of the active profile) after testing at different running-in conditions. "S" in the micrographs indicates the sliding direction.

The topography for different running-in conditions at the dedendum close to the end of the active profile is shown in Fig. 2. The micrographs reveal that surface asperities are plastically deformed for all test conditions. The deformation was influenced more by load than speed so that a higher load resulted in greater deformation. Moreover, micropits occurred after running-in for all test conditions. Thus, micropitting initiates in less than 20,880 cycles. Similar results were reported by Locateli, et al. (15). The most extensive micropitting occurred for RI9-HS, followed by RI5-HS, RI9-LS, and RI5-LS. This indicates that micropitting was influenced more by speed than load. Where the lay is oriented at an angle to the sliding, micropits formed along the lay and in a direction opposite to the sliding, in accordance with Errichello (16)). The morphology of micropitting is clearly illustrated at high magnification in Fig. 3.

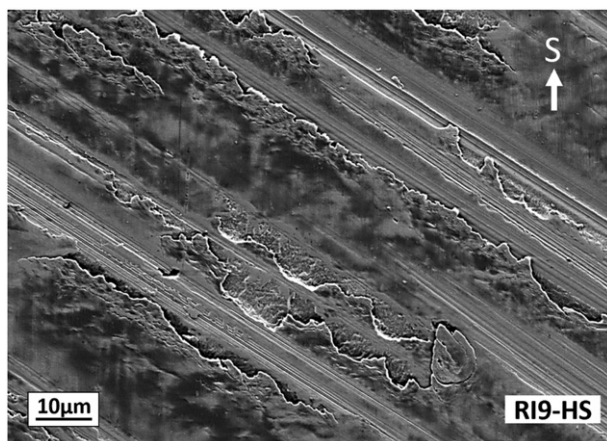
Figure 3. Morphology of micropitting. "S" in the micrographs indicates the sliding direction.

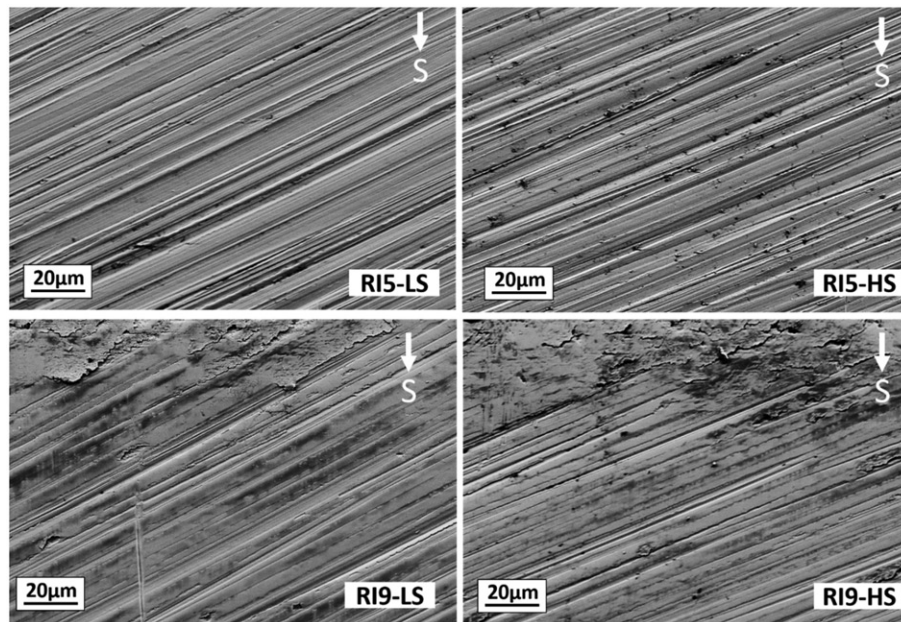
Figure 4. Surface topography close to the tooth tips after testing at different running-in conditions. “S” in the micrographs indicates the sliding direction.

The topography of the tip surfaces is shown in Fig. 4. It is evident from the micrographs that the deformation pattern is different from that of dedendum surfaces. For low load conditions, irrespective of speed, the deformation of asperities is limited, and the topography resembles that of the as-honed condition. On the other hand, asperities were deformed plastically and micropits appeared for high load conditions. Though it is hard to quantify, more micropits were present in combination with high speed.

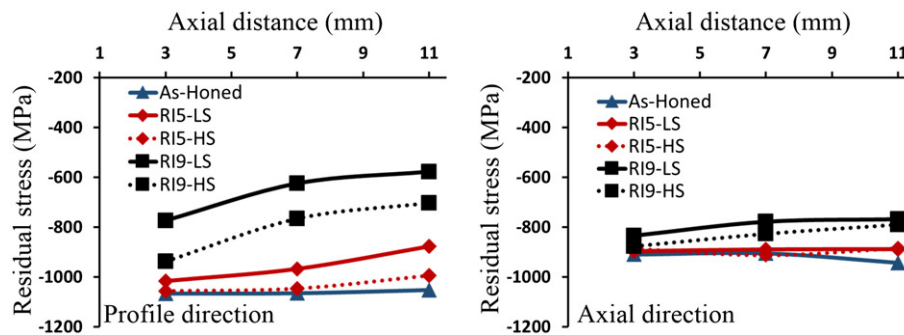
Figure 5. Residual stresses at the dedendum surface for three positions in the axial direction for different conditions.

during initial cycles were closely monitored. Figure 5 summarizes the residual stresses on the dedendum surface for all tests with average values from three different teeth, differing at most by ± 20 MPa. For as-honed gears, the stresses were compressive in both directions and slightly higher in profile direction. After running-in, the stresses tend to decrease in both directions, more so in the profile direction. Tönshoff, et al. (18) explained that maximum load stresses act in the profile direction due to high frictional forces created by combined rolling and sliding. Consequently, severe local plastic deformation in the profile direction results in higher stress variations. For ground gears, Mallipeddi, et al. (9, 19) observed increasing compressive residual stresses in both directions after running-in, which relaxed during further testing, at least in the profile direction. It is important to note that grinding induced much lower stresses than honing. This shows that the evolution of stresses is also dependent on the initial stress state and its response to material yielding.

The lowest compressive stresses were observed for RI9-LS. Overall, load had a great influence on stress relaxation, and for both loads the combination with low speed resulted in greater stress relaxation. Running-in also resulted in a

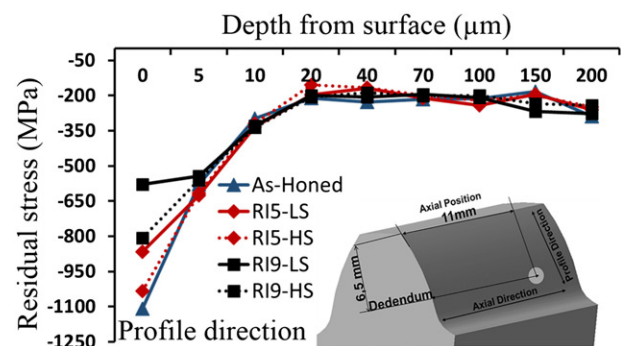
Figure 6. Residual stress profiles for different conditions.

Residual stress depth profiles are shown in Fig. 6. The case stress was around 200 MPa, equal in both directions. Honing increased the stresses in the outermost ~ 10 μm , whereas the relaxation induced by running-in was limited to a depth of ~ 5 μm . Similar results were reported by Tönshoff, et al. (18). In that study, honed gears made of the

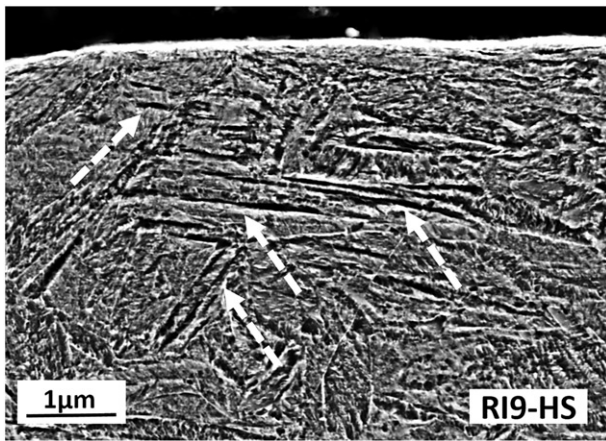
Figure 7. Micrograph of RI9-HS with distinct features.

For as-honed gears, the microstructure of the case-hardened layer consists of plate martensite. The surface-retained austenite content was about 9% as determined by X-ray diffraction. After running-in, a distinct structural feature was observed near the tooth surface (to a depth of $\sim 5 \mu\text{m}$) along the profile but mostly at the dedendum. An example is shown in Fig. 7. The morphology consists of thin parallel bands oriented in different directions and sometimes intersecting.

Though it is hard to quantify, more bands were seen for RI9 tests and in particular for RI9-LS. In a previous study (Mallipeddi, et al. (9)), the authors observed these features in ground gears that were run-in under the same test conditions. The morphology of these bands appears similar to that of deformation-induced martensite in stainless steel (Das, et al. (22)). However, this is not likely to be the case in this study because the retained austenite content remains within 8–9% from as-honed to running-in test conditions.

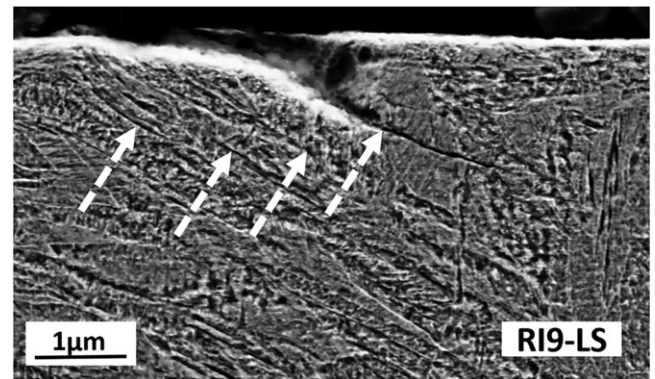
Figure 8. Distinct features associated with surface cracks.

Detailed cross section analyses also revealed the association of these features with surface cracks (Fig. 8), known to be connected to asperities/the surface lay (Mallipeddi, et al. (9)). This indicates that these features could be deformation

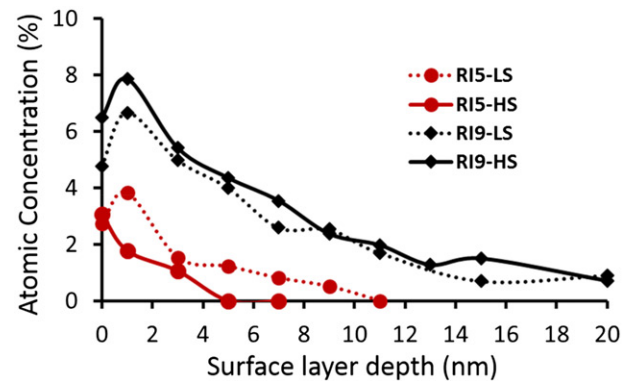
Figure 9. Phosphorous depth profiles obtained by XPS for different running-in conditions.

A tribofilm develops depending on the testing, and the most interesting elements to follow are P and S from EP additives. Phosphorous was observed after running-in as shown in Fig. 9. Higher concentrations (~ 7 at%) and thicker layers (~ 11 nm) were recorded for high running-in load, independent of speed. This is in conjunction with the evolution of surface topography where severe deformation was seen for higher running-in load. At low load, significantly less P was recorded in similar concentrations for both speeds. The other main EP additive constituent, S, was not found in any test condition. Overall, the load clearly influenced the tribofilm formation, whereas it appears unaffected by speed.
