## **NON-DESTRUCTIVE TESTING OF THE HISTORIC TIMBER ROOF STRUCTURES OF THE NATIONAL MUSEUM IN STOCKHOLM,**

# NON-DESTRUCTIVE TESTING OF THE HISTORIC TIMBER ROOF STRUCTURES OF THE NATIONAL MUSEUM IN STOCKHOLM, SWEDEN

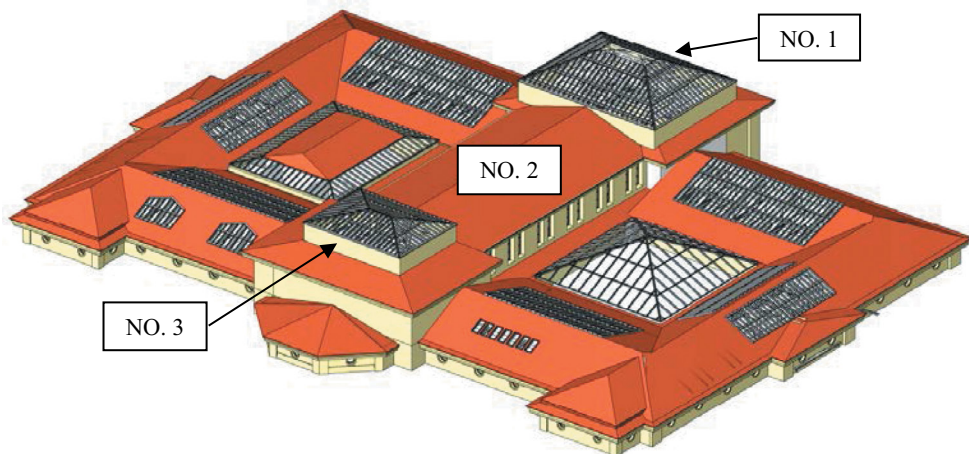
Figure 1: The overview of the National Museum roof structures.

For the structural assessment calculations of two lanterns roof structures a numerical 3D model was prepared based on a 3D-CAD model (Figs 1 and 2). The roof structure no. 1 is presented in Fig. 3, while the roof structure no. 3 is presented in Fig. 5. A 2D numerical

model for roof structure no. 2 was prepared based on 3D-CAD model (Figs 1, 2 and 4). In this chapter only these three types of roof structures are presented as the non-destructive testing of structural timber was performed only for those historical roof structures. Other roof structures (Figs 1 and 2) were strengthened and rebuilt without any further non-destructive testing of structural timber.

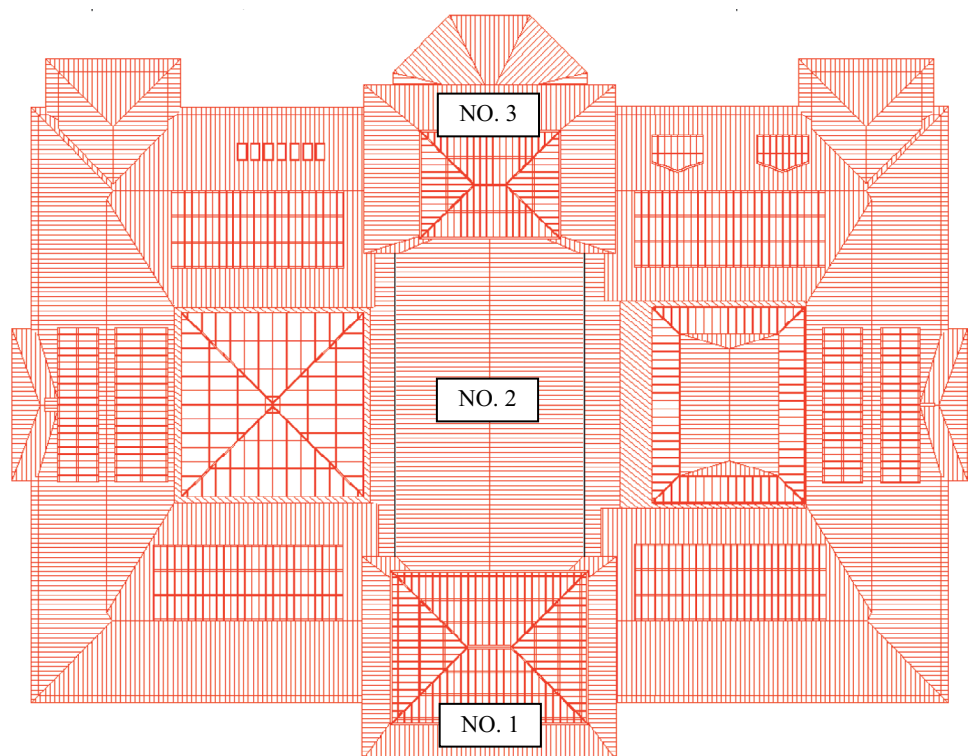
Figure 2: The overview of the National Museum roof structures.

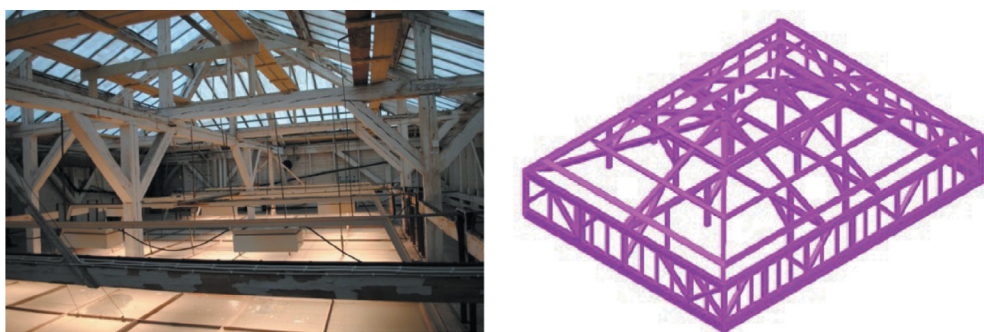
Figure 3: The roof structure no. 1.

The roof structure type 1 includes two transversal frames and one longitudinal frame carrying these two transversal frame structures (Fig. 3). The investigation campaign included a 3D scanning and detailed geometrical survey. Data collected during the investigation campaign were used for the preliminary analysis of the roof structure.

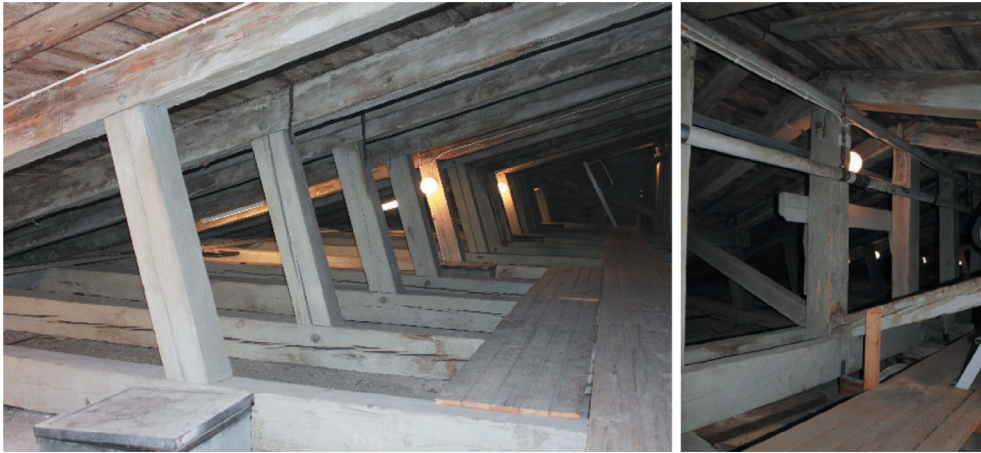
Figure 4: The roof structure no. 2.

The roof structure type 2 is called a king post truss with two principal rafters, a tie beam and a central vertical king post. Two different types of the king post trusses were built in the roof on the National Museum. The first type of trusses included two angled struts connected directly to the king post while the second type of trusses included two angled struts connected to tie beam (Fig. 4).

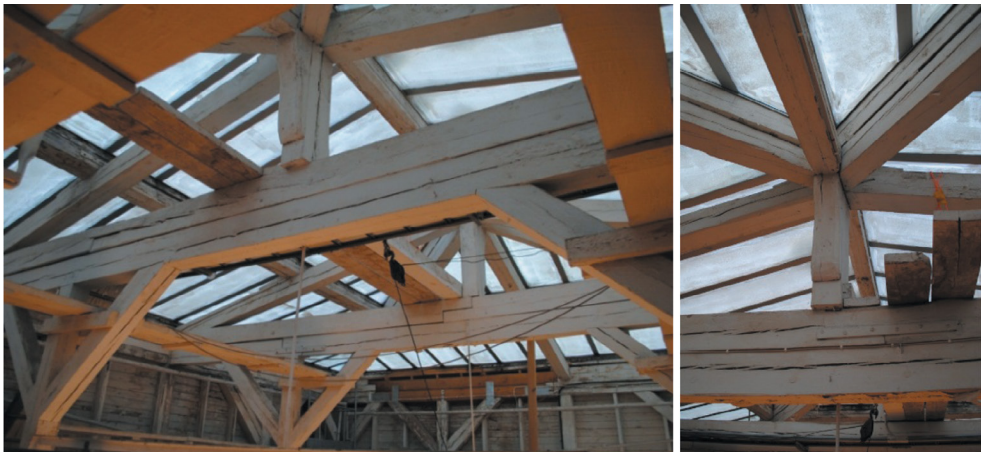
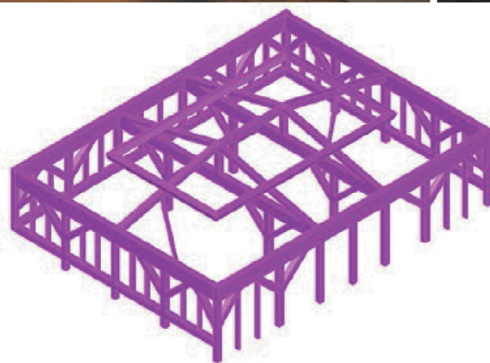
Figure 5: The roof structure no. 3.

The roof structure type 3 is similar in geometry to the roof structure type 1 and includes two transversal frames connected in apex with a ridge beam and two longitudinal rafters (Fig. 5).

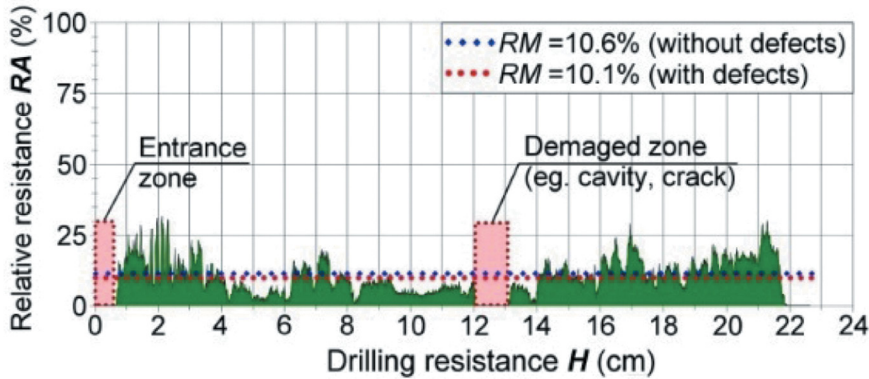
A 5-mm-deep entrance and exit zone, not taken into account in  $RM$  calculations, was adopted. The places with relative resistance ( $RA$ ) values below 10% and not longer than 5 mm were regarded as defective zones. An exemplary graph  $z$  with calculated resistance measure ( $RM$ ) values, with and without taking into account the present defects, is shown in Fig. 6.

Figure 6: Exemplary drilling resistance graph with marked  $RM$  values (with and without defects) and entrance zone (0.5 cm)

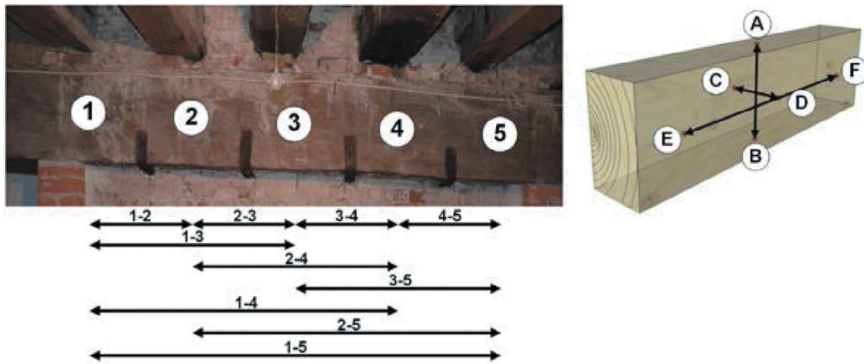
Figure 7: (Right) Illustration of a stepwise (1–5) stress-wave-based assessment approach along a structural beam [6] and (left) measurements in different directions to detect the extent of the damage/deterioration [7] (A–B, C–D and E–F).

Such a stress-wave-based condition assessment strategy is simply illustrated in Fig. 7, where critical areas from the visual inspection can be measured stepwise in different directions to identify decay and its extent on the structural element at different locations along the beam [7, 8]. The transmission time is highly correlated with the MOE, eqn (2), which is of great importance for evaluation of the structural soundness of beams, purlins and columns in large timber structures [9].

The main use was firstly to investigate the quantitative (density) parameters using a calibration procedure described by Ref. [5] and, secondly, as a complement, to inspect qualitative parameters such as the interior condition of critical and/or deteriorated sections and accessible structural details; see e.g. Fig. 7.

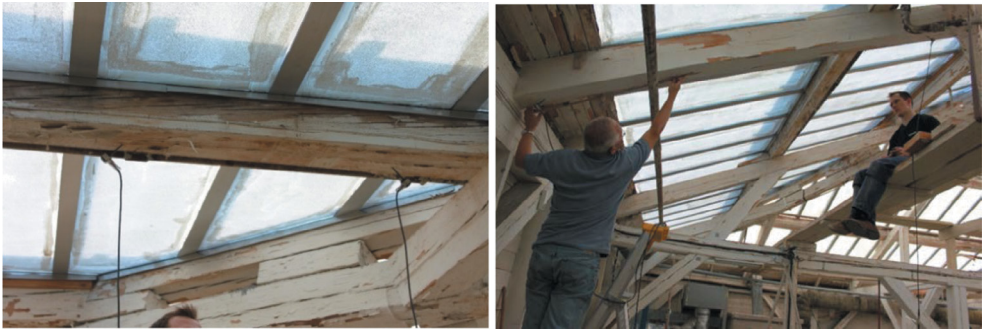
Figure 8: Photo no. 1942 (left), photo no. 1943 (right).

Only three members showed an MOE ( $E_d$ ) lower than 10,000 MPa. The measurement from the rafter of roof structure type 1, Fig. 8 (left) (Photo no. 1942) at this location, showed deterioration, and the MOE was measured to only 7,700 MPa, whereas the measurement of the whole rafter showed 10,200 MPa. The Jack rafter, Fig. 8 (right) (Photo no. 1943), showed 9,800 MPa and the main beam along gable wall, Fig. 8 (right) (Photo no. 1943), showed 9,900 MPa.

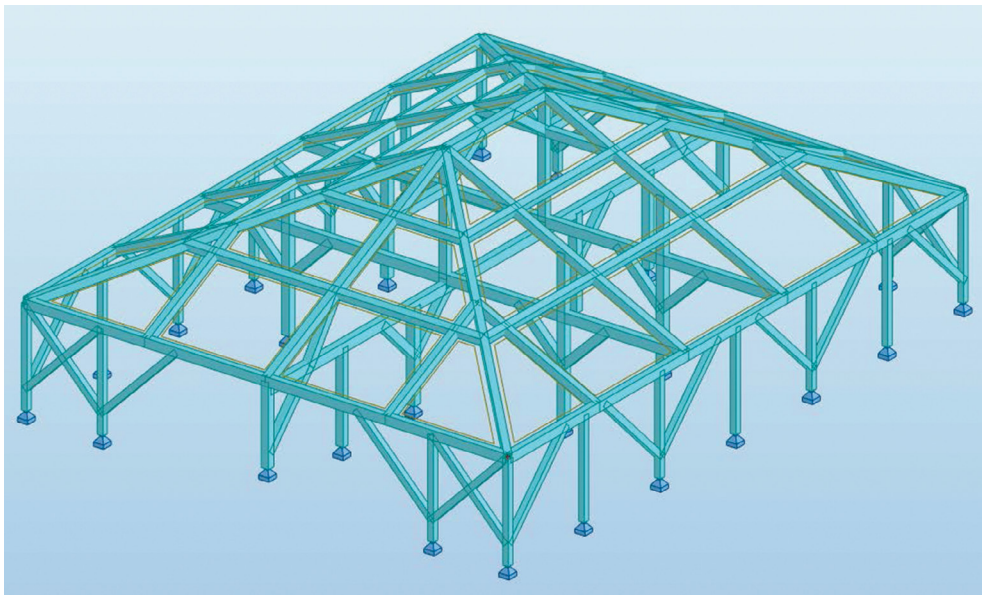
For the structural assessment calculations, the geometrical survey data were used to prepare numerical 2D and 3D models. Figures 9 and 10 present the 3D numerical model of roof structure type 1. The structural 3D modelling process did not focus on details (carpentry joints and connections) modelling. The structural analysis of roof types 1–3, with timber strength class assigned to C30, showed satisfactory results both in ULS and SLS designs. Only in roof type 1 four rafters and purlins were removed and exchanged with new glulam beams due to architectural design of new glass roof structure. Purlins in roof type 3 were also removed and exchanged with new glulam beams due to the same architectural design of glass roof structure. Roof structure type 2 was neither strengthened nor rebuilt from original design.

Figure 9: 3D numerical model

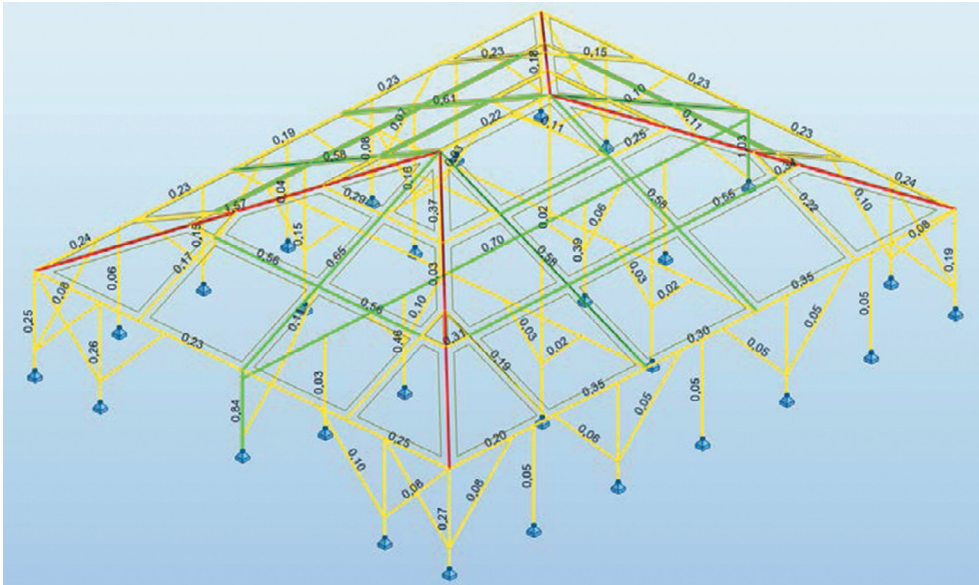
Figure 10: Results – utilization ratio for roof structure type 1 – timber strength class C30.
