Fatigue crack growth of electron beam melted Ti-6AL-4V in high-pressure hydrogen

Fatigue Crack Growth of Electron Beam Melted Ti-6Al-4V in High-Pressure Hydrogen

Keywords: fatigue crack growth (FCG); electron beam melting (EBM); Ti-6Al-4V; hydrogen embrittlement (HE)

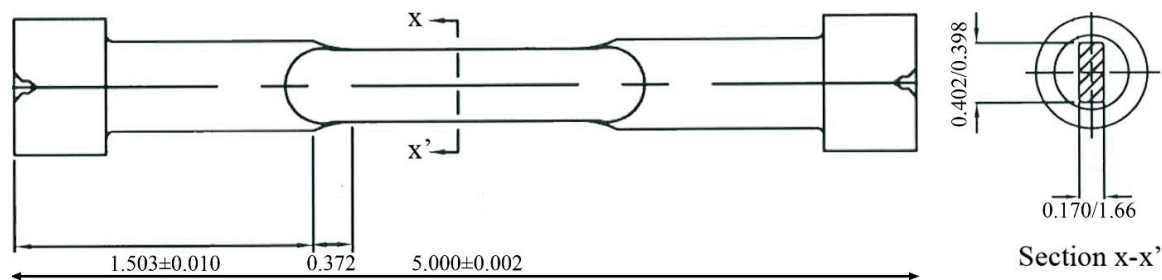
Figure 1. Sketch of Kb bar specimen. Dimensions in mm (printed with permission from Metcut Research).

EBM Ti-6Al-4V samples were manufactured with an Arcam Q20+ machine, using a layer thickness of 90 μ m. Cylinders were manufactured having a length of 135 mm and a diameter of 25 mm. The layers were oriented perpendicular to the major axis of the cylinders i.e., the applied load during the FCG tests was perpendicular to the AM built layers. The powder used was Ti-6Al-4V B110 (Virgin Hoeganaes) in accordance with the aerospace material specification AMS 4992. Prior to testing, the samples received a hot isostatic pressure (HIP) treatment at 920 ± 10 °C for two hours with a pressure of 1020 bar, followed by a heat treatment at 704 ± 10 °C for two hours. Both HIP and heat treatment were conducted in argon. Out of the manufactured cylinders, Kb bars were machined (see Figure 1) using low stress grinding and polishing of the gauge section. A tensile test was performed on the post treated material and the result showed a yield strength of 890 MPa and tensile strength 990 MPa.

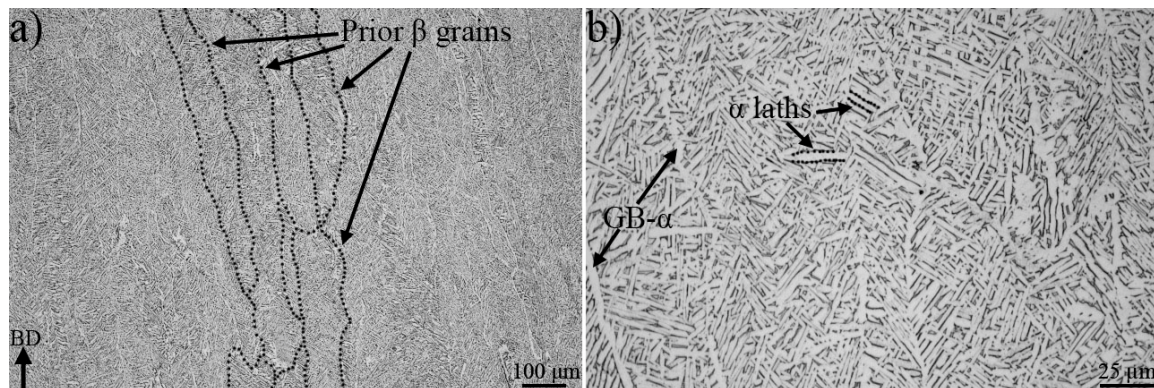
Figure 2. In (a) columnar prior β grains and in (b) the basketweave microstructure are shown. The black arrow in the bottom left corner in (a) points towards the build direction (BD).

The EBM Ti-6Al-4V material consisted of columnar prior β grains. The grain boundaries are illustrated as black dotted lines in Figure 2a and they were elongated parallel to the build direction, with lengths up to approximately 2 mm. In the plane perpendicular to the build direction, the prior β grains were equiaxed, with widths of $\sim 100 \mu\text{m}$. The prior β grains were partially separated by discontinuous grain boundary α (GB- α) and the microstructure within the prior β grains was basketweave, with an average α lath width of $2.2 \pm 0.6 \mu\text{m}$, see Figure 2b.

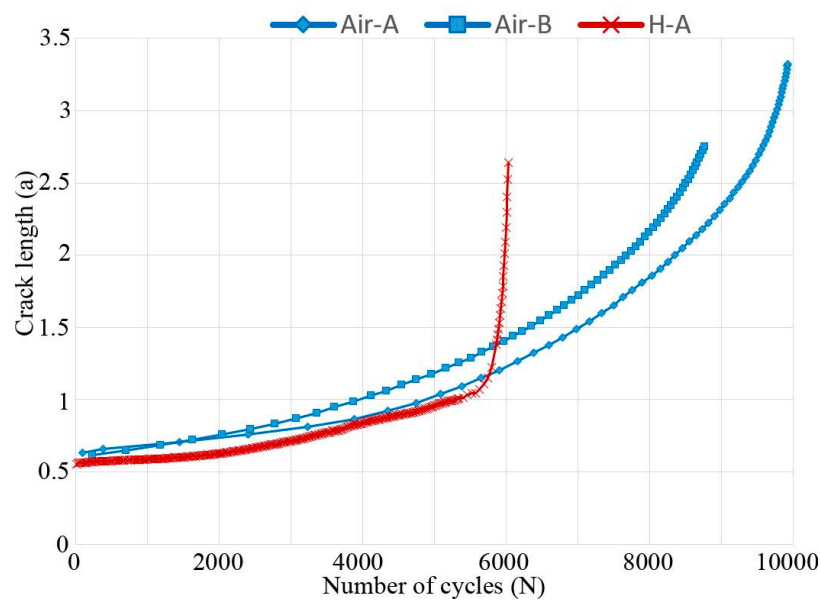
Figure 3. Crack length versus the number of cycles for all three tested electron beam melting (EBM) samples. At ~5600 cycles the crack length of the hydrogen-tested sample accelerates.

Different plots of FCG test data are shown in Figures 3–5; crack length versus number of cycles, crack growth rate versus ΔK , and ratio between crack growth rate in hydrogen (specimen H-A) and air (specimen Air-B). The two air-tested samples followed the Paris law with similar inclination (see Figure 4). The hydrogen-tested sample, on the other hand, has a fluctuating crack growth rate in the first stage of the test. After the fluctuating stage, at $\Delta K \sim 23 \text{ MPa} \sqrt{\text{m}}$, a sudden increase in crack growth rate was observed. The resulting increase in crack length is shown in Figure 3: After ~ 5600 cycles there is a sudden offset in crack growth rate for H-A, whereas for Air-A/B no such abrupt offset is present. Figure 5 shows that below $\sim 23 \text{ MPa} \sqrt{\text{m}}$ the relative crack propagation rate is around one, indicating no difference in air and hydrogen tests. Around this value of ΔK ($23 \text{ MPa} \sqrt{\text{m}}$), the crack propagation rate ratio started to increase, and continues to do so at a constant rate up to $\sim 32 \text{ MPa} \sqrt{\text{m}}$, where it reaches a plateau. By then, the crack propagation rate of the material tested in hydrogen is over 12 times higher than in air.

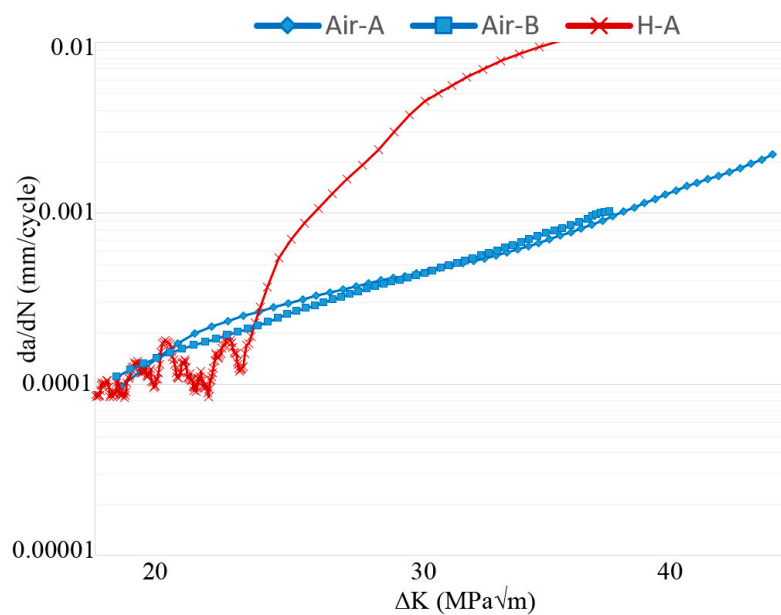
Figure 4. Crack growth rate versus ΔK . The hydrogen-tested material fluctuates below $23 \text{ MPa} \sqrt{m}$, while accelerating above. The air-tested material follows Paris law.

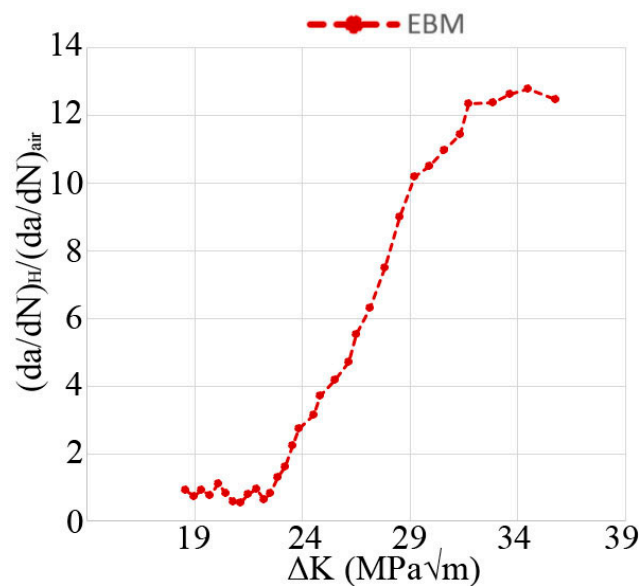
Figure 5. Relative crack propagation rate between hydrogen and air-tested material versus ΔK . At $23 \text{ MPa} \sqrt{m}$ the relative crack propagation increases steadily while reaching a plateau at $31 \text{ MPa} \sqrt{m}$.

The relative crack growth rate between the hydrogen and air-tested samples, as shown in Figure 5, clearly shows the critical effect of the presence of hydrogen on titanium: At high ΔK , the FCG rates were roughly 10 times larger in a hydrogen atmosphere. As previously discussed, there was an acceleration in the FCG rate at 23 MPa \sqrt{m} . However, Figure 5 also shows that this acceleration did not continue until final failure. At $\Delta K > 31$ MPa \sqrt{m} , the relationship between the hydrogen and air-tested samples seemed to have reached a plateau, indicating that increased ΔK in this range and increased hydrogen content ahead of the crack tip did not promote additional acceleration of the FCG rate for EBM built Ti-6Al-4V. Apart from the presence of secondary cracks, the fracture surface cross-section of the hydrogen and air-tested material differed regarding crack path. The crack path in hydrogen-tested material was tortuous in nature, whereas it was relatively flat in air-tested material. Crack paths of both specimen types crossed through α laths, as well as propagated parallel to α laths in the α/β interface.

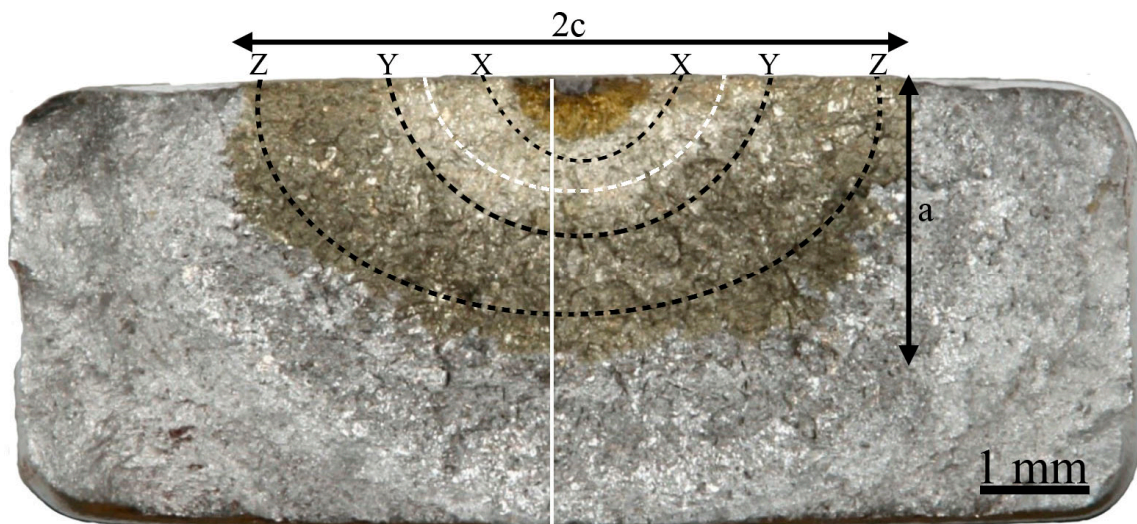
Figure 6. Overview of H-A fracture surface. The two tint temperatures, 450 and 350 °C, resulted in the two different golden color contrasts shown in the figure. “ $2c$ ” represents the width and “ a ” the length of the crack. The three semi-elliptical dashed lines X, Y, and Z show profiles where fractography was performed in higher detail. The white dotted line in-between the X and Y lines corresponds to the $\Delta K 23 \text{ MPa} \sqrt{m}$. The vertical white line indicates the cross-section where crack profiles were investigated.

Figure 6 shows the fracture surface of the hydrogen-tested sample (H-A). A change in macroscopic appearance was observed at a crack length $\sim 1 \text{ mm}$ (this crack length is shown in Figure 3 to coincide with the accelerated crack growth), which corresponded to $\Delta K 23 \text{ MPa} \sqrt{m}$ and the location of this ΔK is shown by a white dashed semi-ellipse in Figure 6 (in-between X and Y line). The lines X, Y, and Z shown in Figure 6, following semi-elliptical paths, correspond to fractographic locations where the fracture surface has been characterized extra carefully. The X line surrounds the pre-crack, Y is in the middle of the crack, and Z is at the end of the crack. Table 1 presents lengths and widths of notch, pre-crack, and the fatigue crack of all samples. The lengths a and $2c$ of the final fatigue crack are illustrated in Figure 6.

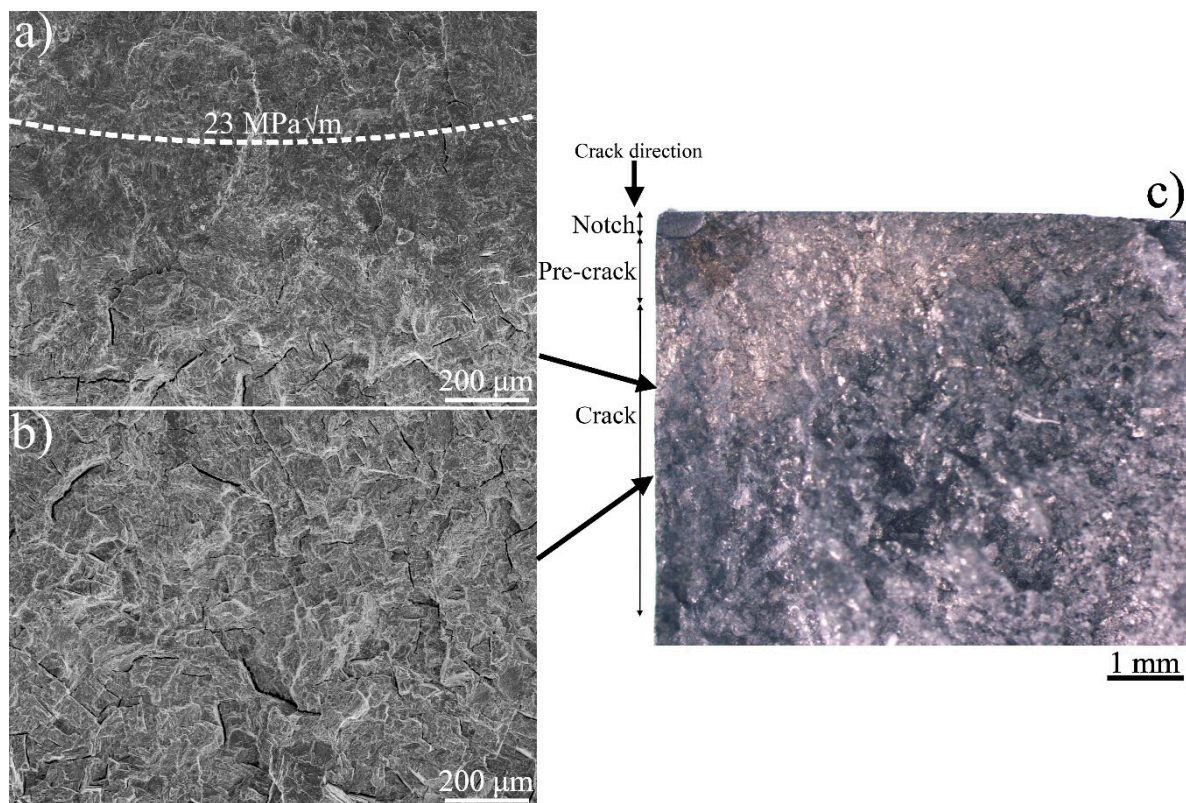
Figure 7. In (a) the transition zone from flat to rough fracture surface (the white dotted semi-ellipse shows $\Delta K 23 \text{ MPa} \sqrt{m}$), whereas (b) shows a rough fracture surface with large cracks. In (c) a section of H-A fracture surface is shown, cut as indicated by the vertical white line in Figure 6.

In Figure 7a,b representative areas along Y and Z in Figure 6 of the fracture surface of the hydrogen-tested sample are shown, in Figure 7c the position of the crack profile in the ground specimen (white vertical line in Figure 6) is shown. A transition in fracture surface is shown in Figure 7a, below the white dashed semi-ellipse corresponding to crack length where the ΔK was $23 \text{ MPa} \sqrt{m}$. At this ΔK the fracture surface starts to transition from flat to rough. In Figure 7b (region Z) large cracks, exceeding lengths of $100 \mu\text{m}$, are observed on the fracture surface.

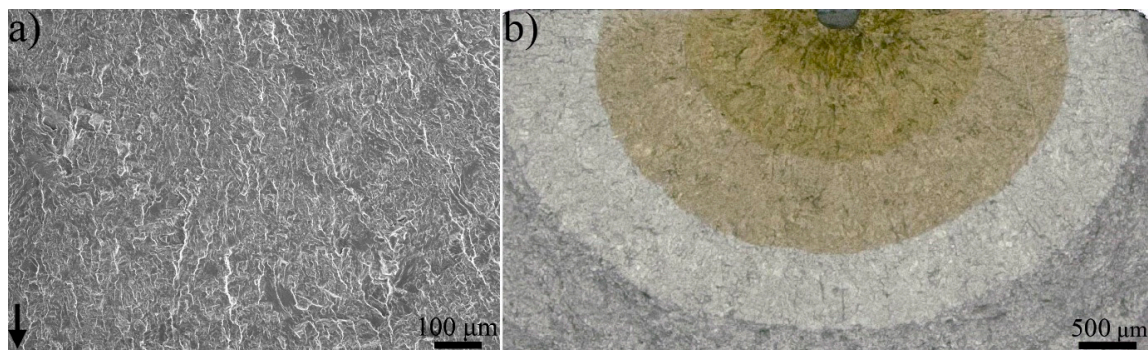
Figure 8. (a) 100× magnification fracture surface image of air-tested material (sample Air-B) in the region ~Y. (b) lower magnification image that shows an overview of the whole fracture surface. The black arrow points towards the crack propagation direction.

Figure 8 shows the characteristic fracture surface of the air-tested material, in Figure 8a higher magnification, whereas in Figure 8b lower magnification. The transition area observed in Figure 7, from flat to rough, did not exist in the air-tested material, neither do the large cracks.

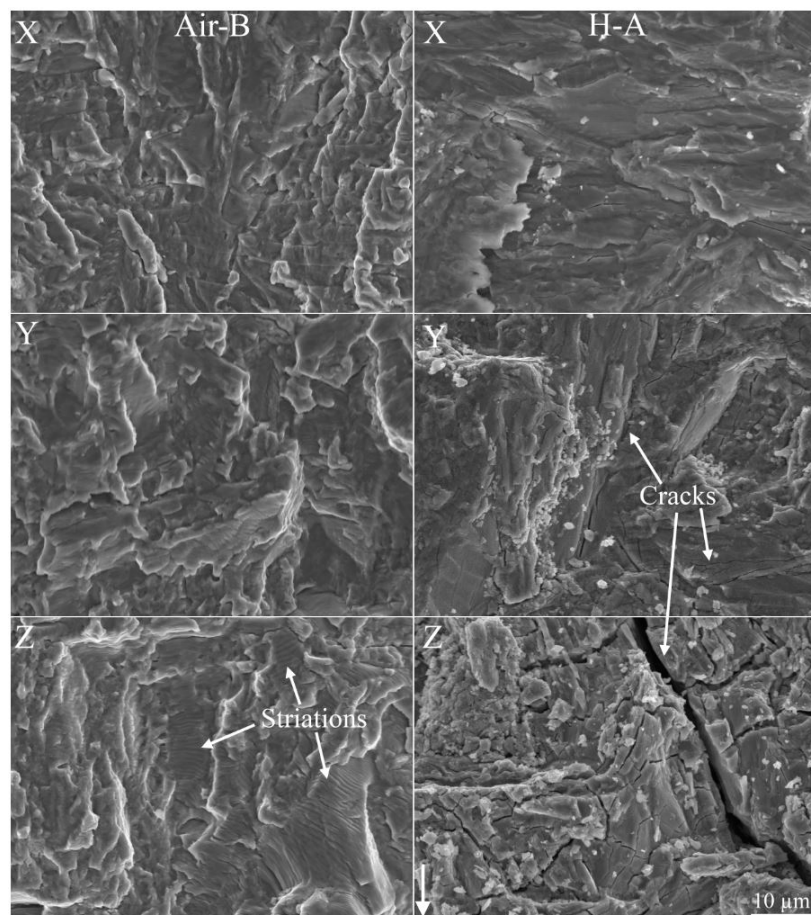
Figure 9. Images of the three sections X-Z (see Figure 6 for locations of the areas on the fracture surface) for one air (sample Air-B) and one hydrogen (sample H-A) tested sample. The images are in the same magnification and the white arrow in the bottom right indicates the crack propagation direction. In section Z of Air-B, examples of striations are indicated with the white arrows. In sections Y and Z of H-A, white arrows point at cracks; their dimensions increase from the former section to the latter.

In Figure 9 representative images of the fracture surface are shown along the profiles X to Z (see Figure 6 for illustration of the locations on the fracture surface). In the air-tested samples, striations were observed along the whole fatigue crack, becoming increasingly larger the greater the ΔK became. In Air-B, section X, striations were only observed at higher magnification, whereas in section Z they were clearly visible for the present magnification (2000×).

In the hydrogen-tested sample, the fracture surface on the first stage of the fatigue crack (section X) appeared flat. With increased ΔK (above $23 \text{ MPa} \sqrt{\text{m}}$ i.e., section Y) an increase in fracture surface tortuosity aroused, along with the appearance of small cracks. Then, towards the end of the fatigue crack (section Z), larger cracks were observed with dimensions of $\sim 100 \mu\text{m}$. At the flat area of the H-A's fracture surface, i.e., below $23 \text{ MPa} \sqrt{\text{m}}$, features that resembled crack arrest marks (CAM) were observed. Crack propagation stops at the CAM interface, causing the formation of these marks. The origin could for example be the cleavage of a hydride. In Figure 10 features that resemble CAMs are marked by white arrows, where each plateau is the end of a CAM, which according to literature could indicate the interface between the hydride and titanium base metal [4,32]. Note that the CAM locations were not numerous.

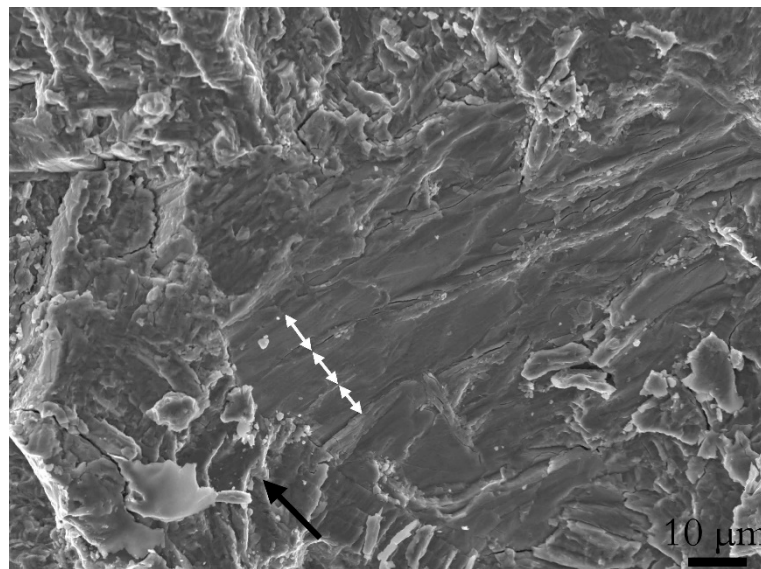
Figure 10. An area with features that resembled crack arrest marks (CAM). Each white arrow indicates a possible CAM, where each plateau could be a hydride titanium interface between cleaved hydrides. The black arrows show the crack growth direction.

As discussed and observed by Lynch [4,33] and others [26,34–39], the mechanical properties of titanium are expected to deteriorate when exposed to hydrogen, due to HE [3]. Such deterioration of the mechanical properties was observed in this work. When exposing the EBM built Ti-6Al-4V to hydrogen-rich atmosphere, hydrogen can be absorbed and diffused throughout the material to the crack tip. At the crack tip the hydrogen can interact with the titanium either by the nucleation of hydrides, resulting in HE through brittle fracture of titanium hydrides, or through one or several other HE mechanisms [4,34–36,40]. On the first stages of the test the FCG rate fluctuated (as shown in Figure 4 and this is believed to be due to temporarily arrests of the crack i.e., CAMs. The nucleation and cleavage of hydrides are suggested in literature to be repeated, forming a relatively flat region on the fracture surface with the presence of features such as CAMs (see Figure 10) [26,32].

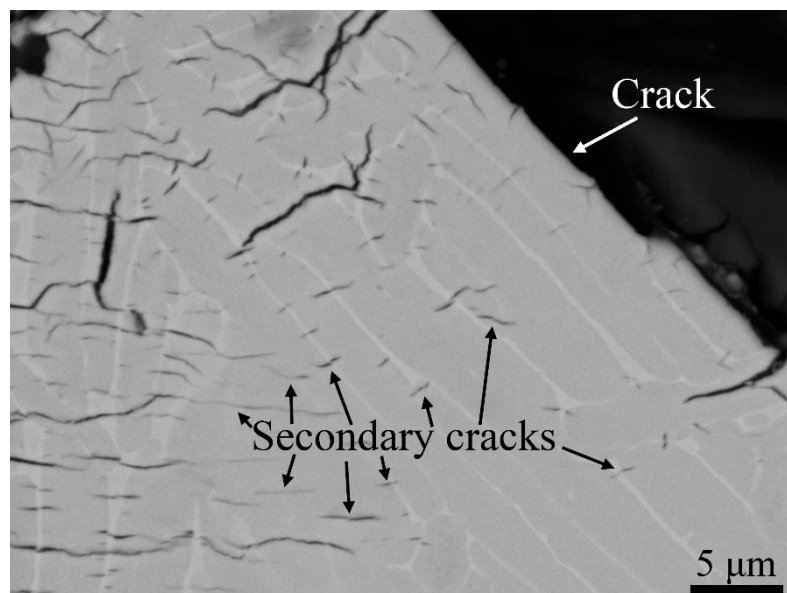
Figure 11. Image of a crack profile for sample H-A. It shows secondary cracks that grow across α/β interfaces. In the upper right corner, the crack propagated along an α lath, seemingly in the α/β interface.

Figure 11 is a high magnification image of a fracture surface cross-section in the hydrogen tested material. Secondary cracks were present across α/β interfaces. The crack path can be seen on the upper right corner, showing that the crack propagated along an α lath, seemingly in the α/β interface.

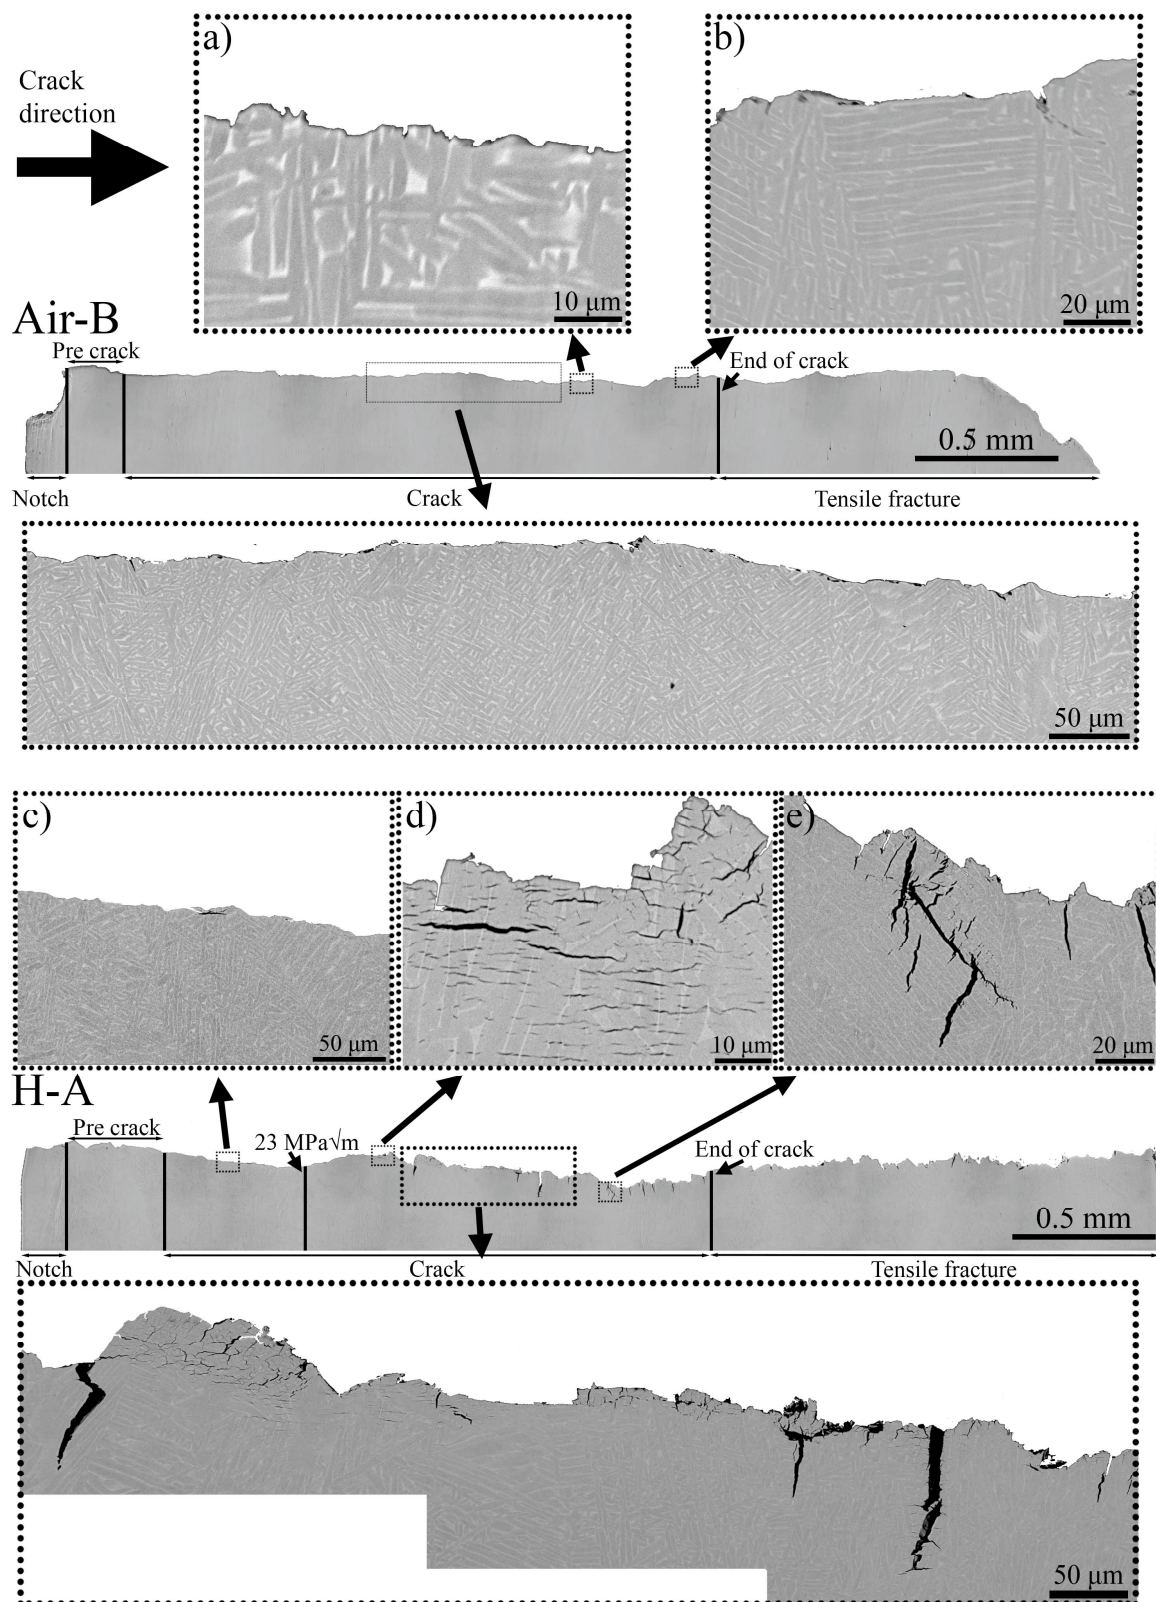
Figure 12. Crack-profiles of Air-B and H-A samples. The crack profiles correspond to a cross-section illustrated in Figure 6 as a white vertical line. In H-A, many larger cracks that grew perpendicular to the fracture surface were observed, along with numerous smaller secondary cracks that grew parallel. In H-A the crack path was tortuous, whereas in Air-B it was comparably smooth. Compared to H-A no cracks were present in Air-B. Images (a–e) show magnified areas.

In Figure 12 two crack profiles are shown (one for Air-B and one for H-A). The crack profiles correspond to the cross-section illustrated as a white vertical line in Figure 6. Crack profiles covering the whole fracture surface from notch to final tensile fracture were obtained in LOM, while the remaining images, Figure 12a–e, were obtained in an SEM using backscattered electrons.

The crack profile showed a similar pattern as was observed on the fracture surfaces. For H-A, in the region from the start of crack to $\Delta K 23 \text{ MPa} \sqrt{m}$, few cracks are observed i.e., image (c), from $23 \text{ MPa} \sqrt{m}$ and onwards large vertical (perpendicular to the crack direction) cracks were observed. With higher magnification also numerous small secondary cracks were observed after the $\Delta K 23 \text{ MPa} \sqrt{m}$, see Figure 12d. Note that these smaller secondary cracks had no connection to the main crack. For the H-A sample, three areas are shown in higher magnification; in-between pre-crack and $23 \text{ Pa} \sqrt{m}$ i.e., (c), after $23 \text{ MPa} \sqrt{m}$ i.e., (d), and before final crack i.e., (e). In (c) the crack profile was less tortuous and no vertical cracks or secondary cracks were observed. However, directly after $23 \text{ MPa} \sqrt{m}$, secondary cracks were observed as shown in Figure 12d. After area (d), deep vertical cracks appeared as shown in (e). The maximum major axis for the secondary cracks was in the dimensions of 10 to 20 μm , whereas the vertical cracks reached about 50 to 70 μm .

The hydrogen-tested sample had a tortuous crack profile, whereas the air-tested sample had a comparably straight crack path, with a homogeneous appearance throughout the various ΔK . The cracks propagated both parallel to the direction of α laths in the α/β interface and perpendicular to the laths, for both the air and hydrogen-tested material. Due to the build-orientation of the samples in regard to the load, the propagation of the fatigue crack was perpendicular to the major axis of the prior β grains i.e., perpendicular to the heat gradient, thus no propagation along grain boundary α could be observed.

For the air-tested material, no deep cracks were observed along the crack profile and features that appeared to be cracks on the fracture surface were shown to be superficial. In Figure 12b, the largest identified crack in Air-B sample is shown. The vertical cracks shown in (e) both propagated parallel to an α lath in the α/β interface, then switched to propagation across several α laths. The location of the notch, pre-crack and final crack were approximately the same for both H-A and Air-B, as was shown in Table 1.

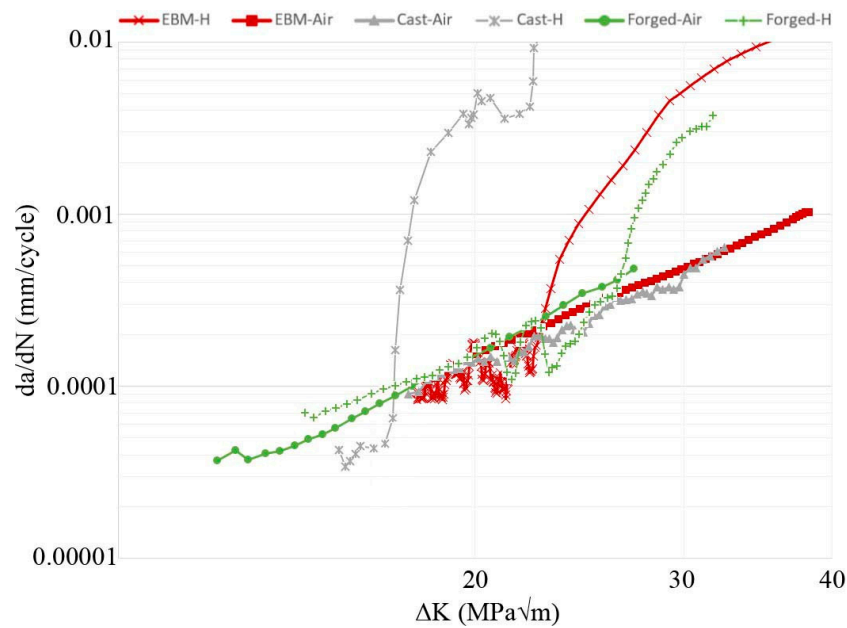
Figure 13. Fatigue crack growth (FCG) data for EBM, forged [26], and cast [28] Ti-6Al-4V. The FCG properties of material exposed to air and hydrogen atmosphere are shown, where the crack growth rate da/dN is plotted on the y-axis and the ΔK on the x-axis.

In Figures 13 and 14, the FCG properties of the investigated Ti-6Al-4V EBM samples are compared to those of forged and cast material of the same alloy (data source: Gaddam et al. [26,28]), both in air and hydrogen atmospheres. The data in these references have been obtained through testing with similar ΔK .

In Figure 13 the crack growth rate (da/dN) is plotted against ΔK ($MPa \sqrt{m}$). In Figure 14 the crack propagation rate in hydrogen environment relative to that in air is plotted as a function of ΔK . A difference in FCG rate behavior was observed between the material exposed to the high-pressure hydrogen and air: For the air-tested material, the FCG rate followed Paris law. For the hydrogen-tested material the FCG rate fluctuated at first, then at certain ΔK , depending on the microstructure, the FCG rate increased fast. The dotted square in Figure 14 is a magnified area to make it easier to distinguish

The FCG behavior of cast Ti-6Al-4V illustrated in Figure 13 can be explained as follows. Cast Ti-6Al-4V has been shown to have a higher β phase fraction than the same alloy produced by EBM [44]. In addition, the casting's coarse microstructure means a lower number of hydrogen traps. Both these reasons favor faster hydrogen diffusion. Then, due to faster diffusion rate sufficient hydrogen is diffused ahead of the crack tip, for the material to experience at least one of the HE mechanisms at $17 \text{ MPa } \sqrt{\text{m}}$, which accelerates the FCG rate even further, reaching a relative FCG rate that is ~ 160 times higher in hydrogen than in air. Then the same phenomena happen for the EBM and forged material at $23 \text{ MPa } \sqrt{\text{m}}$ and $26 \text{ MPa } \sqrt{\text{m}}$, respectively. The results are in well accordance to Tal-Gutelmacher et al. [14], that also found the bimodal microstructure to be less sensible to HE than the Widmanstätten microstructure with its more continuous network of residual β phase.

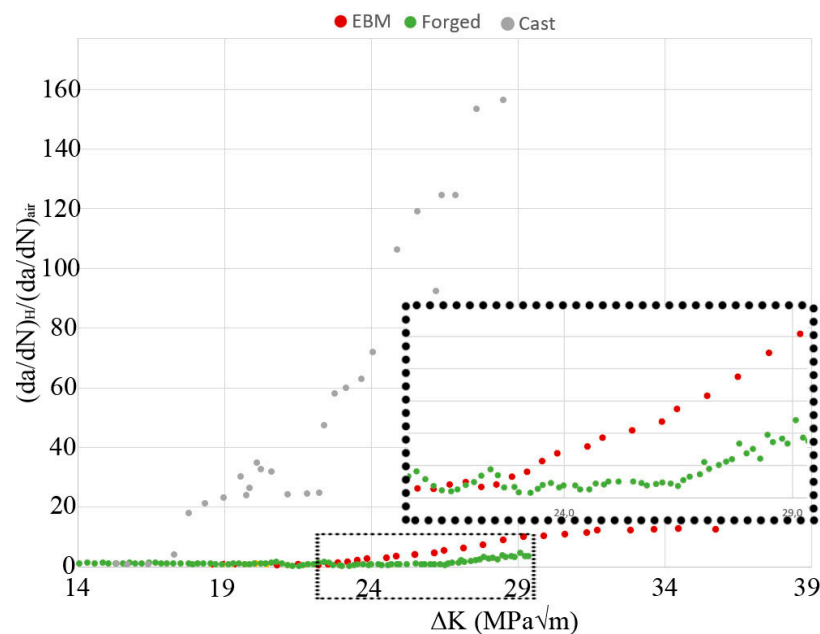
Figure 14. FCG data for EBM, forged [26], and cast [28] Ti-6Al-4V. The y-axis shows the crack propagation rate in hydrogen divided by the crack propagation rate for air, the x-axis shows ΔK . The dashed box is a magnified image to more clearly show the critical points in crack growth rate for the EBM and forged material.

the difference between the EBM and forged materials. In cast Ti-6Al-4V, this occurrence appears at a ΔK of $\sim 17 \text{ MPa } \sqrt{\text{m}}$; in EBM-built Ti-6Al-4V, at $\sim 23 \text{ MPa } \sqrt{\text{m}}$; in forgings of the same alloy, at $\sim 26 \text{ MPa } \sqrt{\text{m}}$. In Figure 14 it is furthermore shown that the maximum FCG rate difference between the hydrogen and air atmosphere was 160 times for the cast material, whereas for the EBM material it was 10 times and the forged material 5 times, all values at $\Delta K = 29 \text{ MPa } \sqrt{\text{m}}$.
