## **Fatigue reinforcement during repainting for two motorway bridges**

## Fatigue reinforcement during repainting for two motorway bridges

Jacques BERTHELLEMY<sup>a\*</sup>, Asma MANAI<sup>b</sup><sup>a</sup>*Cerema, France*<sup>b</sup>*Chalmers university of technology, Sweden*

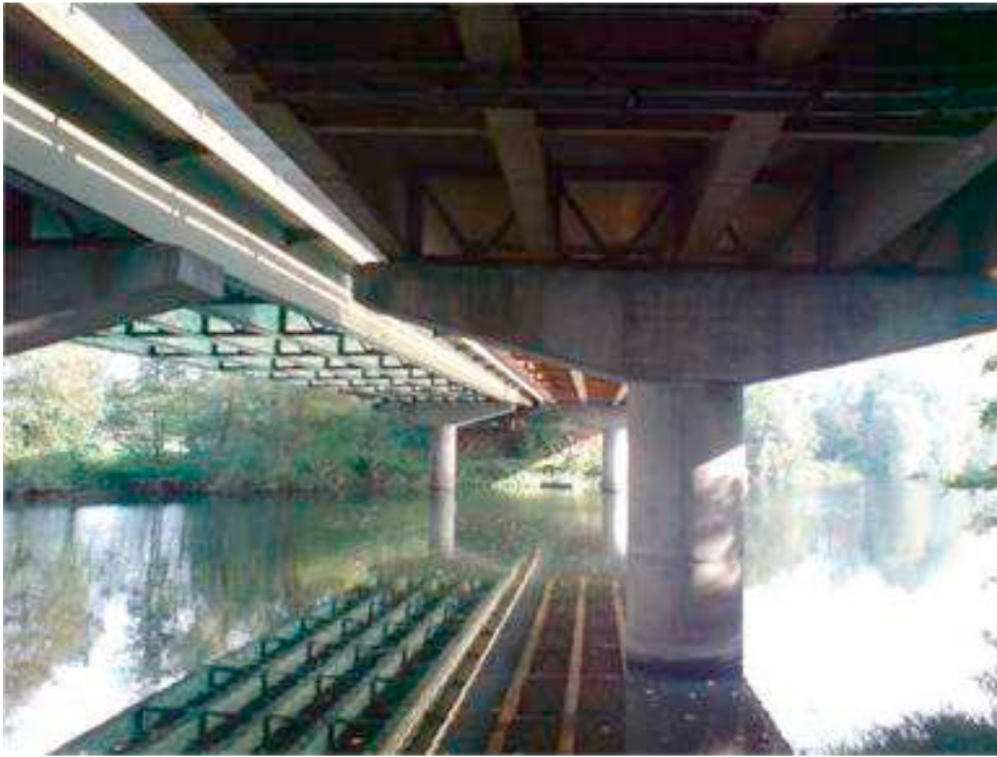
*Figure 1 : Sight of the beams of the two independent bridges supporting the highway*

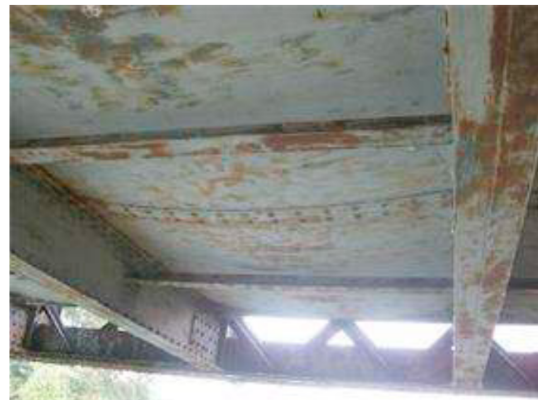
*Figure 3 : steel-concrete composite deck (built around 1900)*

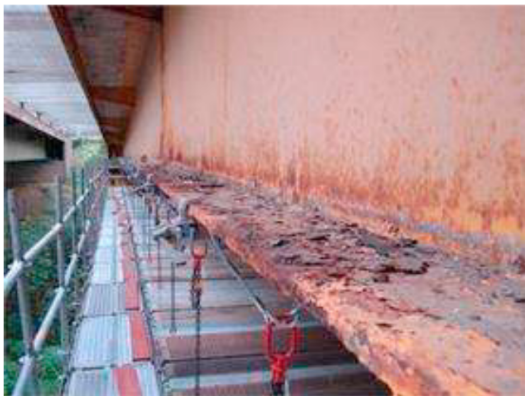
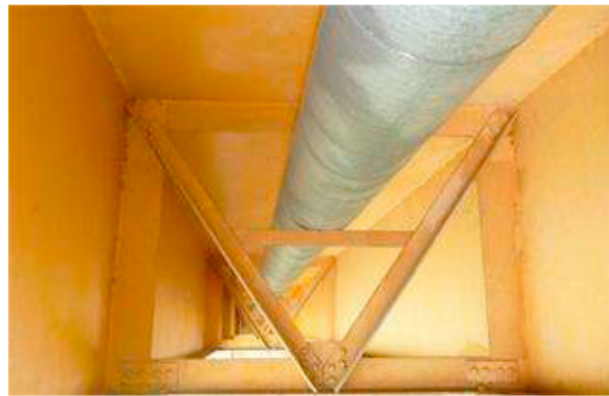
The fatigue strengths given in the Eurocode 3, Part 9-1 apply to structures operating under normal atmospheric conditions and with sufficient corrosion protection and regular maintenance. The degradations observed on anti-corrosive protection were very unequal. They were much more marked on the outside of the lateral beams than on the intermediate beams (see Figure 6). That's why a special treatment of the outside of lateral beams was carried out.

Outside of the lateral beam

Intermediate beams and bottom flange of composite deck

Figure 6: Disparity of degradations of protection against corrosion

Because of the very strong disparity of degradations among the old paintings highlighted by the photographs of figure 4, the adopted solution consists in complete blasting and renovating only the very degraded zones (edge beam webs, specific bolted connection, zones on abutments, ...). This is very economic and limits the risks of dissemination of lead and other toxic chemical pollutants on the building site. It is true on the other hand that extended zones that had remained in good condition, will stay protected by lead.

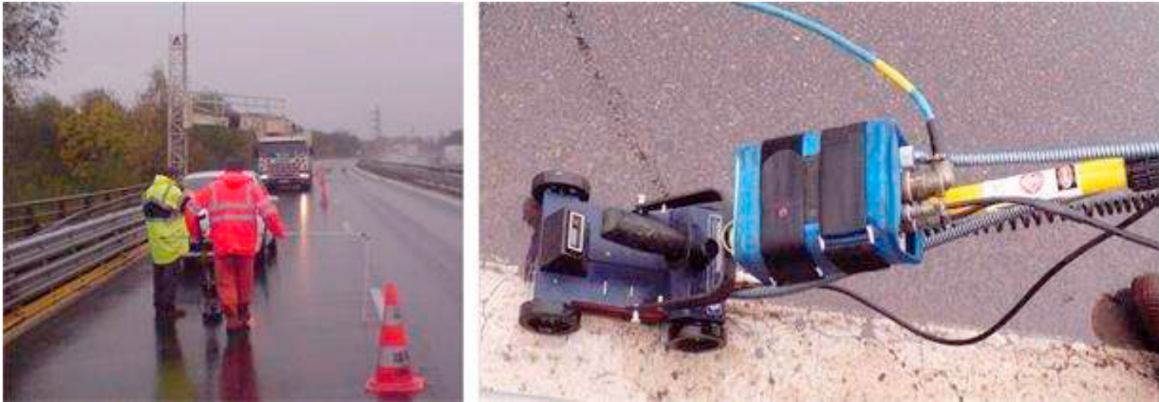
The examination using the radar led to conclude that the original old waterproofing (see figure 7), had preserved its effectiveness everywhere. In addition of that, some drillings of control through the bottom plate revealed neither

degradation, nor reduction in thickness dimension. The thickness of the bottom plate of the composite deck was even accurately measured to 8,6 millimetres, instead of the theoretical value of 8 millimetres that was expected according to the original design.

*Figure 7 : Radar examination of the composite slab and its waterproofing*

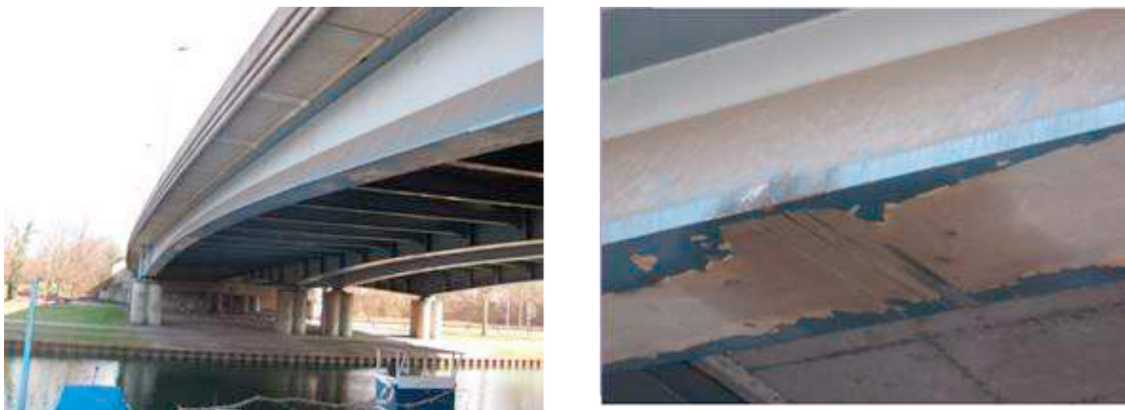
- ✓ **reinforcement of the bottom flange regarding the impact of oversized vehicles.** It was not the case for the Dancourt bridges but it was determinant and efficient for the bridges in Strasbourg presented in Figure 9.

Figure 9 : *Bridges of the ring of Strasbourg at the crossing of the street "des Bouchers"*

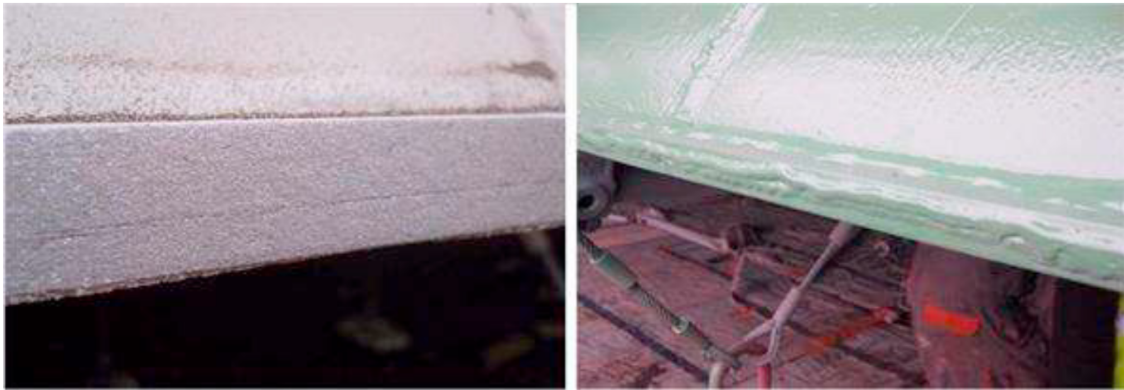
The welding of the additional sloping plates revealed some pre-existing imperfections of the basic bottom flanges by causing some cracks in a horizontal plane crossing these flanges. The old plates of the seventies had been elaborated before the implementation in the forging mills with continuous casting. Some delamination defects of origin due to impurities were opened by the welding of the additional sloping plates.

*Aspect just after detection (Photo J.Y. Joineau)**Aspect after treatment**Figure 11 : Treatment of the inter-lamellate longitudinal cracks*

It was thus decided to simply weld shot the delamination cracks revealed by welding the additional sloping plates. A fillet weld of minimal thickness ( $\leq 5\text{ mm}$ ) was deposited in the longitudinal direction along the cracks on the edge of the bottom flanges. These fillet welds treat each zone detected by US investigation with a margin excess-length of 300 mm at each end of the cracks (Figure 11). In addition to its mechanical role, this closing of the interstice stops corrosion there by preventing any renewal of oxygen.

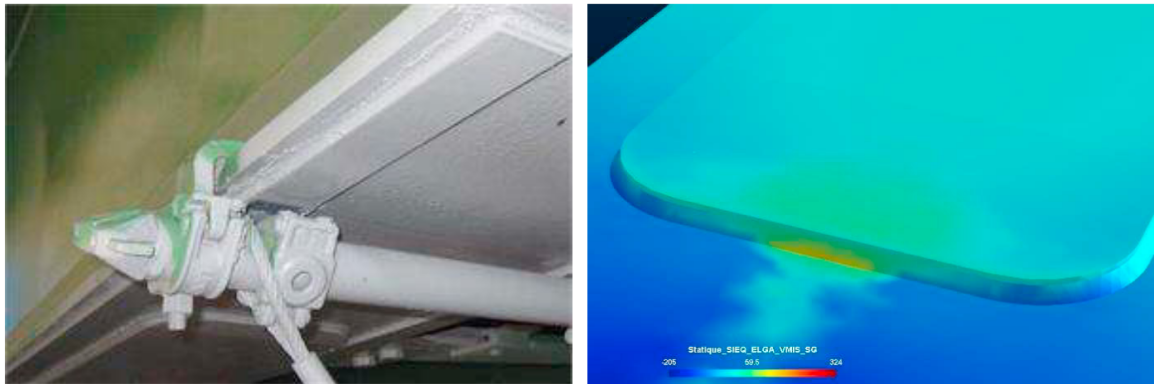
*A - View of the ends of the cover plates with the carbon fibers stripes**B - SLS Stress concentration at cover plates ends before reinforcements**Figure 12 : Geometry of the cover plates ends of the Dancourt bridges*

Figure 12 shows the geometry of these cover plates and the results of a recent first calculation of the stress concentration (von Mises criterium). The results of Figure 12-B are only qualitative then the effective notch stress method is required to evaluate the local stresses. In addition, this method was not available at Setra in 2008 when a decision had to be taken regarding the Dancourt bridges.

to retardation of the crack initiation phase [16]. But TIG dressing cannot be recommended as the best treatment at the centre of the cover plates ends (see figure 12-B) since Fisher et al. [19] noted that improvement of cover plate by TIG dressing at the weld toe is sufficient in a few instances to force the crack to originate from the weld root. In addition, no cracks were detected at Dancourt at cover-plate ends that needed to be repaired by TIG dressing at weld toe.

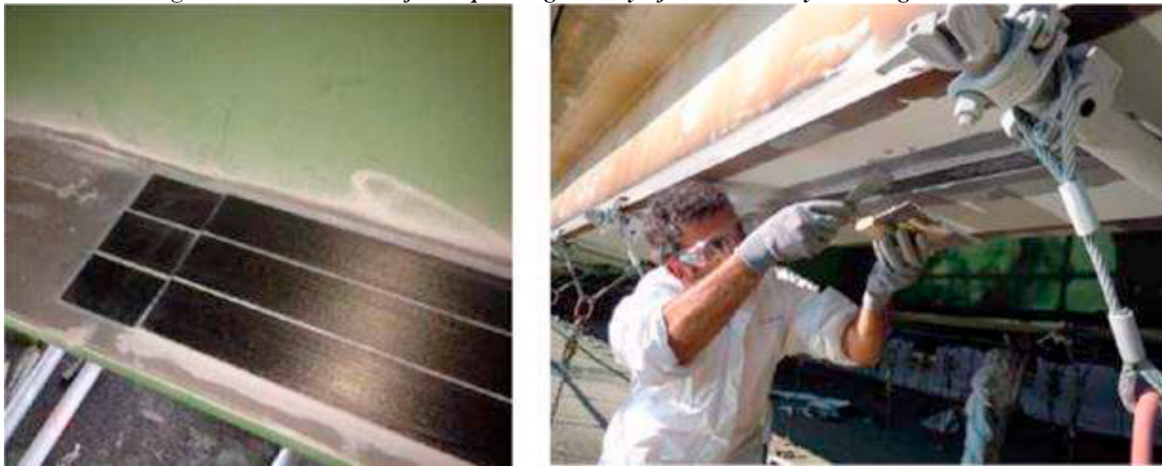
Figure 15 : Implementation of the carbon plates

The reinforcements by carbon fibers with the optimal geometry was only possible for the second bridge. The Figure 15 shows the implementation for the first bridge. This implementation was controlled by the Laboratories of Ponts et Chaussées of Strasbourg and Autun.

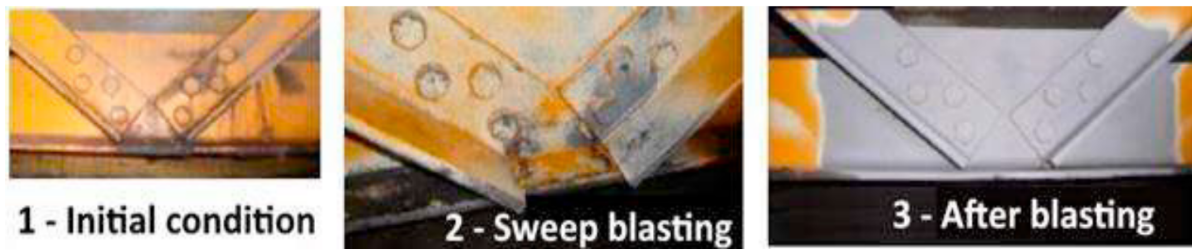
Figure 17 shows the steps for the re-painting work. The quality of the technical proposals of the companies (containment, ventilation, organization of the dressing rooms for the workers, measurements of control) belonged to the criteria of judgment of the offers. Abrasive and UHP-water were the two possible techniques for sweep blasting.

Figure 17 : *Intermediate transverse beam at different blasting levels*

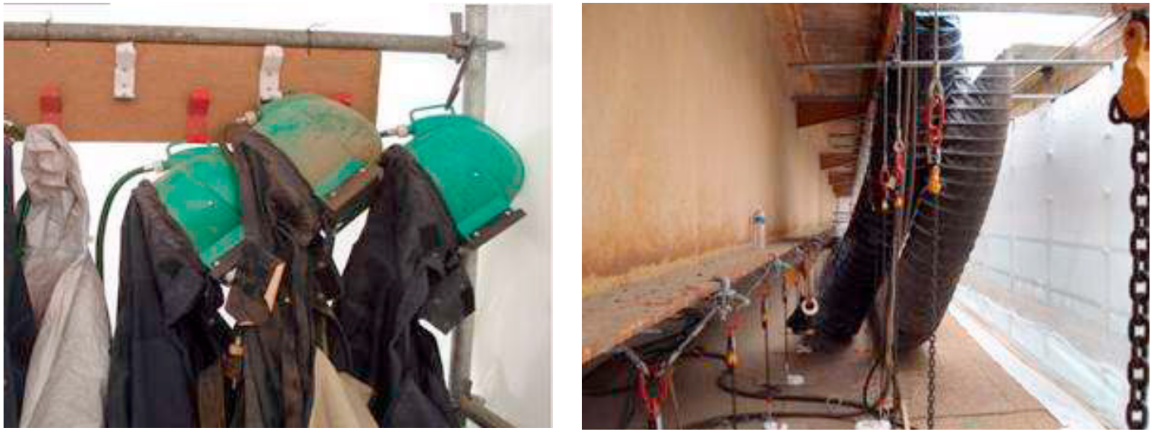
- ✓ well dimensioned systems of aspiration and ventilation are an essential point to answer the hygiene and safety priority concern to avoid any intoxication with lead,
- ✓ wearing of masks on building site,
- ✓ passages by a sluice of decontamination and a dressing room at the occasion of all types of pause, for toilets or meal in particular. It is easier to write down on the contract-paper this last point, than to ensure its respect in practice.

*Figure 18: Dressing room and masks for hygiene and safety  
Containment of the working site to protect the environment, and strong vacuum cleaners.*
