Goel, S., Bourreau, K., Olsson, J. et al (2020). Can Appropriate Thermal Post-Treatment Make Defect Content in as-Built Electron Beam Additively Manufactured Alloy 718 Irrelevant?. *Materials*, 13(3). <http://dx.doi.org/10.3390/ma13030536>

# Can Appropriate Thermal Post-Treatment Make Defect Content in as-Built Electron Beam Additively Manufactured Alloy 718 Irrelevant?

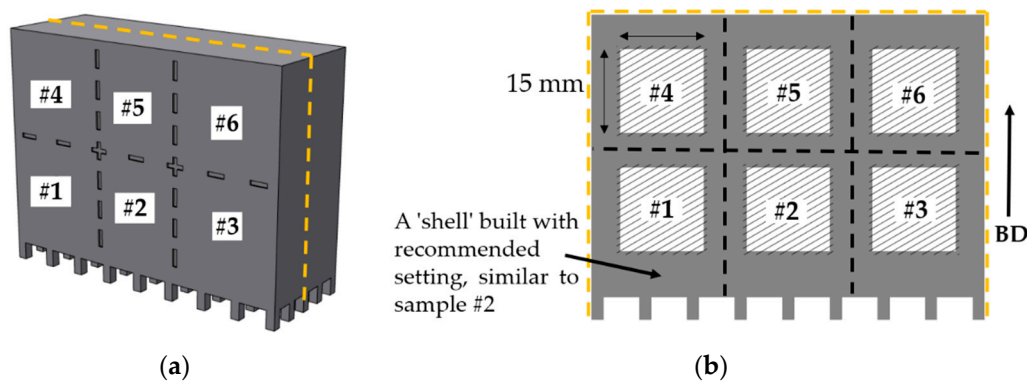
**Figure 1.** Schematic of the CAD model of one of multiple identical blocks comprising the electron beam melting (EBM) build (a), and cross-section view of the block revealing the cubes (marked by hatched lines) processed with different line spacing (b). The arrow on the right shows the build direction, BD.

Samples were EBM built with different defect contents by varying LS to assess their response to identical post-treatments, particularly HIPing. Plasma atomized Alloy 718 powder (AP&C, Québec, Canada) [5] recycled ~20 times was used. Six different samples ( $15 \times 15 \times 15 \text{ mm}^3$ ) (Figure 1), henceforth referred to as AB#1 to AB#6, were built using EBM (Model A2X, Arcam AB, Gothenburg, Sweden) with varying LS corresponding to different processing speeds (expressed as relative melting time and relative melted area per unit time by normalizing with the “standard” values), as summarized in Table 1. All the samples were melted by a snake hatch method during which the electron beam was moved in a back-and-forth raster scan pattern [18]. All the other process parameters were kept constant as per the EBM process theme version 4.2.205, and some of the key process parameters associated with this theme are listed in Table 2. It is worth mentioning that the parameter speed function dynamically adjusts the electron beam scan speed depending on the scan length [22].

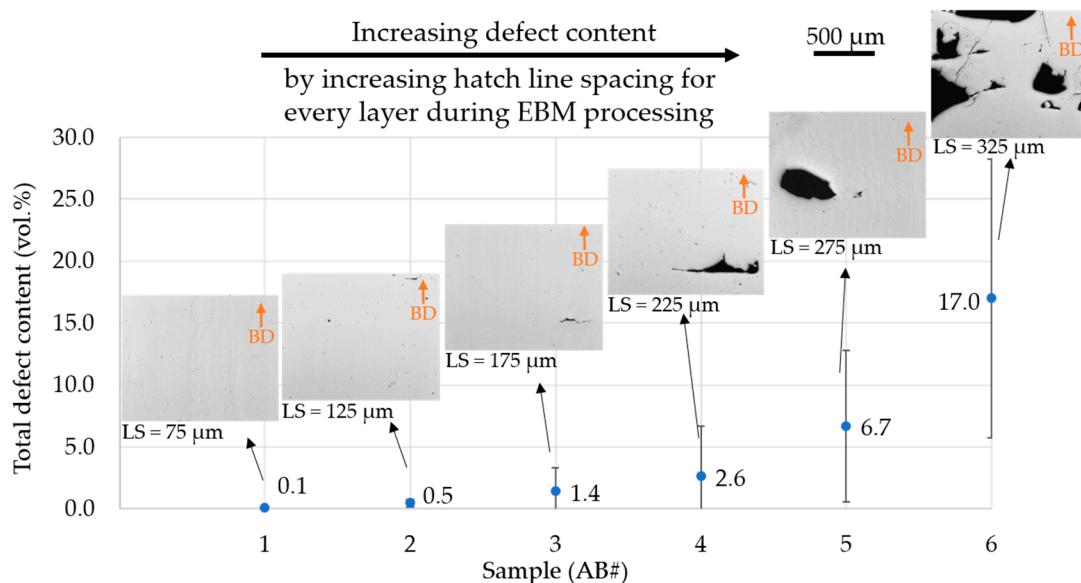
**Figure 2.** Defect content in as-built samples intentionally built with varied hatch line spacing (LS). The size and amount of defects are visualized in the insets. Arrows in the inset indicate build direction.

The as-built microstructures of samples processed with varying LS corresponding to different melting speeds (Table 1) are depicted in Figure 2. Increase in LS above the “recommended” value resulted in a rise in the defect content, as shown in Figure 2. The defect contents stated represent the sum of all types of defects observed in the as-built samples, i.e., gas and shrinkage porosity, and lack of fusion. Incidentally, these defects were also present in samples produced at the recommended LS = 125  $\mu\text{m}$  (AB#2) as well as at lower LS = 75  $\mu\text{m}$  (AB#1). Samples intentionally produced with higher LS exhibited defect contents up to 17%, as shown in Figure 2 and also visualized in accompanying micrographs. In a word, a systematic increase in line offset (processing speed) from 75 to 325  $\mu\text{m}$  resulted in an increased defect content ranging from 0.1% to 17% in the investigated samples. It is worth mentioning that large defects such as those observed in samples AB#5 (LS = 275  $\mu\text{m}$ ) and AB#6 (LS = 325  $\mu\text{m}$ ) are not typical of an EBM built even with not fully optimized processing conditions [23]. However, these samples were produced for the present ‘proof of concept’ investigation regarding the extent of defect closure enabled through HIPing.

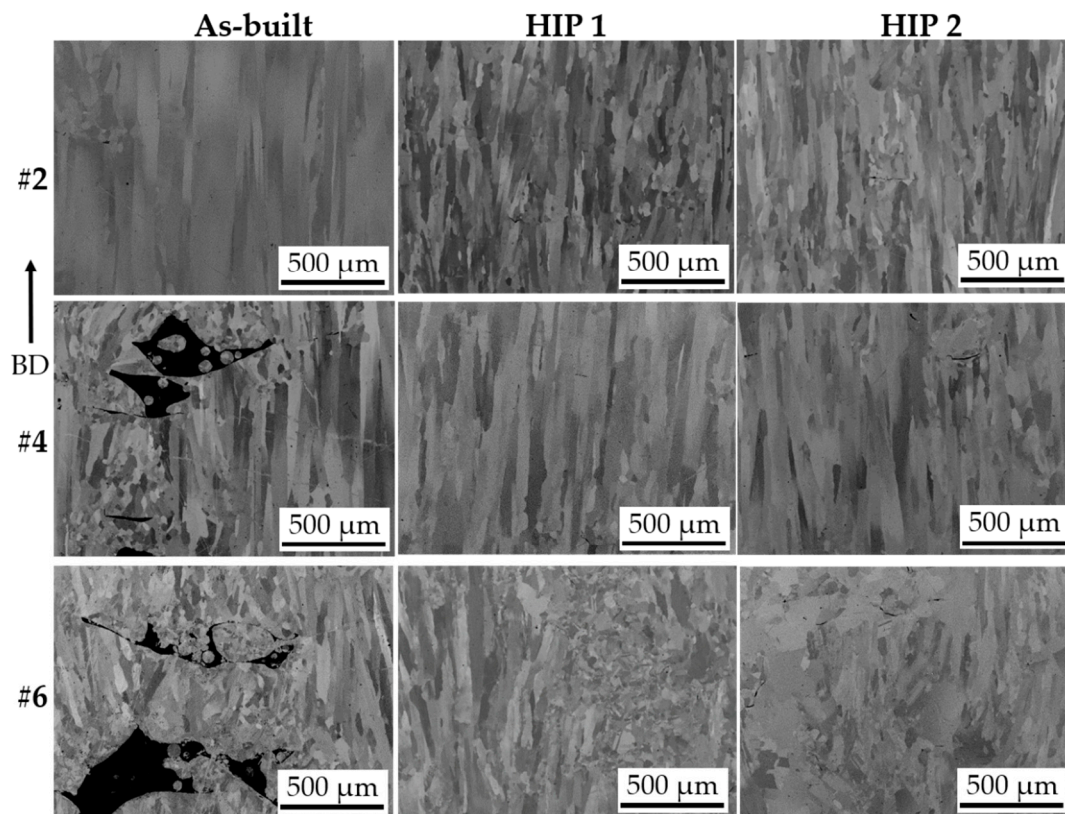
**Figure 3.** SEM micrographs showing defects in samples #2 (LS = 125  $\mu\text{m}$ ), #4 (LS = 225  $\mu\text{m}$ ), and #6 (LS = 325  $\mu\text{m}$ ) in as-built and HIP'ed conditions. The arrow indicates the build direction.

Samples with distinct defect contents, i.e., AB#2, AB#4, and AB#6 were subjected to two HIPing treatments to investigate the efficacy of defect closure. The defect contents in as-built samples AB#2, AB#4, and AB#6 (corresponding to LS = 125, 225, and 325  $\mu\text{m}$ , respectively) were 0.5%, 2.6%, and 17%, respectively. After both the HIPing treatments, the defect content in all samples was significantly reduced, regardless of the original extent, as summarized in Table 4. Moreover, the difference in the extent of defect closure accomplished at 1120  $^{\circ}\text{C}$  (HIP1) and 1185  $^{\circ}\text{C}$  (HIP2) was not significant. The considerable densification of samples achieved by HIPing is also visualized from the microstructures in Figure 3. Furthermore, the small amount of remnant defects in all HIP'ed samples discussed were found to be typically associated with the presence of Al-rich oxide, which can inhibit complete defect closure. This is clearly evident from the representative EDS results given in Figure 4. It is worth mentioning that Al-rich oxides are thermodynamically very stable and not removed by HIPing, as previously observed in HIP'ed EBM Alloy 718 [24].

Such extensive and efficient reduction in the defect content by orders of magnitude (as evident from Table 4 and Figure 3) *prima facie* provides an opportunity to also potentially increase productivity—at least to some reasonable extent—during EBM processing. It is worth mentioning that the melting step typically comprises ~35% (the exact value depends on the build design [22]) of the layer heating time (preheat + melt + post-heat), which corresponds to 15% of the total layer processing time (also including lowering of build platform + powder raking) spent during the EBM process. Therefore, decreasing the melting time (by increasing the LS, as done in this study) would also have a corresponding effect on the overall EBM processing time.

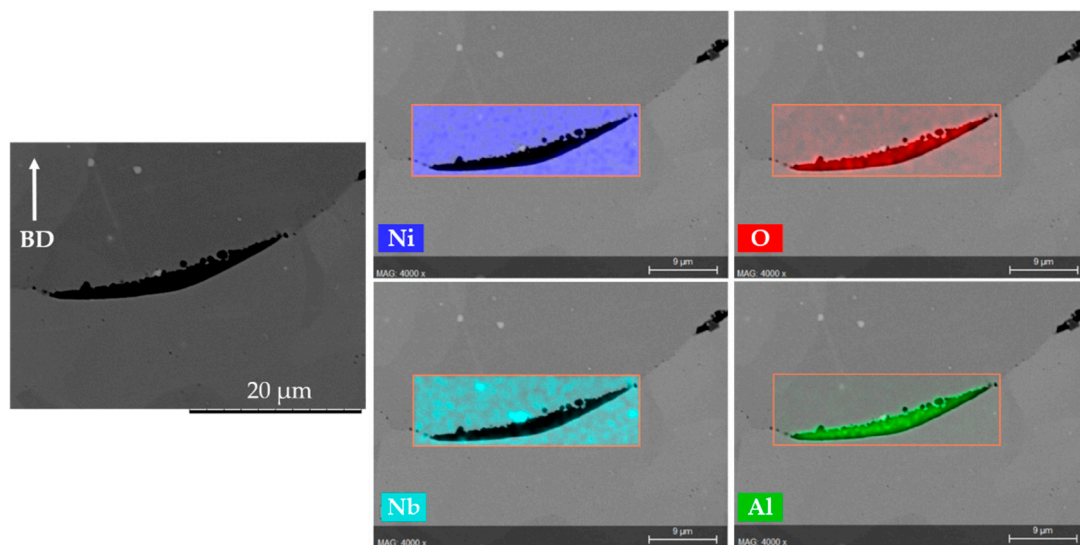
**Figure 4.** Representative EDS analysis showing inclusions typically associated with many remnant defects in sample #4 (LS = 225  $\mu\text{m}$ ) after HIP1. The arrow indicates the build direction.

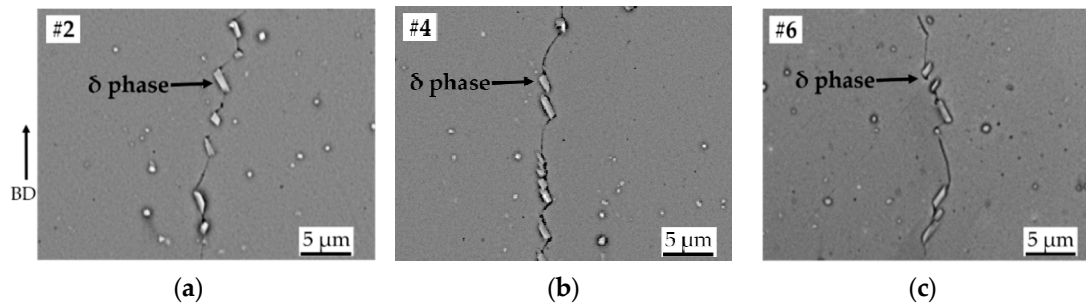
**Figure 5.** SEM micrographs of HIP1 + STA samples (a) LS = 125  $\mu\text{m}$ , (b) LS = 225  $\mu\text{m}$ , and (c) LS = 325  $\mu\text{m}$  showing similar distribution of the  $\delta$  phase. The arrow indicates the build direction.

Since the solution treatment was carried out at 954 °C, all the HIP1 + STA samples #2, #4, and #6 (corresponding to LS = 125, 225, and 325  $\mu\text{m}$ , respectively) exhibited a virtually similar distribution of grain boundary  $\delta$  phase, as shown in Figure 5a–c. This is in accordance with the reported time–temperature–transformation diagram of Alloy 718 [29], and has also been previously

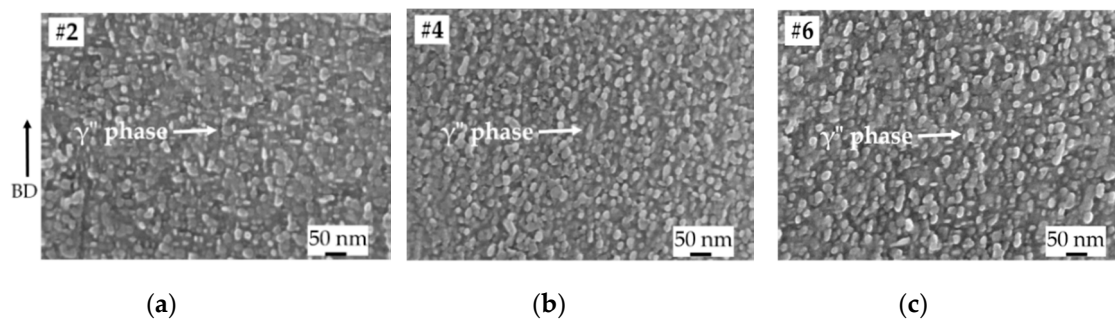
**Figure 6.** SEM micrographs of HIP1 + STA samples (a) LS = 125  $\mu\text{m}$ , (b) LS = 225  $\mu\text{m}$ , and (c) LS = 325  $\mu\text{m}$  showing similar distribution of the  $\gamma''$  phase. The arrow indicates the build direction.

observed in solution-treated EBM Alloy 718 that was not subjected to prior HIPing [10]. The effect of aging treatment can be readily seen from the similar distribution of  $\gamma''$  phase as shown in Figure 6a–c. These microstructural similarities in the three samples (HIP1 + STA #2, #4, #6) were also reflected in the microhardness results, as described below.

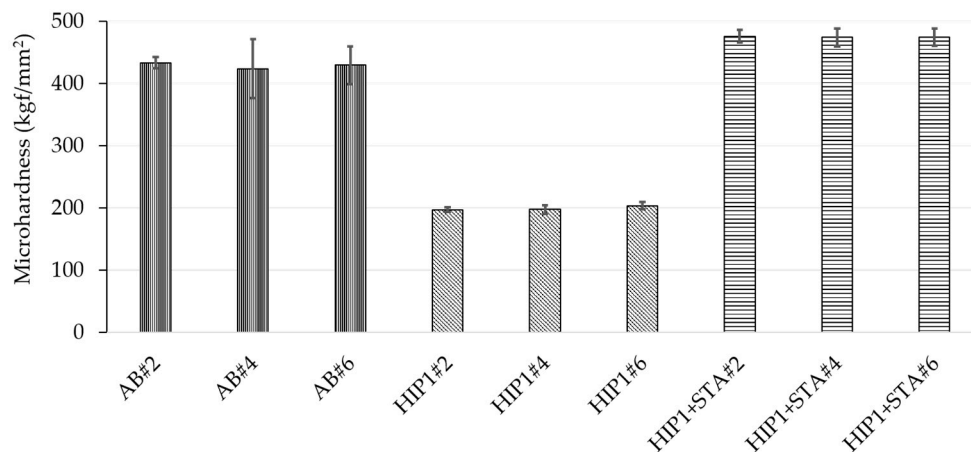
**Figure 7.** Microhardness values of the as-built and post-treated samples #2 (LS = 125  $\mu\text{m}$ ), #4 (LS = 225  $\mu\text{m}$ ), #6 (LS = 325  $\mu\text{m}$ ).

The average microhardness values of the as-built and post-treated samples, determined as previously described in the experimental procedure, are shown in Figure 7. It can be seen that, although the defect contents in the as-built samples were vastly different, they exhibit similar hardness values of  $\sim 430 \text{ kgf/mm}^2$ . This can be explained by the similarity in local melting conditions for the three as-built specimens, as the electron beam parameters were unchanged, and only the line spacing was varied. This contrasts a previous reported study by Lee et al. [23], where hardness was observed to vary ( $405\text{--}450 \text{ kgf/mm}^2$ ) with defect content ( $4.5\%\text{--}0.5\%$ ) of the EBM Alloy 718 samples. In the study by Lee et al. the local melting conditions were varied between the different specimens by changing the focus offset, thereby influencing energy density. The HIP1 treatment caused a reduction in the hardness of all the samples to nearly identical values of  $\sim 200 \text{ kgf/mm}^2$ . This is consistent with the previous observations on EBM and LPBF Alloy 718 [30,31]. After HIP1 + STA, all the samples exhibited similar hardness values ( $\sim 475 \text{ kgf/mm}^2$ ), which were higher than in the as-built condition. This value is close to the reported peak hardness ( $\sim 490 \text{ kgf/mm}^2$ ) of Alloy 718 [10]. Previous studies on EBM Alloy 718 have also reported an increase in hardness in the as-built condition from  $410 \text{ kgf/mm}^2$  to  $470 \text{ kgf/mm}^2$  after aging [32–34]. Thus, the foregoing results amply reveal that, regardless of the vastly different defect content in the as-built condition, the final post-treated condition exhibits a very similar density (Figure 3), phase constitution in terms of  $\delta$  phase and  $\gamma''$  phase distribution (Figures 5 and 6), as well as microhardness values (Figure 7).
