Bond of naturally corroded, plain reinforcing bars in concrete

Robuschi, S., Sumearll, J., Fernandez, I. et al (2021). Bond of naturally corroded, plain reinforcing bars in concrete. *Structure and Infrastructure Engineering*, 17(6): 792-808.
<http://dx.doi.org/10.1080/15732479.2020.1768273>

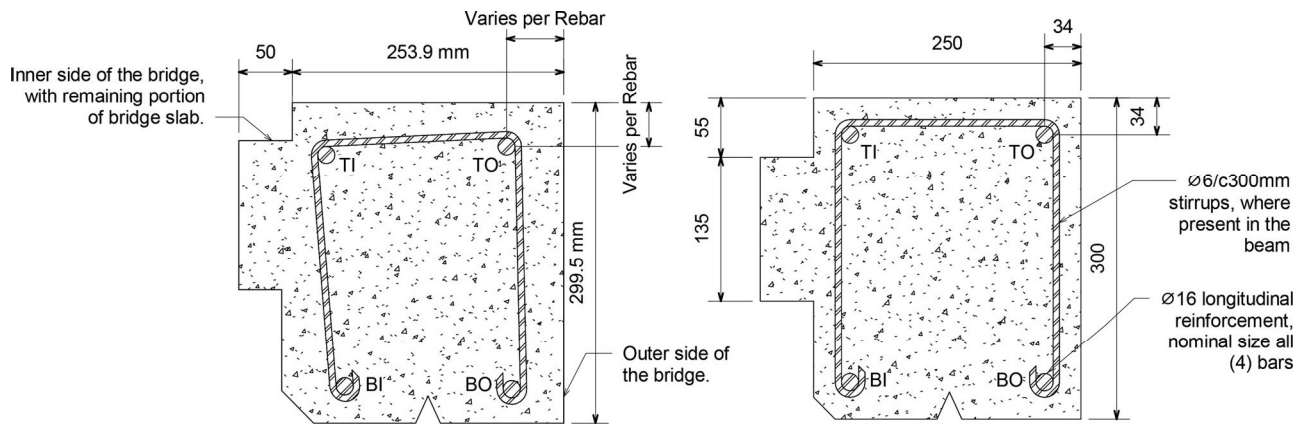
Figure 1. Drafted reference of RC specimen (dimensions in mm). The left image shows width, height, and bar positioning based on average measurements of all specimens. The right image shows nominal dimensions from original drawings of the bridge. Bars are labelled as follows: TO = top-outer, TI = top-inner, BO = bottom-outer, and BI = bottom-inner. The remaining part of cut-off bridge slab is clearly visible on the left.

In order to track the original position of the bars on the bridge, a naming convention was used: Top-Outside (TO), Top-Inside (TI), Bottom-Outside (BO), and Bottom-Inside

(BI) (see Figure 1). ‘Top’ and ‘bottom’ refer to top-cast and bottom-cast bars, and ‘outside’ and ‘inside’ denote the exterior and interior sides of the edge beams as positioned on the bridge, respectively. The specimens were inspected for external damage before testing. Inspections considered both sides of each specimen and tracked information relevant to individual bars: concrete dimensions, concrete cover, and visible cracks (see Figure 3). Each bar was classified based on the extent of visible deterioration of the concrete cover around the bar location. The ‘reference’ (R) state corresponds to the absence of visible damage. Moderate damage, i.e. cracking without loss of the concrete cover, is defined a ‘cracked’ state (C). Substantial damage, i.e. cracking and spalling of the concrete cover, is defined a ‘spalled’ state (S). Figure 4 shows a tabulation of the dataset sorted by bar position, section thickness, minimum concrete cover, presence of a stirrup and classification. Note that measurements of the minimum concrete cover were conducted on the specimens as received after the demolition of the bridge. A concrete cover equal to zero indicates spalling of the concrete and does not represent the minimum concrete cover in the original design of the structure.

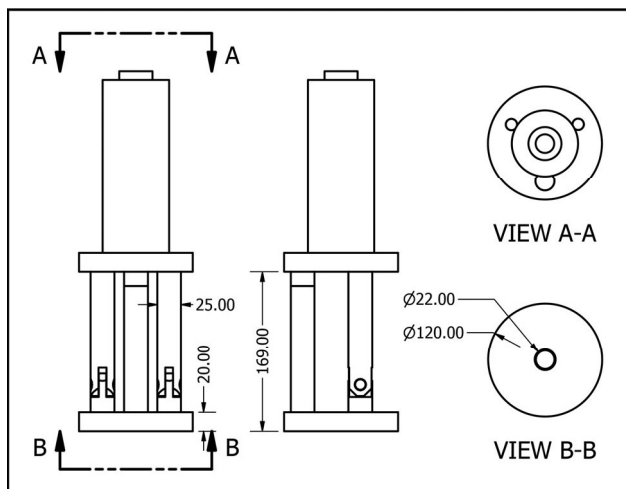
Figure 6. Pullout rig (dimensions in mm), designed by Laboratory Engineer Sebastian Almfeldt.

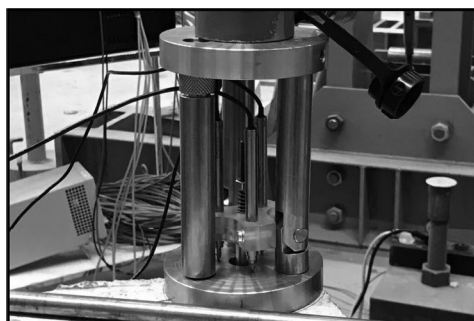
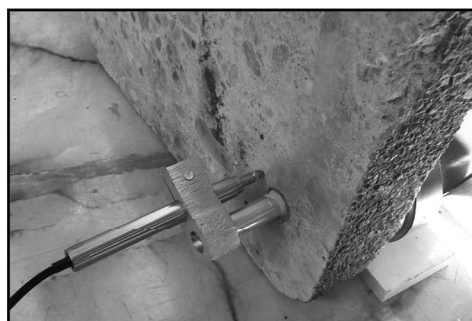
(a) Active slip displacement transducers

(b) Passive slip displacement transducer

Figure 7. Photographs of pull-out rig and slip measurement devices. Note that specimen (b) is tilted with respect to normal testing position to better show the measurement device.

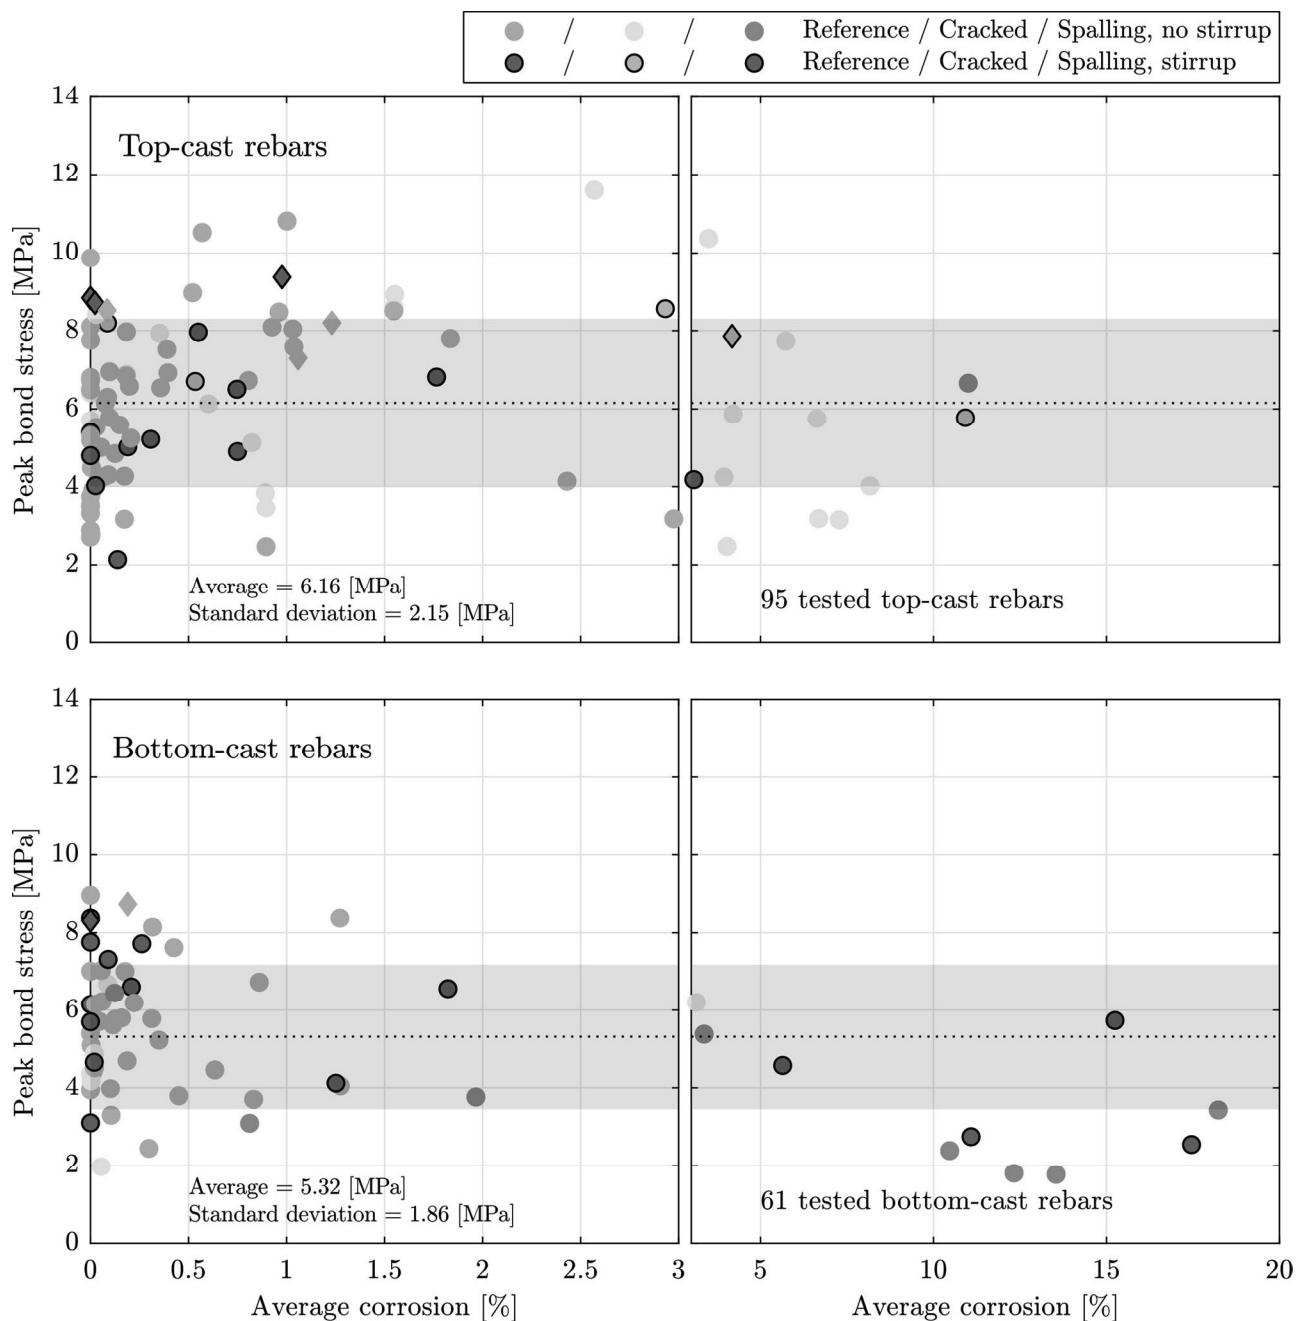
Figure 11. Peak bond stress vs. average corrosion across entire dataset, divided by casting position. Deterioration classification is designated by colour. Dashed black lines mark average value of peak bond stress, and grey colour patches indicate plus/minus one standard deviation. Specimens which exceeded rig capacity are marked with diamond markers.

In Figure 11, the average bond stress at peak of each bar is plotted against the average corrosion level for all tested specimens. On the x-axis, corrosion is presented on two different scales: (from 0 to 3% and from 3 to 20%). This was done to allow the reader to focus on the area with the highest concentration of data, namely, below 3% of corrosion, while still having a full overview of the dataset in the same figure. The grey shaded area corresponds to the average bond stress across the displayed dataset, and the corresponding standard deviation. Successful tests are included in the presented results, together with tests that exceeded the rig capacity, which are marked with a separate marker. Few tests, all 100 mm long, exceeded the rig capacity; possible causes were the overloading of the connecting rod or the yielding of the tested bar. The tests were included by assuming the peak bond stress equal to the maximum bond stress reached during testing.

In Figure 11, different behaviours and characteristics of bottom-cast and top-cast specimens are shown. For top-cast bars, the peak bond stress initially increases with increasing corrosion levels. Loss of bond capacity follows, in connection with the opening of cracks in the surrounding concrete. Bottom-cast bars, instead, show a constant decrease in bond capacity with increasing corrosion level. Spalling damage in the concrete surrounding the bars is already present at relatively low levels of corrosion. Uncorroded bars, however, present highly scattered results for both casting positions.

In Figure 11, spalled specimens are shown to maintain relatively high peak bond stresses. Such observation needs to take into account the absence of data on missing bars in the figure. Many bars had, in fact, approximately 0 MPa bond stress and fell off during test preparation as a result of severe spalling. These results were not included in the figure, but the presence of missing specimens is highlighted by the difference in the number of tested specimens between bottom-cast and top-cast bars (see Figure 4). In total, 32 of the 34 missing bottom-cast specimens were a consequence

of severe spalling. However, of the 20 bottom-cast specimens with a stirrup that were tested, 15 resulted in successful testing despite the presence of splitting cracks in the surrounding concrete (see Figure 11). Thus, the presence of a stirrup helped to maintain bond capacity in the presence of spalling of the concrete cover.
