Numerical assessment of bond-slip relationships for naturally corroded plain reinforcement bars in concrete beams

Yu, X., Robuschi, S., Fernandez, I. et al (2021). Numerical assessment of bond-slip relationships for naturally corroded plain reinforcement bars in concrete beams. *Engineering Structures*, 239. <http://dx.doi.org/10.1016/j.engstruct.2021.112309>

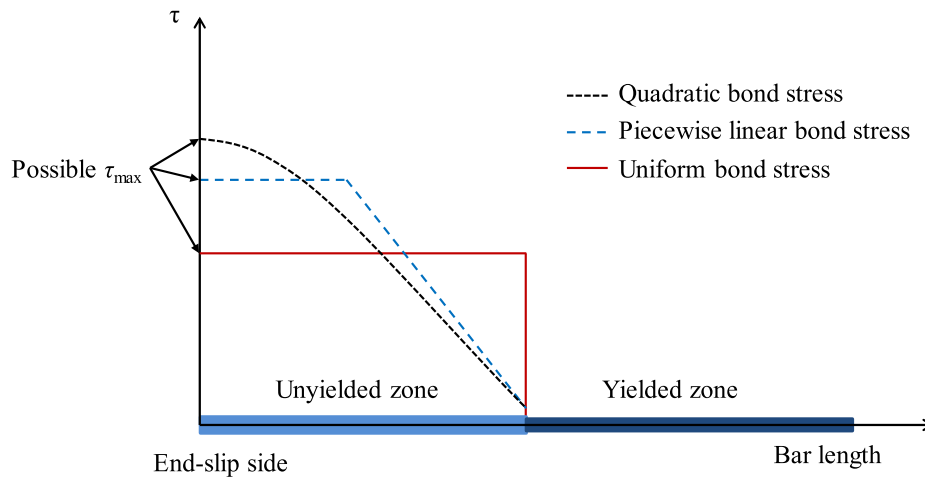
Fig. 12. Examples of different bond distributions along the unyielded zone, at the slip side before end-slip.

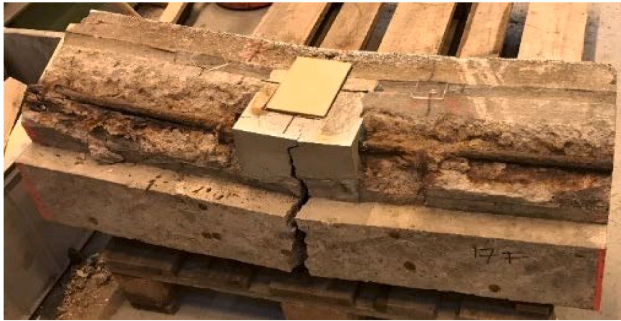
(a) Crack pattern in the outer side from DIC measurement

(b) FE crack pattern in the outer side

(c) Experimental crack pattern on the inner side, as measured.

(d) FE crack pattern on the inner side.

Fig. 14. Comparisons of crack patterns of beam 17F after loading ($\Delta_m = 23.3$ mm).

Fig. 14 shows the crack pattern in both the outer and inner sides of beam 17F, as recorded at the end of the test ($\Delta_m = 23.3$ mm). The crack pattern on the outer side of the beam was captured using digital image correlation (DIC), while that on the inner side was measured after testing. On the outer side, one major bending crack was located at

approximately mid-span, while a minor crack may be observed to have developed on the left side. Only one bending crack formed on the inner side. Good agreement was shown between the FE results and the observed crack pattern. The crack width was also in good agreement, as shown earlier in Figs. 8, 10 and 11. Note that the crack width compared in these figures corresponded to the crack width of the major bending crack, as measured by DIC on the outer side of the beam at reinforcement level. The values measured for the crack width were 31.5 mm (outer side) and 30.7 mm (inner side). The FE analysis results were similar to the experimental ones, at 31.2 mm (outer side) and 28.3 mm (inner side).

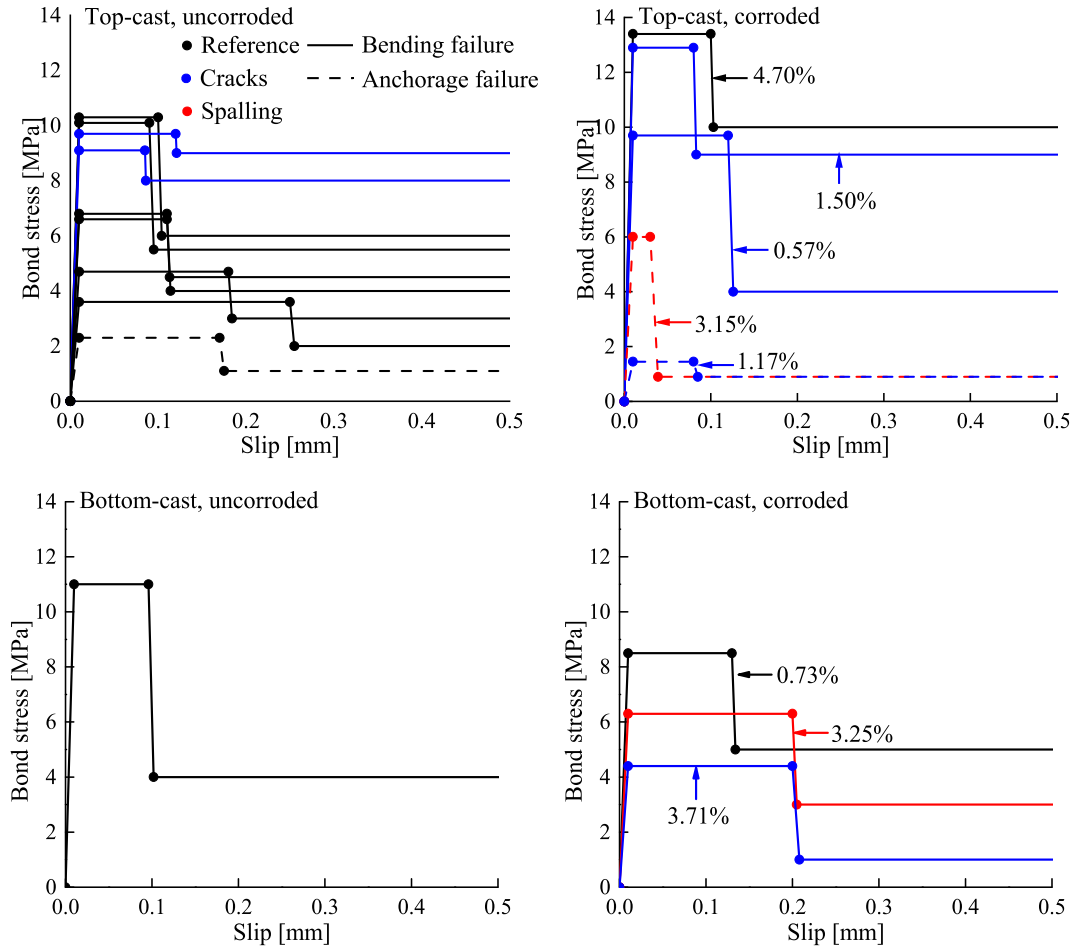
Fig. 19. Calibrated bond stress versus slip for unyielded zones in bars. All results are divided by casting positions and the presence of corrosion. The average corrosion level of 0.5% is used to distinguish between corroded and uncorroded bars. The damage level of each anchorage zone is displayed by colours. Bars with no yielded zone (which slipped before they reached yielding) are marked with a dashed line.
