Numerical assessment of bond-slip relationships for naturally corroded plain reinforcement bars in concrete beams

Yu, X., Robuschi, S., Fernandez, I. et al (2021). Numerical assessment of bond-slip relationships for naturally corroded plain reinforcement bars in concrete beams. *Engineering Structures*, 239. <http://dx.doi.org/10.1016/j.engstruct.2021.112309>

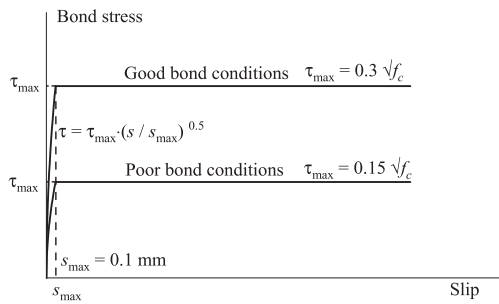
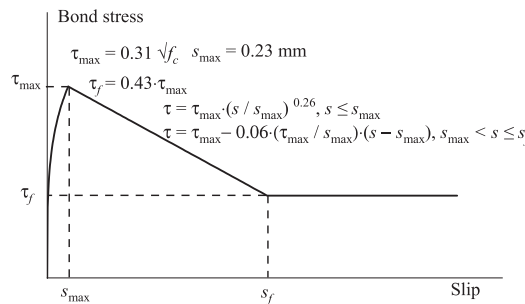
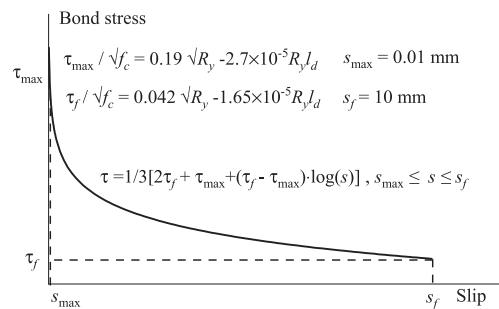
(a) CEB-FIP model code 2010 [34]

(b) Verderame et al. [38]

(c) Feldman and Bartlett [10]; R_y is the roughness of the bar and l_d the embedded length

Fig. 1. Bond-slip relationships for plain bars embedded in concrete.

A limited number of bond-slip relationship for plain bars can be found in codes and literature. In Fig. 1, three examples are presented. The bond-slip relationship for plain bars in Model Code 2010 [34] is

calculated as a function of the concrete compressive strength expressed in MPa. Good and poor bond conditions (depending on the placement and confinement of the bar) are distinguished, and a reduction factor of 0.5 is suggested for poor conditions. The bond-slip relationship is described by an ascending non-linear curve up to the maximum bond stress, followed by a constant branch. The slip corresponding to the maximum bond stress is constant and equal to 0.1 mm. Other bond models can be found in the literature for uncorroded plain bars, most commonly based on the results of pull-out tests. Verderame et al. [38] proposed a bond-slip model with as well an initial non-linear branch, but with a larger slip value at peak; 0.23 mm. The model introduces a linear descending branch for the after-peak behavior, followed by a plateau. The compressive strength of the concrete remains the main parameter for the definition of the maximum bond strength. A third bond-slip constitutive model worth mentioning is by Feldman and Bartlett [10]. Their empirical model differs from the others in the use of a non-linear descending branch and in including parameters in addition to the compressive strength for the calculation of the bond strength: the roughness of the bar (R_y) and the embedded length (l_d).

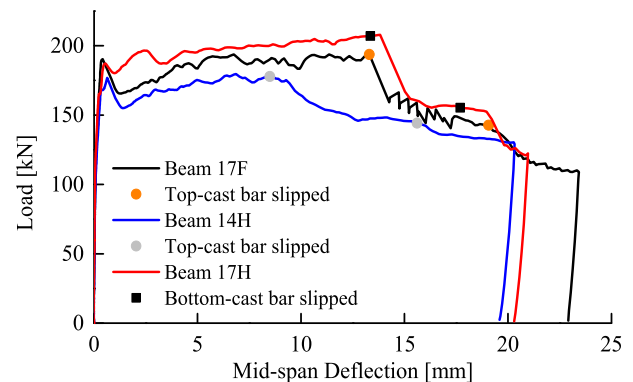
Fig. 3. Typical load versus mid-span deflection curves in beam tests, examples of 17F, 14H, and 17H.

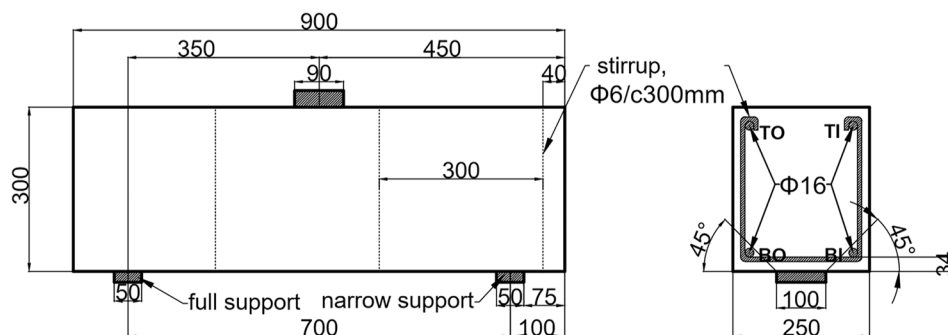
Fig. 2. Test set-up and view of narrow support in the beam tests [11]. The beam shown was tested as positioned on the bridge. Measurements in mm.

A three-point bending test set-up was used to bring the specimens to failure, see Fig. 2. The test configuration was designed to evaluate the influence of corrosion on the anchorage capacity of the tensile bars [24]. A narrow support (NS, 50 mm × 100 mm), was placed on one end of the beams, to minimise the confinement effect on the tensile reinforcements due to support pressure. A full support (FS, 50 mm × 250 mm), was used at the other end of the beam, to prevent the beam from tipping during loading. To assess the influence of the casting position of the bars (in other words, top or bottom-cast bars), the beams were positioned in two different configurations in the rig; as positioned on the bridge or upside down. For the present study, two beams were chosen as positioned on the bridge and seven upside-down. The reasons for testing more upside down beams were twofold; (1) because top-cast bars are known to have a weaker bond between concrete and steel and were therefore deemed more interesting and (2) because severe corrosion damage occurred, with bars falling off in the bottom inner position. Thus, there were not so many relevant results available for beams tested as positioned on the bridge.

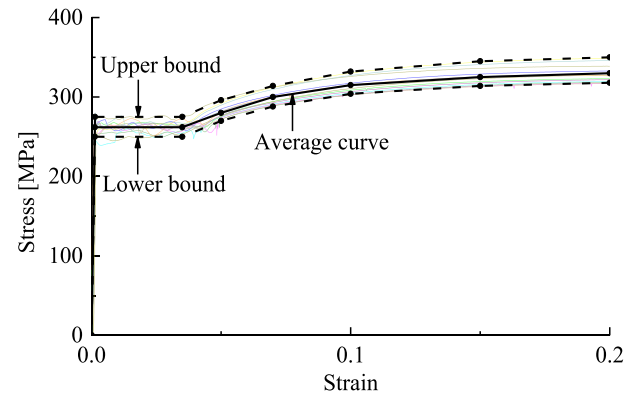
Fig. 5. Upper and lower bound of the stress–strain curves and average stress–strain curve used in the model.

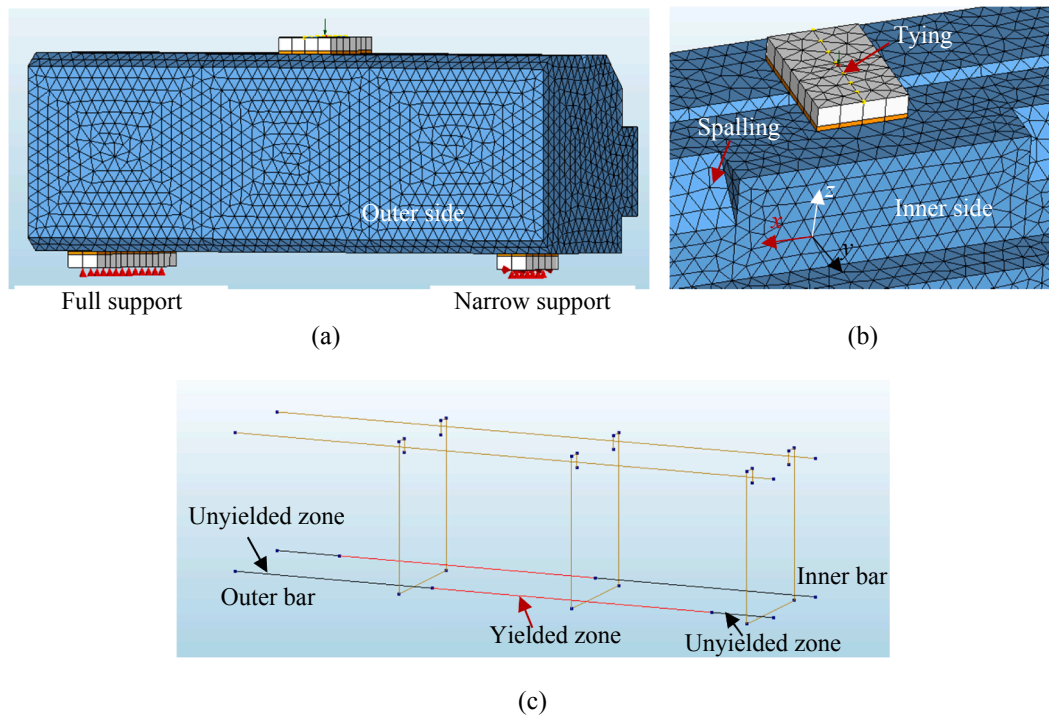
Fig. 6. Overview of an FE model for a tested beam: (a) 3D FE model with boundaries; (b) details at the loading plate, with the inclined surface corresponding to where the cover was spalled off; (c) layout of reinforcement bars.

The finite element software DIANA 10.2 [28] was used for the analyses. The geometry of each model was based on the specific measurements of the corresponding specimen. An overview of a 3D model is shown in Fig. 6. Spalling of concrete cover was included in the model by removing the concrete surrounding the bar at the spalled locations, as shown in Fig. 6b. Corrosion of the reinforcement was implemented as an average cross-sectional reduction of reinforcement area in the unyielded segments. Corrosion was not considered in the cross-section of the yielded segment of the reinforcement bar; due to the deformation induced by yielding, it was not possible to calculate the average corrosion level of the segments with 3D scanning data. The influence of corrosion damages on the yielding behaviour was however observed to

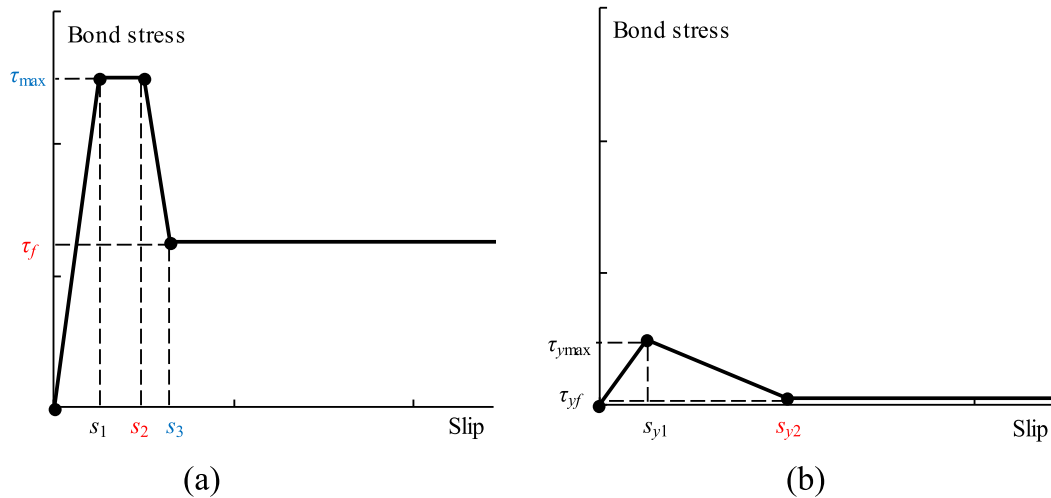
Fig. 7. Bond-slip relationships for (a) unyielded zones and (b) yielded zone. The parameters are divided into three sets: 1 (black), with the same values for all bars; 2 (blue) calculated manually and 3 (red) calibrated individually. (For interpretation of the references to colour in this figure legend, the reader is referred to the web version of this article.)

Fig. 7 describes the bond-slip relationships used for the yielded and unyielded zones. Such relationships were defined by nine different parameters; five for the unyielded bond-slip and four for the yielded one.

The nine parameters were divided into three sets (highlighted in different colours in Fig. 7), due to different roles in the calibration procedure (details in Section 4). The bond-slip relationship for the unyielded zones resembles the one proposed in CEB-FIP Mode Code 2010 [34], which is characterised by four branches; ascending, plateau, descending and residual. The following parameters define the transition between branches: τ_{\max} and τ_f are, respectively, maximum bond stress and residual bond stress for unyielded zones; s_1 and s_2 are the slips at the start and end of the maximum bond stress plateau. Finally, s_3 corresponds to the slip when residual bond stress is reached. However, the bond-slip relationship for the yielded zone consists of only three branches; ascending, descending and residual. Thus, no plateau is included for the yielded zone. The main parameters defining the transition between branches are $\tau_{y\max}$ and τ_{yf} (representing maximum and residual bond stresses respectively) and s_{y1} and s_{y2} (corresponding to the slip at maximum bond stress and slip at the beginning of the residual bond stress branch respectively). In addition, at the steel concrete interface the normal stiffness modulus was set to 2×10^{14} N/m³, while the shear stiffness modulus was calculated as τ_{\max}/s_1 , $\tau_{y\max}/s_{y1}$.

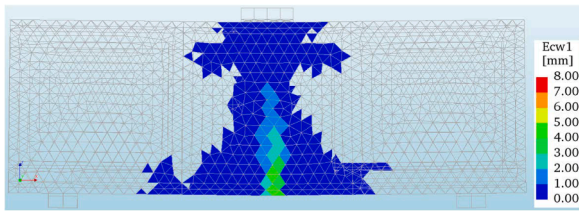
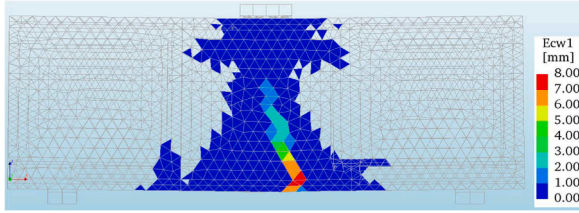
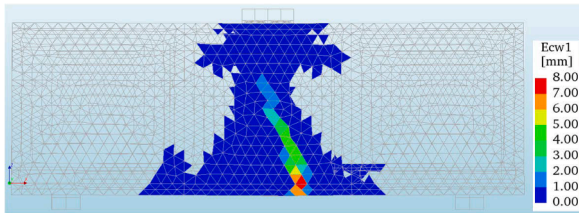
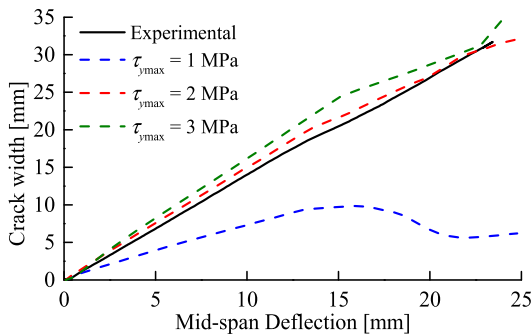
(a) $\tau_{y\max} = 1$ MPa. Contour plot of the crack width at $\Delta_m = 4.1$ mm.

(b) $\tau_{y\max} = 2$ MPa. Contour plot of the crack width at $\Delta_m = 4.1$ mm.

(c) $\tau_{y\max} = 3$ MPa. Contour plot of the crack width at $\Delta_m = 4.1$ mm.

(d) Crack opening versus mid-span deflection for various $\tau_{y\max}$ values. The crack width obtained from experimental results appears in black.**Fig. 8.** Crack behaviour in the FE analyses, with varying $\tau_{y\max}$.

Accordingly, three $\tau_{y\max}$ values between these boundaries were investigated in the parametric study; 1, 2 and 3 MPa. It was observed that $\tau_{y\max}$ largely affected crack width and mid-span deflection (Δ_m) at end-slip. Fig. 8 shows the crack pattern and crack width in the various analyses. As may be observed in Fig. 8d, the results for $\tau_{y\max}$ equal to 2 or 3 MPa showed good agreement for crack width, while a value of 1 MPa underestimated it. Further, in Table 3, it may be seen that $\tau_{y\max}$ equal to 1 or 2 MPa gave reasonable values for the mid-span deflection at end-slip, while $\tau_{y\max}$ equal to 3 MPa did not. Accordingly, $\tau_{y\max}$ at 2 MPa was chosen, as this value gave the best agreement for both crack width and mid-span deflection at end-slip.

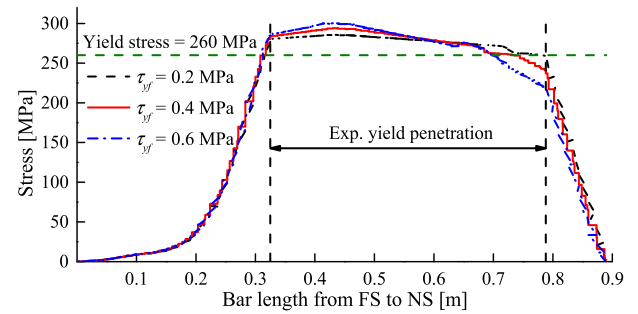
**Fig. 9.** Bar stress distributions at end-slip ($\Delta_m = 19.2$ mm) in the analyses of $\tau_{yf} = 0.2$.

The tensile stress distribution along the bar was also affected by the chosen τ_{yf} value. Fig. 9 describes the stress distributions of the bar at a mid-span deflection (Δ_m) of 19.2 mm (when the bar started slipping on the side with the narrow support) for different τ_{yf} values. From the results, it was concluded that τ_{yf} equal to 0.2 MPa produced better agreement in both yield penetration and stress distribution. High τ_{yf}

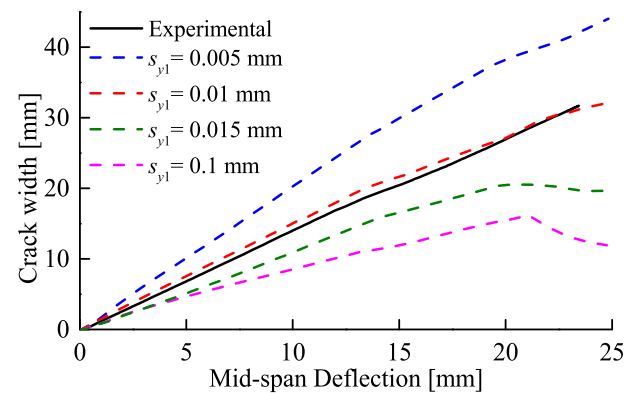
**Fig. 10.** Measured crack width compared to crack width output of the beam models, for different s_{y1} values. All results are plotted against mid-span deflection.

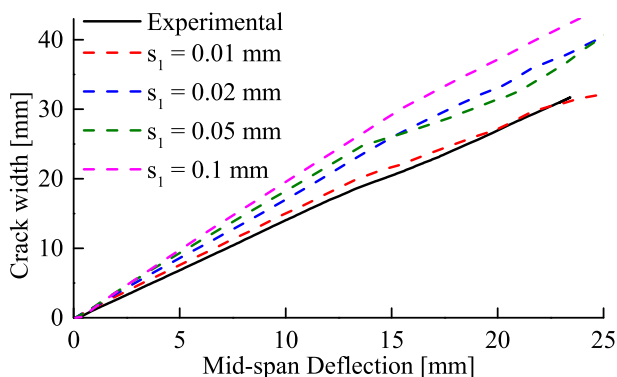
Fig. 11. The measured crack width is compared to the crack width in the analyses with different s_1 values. All results are plotted against mid-span deflection.

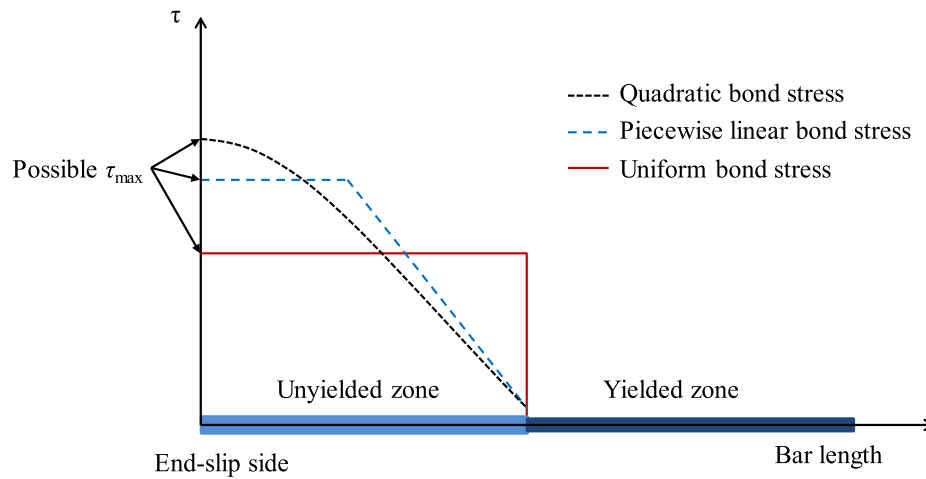
Fig. 12. Examples of different bond distributions along the unyielded zone, at the slip side before end-slip.

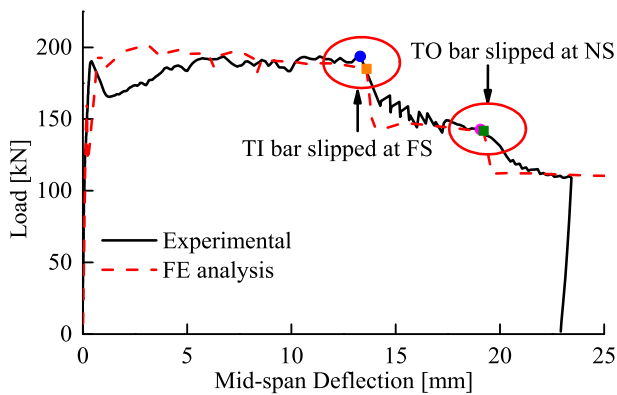
Fig. 13. Comparison of load versus mid-span deflection response for beam 17F; experimental and calibrated FE analysis results.

The load versus mid-span deflection from testing and FE analyses of beam 17F is shown in Fig. 13. In both test and analysis, the beam behaviour was governed by the appearance of a bending crack at mid-span followed by yielding of the tensile reinforcement bars. Thereafter, the applied load remained approximately constant, up to a mid-span deflection of 13.3 mm in testing and 13.6 mm in FE analysis (when the top inner (TI) bar at the full support (FS) side slipped). At a deflection of 19.1 mm (test) and 19.2 mm (FE analysis), the top outer (TO) bar at the narrow support (NS) also slipped. Note that the bars are named based on their original position on the bridge and that beam 17F was tested upside down. As may be seen in Fig. 13, the agreement between the analysis and the experiment is very good. The model was able to capture the overall beam response during all stages, including cracking, maximum load, remaining load and deflection when end-slip of the various bars occurred.

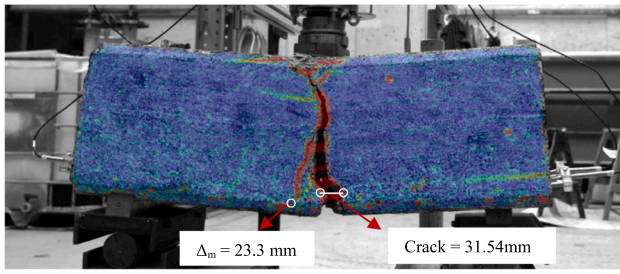
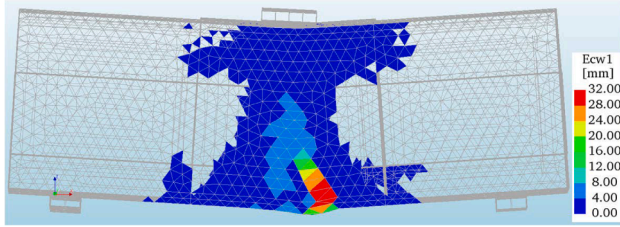
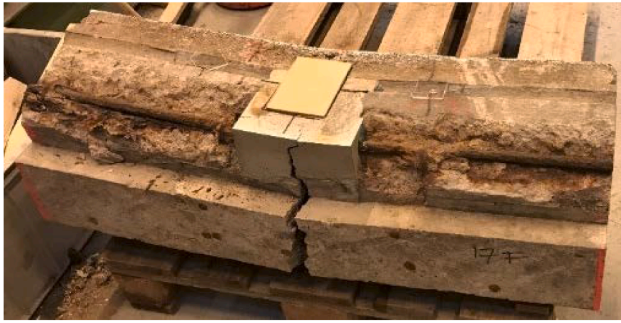
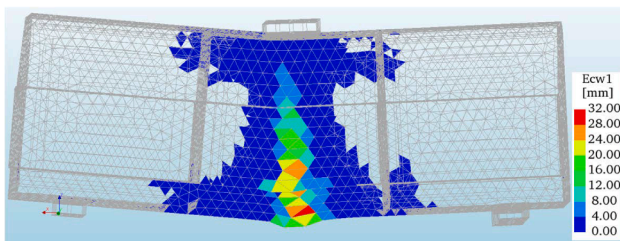
(a) Crack pattern in the outer side from DIC measurement

(b) FE crack pattern in the outer side

(c) Experimental crack pattern on the inner side, as measured.

(d) FE crack pattern on the inner side.

Fig. 14. Comparisons of crack patterns of beam 17F after loading ($\Delta_m = 23.3$ mm).

Fig. 14 shows the crack pattern in both the outer and inner sides of beam 17F, as recorded at the end of the test ($\Delta_m = 23.3$ mm). The crack pattern on the outer side of the beam was captured using digital image correlation (DIC), while that on the inner side was measured after testing. On the outer side, one major bending crack was located at

approximately mid-span, while a minor crack may be observed to have developed on the left side. Only one bending crack formed on the inner side. Good agreement was shown between the FE results and the observed crack pattern. The crack width was also in good agreement, as shown earlier in Figs. 8, 10 and 11. Note that the crack width compared in these figures corresponded to the crack width of the major bending crack, as measured by DIC on the outer side of the beam at reinforcement level. The values measured for the crack width were 31.5 mm (outer side) and 30.7 mm (inner side). The FE analysis results were similar to the experimental ones, at 31.2 mm (outer side) and 28.3 mm (inner side).

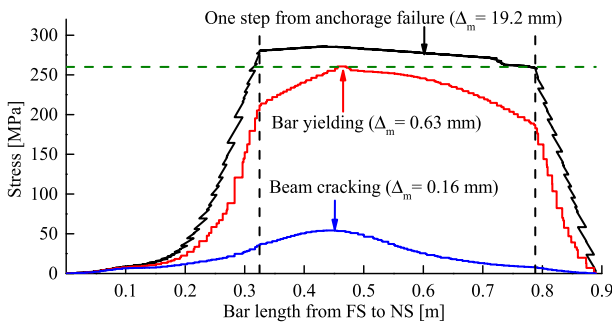
**Fig. 15.** Variations of the stresses in the bar (TO) along the bar length. The dashed black lines mark the positions of the yield penetration in the experiment. The dashed green line represents the yield stress of the bar. (For interpretation of the references to colour in this figure legend, the reader is referred to the web version of this article.)

Tensile stress, bond stress and slip along the length of the studied bar at three different loading stages (cracking, bar yielding and failure) are shown in Figs. 15 and 16. The yield penetration in the FE analyses increased from the onset of yielding until slip occurred. At this point, the yield penetration in the analyses was in good agreement with the experimental measurements of length and position.

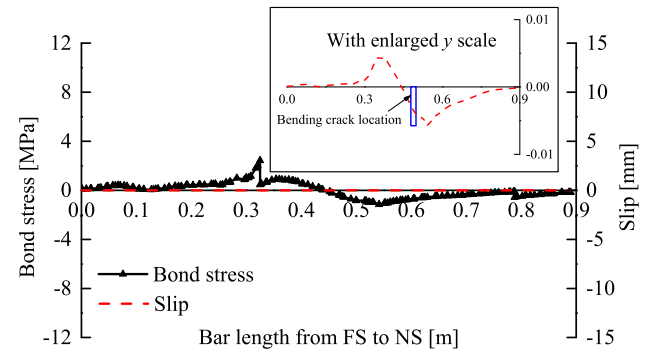
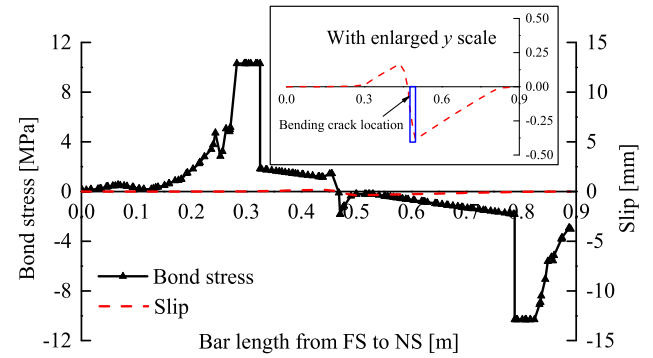
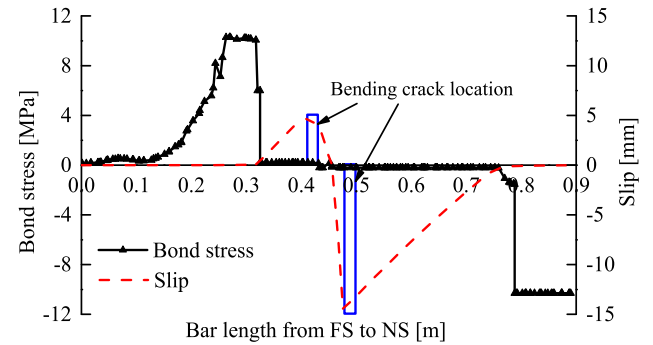
(a) At cracking ($\Delta_m = 0.16$ mm).

(b) At yielding ($\Delta_m = 0.63$ mm).

(c) Just before end-slip occurred ($\Delta_m = 19.2$ mm).**Fig. 16.** Variations in bond stress and slip along TO bar in the analysis of beam 17F.

The changes in bond behaviour along the length of the bar aligned well with the changes in its tensile stress distribution at the various loading points. At cracking, good bond conditions allowed for transfer of stresses between the reinforcement and its surrounding concrete. Thus, the stress in the bar was symmetrical, decreasing with the distance from the centre of the bar (Fig. 15) and following the bending moment distribution. The bond stress did not reach the maximum bond stress in either the yielded, $\tau_{y\max}$, or unyielded, τ_{\max} , zones. The opening of the

bending crack is clearly visible in Fig. 16a, as characterised by an initial bar slip at the crack location.

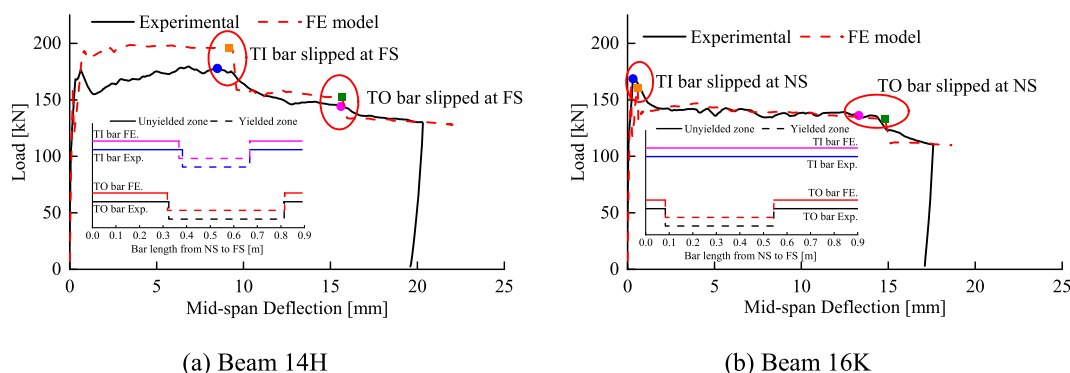
Fig. 17. Comparisons between FE analyses and experimental results for two of the analysed beams.

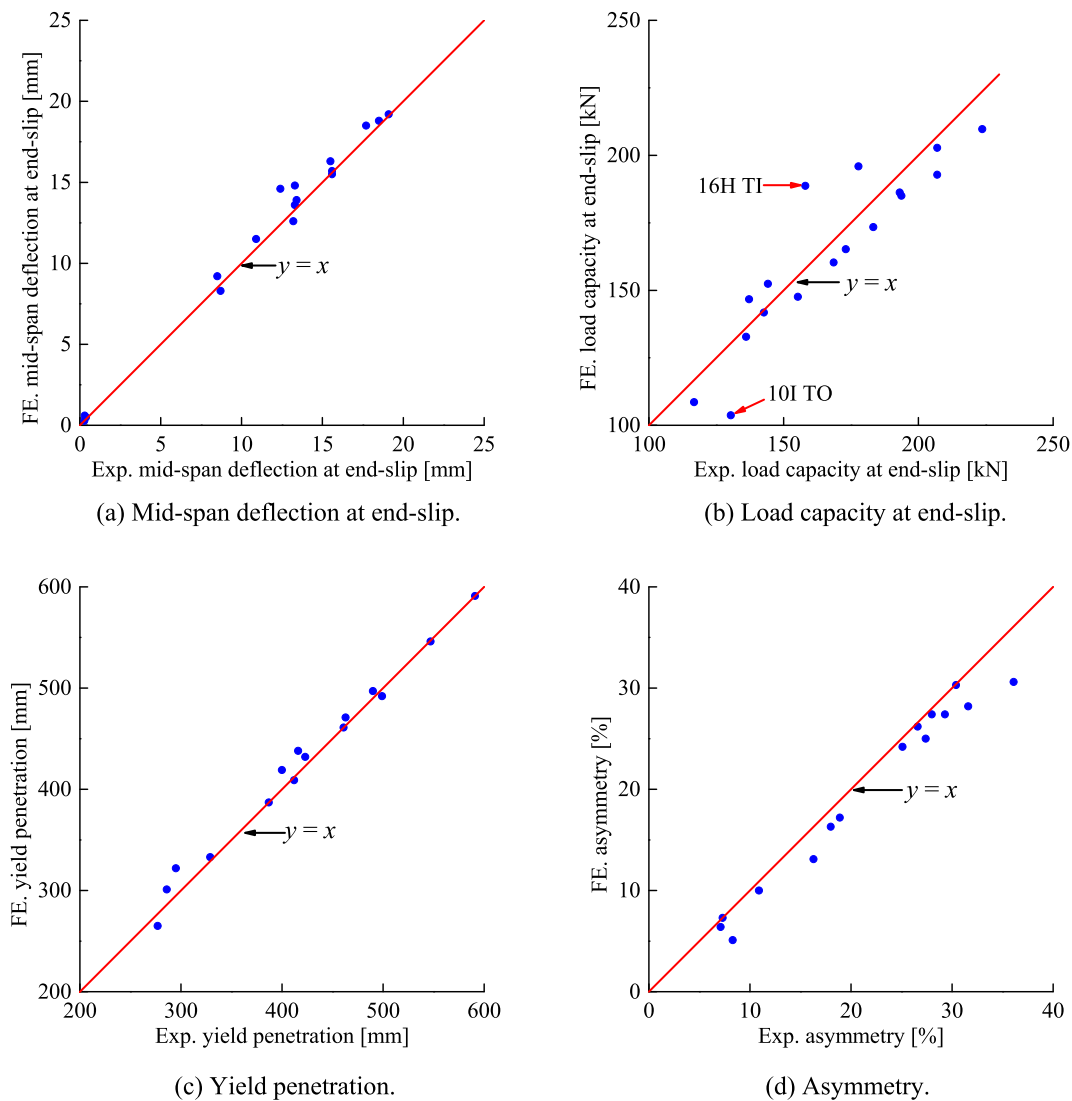
**Fig. 18.** Comparisons of FE analyses, with calibrated bond-slip as input, and experimental results.

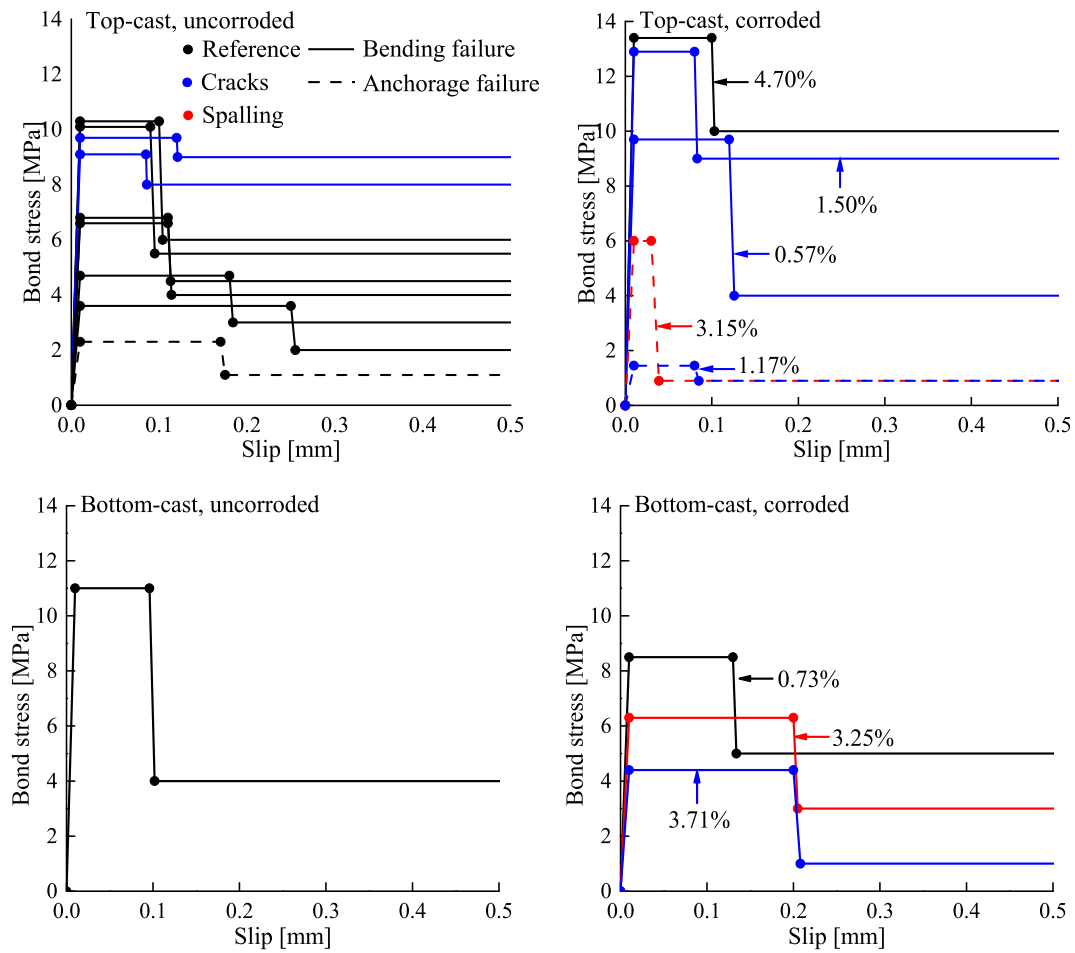
Fig. 19. Calibrated bond stress versus slip for unyielded zones in bars. All results are divided by casting positions and the presence of corrosion. The average corrosion level of 0.5% is used to distinguish between corroded and uncorroded bars. The damage level of each anchorage zone is displayed by colours. Bars with no yielded zone (which slipped before they reached yielding) are marked with a dashed line.

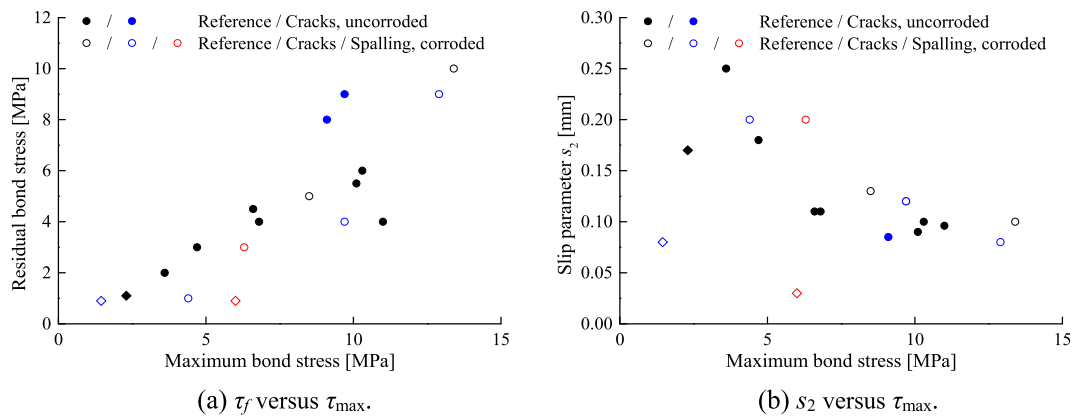
Fig. 20. (a) Residual bond stress versus the maximum bond stress and (b) slip at the end of maximum bond stress plateau for unyielded zones versus maximum bond stress. The damage level in each anchorage zone is shown using colours. The uncorroded bars are marked with filled dots, and the corroded ones are marked with unfilled dots. Bars that failed in anchorage before yielding are marked with lozenges.

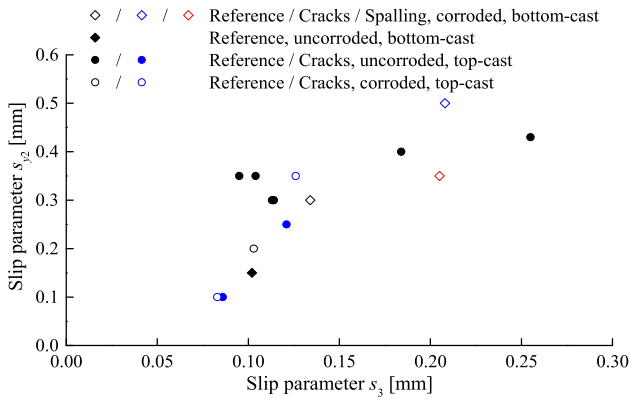
Fig. 21. The slip parameter s_{y2} against slip parameter s_3 . The damage level in each anchorage zone is shown by colours. The uncorroded bars are marked with filled dots, and the corroded ones are marked with unfilled dots. Different shapes indicate the casting position of the bars.

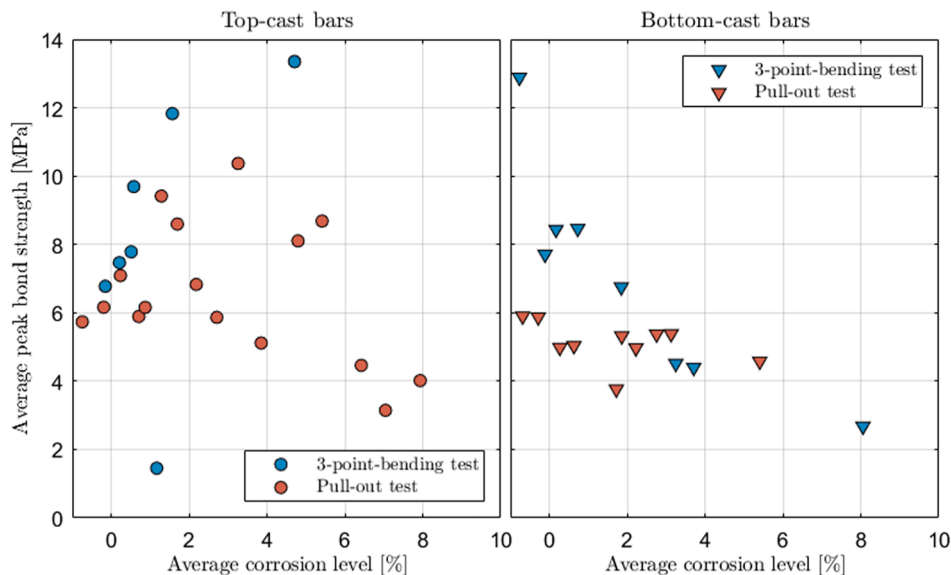
Fig. 22. Average peak bond strength and corresponding average corrosion level of top- and bottom-cast bars tested both in 3-point bending and with pull-out tests. Each point in the graph represents the bond strength of the tested bars averaged over an interval of 0.5% of corrosion.

In Fig. 22, the average peak bond strength over a corrosion interval of 0.5% is presented, both for bottom and top-cast bars. Experimental results from pull-out tests and 3-point bending tests are compared. The

tests results are shown to follow a similar trend, both for top- and bottom-cast bars. The average peak bond strength recorded in the pull-out tests is consistently lower than in the 3-point bending tests. Such observation indicates that the acquired data are likely to be on the safe side. Thus, the authors believe that pull-out tests could be a useful, fast and cheap option for acquiring data on existing structures. Average bond strength is shown to well correspond to structural tests results both in

trends and order of magnitude in Fig. 22.

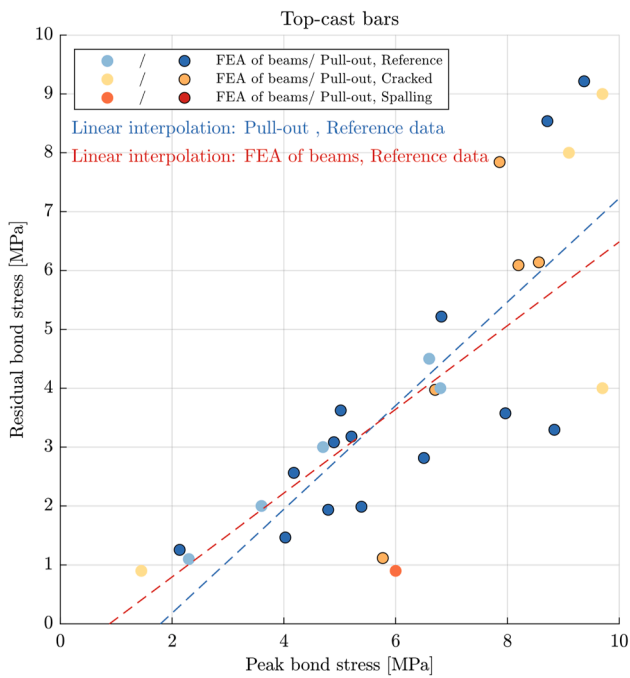
Fig. 23. Residual bond stress versus the maximum bond stress of top-cast bars, as obtained from the calibration of FE analyses of beams and pull-out test results. Results from reference specimens are linearly interpolated, for FE analysis (in orange), and for pull-out tests results (in blue). Different colours of the markers indicate different levels of damage in the surrounding concrete. (For interpretation of the references to colour in this figure legend, the reader is referred to the web version of this article.)

In Fig. 23, the residual bond strength, as obtained from the calibration of the bond-slip curves in this work, is plotted against the maximum bond strength, re-presenting data from Fig. 20a. Additionally, the residual bond strength as obtained from the pull-out tests (defined as the bond stress recorded at 4.5 mm of slip) is presented against the recorded maximum bond strength. Only results from top-cast bars were chosen,

given the more significant amount of data obtained in the FE analyses. Two linear interpolations are presented for reference bars, one for pull-out data and one from FE results. The choice of reference bars is again based on the amount of data points.
