## **Long-term performance of distributed optical fiber sensors embedded in reinforced concrete beams under sustained deflection and cyclic loading**

# Long-Term Performance of Distributed Optical Fiber Sensors Embedded in Reinforced Concrete Beams under Sustained Deflection and Cyclic Loading

**Citation:** Fernandez, I.; Berrocal, C.G.; Rempling, R. Long-Term Performance of Distributed Optical Fiber Sensors Embedded in Reinforced Concrete Beams under Sustained Deflection and Cyclic Loading. *Sensors* **2021**, *21*, 6338. <https://doi.org/10.3390/s21196338>

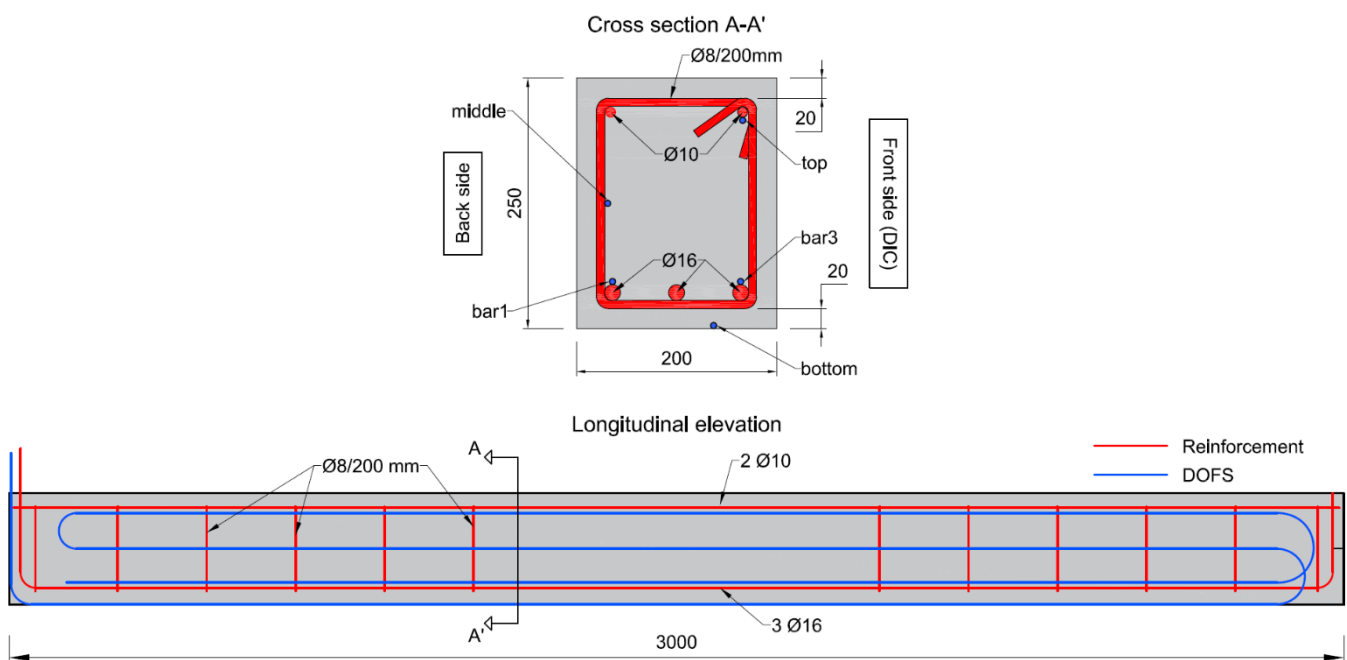
**Figure 1.** Geometry of the beam specimens, reinforcement layout and DOFS configuration (all measurements in mm).

The specimens used in this work were RC beams with a total length of 3 m and a rectangular cross-section of  $200 \times 250$  mm. Each beam was reinforced with three  $\varnothing 16$  mm rebar at the bottom and two  $\varnothing 10$  mm at the top. Moreover, six  $\varnothing 8$  mm closed-loop stirrups equally spaced at 200 mm were placed on either side of the beams. All reinforcement was made of normal ductility carbon-steel (B500B) with a nominal yield strength of 500 MPa. Plastic spacers were placed between the stirrups and the bottom and lateral sides of the form to ensure a clear concrete cover of 20 mm. The ends of the bottom bars were bent upwards to improve the anchorage. The geometry and reinforcement layout of the beams is presented in Figure 1. Note that at one of the beam ends, the bars protruded from the concrete surface, which was required for a later stage of the experiments in which accelerated corrosion was planned.

For each beam, a single DOFS was installed in a multilayer configuration to monitor the variation of strain along the beam in the region between the supports at five different locations of the beam's cross-section: above the two outer tensile rebars (bar 1 and bar 3); under one of the compressive rebars (top); at mid-height (middle); and at the bottom surface of the beam (bottom). The DOFS were either supported along the longitudinal reinforcement (bar1, bar3 and top), fixed to the stirrups (middle) or resting on the formwork (bottom), using electric tape to fix the sensors in place.

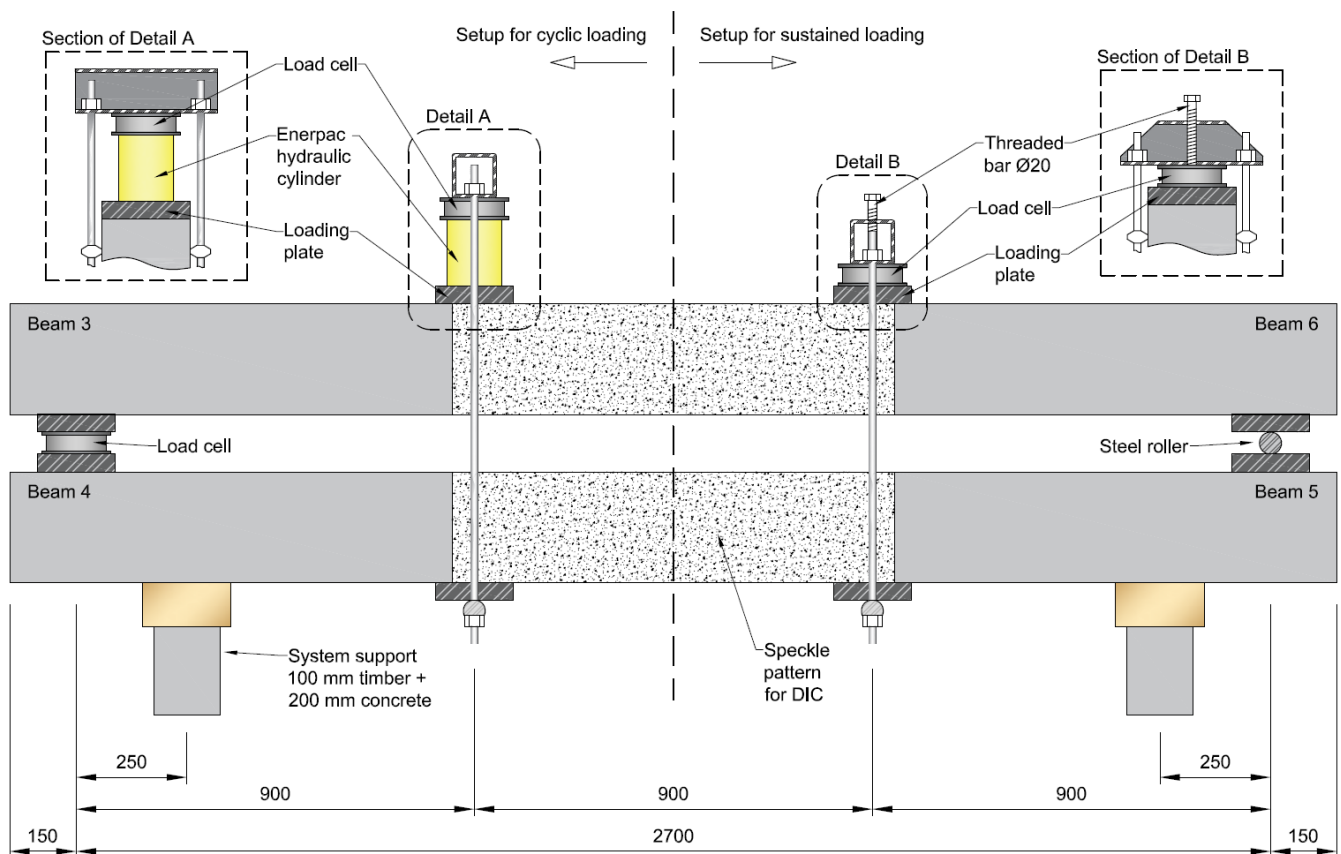
**Figure 2.** Loading setup for the long-term loading experiments (all measurements in mm).

For the long-term loading, the beams were divided into two groups and the beams in each group were clamped together according to the setup illustrated in Figure 2. In that setup, the bottom beam was turned upside down so that the tension reinforcement was facing upwards. Then, the top beam was positioned onto two sets of support plates resting on the bottom beam, the centers of which were 2700 mm apart. Thereafter, the load was introduced at two loading points, where the clamping devices were mounted, which divided the total span into three equal spans of 900 mm.

For the group of beams subjected to cyclic loading, a hydraulic cylinder was placed between the clamping device and the loading plate of the top beam, cf. Detail A in Figure 2; the imposed deformation on the group of beams subjected to sustained deflection was achieved by tightening a threaded bolt screwed into the clamping device, cf. Detail B in Figure 2. Two load cells were provisioned at the loading points over the top beam and one more between the support plates at one of the ends in order to ensure a symmetric load distribution. The load of the Enerpac hydraulic cylinder was automatically controlled using a close-loop feedback control system retrofitted with the measurement of the load-cells.

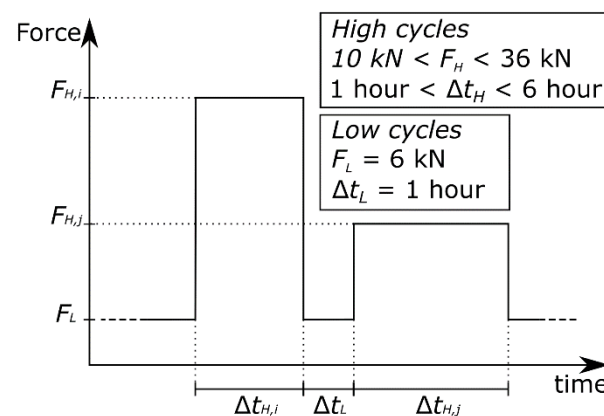
Figure 3. Definition of the loading procedure for the cyclically loaded beams.

The definition of the loading procedure for the cyclically loaded beams in the time domain was performed according to a squared wave signal where both the amplitude and the duration of the pulses were randomly varied within a given interval, as illustrated in Figure 3. A closed-loop feedback system was used to control the load applied by the hydraulic cylinders. The maximum load applied for each cycle varied between 10 and 36 kN (per cylinder) whereas the pulse duration varied between 1 and 6 h. Conversely, both the load and the interval between pulses were kept constant at 6 kN and 1 h, respectively. The beams subjected to sustained deflection were initially loaded to approximately 30 kN (per loading point) and then reloaded after 44 days to compensate the part of the load lost due to creep effects.

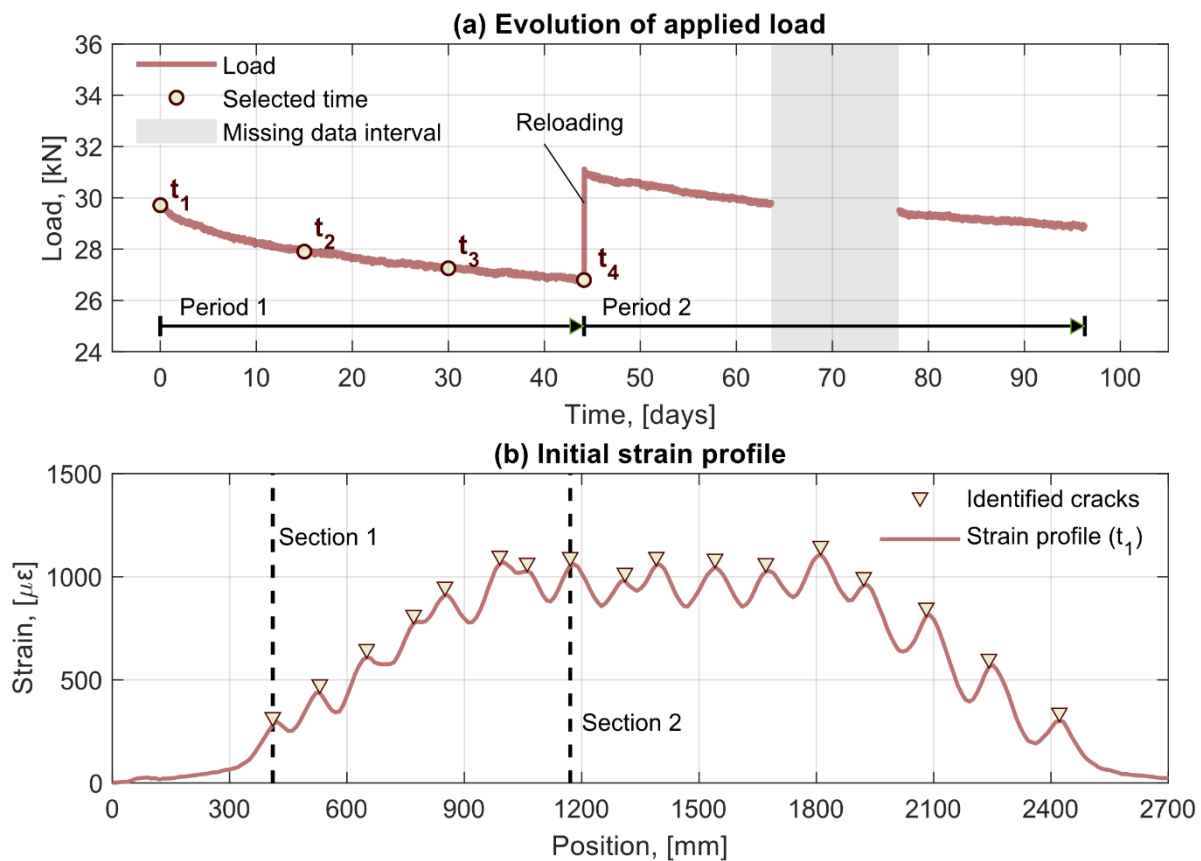
**Figure 4.** (a) Time evolution of the load for the beams subjected to sustained deflection where four selected times of interest ( $t_1$ ,  $t_2$ ,  $t_3$ ,  $t_4$ ) are indicated by markers. (b) Strain profile at one of the tensile reinforcement bars of beam 5 at the beginning of the test. Triangular markers indicate the positions of identified cracks and dashed lines highlight the position of two sections of interest, a crack in the shear span (Section 1) and a crack in the constant moment region (Section 2).

The variation of the load in the beams subjected to a sustained deflection as measured by a load cell located over one of the loading plates is presented in Figure 4a. A gradual load decay due to relaxation effects caused by the creep of the concrete can be observed up to the point where the load was manually increased to restore the initial load level. Thereafter, the load continued decreasing following a trend similar to before the reloading. Accordingly, the total monitoring time is divided into two periods, where the beginning of the second period is marked by the reloading of the beams. Four different times in period one, depicted in Figure 4a as circular markers, were selected to investigate variations over time of the spatial distribution of the beam parameters. Note that in period two, a certain region is shaded in grey indicating a period of missing data due to unavailability of the optical fiber interrogator.

Figure 4b shows the initial distribution of strains at the tensile reinforcement in beam 5, where the position of identified cracks, clearly discernible in the strain profile as strain peaks, have been indicated by triangular markers. Two sections of interest were selected to investigate the variation over time of the DOFS measurements, as well as derived magnitudes, for specific locations. The sections corresponded to the position of two different cracks, one located in the shear span (Section 1) and one in the constant moment region (Section 2), as shown in Figure 4b.

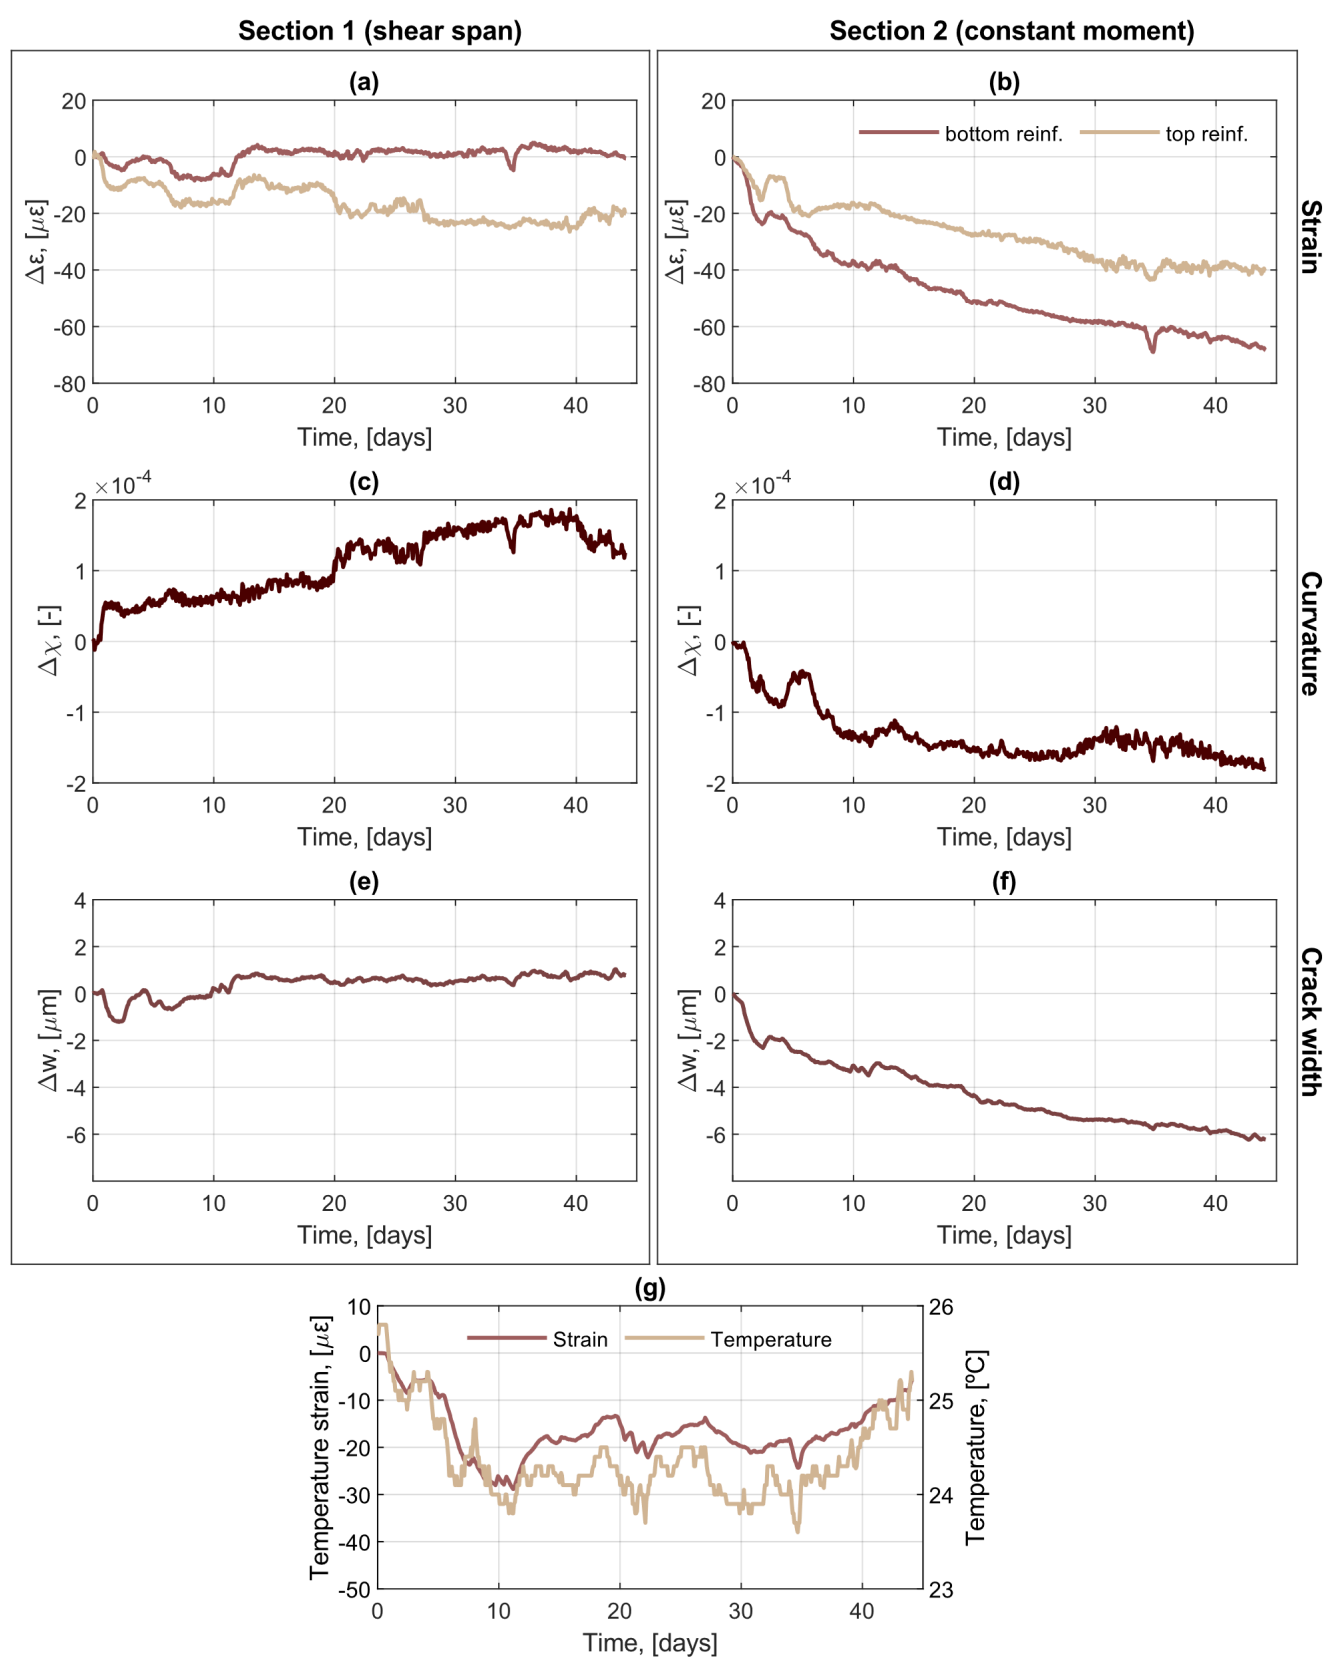
**Figure 5.** Incremental variation of measured and calculated magnitudes in the beam over time for Sections 1 and 2: (a,b) strain; (c,d) curvature; (e,f) crack width. (g) Variation of ambient temperature and the corresponding temperature-induced strain.

The increments of strain at the top and bottom reinforcement, the increments of curvature and the increments of crack width during period 1 is presented for Sections 1 and 2 in Figure 5a,c,e and Figure 5b,d,f), respectively. Furthermore, Figure 5g shows the measured ambient temperature and the variation of strain in the concrete attributable to temperature changes. The temperature strain, which is used for temperature compensation, was obtained by analyzing the strain in a section of the fiber optic cable embedded beyond the beam support, hence in a section without mechanically induced strains.

Looking at the results of Section 2, Figure 5b reveals that the strains at the bottom reinforcement suffer a negative increment, i.e., they decrease in magnitude, which can be explained by the progressive loss of load observed, although to a lesser extent, the strains at the top reinforcement also become more negative, i.e., they increase in magnitude, which can be attributed to the concrete creep in the compressive zone of the beam. Note that the increase in magnitude of the compressive strains is not incompatible with the decrease in load since creep-induced strains are not mechanical strains. However, they do contribute to the curvature and deflection of the beam. Accordingly, using the strain at the bottom

Interestingly, the curvature at Section 1, located in the shear span of the beam, follows an opposite trend to that of the curvature at Section 2. In Section 1, the strain at the top reinforcement decreases similar to what was observed for Section 2, which can also be attributed to the effect of concrete creep. Conversely, the strain at the bottom reinforcement does not display any significant change. This seems to indicate that a redistribution of curvature in the beam occurs under conditions of sustained deflection, where the curvature decreases in the most loaded region, where the curvature is initially larger, and it increases in regions where the curvature is lower from the start.

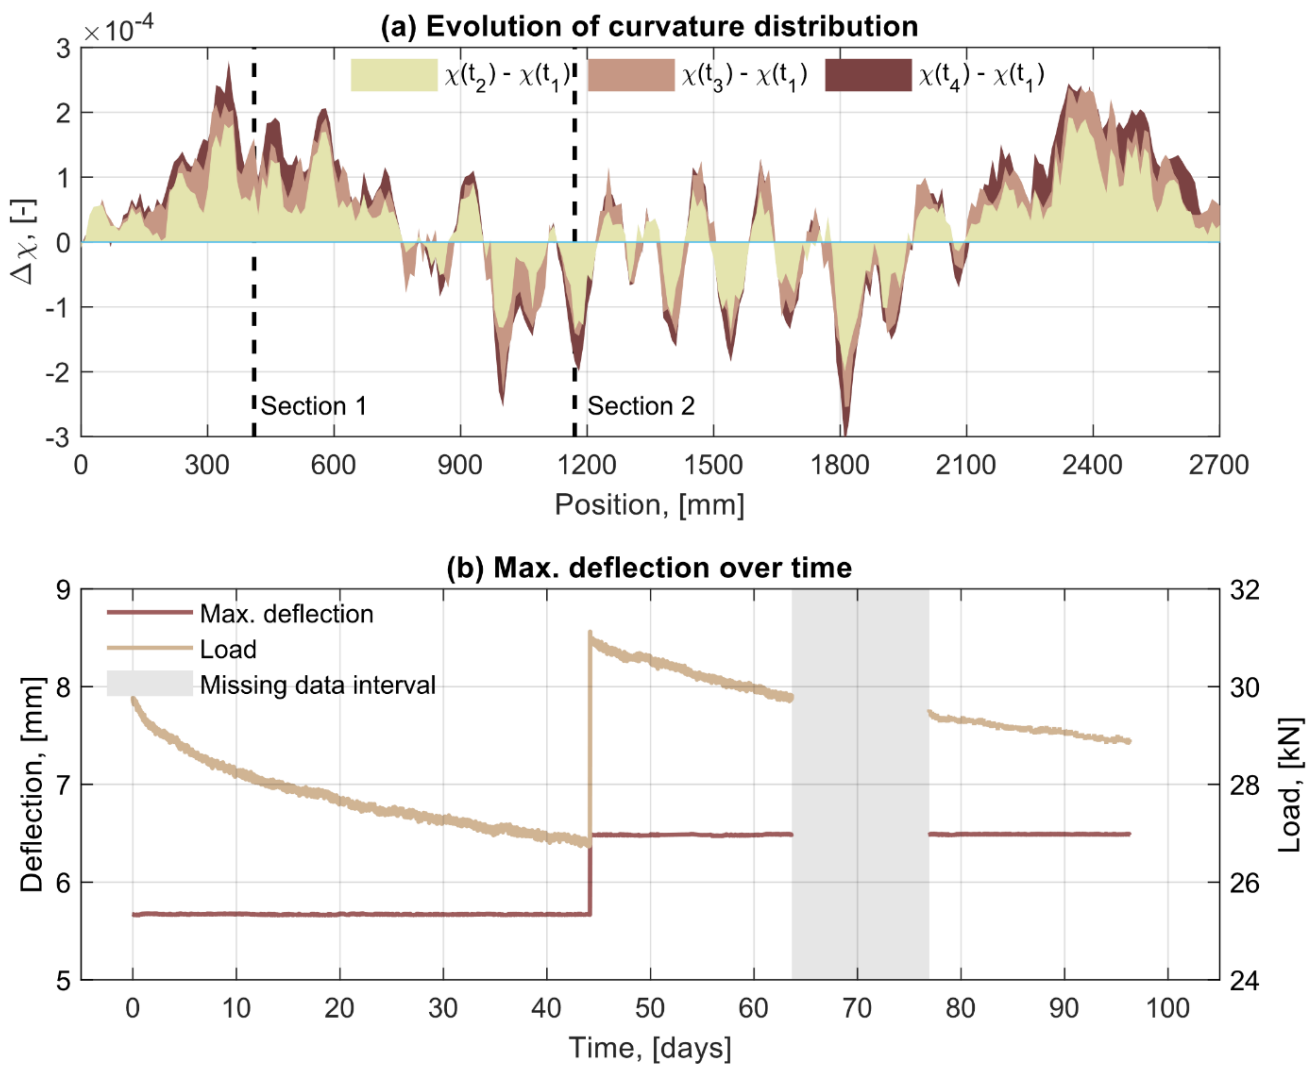
**Figure 6.** (a) Distribution of curvature increment along the beam for the instants  $t_2$ ,  $t_3$  and  $t_4$  with respect to the initial instant  $t_1$ ; (b) evolution of the maximum deflection in beam 5 calculated from the DOFS strain measurements together with the corresponding evolution of applied load.

In order to confirm whether the hypothesis that a redistribution of curvatures exist in the beam under sustained deflection, the distribution of curvature increments along the beam calculated at  $t_2$ ,  $t_3$  and  $t_4$  with respect to the initial instant  $t_1$  is presented in Figure 6a. As observed, a decrease in curvature occurs for all the cracked sections located in the constant moment region, and even for those that are outside the region but close to it, whereas for the sections between cracks the curvature generally increased. In the region of the shear spans closer to the support, on the other hand, a consistent but non-uniform increase in the curvature is observed within a distance of between 600 and 700 mm from the support. From Figure 6a it can be also appreciated that the rate of change is faster in the beginning, which indicates that the redistribution of curvature is driven by creep and is likely caused by the differential rate of creep deformation occurring between the most loaded sections (cracked section in the constant moment regions) and the rest of sections.

Last, in Figure 6b, the maximum deflection calculated through the double integration of the curvature distributions defined in Equation (1) is presented. As observed, the maximum deflection remains constant within each of the two periods, and it only increased at the instant when the beams were reloaded to restore the initial load level. These results demonstrate that the DOFS were able to measure correctly during the entire monitoring period and that the variation of strains and the consequent redistribution of curvatures observed in Figure 6a were measured accurately despite their magnitude being very small.

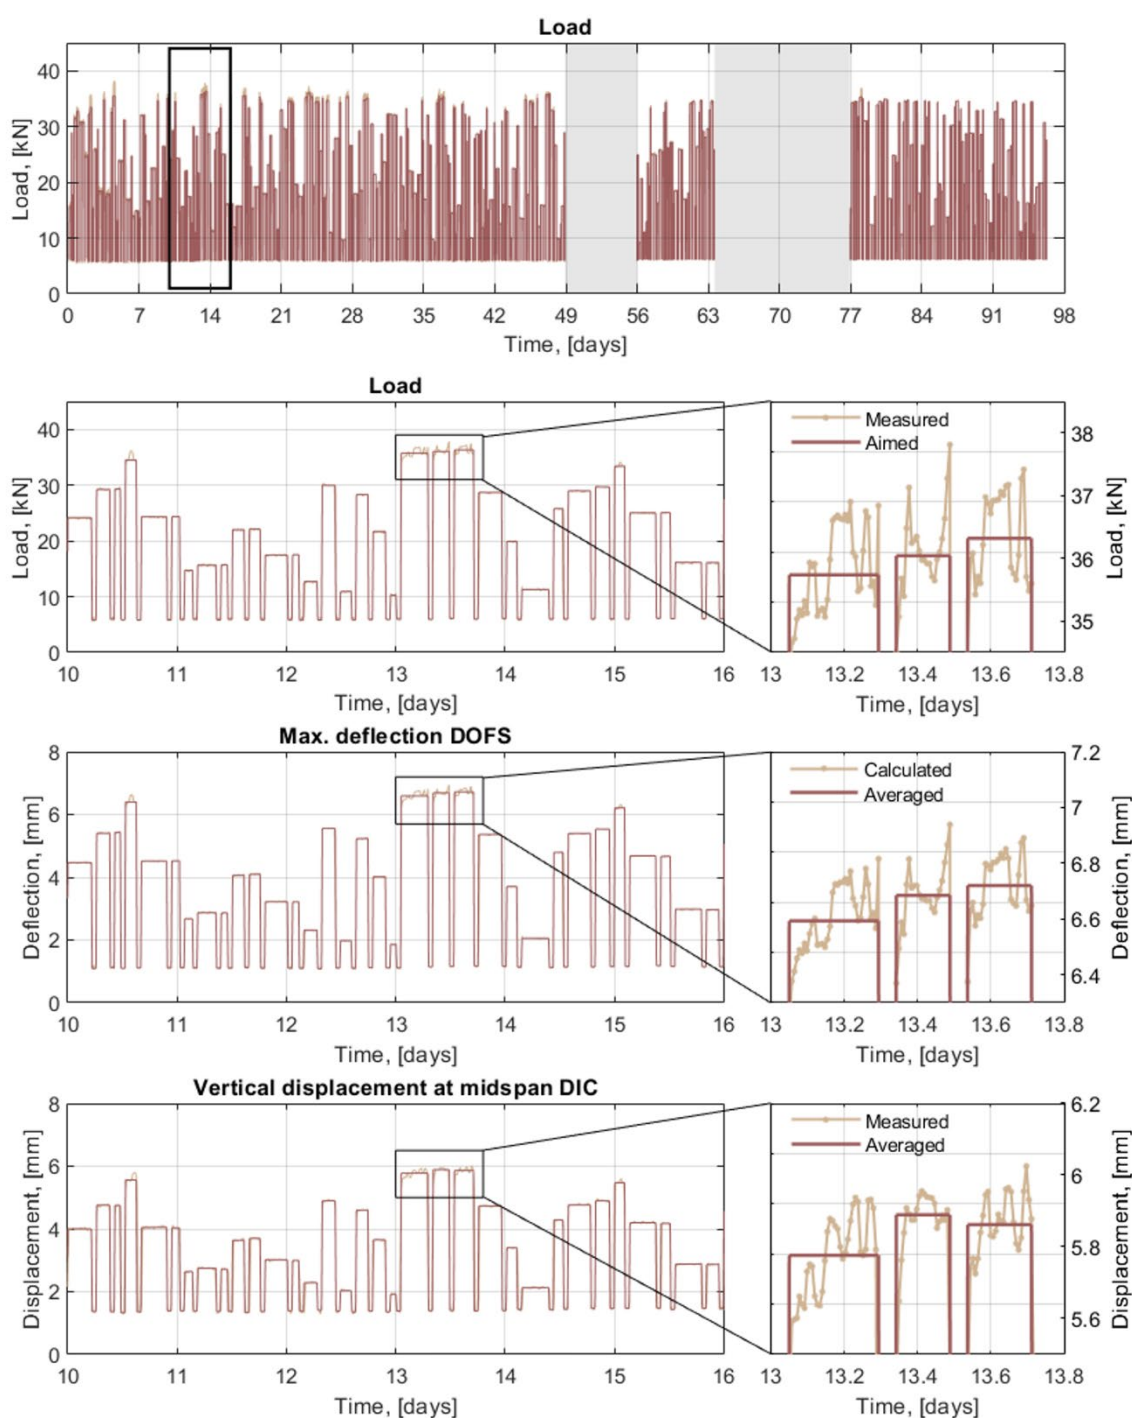
**Figure 7.** Load history of the beams subjected to cyclic loading. A zoomed-in region is presented to show the variability of the load cycles both in load magnitude and pulse duration and how the corresponding measurements of the DOFS and DIC correlate with the applied load. A further zoomed-in region is presented for the load, DOFS deflection and DIC displacement to illustrate the noise of the load-control system and the averaged values used for the analysis of results.

The load history of the beams subjected to cyclic loading is presented in Figure 7 where the more than 400 load cycles applied during the monitoring period are displayed. The additional period of missing data between the days 49 and 56 of the test was caused by a malfunctioning of the hydraulic system used to apply the loads.

A zoom-in of the load history between days 10 and 16 of the test is also presented in Figure 7 to better appreciate the variability of the load cycles, together with the maximum deflection calculated from the DOFS measurements and the midspan displacement measured from the DIC system for the same period. As observed, a good agreement exists between the overall shape of the deflection/displacement measured by both monitoring systems and the shape of the applied load. However, a closer look at the acquired data revealed that the values measured by the load cells differed significantly from the aimed load values due to the inability of the system to accurately stabilize the oil pressure, hence the load, resulting in discrepancies of up to  $\pm 5\%$ . More importantly, due to the slight time shift in the acquisition of data between the different systems (load cells, DOFS and DIC), the comparison of results for a specific load cycle is no longer straightforward. Therefore, in order to minimize the impact of the load signal noise on the comparison of results, an averaging procedure was carried out to obtain mean values of the load as well as deflections and displacements (see Figure 7).

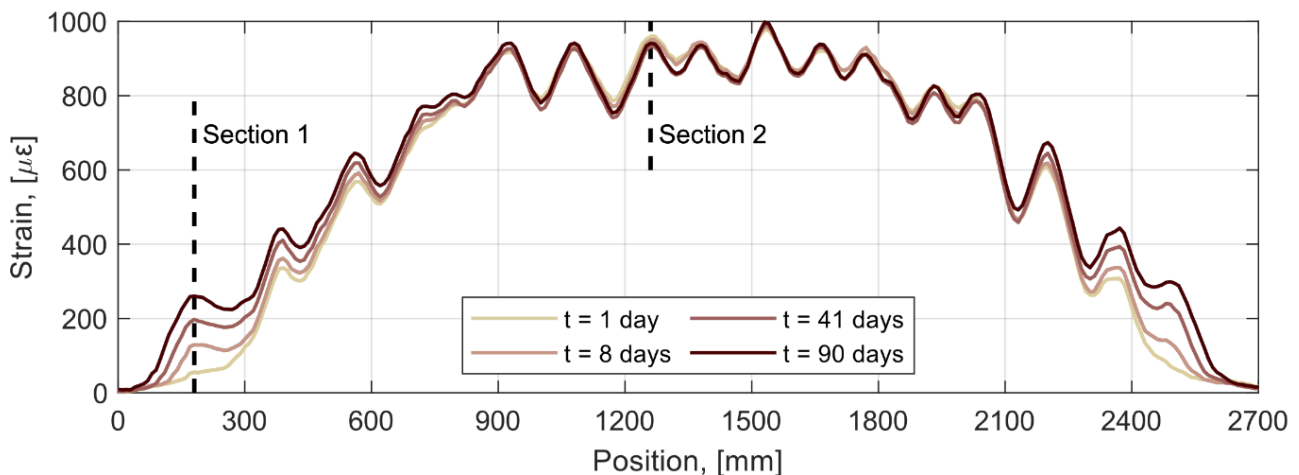
**Figure 8.** Strain profiles at the tensile reinforcement of beam 4 at different times for a loading cycle of ca. 28.5 kN.

To study how repeated load cycles affect the strain distribution at the tensile reinforcement, the strain profiles measured by the DOFS during the application of a load cycle of similar magnitude (28.5 kN), but occurring at different times during the test, are presented in Figure 8. As observed, the strain remains virtually unaltered in the central 900 mm of the beam with no apparent difference between the strain profile at day 1 and at day 90. This seems to indicate that despite the cyclic loading, no bond degradation occurred between

the reinforcement and the concrete at that load level. Conversely, an increasing trend is observed for the strain in the shear span regions, which is more evident near the supports. This effect can be explained by the formation of new cracks and the development of existing incipient cracks in the shear span caused by the higher load levels reached in the cyclic loading compared to the pre-cracking procedure.

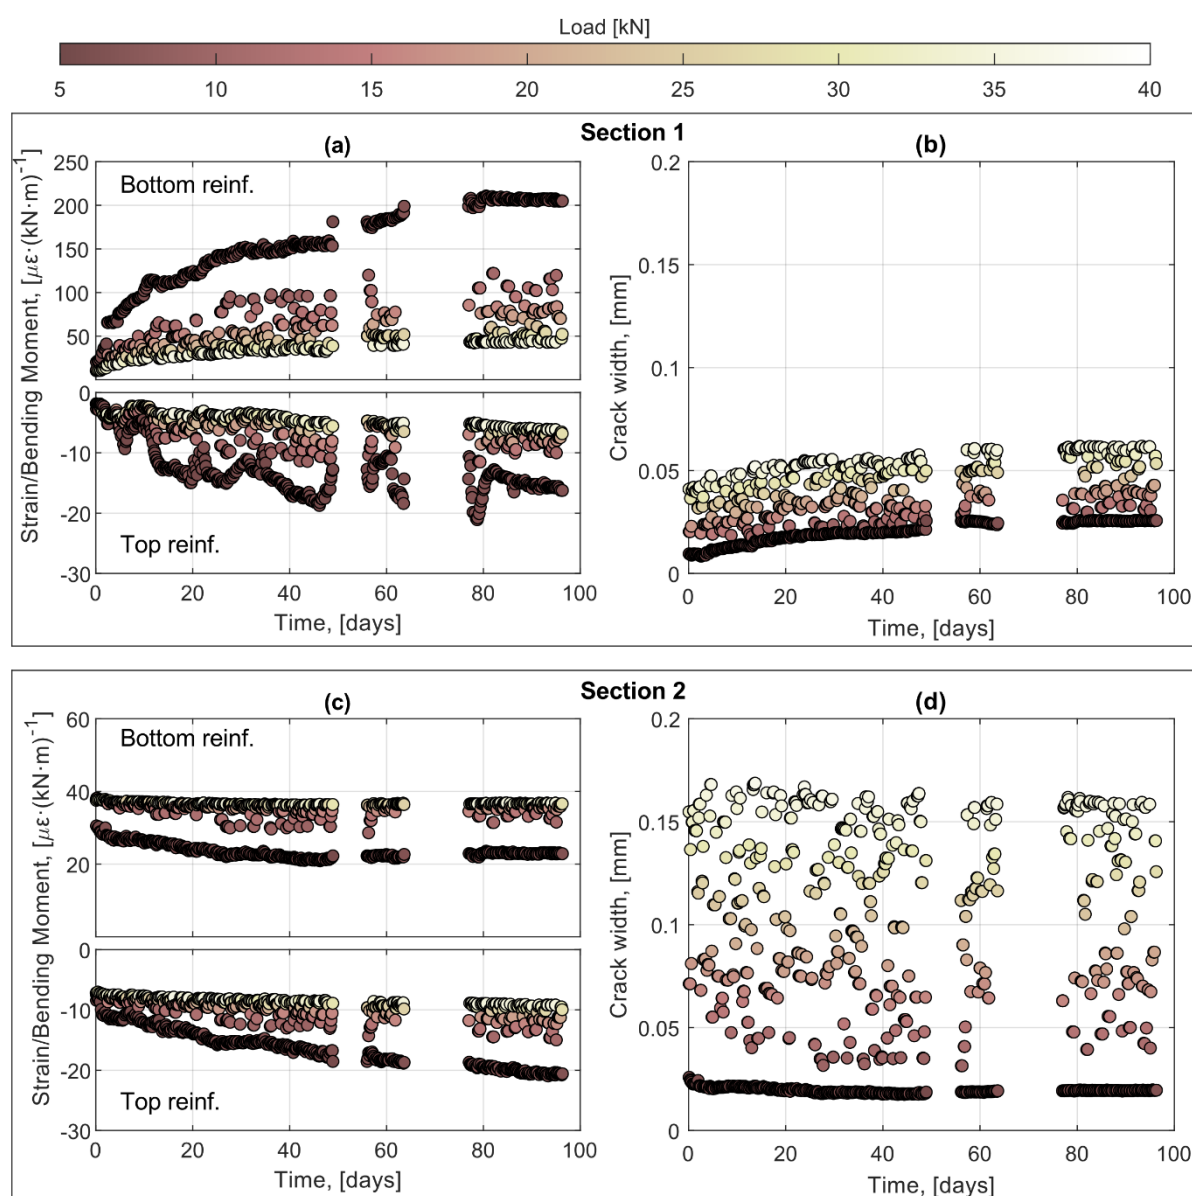
**Figure 9.** Evolution of strains over time represented as the ratio between the DOFS strain measurement and the section bending moment and evolution of crack width for Section 1 (a,b) and Section 2 (c,d).

In Figure 9, the evolution of strain at the bottom and top reinforcement of beam 4 is presented for both Sections 1 and 2 (cf. Figure 8) together with the evolution of the crack width for each section. Note, however, that to attain comparable strain results, the impact of the loading cycle and the influence of the section position were removed by normalizing the values of the strain by the corresponding sectional bending moment. An observation common to both sections is the fact that the magnitude of the top reinforcement strain under the low-cycle load increases, proportionally, much faster than the strain at higher loads which in most cases displayed a very limited variation. This can be explained by the development of greater creep strains under the continuously applied low-cycle load compared to the relatively instantaneous loading-unloading of each individual cycle.

The strain measured at the bottom reinforcement, on the other hand, displays a different behavior for the two investigated sections. For instance, in Section 1, the measured strain clearly increases with the number of cycles. This is attributed to the imperfect closure of cracks during the unloading phase of the cycle, which leads to compressive stresses in the cracks and a residual crack opening causing the appearance of steel stresses, hence strains, larger than what would be expected. This effect, which was suggested by Hordijk [41] and later verified experimentally using DOFS by Cantone et al. [34], is supported by the increasing crack width observed in Section 1, see Figure 9b. Conversely, in Section 2, the bottom reinforcement strains decrease with the number of cycles applied, yet the variation of the crack width is almost negligible. This could be explained by a weaker bond between concrete and steel in the unloading phase, which enables the concrete between cracks to recover a greater fraction of its elastic strain. It should be noted that the effect of imperfect crack closure is more pronounced for inclined cracks and stress levels close to zero, which explains why is not observed for the cracks in the region with constant bending moment. Last, it is interesting to note that whereas the residual crack width for Sections 1 and 2 varies over time, the difference between the crack width at minimum and maximum loads seems to remain constant.

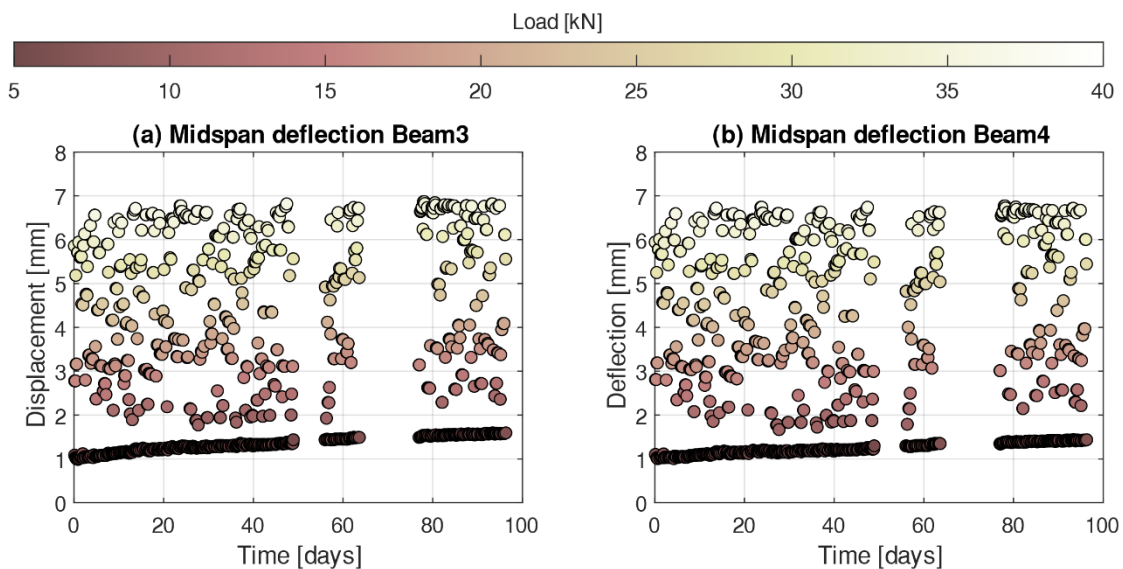
**Figure 10.** Evolution of the midspan deflection calculated from DOFS strain measurements for (a) beam 3 and (b) beam 4.

The deflection of an element subjected primarily to bending action is a good indicator of the performance of the element while in service and, in many cases, it can be directly compared to reference threshold values specified in current design codes to ensure the functionality of the structure. Therefore, obtaining the long-term deflection of a structural element subjected to external loading can be of interest to verify the condition of the element. In Section 3.1.3, it was shown that the deflections calculated from the DOFS strain measurements agreed well with the actual imposed deflection on the monitored beam for a period of more than three months. In this section, the aim is to assess whether the DOFS measurements can be used to obtain an accurate calculation of the beam deflection over the same period when subjected to repeated cyclic loading.

for the DIC system. In this study, only the central region of the beam was captured in the pictures taken with the digital camera, which means that any support settlement occurring outside the field of vision of the camera cannot be accounted for in the calculation of the beam deflection. In addition, in the analysis of the DIC results, a progressive drifting in the fixture of the camera was detected, which compromised the accuracy of the DIC results for the calculation of long-term deflections. Therefore, Figure 10 presents the long-term deflection of beam 3 and beam 4 only for the values calculated based on the DOFS strains measurements. As observed, the flexural behavior of both beams is almost identical, describing a slight increasing tendency of the residual midspan deflection over time, which can be attributed to creep effects. The results show only slight differences between the two beams, indicating a minor variation of the stiffness. More importantly, the similarity between the results obtained by two individual DOFS on two separate specimens with the same geometry and subjected to the same load denotes a good repeatability of the presented methodology, hence a robust solution to monitor deflections.

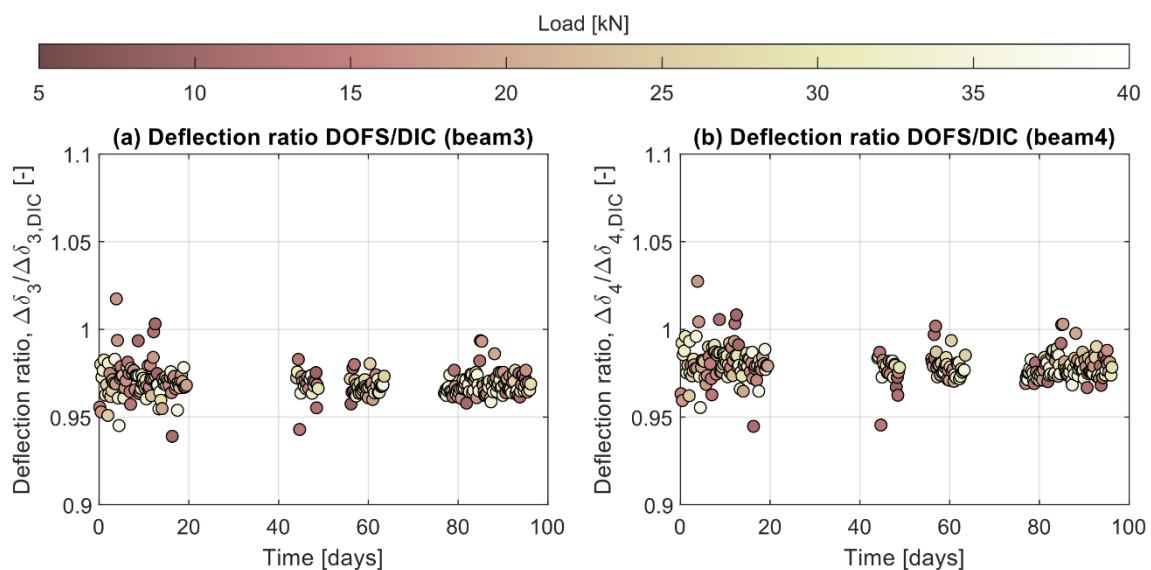
**Figure 11.** Ratio of the deflection increment calculated from the DOFS and measured by the DIC for (a) beam 3 and (b) beam 4.

positive for beam 3 and negative for beam 4. The comparison of the deflection increments for each individual cycle is presented in Figure 11a,b in the form of deflection ratios between the DOFS and the DIC for beam 3 and beam 4, respectively. As observed, in both cases the mean error is below 5%, which agrees with previous results by the authors [25]. Furthermore, it is worth highlighting that the results show very little scatter and that no apparent influence of the applied load level nor the number of cycles can be observed. These results reveal that the calculation of deflections based on DOFS is reliable over time, even under repeated load cycles, and potentially more robust than non-contact image-based systems since it does not require a fixed external reference for the computation of deflections.

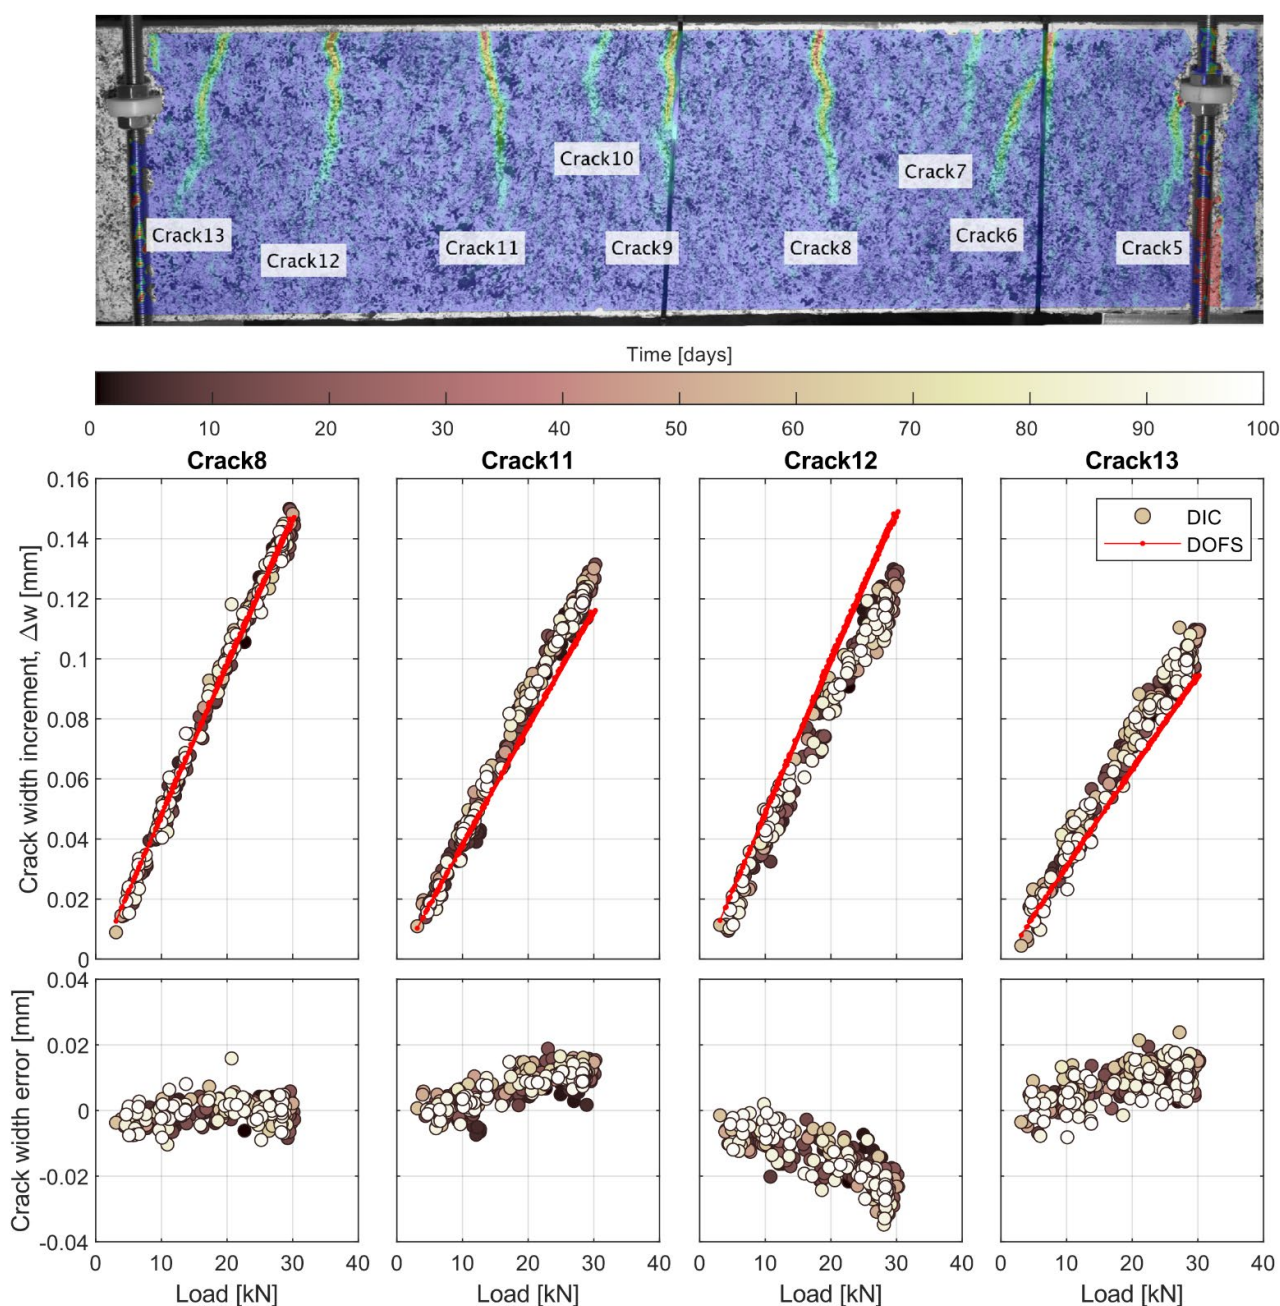
**Figure 12.** Results of the DIC showing the field of principal strains to highlight the position of cracks on the surface of beam 4 along the region of constant bending moment (**top**). Relationship between increment of crack width and applied load for selected cracks (**middle**). Crack width error between the DIC and DOFS measurements (**bottom**).

The results of the comparison are presented in Figure 12 as a function of the cycle load, where each marker corresponds to one cycle and the color of the marker indicates the time, in days, for which the cycle occurred. Additionally, the crack width error calculated as the difference between the increment of crack width measured by the DIC and the DOFS is also presented in Figure 12 for each crack. In terms of accuracy, it can be observed that the agreement between the DOFS and the DIC varies from crack to crack but, overall, the maximum error is generally below 0.02 mm, except for one crack where it reaches 0.04 mm at higher loads, which is in accordance with previous results [25]. Moreover, in all

cases the relationship between the increment of crack width and the applied load remains linear for both the DIC and the DOFS. This agrees with the results shown in Figure 9b,d, in which despite a certain variation of the total crack width over time, the variation of crack width between the peak and low cycle loads remained nearly constant. The fact that increment of crack width stayed proportional to the applied load over time suggests that the cyclic loading did not cause any significant bond degradation, which otherwise would be translated into an increased crack width over time. Furthermore, it is worth noting that despite the linearity observed in the results from both systems, the DOFS results exhibit a much lower scatter than the DIC. These results further highlight the potential of DOFS for monitoring of RC structures.
