“Towards improved quality of the works”
**Documented examples of existing situations
regarding quality of works**

Final report, March 2016

**Heike Erhorn-Kluttig, Hans Erhorn, Sarah Doster
(Fraunhofer Institute for Building Physics, Germany)**

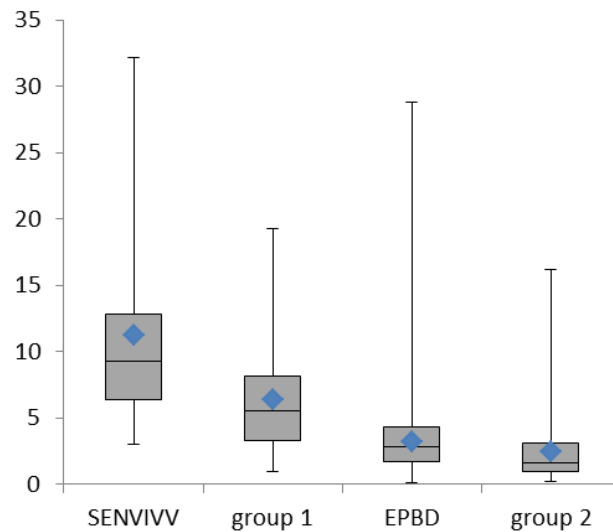
The results show that the mean leakage rate is about 6 ACH50 for the randomly selected houses ('group 1') and 3 ACH50 for the houses in the databases (EPBD and 'group 2'). The houses in the databases are tested upon the initiative of the owner and are a reference for dwellings that are intended to be airtight. Therefore, the attention to airtight workmanship is substantially higher for these cases than in the randomly selected houses. However, compared to the situation in the 1990's the results show that the airtightness achieved in current construction practice has improved in general.

The results demonstrate the substantial difference between the air tightness achieved by 'mainstream' workmanship and results obtained by the 'engaged' market. Since a large portion of the leakage can be

Figure 1: Air leakage rate in single-family houses

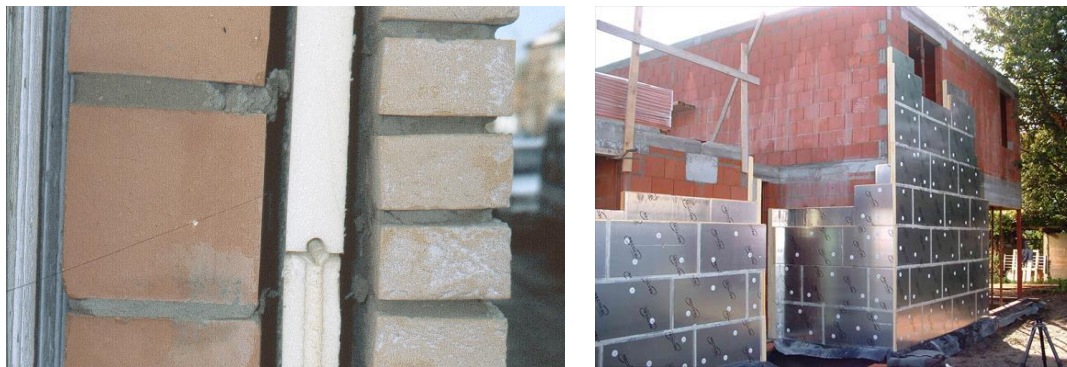
Summary: When thermal insulation is installed in a cavity wall construction, special attention must be paid to the absence of residual cavities surrounding the layer. Otherwise a considerable increase of the heat transfer can be expected, due to air flows around and through the insulation layer, caused by natural convection (Lecompte 1990). In case of poor workmanship, the use of insulation boards introduces the presence of joints between the boards themselves and between the boards and other components, coupled with the residual air layers on both sides of the insulation resulting from the uneven surfaces of cavity facing masonry construction. In a large number of experimental studies performed in the laboratory and in the field in between 1985 and 2000, the laboratory of building physics at KULeuven showed that the U-value of cavity walls increase substantially as a result of incorrectly installed insulation layers, [15]. The overall U-value may be a factor 4 higher than the design U-value of 0.2 W/m²K in case a 10 mm residual cavity is present in between the insulation layer and the inner masonry leaf, and 10 mm wide gaps exist in between the insulation boards. At the time, gaps and cavities with a width of this order of magnitude could be easily found in most construction sites. This was caused by the fact that masons were insufficiently trained to handle and install thermal insulation, and that the traditional construction sequence with internal scaffolding was not adequate to allow for a correct installation of insulation boards. As a result of the findings of the KULeuven the construction practice in Belgium has changed since the 1990's, with improved training of masons and an optimized construction sequence. The correct sequence is to construct first the inner leaf paying attention to the evenness of the cavity facing surface,

then fixing the insulation layer by pressing it against the inner leaf using screwed cavity ties and by interlocking and taping joints between boards, and finally constructing the brick veneer (see figure). Thermal insulation manufacturers also provide improved board designs with tongue-and-groove joint systems and compatible tapes to assist correct installation.

Figure 2: Installing cavity wall insulation: poor (left) versus good (right) workmanship

The occurrence of installation errors was widespread, but as the follow-up study in 2014 showed, the extent of the errors has decreased, although none of the construction sites investigated was completely flawless.

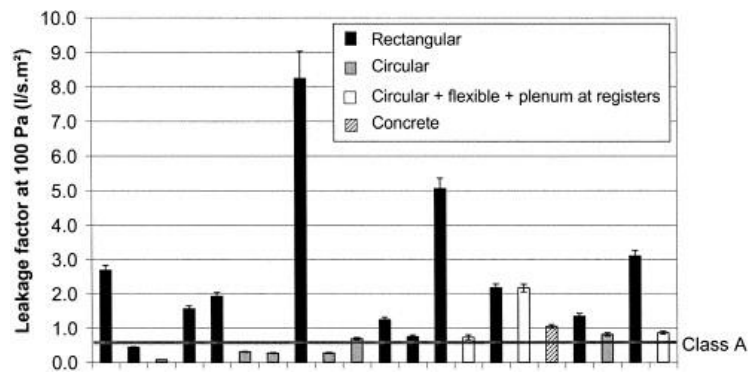
Figure 5: Leakage factor at 100 Pa for the investigated systems in France.

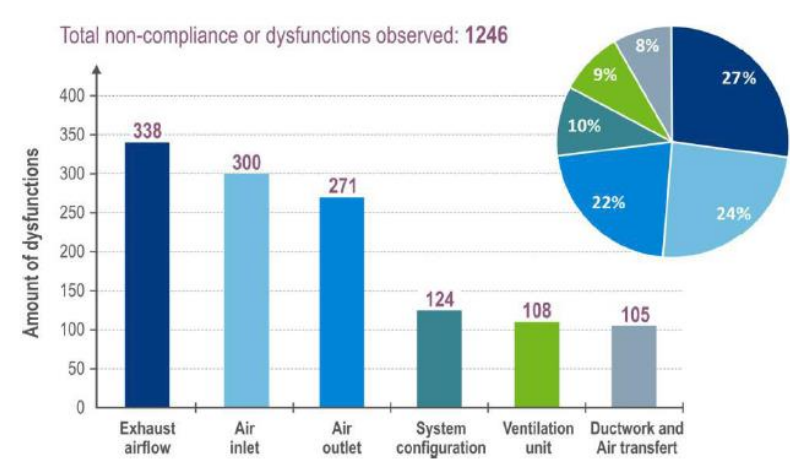
Summary: This analysis, based on French regulatory compliance controls and performed only on ventilation regulation (among 7 other regulations including energy performance), gives clear information about ventilation dysfunctions localisation and qualification. Up to now, only 1.287 dwellings have been analysed through 373 control reports performed between 2008 and 2011. Nearly all dwellings of the sample are equipped with simple exhaust mechanical ventilation. Humidity demand-controlled ventilation accounts for 74% of the sample. Balanced ventilation is found only in 10 single-family dwellings. The statistical analysis of this sample reveals that 604 dwellings out of 1.287, that is 47% of the sample, do not comply with the ventilation regulation. It also means that 47% of the sample present at least one non-compliance remark. The non-compliance rate is 68% for single-family dwellings, and 44% for multi-family dwellings.

Figure 6: Ventilation dysfunctions

- ✓ ventilation installation verification is rarely planned during the construction phase;
- ✓ ventilation system commissioning control is not systematic or is incomplete;
- ✓ in-site ventilation system mounting is often far from the expected quality;
- ✓ even if adapted industrial solutions are available, ventilation system dysfunctions are very frequently observed

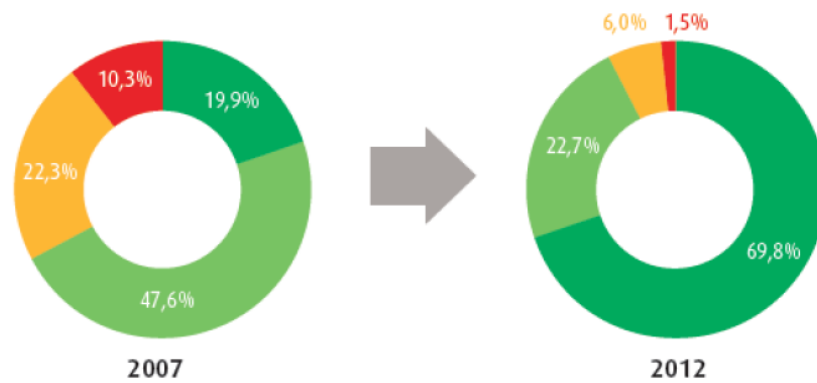
Between 2007 and 2012, 11.817 installations with a solar thermal domestic hot water system have been audited. The results of the audits operated in 2012 on solar thermal domestic hot water systems (their number is not indicated) show that:

- ✓ 93% of the audited installations have an excellent (70%) or good quality (23%);
- ✓ the quality is insufficient for 6% of the audited installations (orange);
- ✓ 1,5% of the audits show a failing installation.

Figure 7: Results of the audits operated in the years 2007 and 2012 by Qualit'EnR on solar thermal domestic hot water systems under the quality label Qualisol. (dark green: excellent, light green: good, orange: insufficient, red: failing)

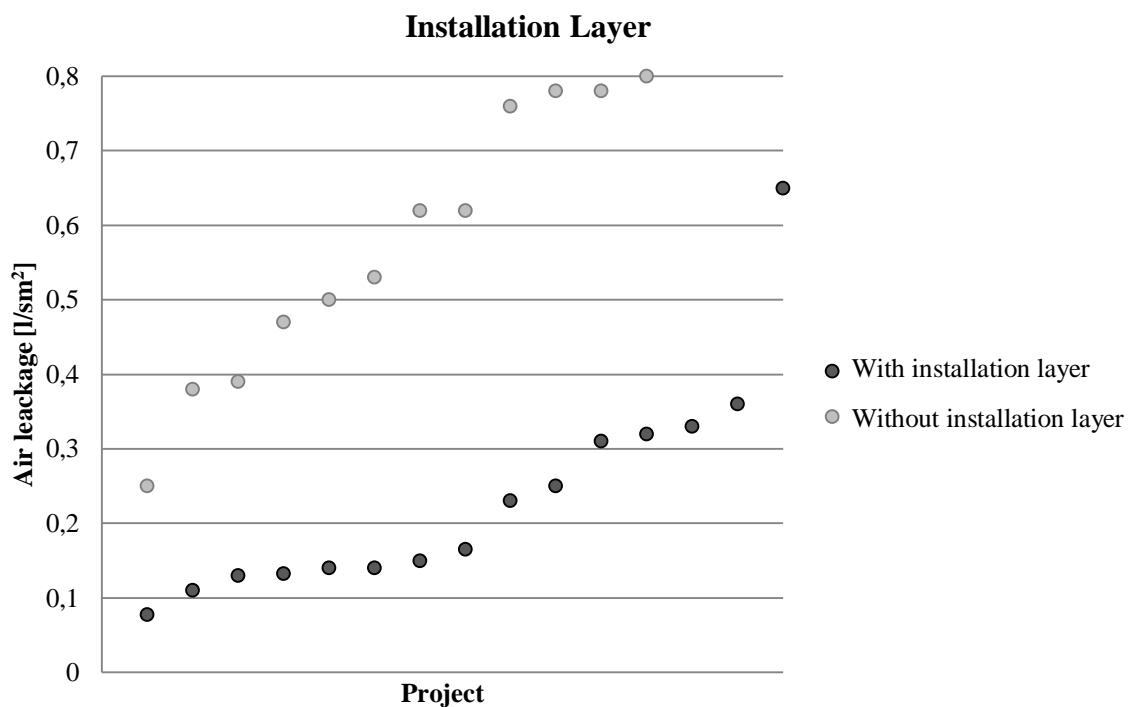
The installation layer (recessed air barrier) is most likely the one technical solution that affects the building envelope's air tightness most. The study shows that an installation layer usually results in an air leakage lower than 0.5 l/sm² and should therefore be used to fulfil a requirement of 0.3 l/sm². A combination of several methods, see following examples, should be used to achieve an air leakage of 0.3 l/sm²:

Figure 9: Air leakages of different building envelopes divided into walls with and without specific installation layer. (Source: [8]).

- ✓ Use metal plate spigots around vents.
- ✓ Plastic foil should be folded into the window recesses and swelling insulation should be used in the connection between external wall and window frame.
- ✓ In the connection between the external wall and bottom slab the plastic foil is clamped with sealing.
- ✓ In order to seal joints, the plastic foil is clamped between solid materials together with butyl rubber strip.
- ✓ With ventilation systems using both supply and extract air (and heat recovery), care should be taken to reduce the number of penetrations through the plastic foil, for example by the use of a suspended ceiling.
- ✓ Risk structures, such as spotlights and interior attic hatches, should be avoided.

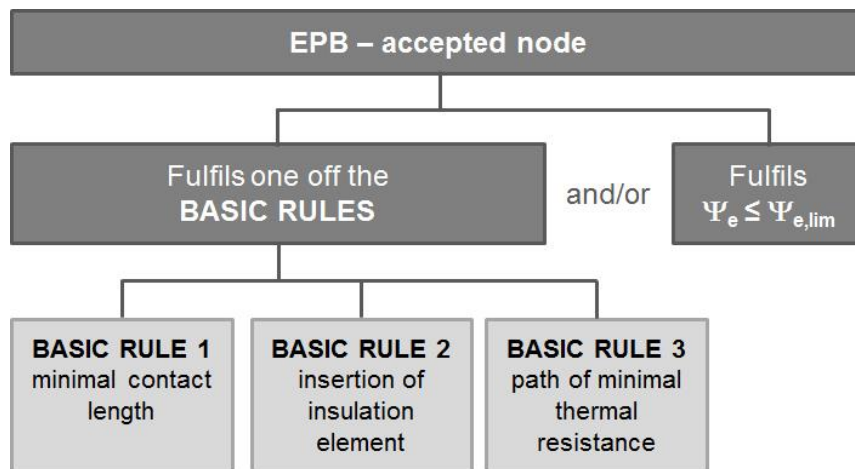
Apart from fulfilling one of the three basic rules a thermal bridge is also considered to be EPB-accepted if its thermal transmittance is smaller than a limit value (see figure 10). The limit value is depending on the geometry of the construction node. This allows for instance building industry to provide specific thermal bridge atlases that can be applied by designers without any further calculations. Several major building manufacturing companies have developed product documentation and reporting tools based on the EPB-methodology.

Figure 10: Possibilities for the assessment of EPB-accepted nodes (construction nodes with compliant thermal detailing)
