## **Experimental study of compressive properties parallel to grain of glulam**

Totsuka, M., Jockwer, R., Kawahara, H. et al (2022). Experimental study of compressive properties parallel to grain of glulam. *Journal of Wood Science*, 68(1).  
<http://dx.doi.org/10.1186/s10086-022-02040-7>

This paper describes results and analysis of experiment of compression behavior parallel to grain of glulam (Norway Spruce, Japanese cedar, and Japanese cypress), especially in damage zones near loading plates and joints. To investigate the influence factors of physical properties and the mechanism of the damage zone near the loading plates or the joints, compression tests on 90 specimens and surface-measurement tests on 48 specimens were performed. As a result, it was observed that damage zones existed near the loading plates and the joints. The lengths of the damage zone of wood–wood joints are larger than that of wood–steel joints. The length of the damage zone was independent of the load and the height of the specimens. However, the length of the damage zone and its scatter increase as the width of the cross-section increases, as does the roughness on the contact surface. It was considered t

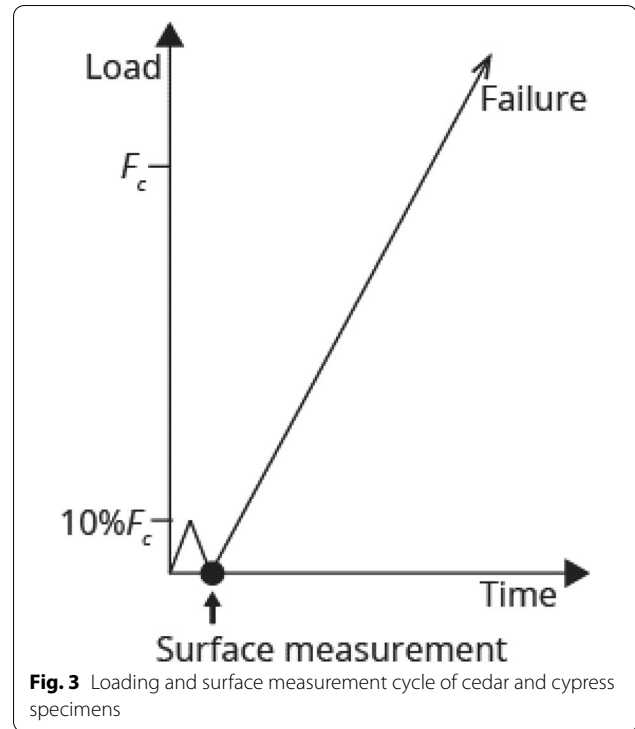
transducers to measure the displacement of the total height of the specimens under displacement control at a rate of 1 mm/min. The loading and surface measurement cycle is shown in Fig. 3. The roughness on the contact surfaces was measured at 10% of the previously published strength  $F_c$  ( $F_c$  is 35 N/mm<sup>2</sup> for cedar and 40 N/mm<sup>2</sup> for cypress) [13], by a hybrid measuring instrument for surface roughness and contour measurement (SV-C4100H8, Mitutoyo, Kanagawa, Japan)

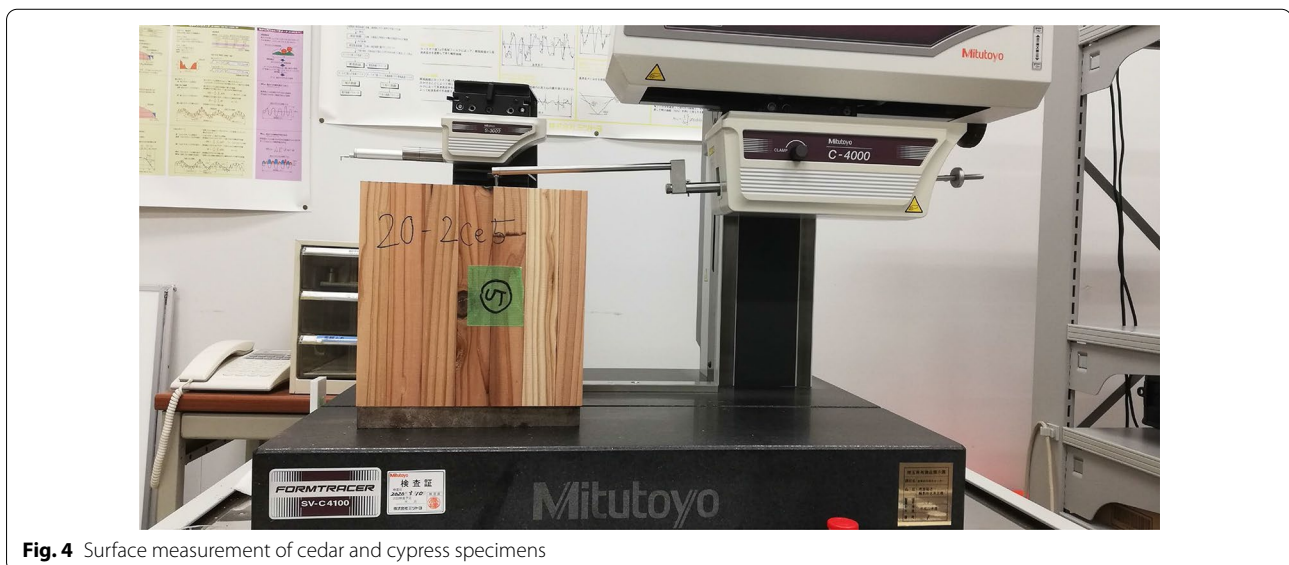
as shown in Fig. 4. It is the device to measure surface roughness by tracing the surface with a stylus. The 2D deformations and local strains in a surface were determined by the DIC system by a digital camera. A 2D optical system captured images at a frequency of 0.2 Hz during the test. The images were processed with the DIC software (GOM correlate, GOM, Braunschweig, Germany) [9]. This software uses an automated computer algorithm to determine local displacements and strains according to deformation images. For all specimens, a speckle pattern, which consisted of black dots on a white surface, was painted on the face of these specimens face.

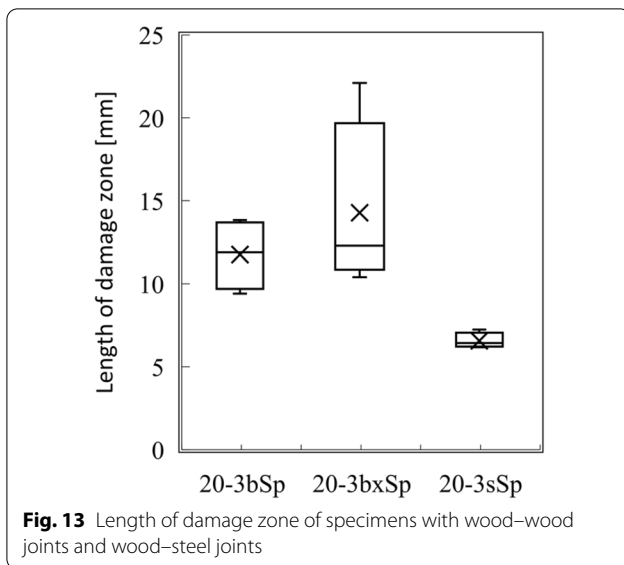
Figure 13 shows the length of the damage zone near wood–wood joints and wood–steel joints. It was considered that the lengths of the damage zone of wood–wood joints are larger than that of wood–steel joints.

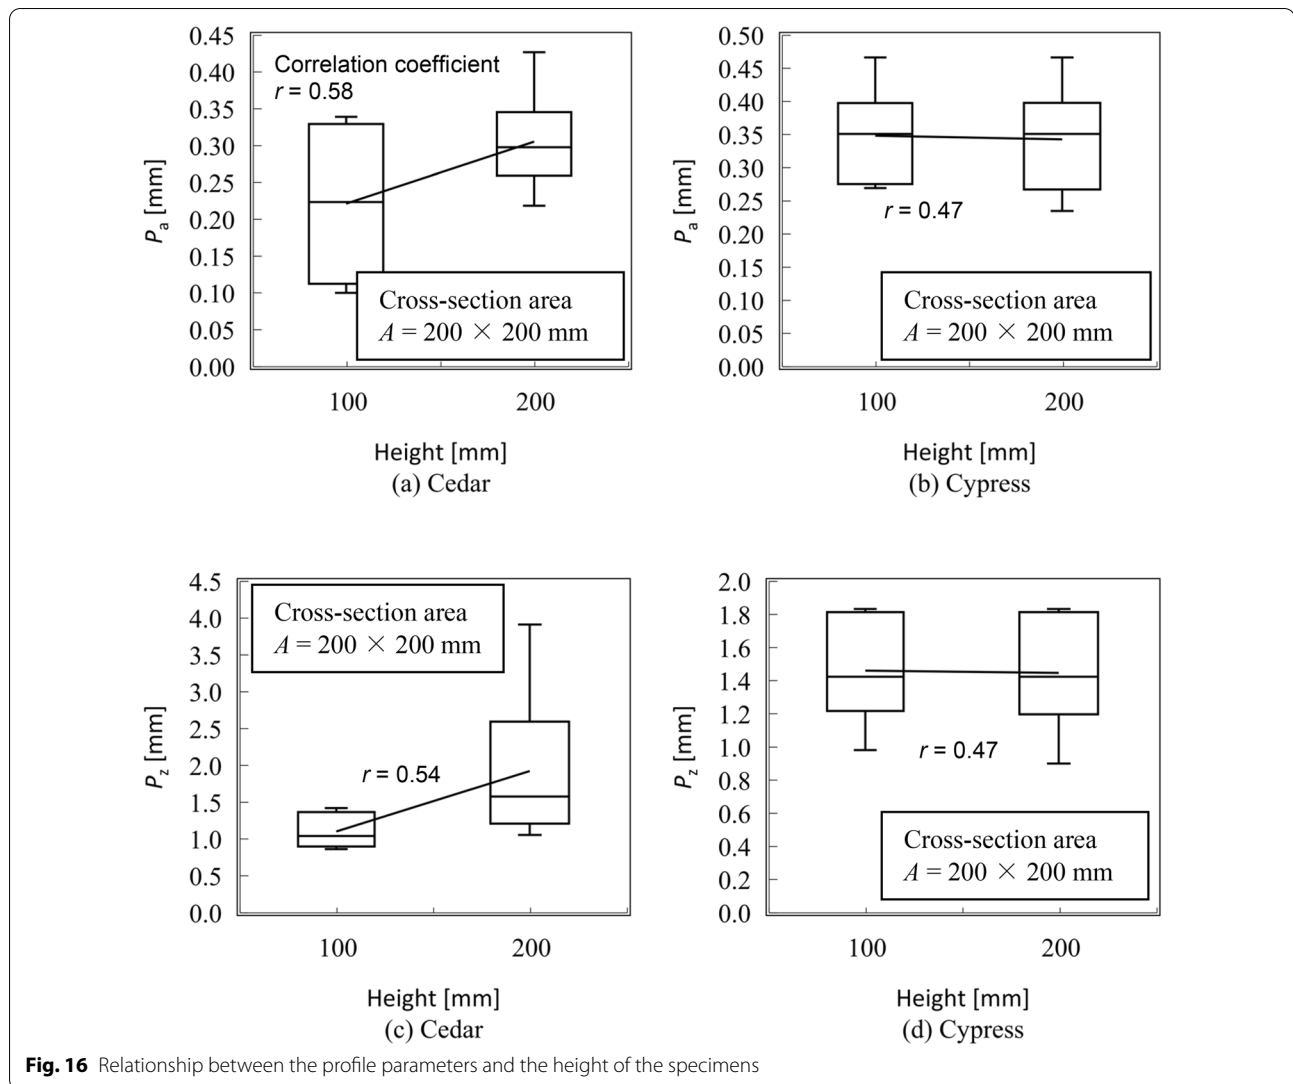
Figure 16 shows a relationship between the profile parameters and the height of the specimens. Lower correlations between the  $P_a$  and  $P_z$  and the height of the specimen were indicated with correlation coefficients of +0.58 ( $P_a$ ) and +0.54 ( $P_z$ ) for the cedar specimens, +0.47 ( $P_a$  and  $P_z$ ) for the cypress specimens. Because it is probable that the length of the damage zone did not depend on the height but the cross-sectional area of the specimens as well as the  $P_a$  and  $P_z$ , it was considered that the cause of the damage zone is the roughness on the contact surface and the length of the damage zone depends on the roughness on the contact surface.

**Fig. 16** Relationship between the profile parameters and the height of the specimens
