Experimental study of FRP-strengthened concrete beams with corroded reinforcement

Yang, J., Haghani Dogaheh, R., Blanksvärd, T. et al (2021). Experimental study of FRP-strengthened concrete beams with corroded reinforcement. *Construction and Building Materials*, 301(2021).
<http://dx.doi.org/10.1016/j.conbuildmat.2021.124076>

Construction and Building Materials

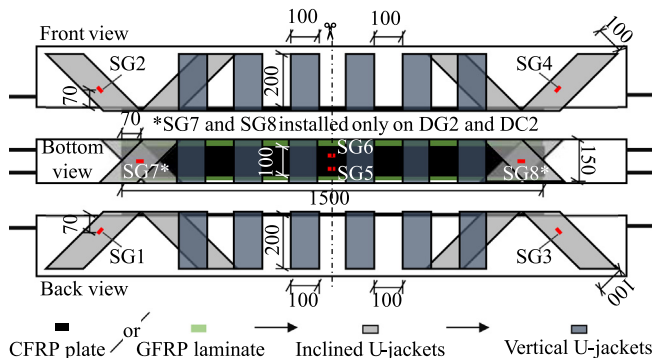
Fig. 3. Schematic of FRP composites applied to deteriorated concrete beams in groups DG and DC, including the position of strain gauges (SG1-SG8).

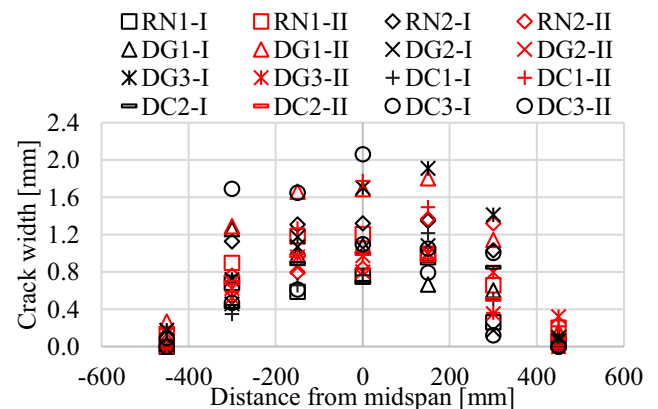
Fig. 5. Width of corrosion-induced cracks measured every 150 mm along all sixteen tensile bars in eight deteriorated beams.

up for the section and plotted in Fig. 5. Although the crack width measurements were widely dispersed, the mean values indicated that the corrosion-induced cracks were wider nearer the midspan. The crack widths at the midspan were in the range of 0.7 to 1.9 mm.
