TOWARDS AN AUTOMATIZED AND OBJECTIVE ASSESSMENT OF DATA FROM VISUAL INSPECTIONS OF BUILDING ENVELOPES

JAN MANDINEC*, PÄR JOHANSSON

*Chalmers University of Technology, Department of Architecture and Civil engineering, Sven Hultins gata 6, 412
58 Gothenburg, Sweden*

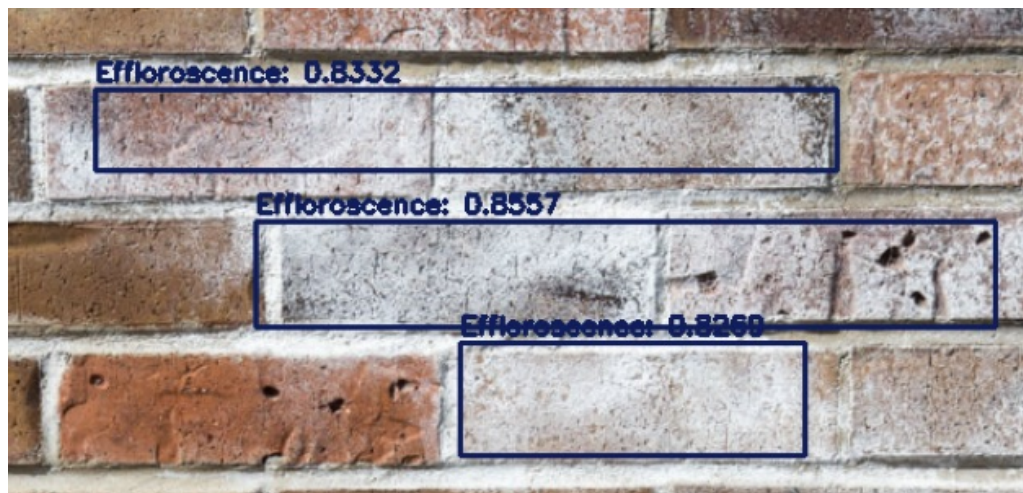
FIGURE 1. Example of output from the Build-Sense model – model draw bounding boxes around damaged area alongside with its level of confidence [18].

The Build-Sense model was originally built for detecting damage on brick walls specializing on drawing bounding boxes around cracks and bricks subjected to spalling and efflorescence. The model is utilizing the concepts of transfer learning and was trained based on 225 images of damaged brick walls (approximately 75 images for each damage type) manually annotated with more than 2000 bounding boxes providing the model with the interpretation of how a damage looks like. Figure 1 shows bounding boxes around efflorescence as they were predicted by Build-Sense model.

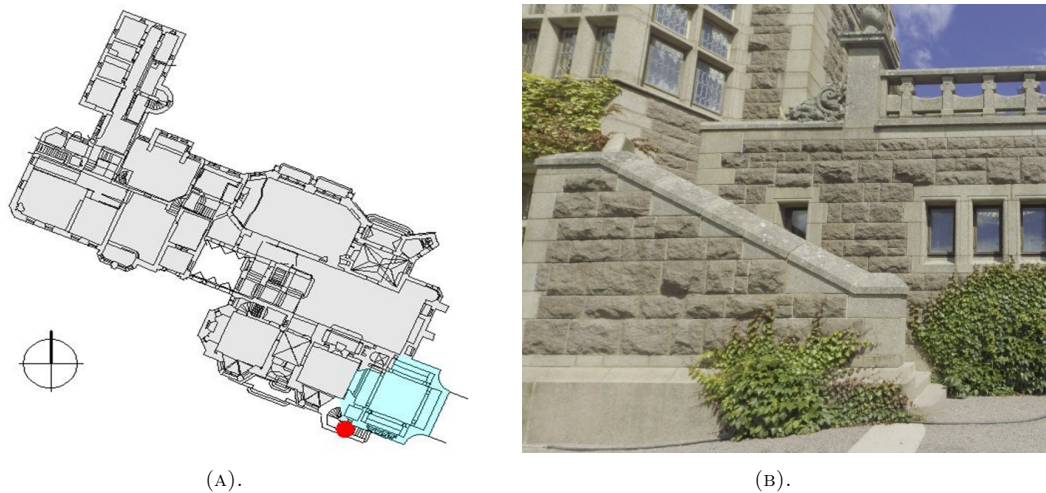
FIGURE 2. (A) Schematic plan on the building's ground floor to the left shows the location where the panoramic photograph was taken (red dot). Gray background indicates multi-storey parts while cyan colour indicates single storey part of the building. (B) Photograph was taken on the stairs leading to the roof of single storey part [19].

Given the fact that joints are continuously disintegrated, mainly on the east side of the south-west façade, the study is limited to the assessment of the Build-Sense model only to one panoramic image which closely depicts the area of interest. The positions of the panoramic image as well as the overall view over the wall of interest is on the Figure 2.

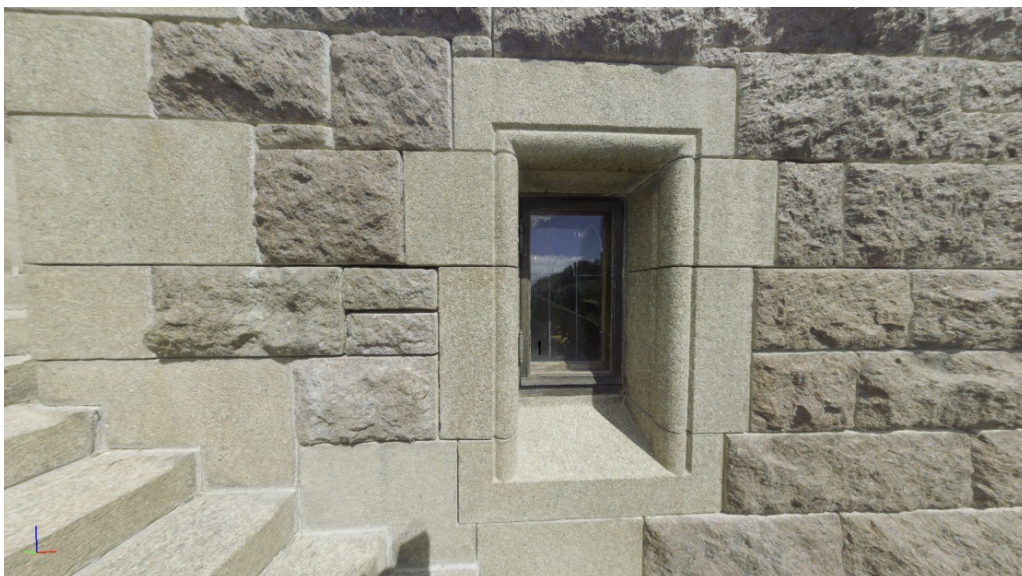
FIGURE 3. Default view from the panoramic image directly facing the area of interest [19].

All images altogether presented in this subchapter were analyzed using retrained Build-Sense model. Figure 3 shows the default (un-zoomed) view from the panoramic image directly facing the building envelope. Note that there are missing joints on the left side of the window. The model there fails to detect any objects of interest.
