Moisture absorption of an aerogel-based coating system under different wetting scenarios

Karim, A., Sasic Kalagasidis, A., Johansson, P. (2023). Moisture absorption of an aerogel-based coating system under different wetting scenarios. *Building and Environment*, 245.
<http://dx.doi.org/10.1016/j.buildenv.2023.110905>

Ali Naman Karim^{*}, Angela Sasic Kalagasidis, Pär Johansson

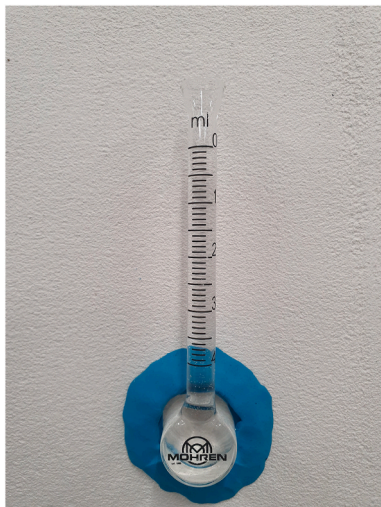
Fig. 8. Karsten tube affixed to the surface of a specimen. A steady water pressure created by 100 mm column corresponds to a wind pressure (1100 Pa) at velocity of 43 m/s.

The second complementary study involved the Karsten tube method, which currently lacks established standards apart from recommendations found in literature [69–71]. The Karsten tube, which consists of a dome with a diameter of 30 mm and a cylindrical tube with a volume of 10 ml (100 mm head of water), was affixed to the front surface of the specimen (Fig. 8). This created a hydrostatic pressure of approximately 1100 Pa, mimicking wind pressure at around 43 m/s wind velocity. The absorbed water was derived manually by monitoring the decreasing volume in the tube at intervals of 1, 5, 10, 15, 30, 60, and 90 min from the start of wetting. Once the volume decreased by 1 ml, it was refilled to maintain a constant pressure. Due to the small contact surface area of the dome, the wetting phase was limited to 90 min. An extended period of wetting would result in water being absorbed by the material surrounding the dome due to capillary forces, stretching the wetting area to an undefined shape and outside the applied pressure.

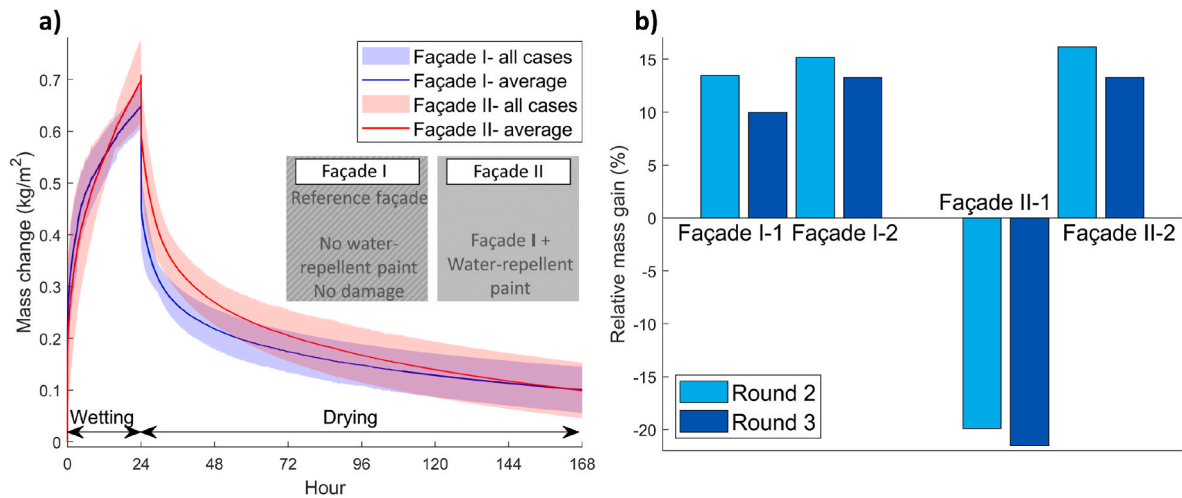
Fig. 9. a) Mass change (kg/m^2) of Façades I-II in the runoff setup. The Shaded graphs represent the total variability in all six rounds of measurements (2 specimens x 3 rounds) for Façades I-II. b) Relative mass gain during the second and third rounds of wetting relative to the first round.

In Fig. 9a, the mass changes (kg/m^2) of Façades I–II during 24 h of wetting and the initial 144 h of drying in the setup are presented. Both Façades I–II exhibited similar performance at wetting and drying. During the first 10 h of wetting, Façade II had up to 6% (0.04 kg/m^2) lower average mass gain, indicating a potentially higher runoff rate compared to Façade I. In contrast, after 24 h of wetting, Façade II had 9% (0.06 kg/m^2) higher average mass gain, suggesting increased runoff for Façade I as the outermost layer became saturated. During the initial 144 h of drying, approximately 85% (0.52 kg/m^2) of the total moisture absorbed by Façades I–II dried out. The average drying rate differed by about 2% between the two façades during this drying phase.

Fig. 9b illustrates the relative mass gain in percentage $((V_3 - V_1) \cdot 100 / V_1)$ during the second or third round of wetting (V_3) compared to the first round (V_1) for each specimen. For one specimen of Façade II (II-2) and both of Façade I, the mass gain during the second and third round of wetting increased by 10–16%, with a smaller increase observed between the second and third rounds. In contrast, for Façade II-1, the mass gain decreased by approximately 20% during the second and third rounds of wetting compared to the first round.

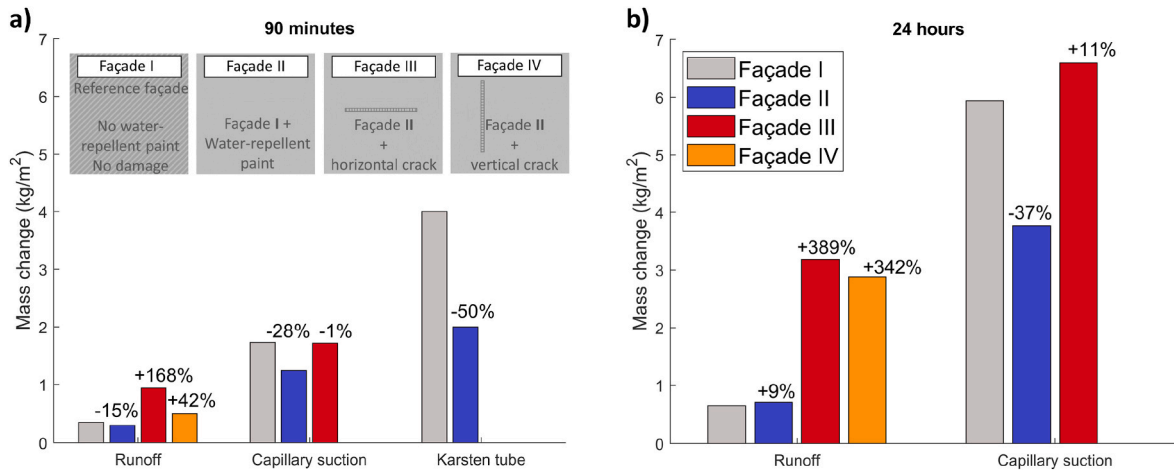
Fig. 16. Comparison of the maximum water absorption of Façades I-IV for different wetting scenarios, at short-term (a) and long-term (b). The relative mass gain between Façades II-IV and Façade I for the same wetting scenario is also provided. For the capillary suction test, the damaged façade was represented by Façade III only as the crack orientation was irrelevant. The Karsten tube tests only involved Façades I-II.

Fig. 16 presents a comparative analysis of the maximum moisture absorption of Façades I-IV for the three wetting scenarios, i.e. runoff, capillary suction, and the Karsten tube. The results are presented for

short-term (represented by 90 min) and long-term (24 h) wetting. For each wetting scenario, the absolute mass change (kg/m^2) and the relative mass gain (%) of Façades II-IV compared to Façade I (reference case) are provided. To be noted is the difference between the crack length of the damaged façades used in the runoff setup (crack length: 300 mm, wall surface: $600 \times 400 \text{ mm}^2$, ratio: 5/10 or 7.5/10) and those used in the capillary suction test (crack length: 30 mm, wall surface: $100 \times 100 \text{ mm}^2$, ratio: 3/10).

For the wetting scenarios examined, runoff wetting resulted in the lowest water absorption for all Façades. Façade III had the highest mass gain, approximately 1.0 kg/m^2 at 90 min and 3.2 kg/m^2 at 24 h of runoff wetting. In contrast, Façade I had values of 0.4 kg/m^2 and 0.6 kg/m^2 for the same time intervals, respectively. Façade II, with water-repellent paint, showed 15% lower mass change than Façade I for short-term wetting and 9% higher mass change for long-term wetting. Among Façades III-IV, Façade III with a horizontal crack had the maximum mass increase.

In the capillary suction test, Façade II had the lowest mass increase, while the damaged Façade III had the highest. The water absorption of Façade II was 28% and 37% lower than Façade I after 90 min and 24 h of wetting, respectively. Façade III had water absorption that was 1% lower and 11% higher than Façade I after the same time intervals. In the Karsten tube test, Façade II had 50% lower water absorption compared to Façade I. As depicted in Fig. 15, the water absorption of Façade II and I after 1 min was around 0 and 0.6 kg/m^2 , respectively. The latter value is comparable to the average water absorption of Façade I during 24 h of runoff wetting. The mass increase for Façade I after 90 min of Karsten tube wetting was around 4.0 kg/m^2 , while it was approximately 1.7 kg/m^2 and 0.35 kg/m^2 for capillary suction and runoff wetting,

respectively. This implies that wetting with high pressure difference over the façade (1100 Pa) could result in 2–12 times greater water absorption compared to wetting with low hydrostatic pressure.
