Monitoring corrosion-induced concrete cracking adjacent to the steel-concrete interface

Alhede, A., Dijkstra, J., Lundgren, K. (2023). Monitoring corrosion-induced concrete cracking adjacent to the steel-concrete interface. *Materials and Structures/Materiaux et Constructions*, 56(9). <http://dx.doi.org/10.1617/s11527-023-02252-3>

Andreas Alhede · Jelke Dijkstra · Karin Lundgren

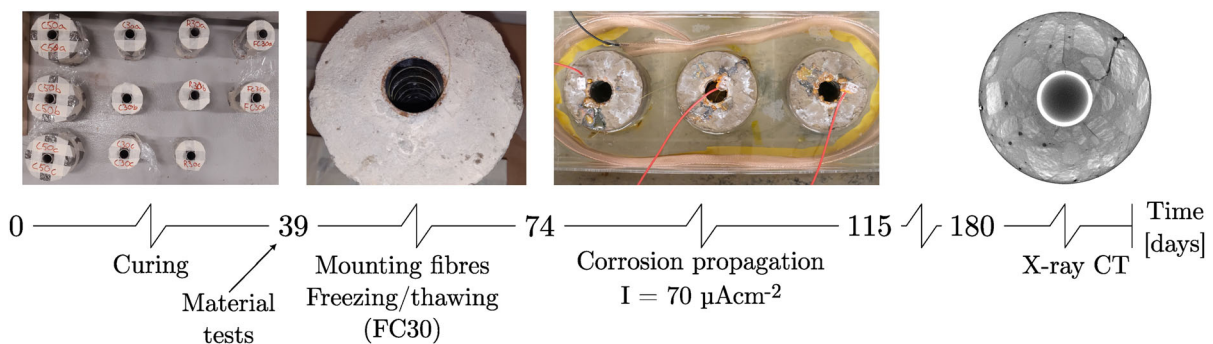
Fig. 1 Timeline of the experiments. Material tests took place 39 days after casting. The corrosion propagation period started 74 days after casting and lasted for 41 days. Specimens of types

C30, FC30 and R30 were scanned using XCT approximately 180 days after casting

corrosion period, most of the specimens were scanned using XCT, from which cracking and corrosion level were evaluated. A timeline of the test procedure is shown in Fig. 1. In the following, the experimental programme, material and methods are elaborated.

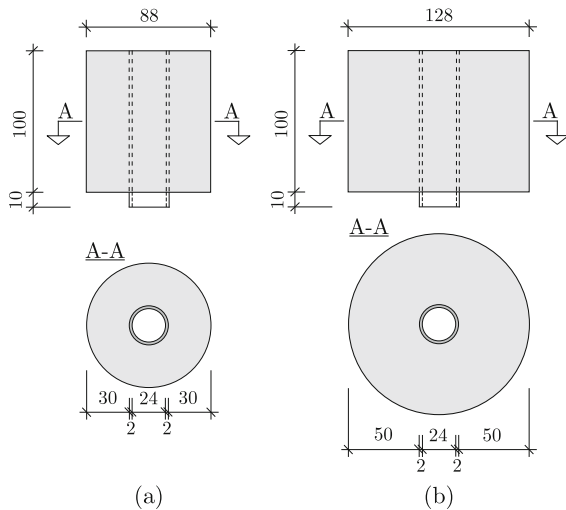
**Fig. 2** Geometry of specimens in series **a** C30, FC30, R30 and **b** C50**Table 2** Concrete mix proportions and mechanical properties measured 28 days after curing

The experimental programme consisted of four different test conditions as listed in Table 1. In addition to the reference tests without accelerated corrosion, the impact of concrete cover thickness and prior freezing damage on the steel corrosion was investigated in additional test types. In total, eleven specimens were included in the experimental programme. The dimensions of the specimens were chosen to ensure a concrete cover thickness of reasonable size compared to the ones used in real structures, while simultaneously achieving a sufficiently high resolution in the XCT scans. Further, the wall thickness and the inner radius of the hollow steel bar were chosen to ensure that the strain on the inside was measurable [19]. All specimens were 100 mm long. The cross-sectional diameter varied from 88 mm for series C30, FC30 and R30, to 128 mm for series C50. A hollow steel bar with outer diameter 28 mm and a wall thickness of 2 mm was cast in the centre of each specimen. The steel bar protruded 10 mm from the bottom surface, see Fig. 2.

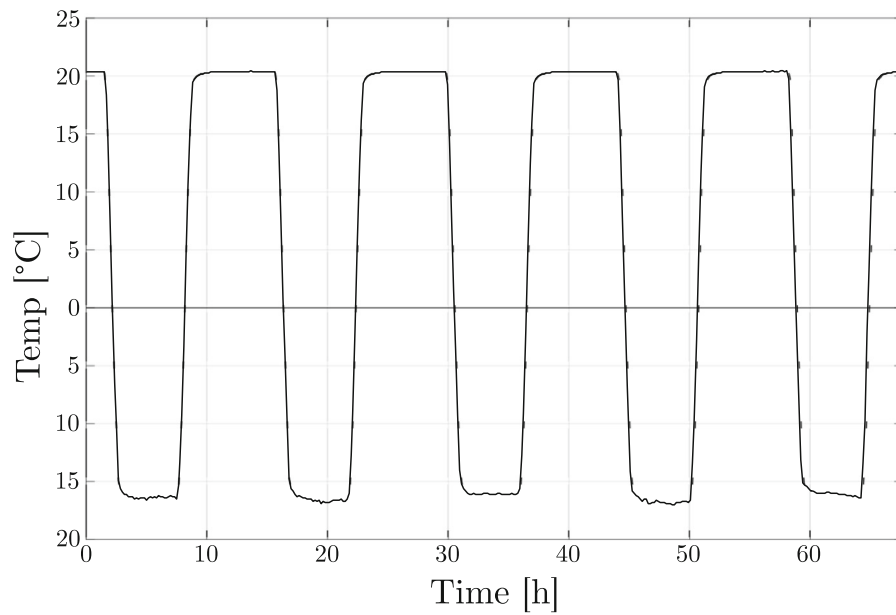
Fig. 3 Ambient air temperature during the freezing and thawing cycles applied to FC30

Prior to accelerated corrosion, the specimens of type FC30 were subjected to freezing and thawing cycles. The specimens were immersed in water for a short time and thereafter wrapped in plastic film to prevent drying and subsequently placed in a climate chamber. The samples were subjected to five temperature cycles between a maximum and minimum temperature of 20 °C and −16 °C, as shown in Fig. 3. The period of each cycle was 14 h.

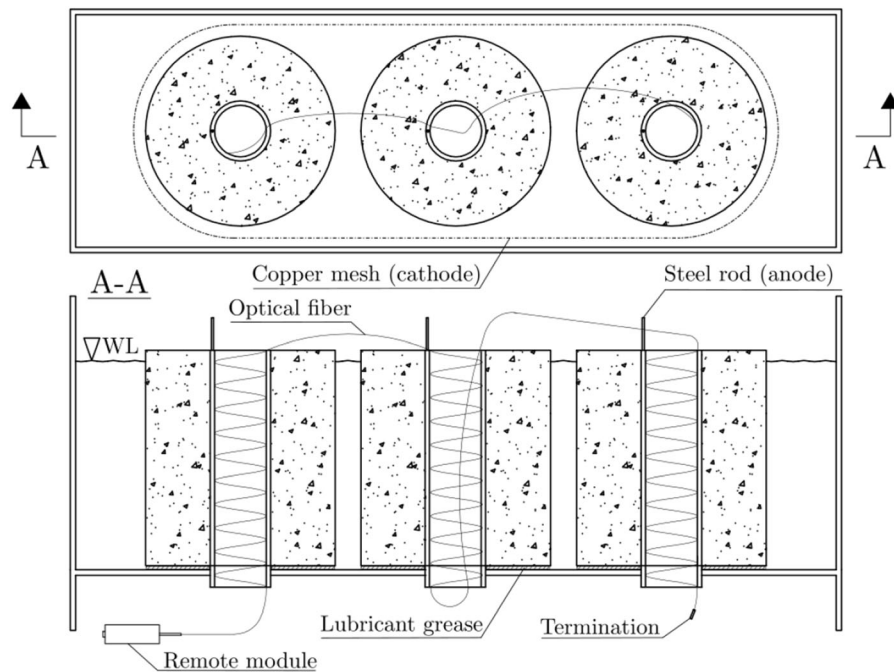
Fig. 4 Experimental setup for test types C30, C50 and FC30. Electrical current was applied to steel rods, welded to the steel bars, and a copper mesh, acting as a cathode, was placed around the specimens to complete the circuit

To accelerate corrosion, electrical current was applied to steel rods, welded to the hollow steel bars, and a copper mesh, acting as a cathode, was placed around the specimens to close the electrical circuit. The applied current density was limited to $70 \mu\text{A cm}^{-2}$, which is considered to be a reasonable value to balance the conflicting requirements of mimicking natural corrosion and the need for short duration corrosion tests [24]. A custom made constant current source with multiple channels was used to apply an electrical current for a period of 41 days. This current source maintained the current density by adjusting the magnitude of the potential difference when the electrical resistivity in the sample changed.

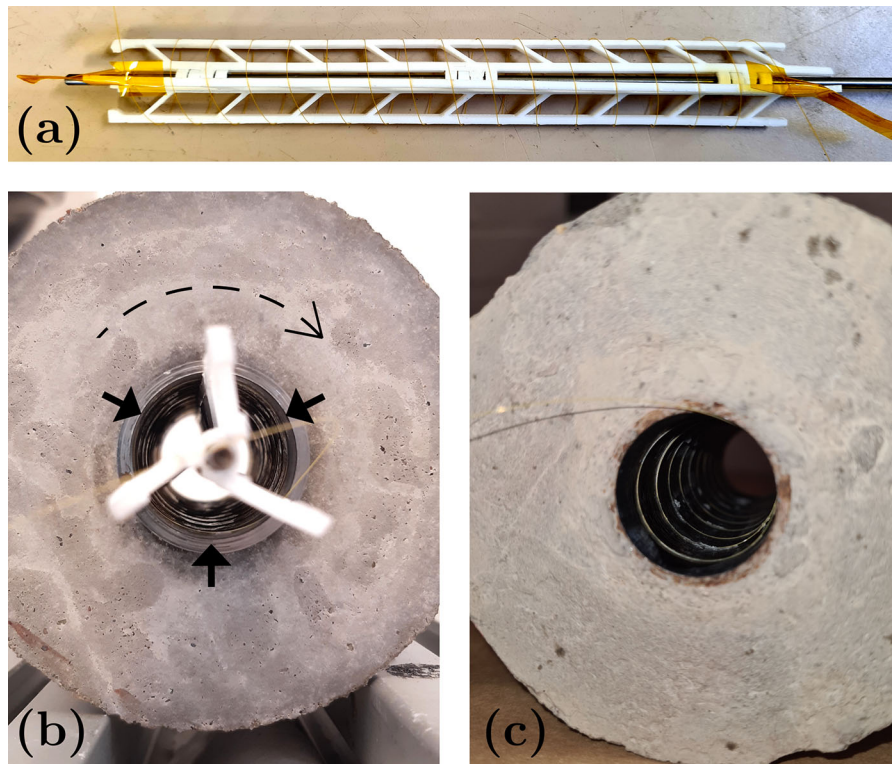
Fig. 5 Process of gluing the fibre on the internal surface of the hollow steel bar. **a** An optical fibre wound around the arms of the tool, restrained with tape. **b** Positioning of the fibre inside the hollow steel bar. The fibre obtained its helical shape by

removing the tape and by rotating the tool around its length, as indicated by the dashed arrow. The fibre was bonded to the steel by gluing the parts in between the plastic arms (solid black arrows). **c** Removal of the tool and additional gluing

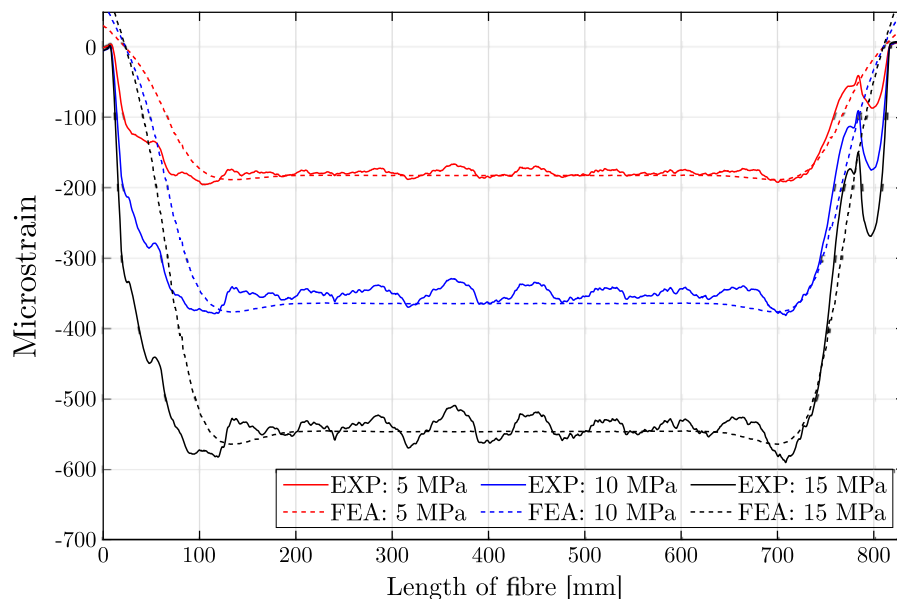
Fig. 6 Measurements of the strain in the fibre when a single instrumented hollow steel bar was subjected to a uniformly distributed hydraulic pressure on the outer surface of the steel in a pressure chamber. Experimental and numerical results, respectively

The suitability of the instrumentation strategy was evaluated by testing the response of a single instrumented hollow steel bar in a pressure chamber. An optical fibre was attached to the inner surface of the hollow steel bar in a similar helical shape as the corrosion experiments. The outer surface of the hollow steel bar was subjected to a uniformly distributed hydraulic pressure of different magnitudes, whilst

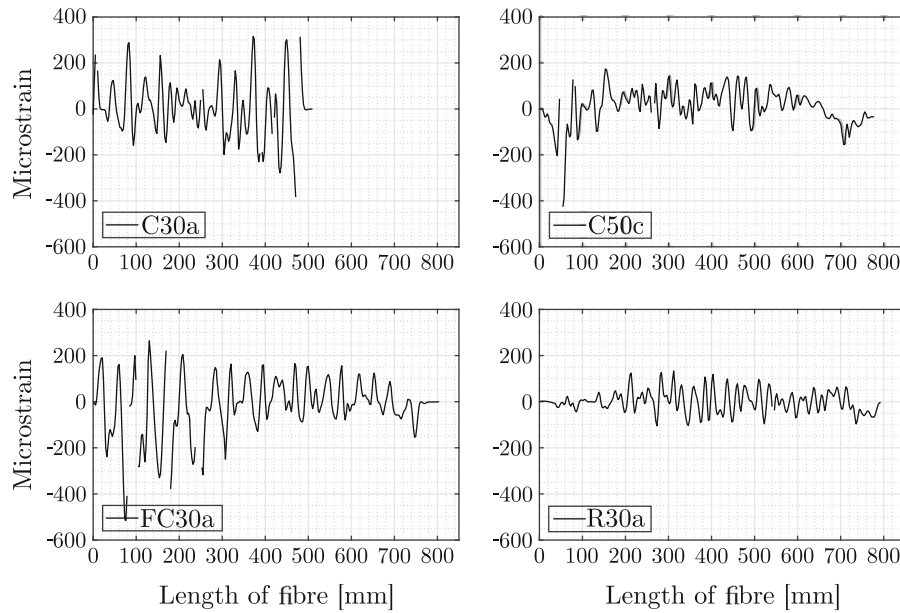
Fig. 7 Profiles of measured strain for four different specimens after one day of impressed current. The strain measurements start from the top surface of the specimens, i.e. the measurements start from the end facing the air and continue downwards

in the steel bars. Note that the length of the fibre in specimen C30a is shorter compared to the others, as this particular fibre had fewer turns

In Fig. 7, strain profiles along the fibre measured after one day of corrosion propagation are presented for one specimen in each series. In these measurements, the strains are relative to the strain in the specimens prior to the corrosion experiment, as a new reference configuration was initialised for each fibre before corrosion started. As can be seen, the strain profiles for

all specimens displayed fluctuating measures of extension and shortening along the fibre length, indicating a non-uniform distribution of radial stress at the surface of the steel. The reason for this behaviour of strain measurements is further discussed in Sect. 3.4. The reference specimen, R30a, had lower peak values of the strain than the specimens with the same geometry subjected to accelerated corrosion, C30a and FC30a. Also, in general, C50c displayed lower peak values than C30a and FC30a.

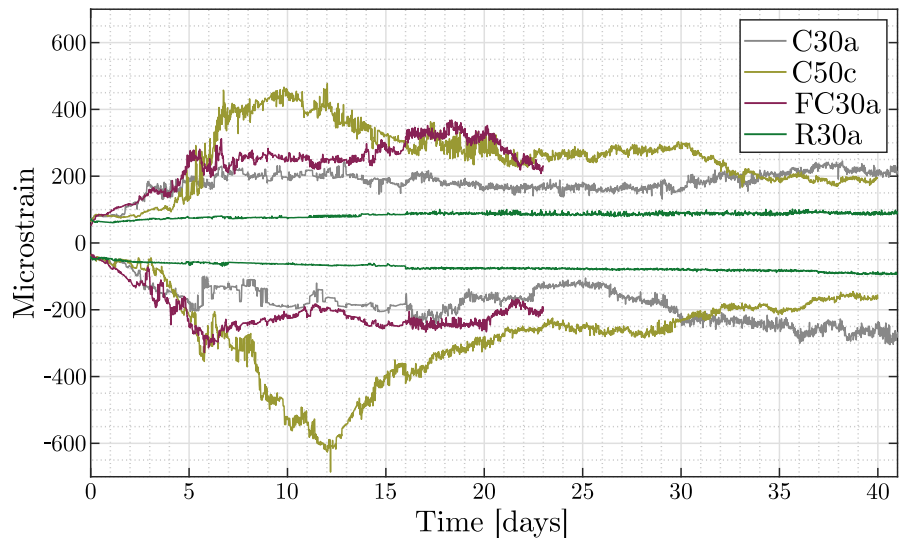
Fig. 8 Average strain of local maxima and minima of each fluctuation cycle (Fig. 7), respectively, along the optical fibre, as a function of time. (R)efERENCE, (C)ORROSION and (F)ROST damaged sample with 30 or 50 mm concrete cover thickness

To study the strain development with time, the mean value of local maxima and minima of each fluctuation cycle were studied (Fig. 7). These mean values and its development with time are shown in Fig. 8 for specimens C30a, FC30a, C50c and R30a. The strain showed the smallest peak values in the reference specimen, R30a. The average strain increment evolved slowly, less than ± 50 microstrain, over the entire period in this specimen. For specimen C30a, the average strain increased to approximately ± 200 microstrain after five days of corrosion propagation. After seventeen days, the strain decreased slightly but increased again after twenty-six days. Largest strain magnitudes were obtained for specimen C50c (with a larger cover), with 450 and -650 microstrain measured after 12 days and thereafter reducing values. For FC30a (subjected to freeze-thawing before corrosion), the strain increased in magnitude approximately linearly up to ± 300 microstrain. Thus, FC30a had slightly larger strain values than the corresponding specimen C30a subjected to corrosion only. Unfortunately, at day twenty-three in the experiment, the fibre broke, which is why no measurements were obtained for FC30a after this period.

The thickness of the concrete cover affected the measured strain in the optical fibre (Fig. 8). For C50c, the strains were larger and the peak occurred later compared to the other specimens. Therefore, a larger

radial pressure and more energy was required to crack the larger concrete cover. For specimens C30a and FC30a, small differences were observed, as seen in Fig. 8. However, no consistent difference could be observed when comparing measurements on all specimens of type C30 and FC30. This may be related to the small number of freeze and thaw cycles (5) applied prior to corrosion, thus their limited impact on the capacity of the concrete cover [28, 29].

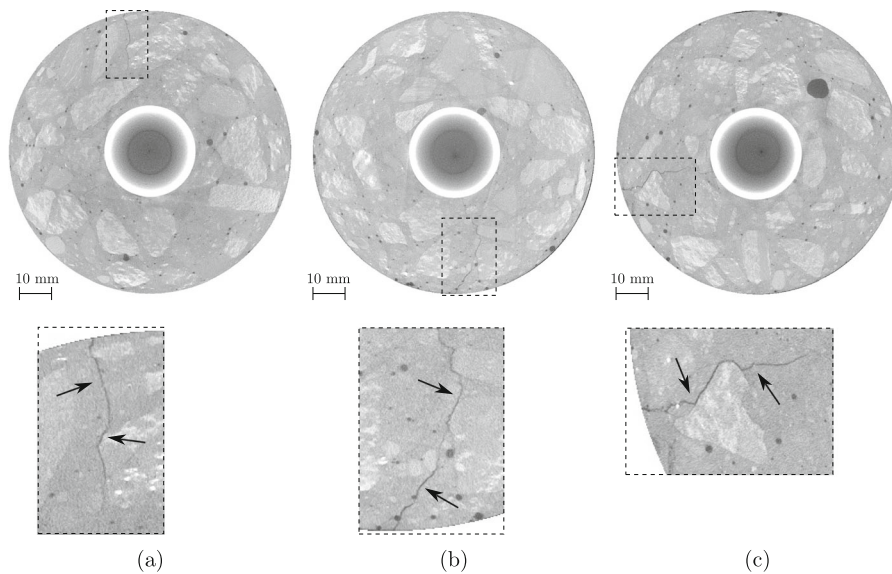
Fig. 9 One cross-sectional slice of **a** R30a, **b** R30b and **c** RC30c, respectively. The images reveal cracking, as indicated by the solid black arrows

XCT was carried out on the specimens of types C30, FC30 and R30 after the corrosion phase. Figure 9 shows one cross-sectional slice for all reference specimens (R30). Cracks in the concrete cover can be identified for all specimens, as indicated with solid arrows. The width of the cover cracks increased with the radial distance from the steel. The XCT data did not reveal corrosion products in the scanned reference specimens, indicating non-corroded condition of the steel. Hence, cover cracking of the reference specimens was probably caused by another mechanism than

In Fig. 9, the XCT data revealed the presence of longitudinal cracks in the concrete of the reference specimens. These cracks were determined to be unrelated to corrosion, as the steel appeared non-corroded in the XCT data which was further corroborated after sandblasting of the extracted steel, as shown in Table 3. All specimens underwent two drying phases; when the optical fibres were mounted and prior to the XCT scan (see Fig. 1). During these phases, drying shrinkage took place, thus imposing restraint stresses in the specimens prior to the corrosion experiment. Despite cracks were not observed on the surface of the specimens prior to the corrosion experiment, the possibility exists that restraint stresses and subsequently internal micro-cracks were induced by shrinkage. However, as a new reference configuration was established for the fibres with respect to these restraint stresses prior to the corrosion experiment, only the change in strain from this state was monitored (Figs. 7 and 8). Therefore, any quantitative assessment of these restraint stresses in the specimens before corrosion started could not be performed.

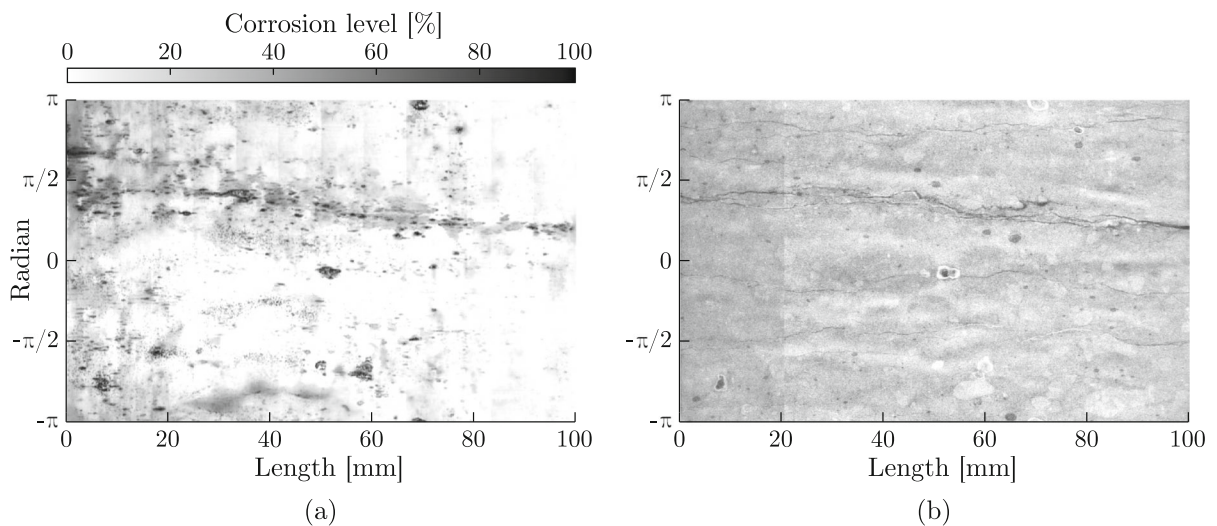
Fig. 10 C30a **a** Corrosion level, and **b** internal cracking as a function of radian and length of the specimen

In Fig. 10, a contour plot of the corrosion level and XCT data revealing internal concrete cracking close to the steel is shown for C30a, over both the radian and length of the specimen. The left and right vertical boundaries of each figure corresponds to the top and bottom side of the specimen, respectively. The internal

cracking in Fig. 10b was evaluated at a radial distance 1.6 mm from the surface of the bar, see circle R1 in Fig. 12a. The evaluation of grey-scale values at the positioning of the circle was done by interpolation of nearest-neighbouring pixels. Note that the corrosion levels are quite large, up to 98%, as they were calculated for the tube, not a solid bar. The corrosion level appears to be non-uniform around the bar, with a

localised band of corrosion along the length. Interestingly, a larger crack (Fig. 10b) can be seen in the same region. In total, five radial cracks can be identified. Some deep corrosion pits can also be observed (Fig. 10a), and it can be noticed that their location agrees with air voids visible in Fig. 10b.

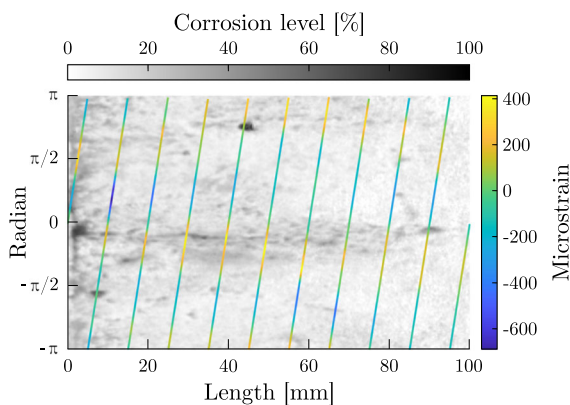
Fig. 11 Specimen C50c: Corrosion level as a function of the radian and length of the specimen. The lines represent the optical fibre and corresponding strain measurements at the last recording

In the following, the interaction between measured strains and corrosion levels is studied. In Fig. 11, strain measurements are superimposed on contour plots of the corrosion level for C50c. The distributed strains correspond to measurements recorded at the end of the corrosion phase. The positioning of the fibre was determined qualitatively by counting the number of turns of the helix and their approximate height per turn. The distribution of the incremental strain can be seen to vary from shortening to extension, as already shown in Fig. 7. In general, in regions where the corrosion level was low, shortening strains can be observed. One localised band with larger corrosion level can be observed along the length of the steel. In

this region, extension strains in the steel were induced. This is further discussed in Sect. 4.

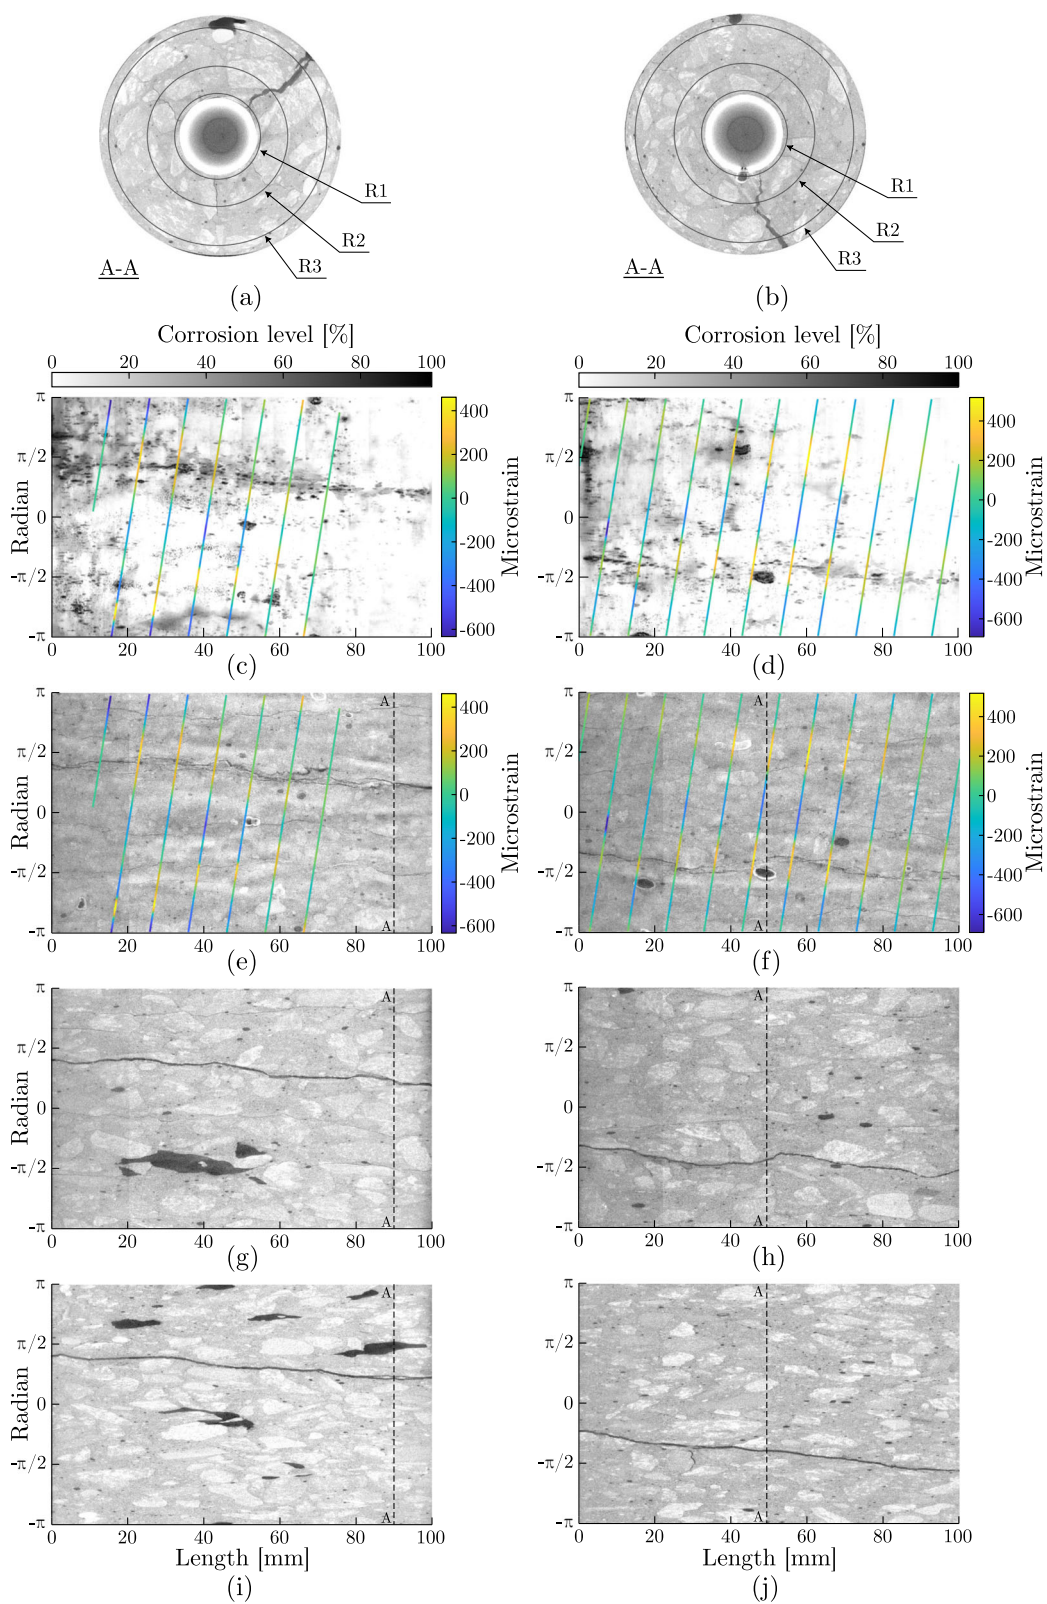
◀ **Fig. 12** Corrosion level, concrete cracking and strain measurements along the optical fibre, shown for C30a (left column) and FC30a (right column). **a–b** One cross-sectional slice of each specimen. **c–d** Corrosion level and strain measurements at the end of the experiment. **e–f** Internal concrete cracking, evaluated at radius R1, and strain measurements at the end of the experiment. **g–h** Internal concrete cracking evaluated at radius R2. **i–j** Internal concrete cracking evaluated at radius R3

The interaction between corrosion level, measured strain in the fibre, and concrete cracking was studied for C30a and FC30a and shown in Fig. 12. Below the cross-sectional slices of the specimens (i.e. Fig. 12a–b), the corresponding distribution of corrosion level and measured strain in the fibre at the end of the corrosion phase are shown (Fig. 12c–d). Analogously, the distribution of concrete cracks are evaluated at three different radial distances from the surface of the steel bars. Figure 12e–f show the distribution of concrete cracks along radial distance R1 for each corresponding specimen, with the measured strain as an overlay. Cracking shown in Figs. 12g–h and 12i–j are evaluated along radial distance R2 and R3, respectively. Close to the SCI, several micro-cracks can be observed (Fig. 12e–f). However, cracking localised into one larger crack for each specimen, as seen in Fig. 12g–j. A localised band of corrosion runs along the length of both specimens, correlating well with the position of the larger cover crack. This indicates that corrosion localised into bands in these regions after cracking of the cover. The hollow steel bars displayed extension strains in the regions where the dominant crack was located. This is clearly visible for FC30b (Fig. 12f), where the peaks in strain along the fibre follows the crack pattern with good precision. For C30a (Fig. 12e), the locations of the peak values in strain correlate well with the crack pattern for the first three turns of the fibre, but deviates slightly for subsequent turns. This deviation is likely due to uncertainties in the positioning of the fibre, which was difficult to determine. For the data presented herein, the extension strains, measured in correspondence to the cover crack, can be interpreted as indicative of stress relief, as the strain measurements are relative to the residual state prior to corrosion.

The distribution of hoop strain around the steel was found to be non-uniform for all specimens during the complete corrosion experiment, with hoop strains varying from extension to shortening. Additionally, a non-uniform distribution of corrosion products was observed in all specimens exposed to accelerated corrosion, i.e. C50c (Fig. 11), C30a and FC30a (Fig. 12). These specimens showed a localised band
