Alhede, A., Dijkstra, J., Lundgren, K. (2023). Monitoring corrosion-induced concrete cracking adjacent to the steel-concrete interface. *Materials and Structures/Materiaux et Constructions*, 56(9). <http://dx.doi.org/10.1617/s11527-023-02252-3>

Monitoring corrosion-induced concrete cracking adjacent to the steel-concrete interface

Andreas Alhede · Jelke Dijkstra · Karin Lundgren

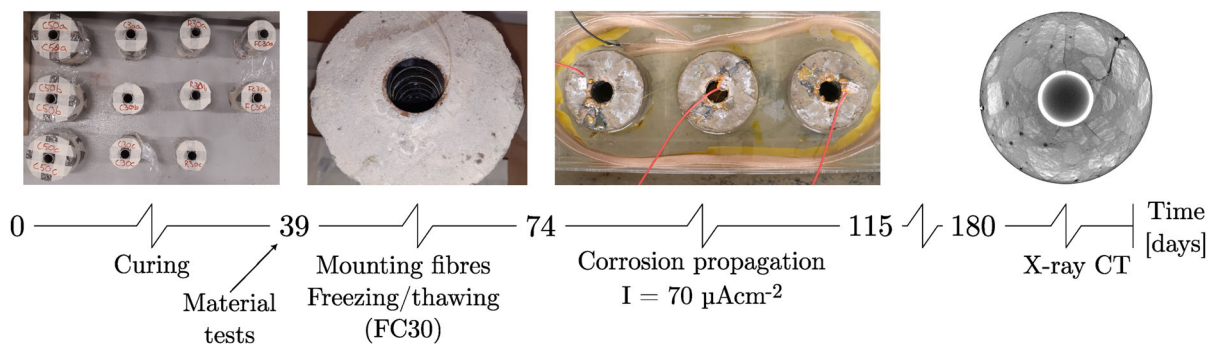
Fig. 1 Timeline of the experiments. Material tests took place 39 days after casting. The corrosion propagation period started 74 days after casting and lasted for 41 days. Specimens of types

C30, FC30 and R30 were scanned using XCT approximately 180 days after casting

corrosion period, most of the specimens were scanned using XCT, from which cracking and corrosion level were evaluated. A timeline of the test procedure is shown in Fig. 1. In the following, the experimental programme, material and methods are elaborated.

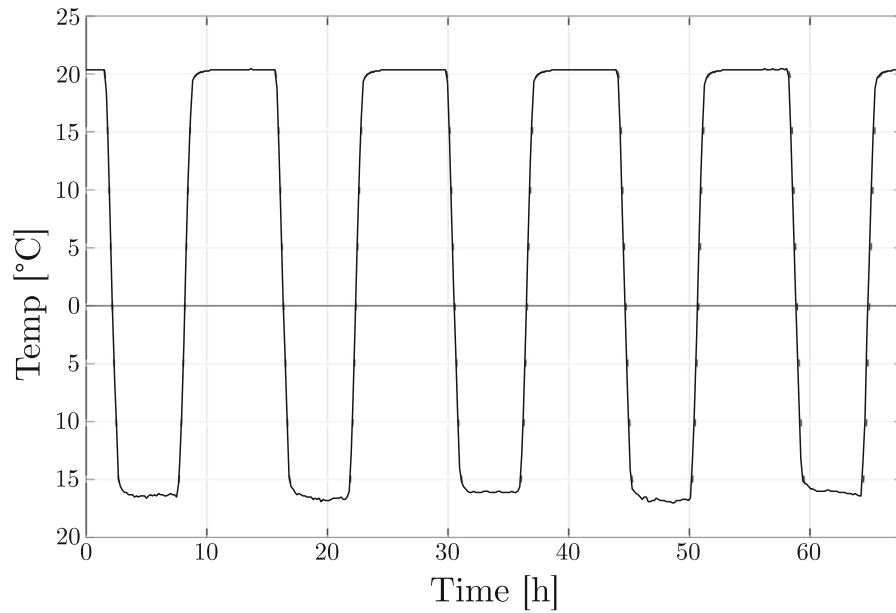
Fig. 3 Ambient air temperature during the freezing and thawing cycles applied to FC30

Prior to accelerated corrosion, the specimens of type FC30 were subjected to freezing and thawing cycles. The specimens were immersed in water for a short time and thereafter wrapped in plastic film to prevent drying and subsequently placed in a climate chamber. The samples were subjected to five temperature cycles between a maximum and minimum temperature of 20 °C and −16 °C, as shown in Fig. 3. The period of each cycle was 14 h.

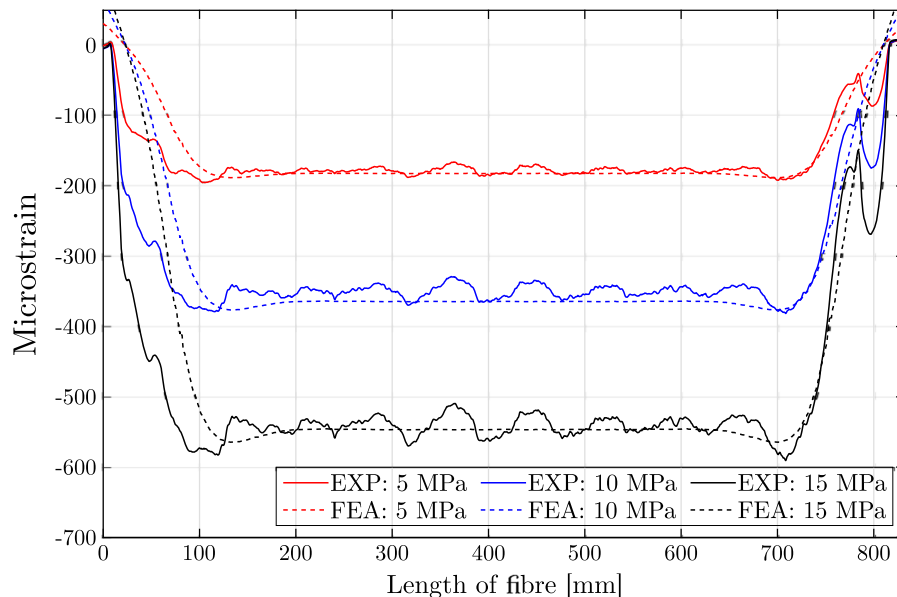
Fig. 6 Measurements of the strain in the fibre when a single instrumented hollow steel bar was subjected to a uniformly distributed hydraulic pressure on the outer surface of the steel in a pressure chamber. Experimental and numerical results, respectively

The suitability of the instrumentation strategy was evaluated by testing the response of a single instrumented hollow steel bar in a pressure chamber. An optical fibre was attached to the inner surface of the hollow steel bar in a similar helical shape as the corrosion experiments. The outer surface of the hollow steel bar was subjected to a uniformly distributed hydraulic pressure of different magnitudes, whilst

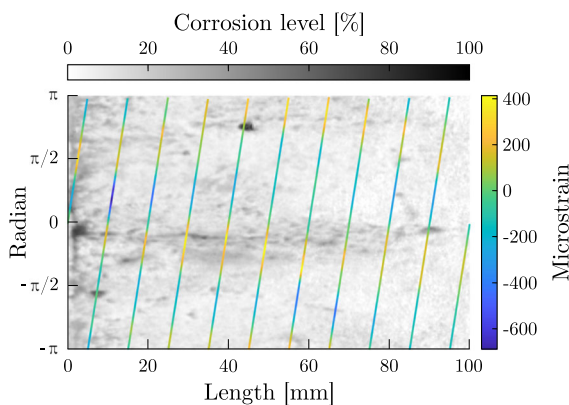
Fig. 11 Specimen C50c: Corrosion level as a function of the radian and length of the specimen. The lines represent the optical fibre and corresponding strain measurements at the last recording

In the following, the interaction between measured strains and corrosion levels is studied. In Fig. 11, strain measurements are superimposed on contour plots of the corrosion level for C50c. The distributed strains correspond to measurements recorded at the end of the corrosion phase. The positioning of the fibre was determined qualitatively by counting the number of turns of the helix and their approximate height per turn. The distribution of the incremental strain can be seen to vary from shortening to extension, as already shown in Fig. 7. In general, in regions where the corrosion level was low, shortening strains can be observed. One localised band with larger corrosion level can be observed along the length of the steel. In

this region, extension strains in the steel were induced. This is further discussed in Sect. 4.
