## **Machining of additively manufactured alloy 718 in as-built and heat-treated condition: surface integrity and cutting tool wear**

Holmberg, J., Berglund, J., Brohede, U. et al (2024). Machining of additively manufactured alloy 718 in as-built and heat-treated condition: surface integrity and cutting tool wear. *International Journal of Advanced Manufacturing Technology*, 130(3-4): 1823-1842. <http://dx.doi.org/10.1007/s00170-023-12727-w>

**Keywords** Additive manufacturing · Alloy 718 · Machining · Tool wear · Surface integrity

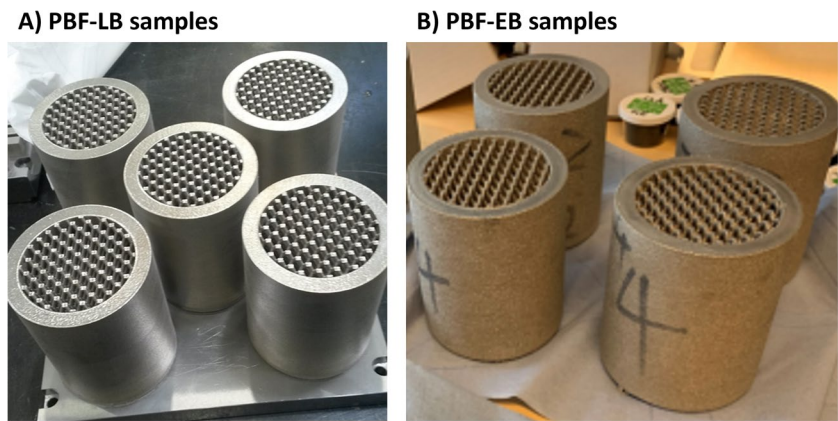
**Fig. 1** Printed test objects from the PBF-LB (A) and PBF-EB (B) process as examined here

Tubular test samples were manufactured with the following design dimensions: length of 110 mm, outer diameter of 90 mm and wall thickness of 10 mm. The build direction was along the symmetry axis of the tubular samples. An internal lattice structure was used to improve the strength and to reduce distortion caused by the repeating heating and cooling during the printing process.

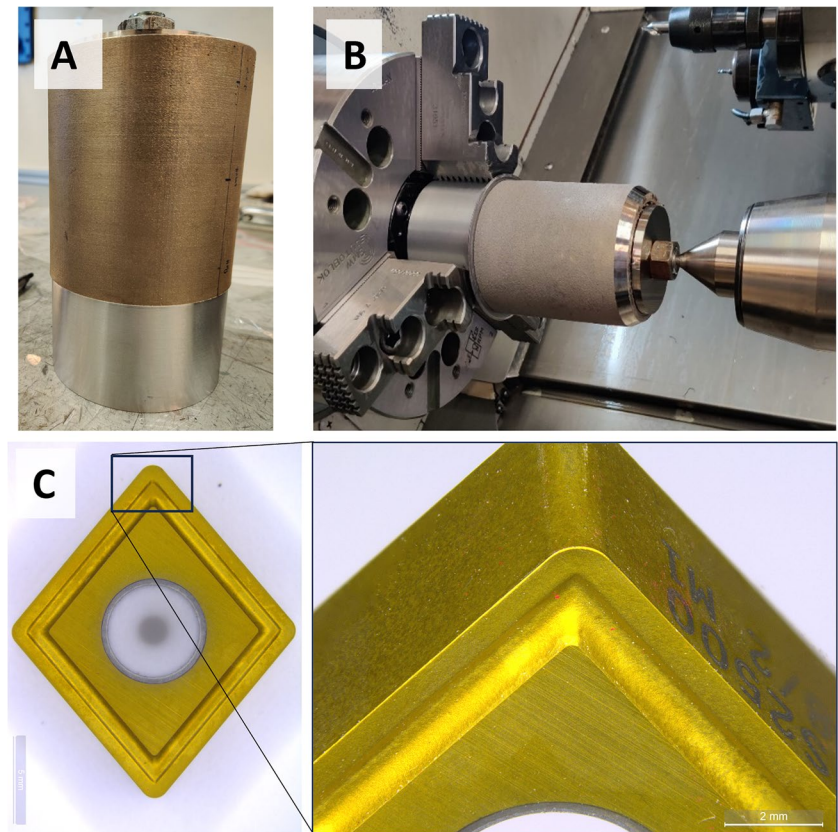
**Fig. 2** Overview of the turning test sample clamping design (A), set-up in the lathe (B), and overview of the insert used for the turning tests (C)

The turning tests were performed in a CNC Okuma LB300-M lathe. The samples were asymmetrical and difficult to machine; hence, a fixture was created as well as a 45° chamfer to enable a stable tool entry and eliminate the risk of tool failure (see Fig. 2). The machining test was done in two steps: step 1, roughing to remove the asymmetry; and step 2, a cutting test to study surface integrity after machining and the associated tool wear. Step 1, also referred to as “cleaning cut,” involved 3 cutting passes in the as-printed condition and 2 cutting passes in the heat-treated condition with the

Machining parameters, used for both “cleaning cuts” and cutting tests, selected on the tool manufacturer’s recommendation for conventional alloy 718 and with the target to remove the least amount of material until a cleaned surface is achieved: cutting speed ( $v_c$ ) 70 m/min, feed rate ( $f$ ) 0.075 mm/rev, and depth of cut ( $a_p$ ) 0.3 mm. All machining tests were conducted with flood coolant. As cutting tools, the PVD-coated carbide inserts ISO CNMG 12 0408–TS2500 were used, with geometry as seen in Fig. 2 and a corner

radius of 0.8 mm, clearance angle of  $0^\circ$  and edge radius of approximately  $32 \pm 2 \mu\text{m}$ , as measured for a new insert. Table 3 shows the test matrix that was used in this study. The purpose of the clean cut was to secure continuous cutting conditions during the cutting test.

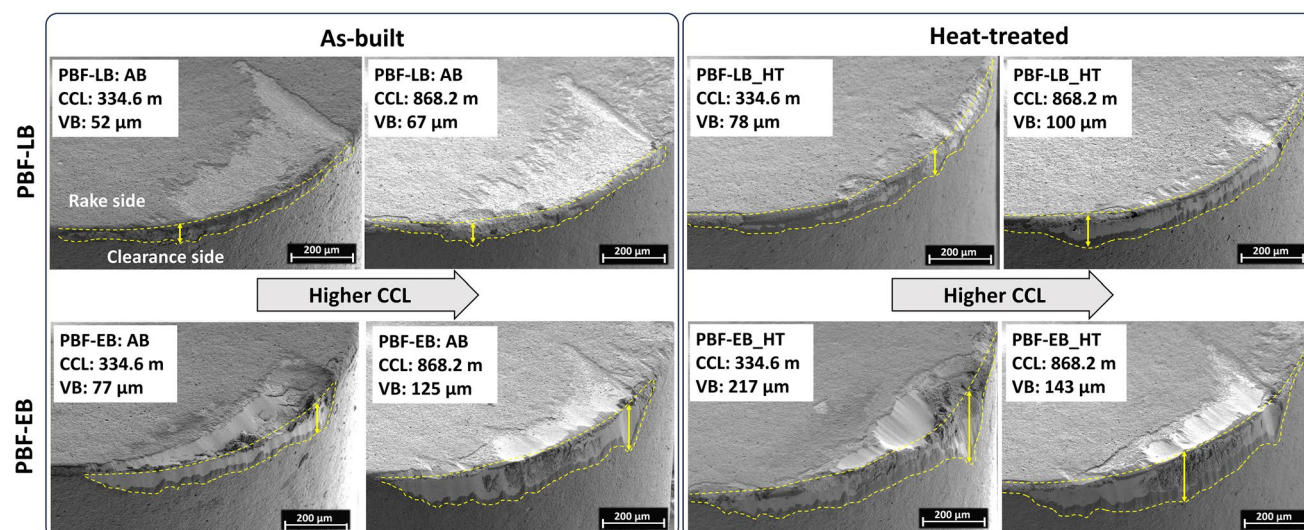
**Fig. 3** SEM images in  $\times 300$  magnification of tool flank wear ( $VB_{Max}$ ) propagation for as-built and heat-treated conditions of PBF-EB and PBF-LB after 334.6 and 868.2 m of cutting length

The tool wear propagation was analysed in the sub-surface after finishing and showed an increasing flank- and crater wear on clearance and rake side respectively on tools used for the as-built PBF-EB. For the as-built PBF-LB material, the tool flank wear was lower on the clearance side and the coating was worn on the rake side, but no crater development. Both variants showed a clear notch at cutting depth (see Fig. 3).

Tool wear mechanisms in heat-treated components were the same as in the as-built variants. The PBF-EB showed a similar wear mechanism in both conditions, while the PBF-LB had more flank wear in the heat-treated condition but with less wear on the rake side (see Fig. 3).

\*Insert suffered from chipping failure as seen in Fig. 3

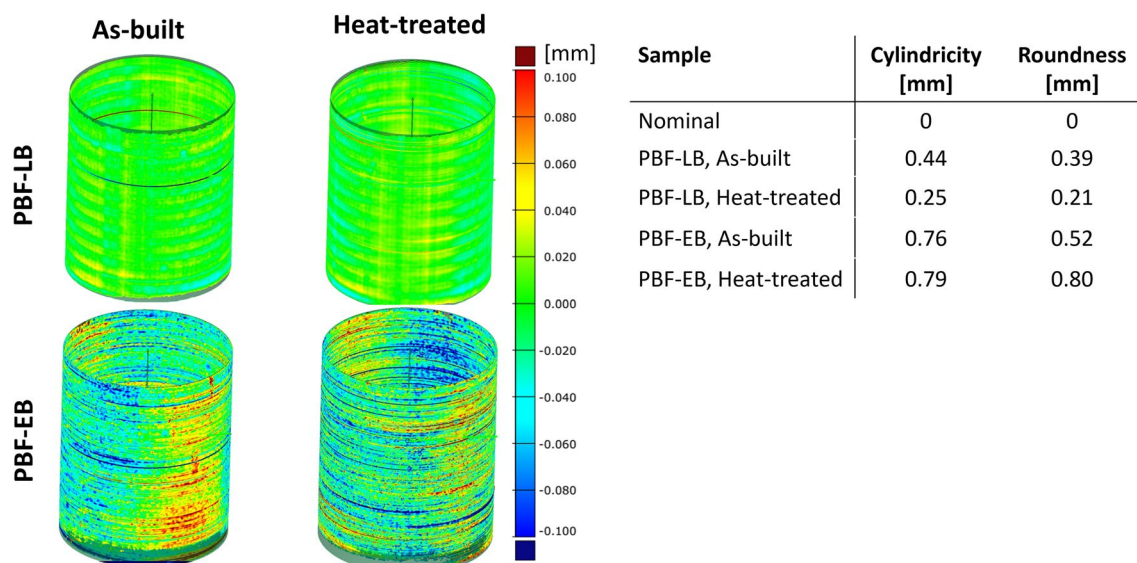
**Fig. 4** 3D scanning analysis in respect to a nominal cylinder showing the deviation, cylindricity and roundness of the PBF-LB and PBF-EB in as-built and heat-treated samples

To simplify the turning operation, rotational symmetric samples were produced for these cutting tests. However, due to the thermal heating and cooling in the printing process, the stress relief operation of the samples was distorted prior to the machining operation. The geometry was measured using 3D scanning and compared to the nominal CAD model as shown in Fig. 4. In general, the PBF-EB showed higher distortion for both conditions, the as-built and heat-treated, in comparison to the PBF-LB samples.

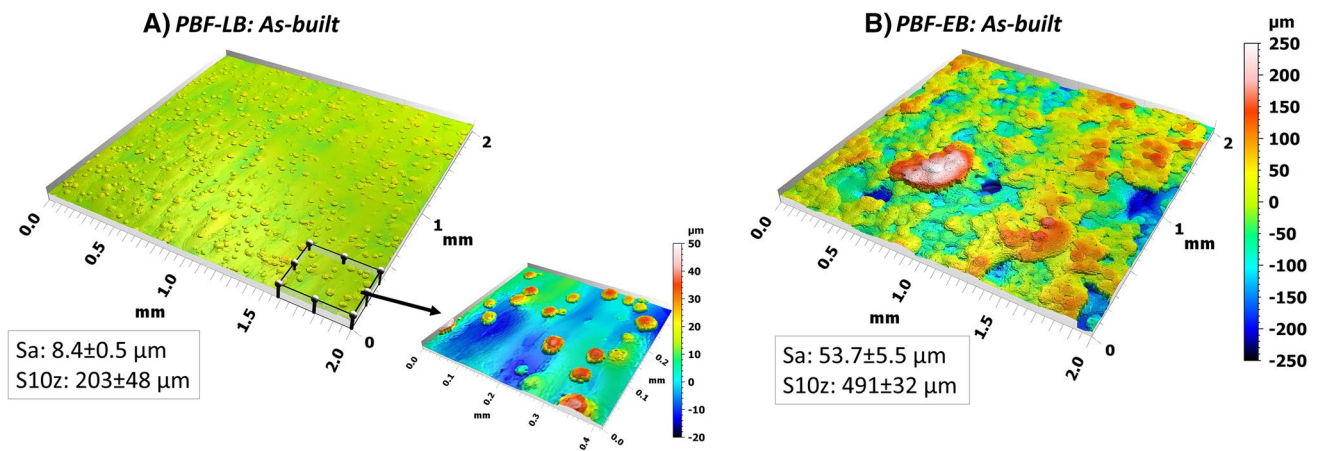
**Fig. 5** 3D topography maps of as-built PBF-LB (A) and PBF-EB (B) samples, before turning

The topography, represented as 3D maps, shows significant differences between as-built PBF-LB and PBF-EB material (as seen in Fig. 5). This difference is also seen in the  $S_a$  and  $S_{10z}$  parameters, which are mean values for three positions of each sample and standard deviations. The results show a 6 times higher  $S_a$  for PBF-EB,  $53.7\ \mu\text{m}$ , compared to the PBF-LB  $8.4\ \mu\text{m}$ . The corresponding  $S_{10z}$

values were 203  $\mu\text{m}$  for PBF-LB and 491  $\mu\text{m}$  for PBF-EB. In principle, this means that to completely remove asperities from the printing process, at least 200  $\mu\text{m}$  need to be removed from the PBF-LB surface and 500  $\mu\text{m}$  from the PBF-EB surface. Additionally, the  $S_a$  and  $S_{10z}$  values show a high variation between the three measurements, shown as a high standard deviation. The two surfaces also show different surface features where the PBF-LB surface has unmelted particles while the PBF-EB surface instead shows larger flake-shaped features with a size of 0.5–1

mm. The topography after heat treatment, not included in Fig. 5, has similar topography values.

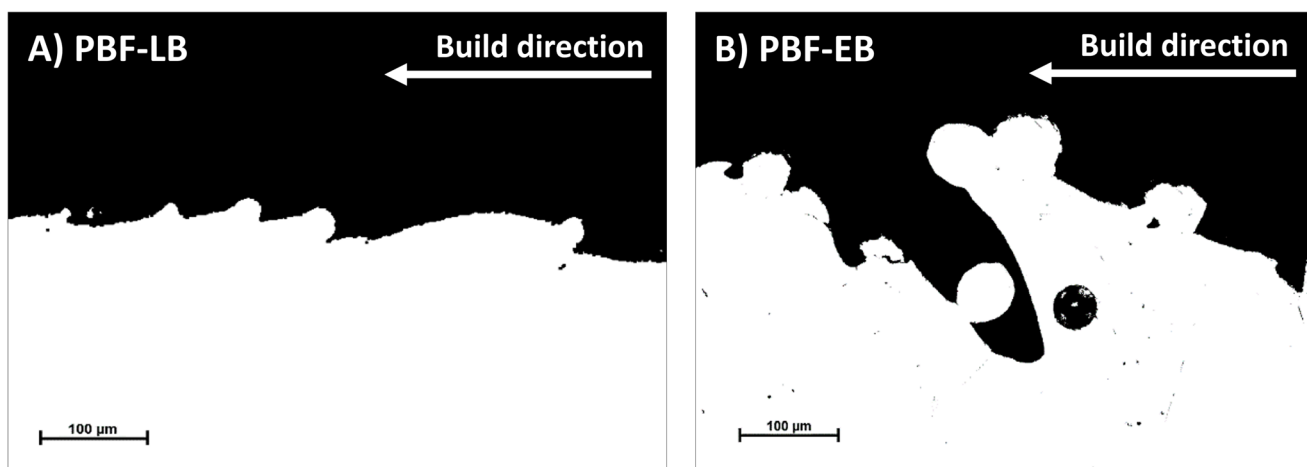
**Fig. 6** Wave like features on the as-built PBF-LB sample (A) and Surface notch features on the as-built PBF-EB sample (B)

The topography was also evaluated as profiles from the cross sections with apparent differences as can be seen in Fig. 6. The two exemplified sections of the as-built material show an outer section consisting of protrusions and partially melted powder particles and an inner section that is completely melted. Comparing the cross-section profiles from the PBF-EB and PBF-LB samples shows an apparent difference in roughness. The PBF-EB profiles show a peak and valley structure that is not present in the PBF-LB profiles. It is also observed re-entrant features, as defined by Triantaphyllou et al. [44], linked to the peak and valley structure for the EB-PBF material, one example of which can be seen in Fig. 6B, while much smaller features are seen in the PBF-LB profiles, Fig. 6A. The protruding roughness features of the PBF-LB surface have directionality that can be described as waves in the direction of

gravity within the build chamber. Such directionality is not observed in the PBF-EB profiles.

lack-of-fusion defects [46]. The PBF-EB surface notches, shown as a peak and valley structure, not observed in the PBF-LB profiles, are likely the result of incompletely filled layers as proposed by Chan et al. and Zhao et al. [6, 7]. One important feature linked to the peak and valley structure is re-entrant features. The PBF-LB profiles on the other hand showed protruding roughness have directionality that can be described as waves in the direction of gravity within the build chamber, which was not observed in the PBF-EB profiles. Such defects are especially dangerous since they have sharp corners perpendicular to the building direction that could act as stress concentration sites and could be hard to detect using non-destructive evaluation techniques [47]. Additionally, under load, it is primarily the outer section that is load carrying and any micro notches in this section will act as stress concentrators that can be detrimental to fatigue life [6]. Hence, post processing of such surface is required if it is to be used as a functional surface.

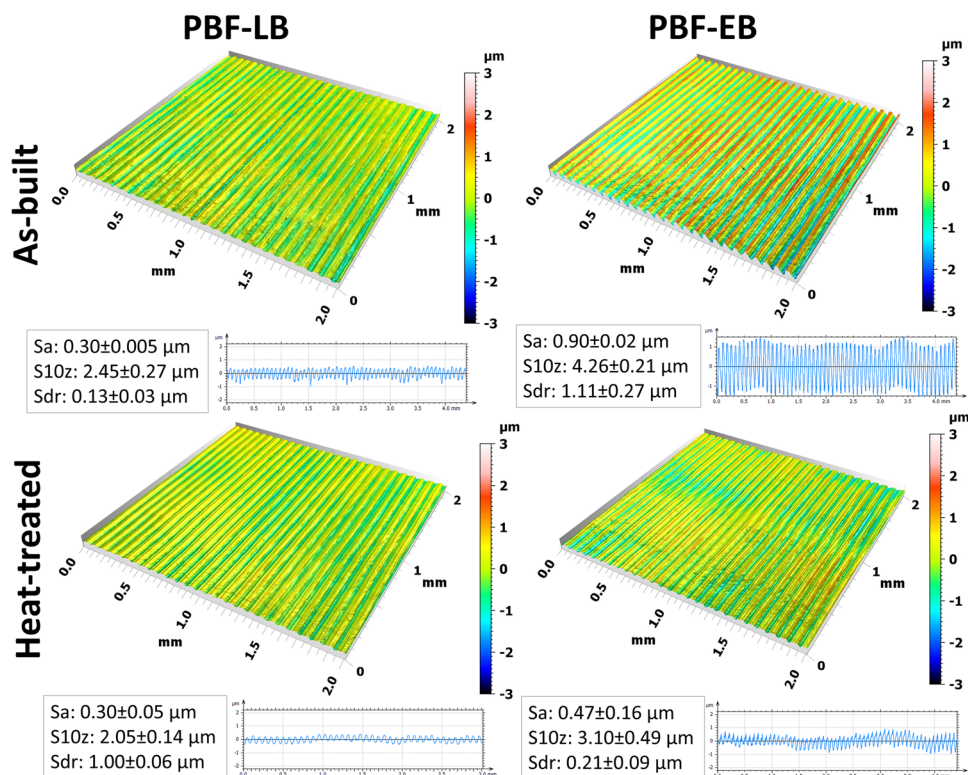
**Fig. 7** 3D topography images, profiles and topography parameters of PBF-LB and PBF-EB in different conditions after finish machining

The 3D topography maps and calculated topography parameters, presented as the mean values from three measurements including the standard deviation, after finish machining are seen in Fig. 7. The results show apparent feed grooves that are the main contributor to the surface roughness. The surface roughness represented by Sa is  $0.3 \mu\text{m}$  for the PBF-LVB in both conditions, while the PBF-EB has higher Sa values compared to PBF-LB, especially for the as-built condition. The higher Sa for the PBF-EB may be due to higher tool wear as the cutting edge becomes blunt, as observed in the tool wear results in Fig. 3. A similar trend is observed for the S10z value. The Sdr parameter shows slightly higher values for PBF-LB in heat-treated condition and the PBF-EB in as-built condition, which implies more texture in the feed grooves for these surfaces. Additionally, in the lower right of each

condition, the mean of ten profiles is shown. This shows the difference in topography as well in terms of the depth and shape of the feed grooves. For PBF-EB, the feed grooves are deeper in as-built condition compared to the heat-treated condition. The heat-treated condition further shows that the amplitude varies. The PBF-LB samples have a much lower feed groove amplitude, and the shape of the peaks is rounder, creating more of a sinusoidal shape compared to the PBF-EB peaks that are irregular. A long

waviness is observed for all samples which most likely are connected to vibrations induced during machining.

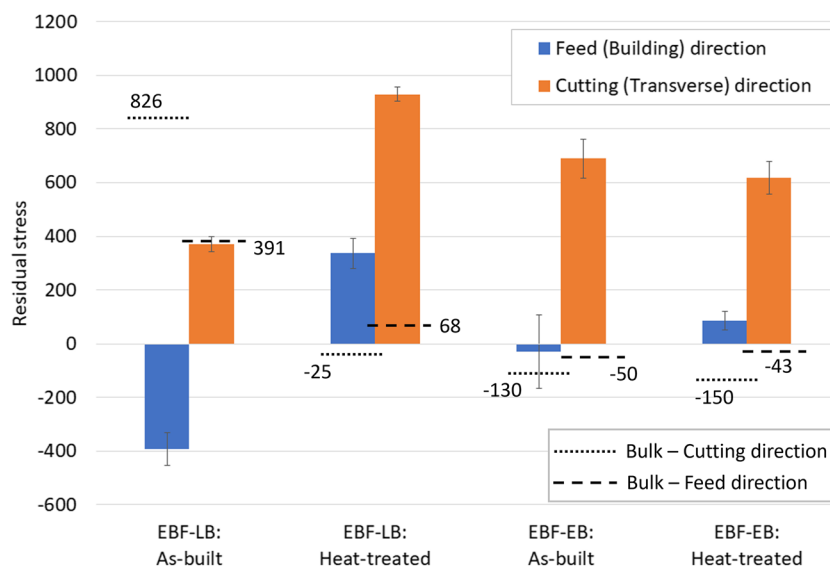
**Fig. 8** Mean surface residual stresses for measurements after machining for PBF-LB and PBF-EB in as-built and heat-treated condition

direction of the samples, and the error bars represent the standard deviation for the three measurements. The dashed lines show the bulk stresses measured at a depth of 0.3 mm below the surface prior to the cutting test.

The surface residual stresses after the finish cut in the PBF-LB and EBP-EB samples in as-built and heat-treated condition are shown in Fig. 8. The results are the mean values for three measurement positions along the building

In general, the results show that turning has induced a significantly different stress condition in the samples related to the two directions, feed and cutting direction. For the as-built PBF-LB material, a moderate compressive stress is introduced in the feed (build) direction and tensile stress in the cutting direction, with a similar magnitude as the bulk prior to machining. A significant change of stresses is observed for the heat-treated material, which shows tensile stresses in both directions ranging up to 900–1000 MPa in cutting direction and a moderate tensile stress of 300–400 MPa in feed direction. In relation to the different positions, a minor difference could be seen in Fig. 8 represented by the error bars.

The corresponding surface residual stresses after machining of the PBF-EB material are low compressive stress in feed direction and high tensile stress in cutting direction for the as-built material. The heat-treated material shows low tensile stresses in feed direction and high tensile stress in cutting direction. In relation to the different positions, a greater difference is observed for the PBF-EB material as shown by the error bars. For all samples, the variation around the sample were measured showing that the stresses could vary up to 140 MPa.

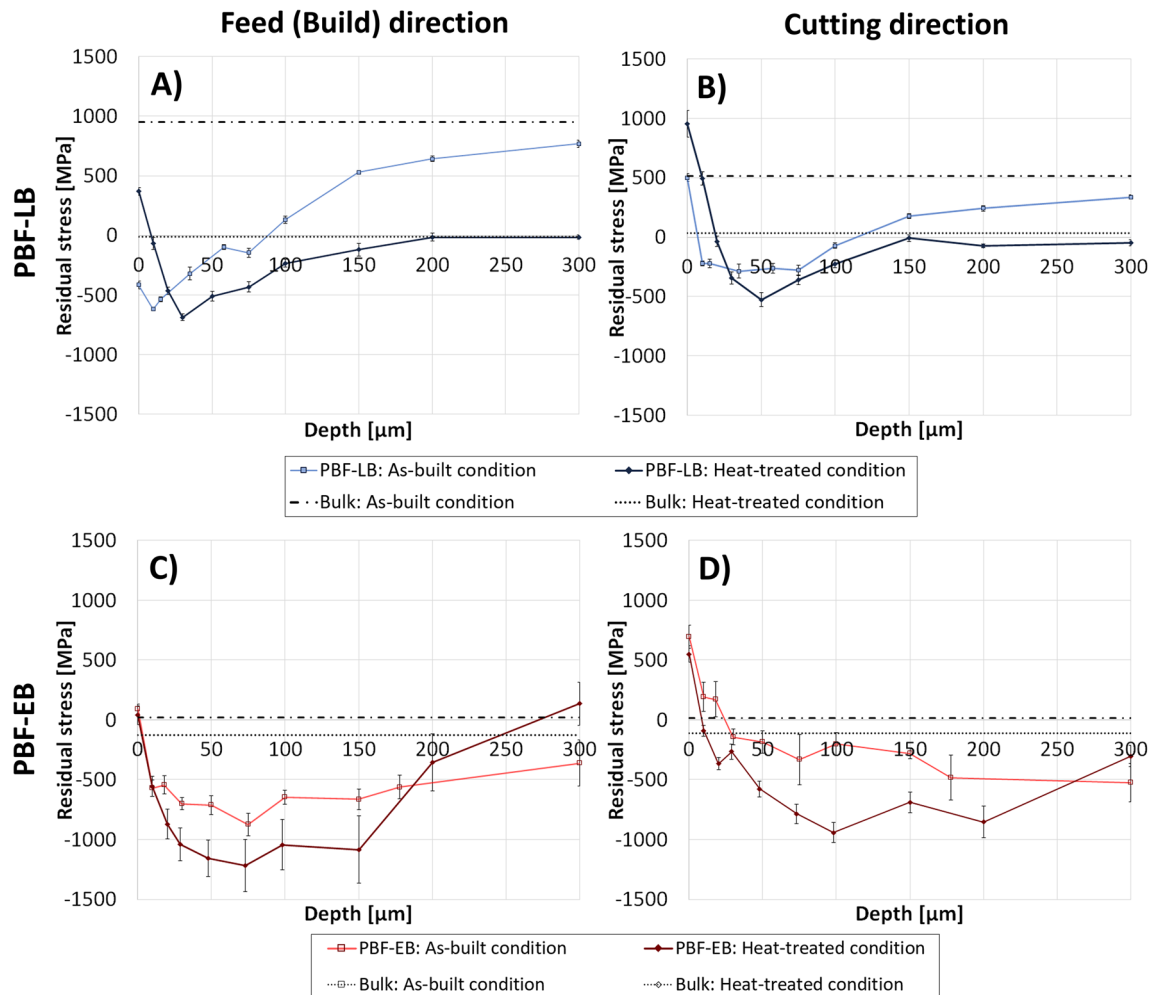
**Fig. 9** Residual stress profiles after turning for as-built and heat-treated conditions of PBF-LB in feed direction (A), PBF-LB in cutting direction (B), PBF-EB in feed direction (C) and PBF-EB in cutting direction (D)

The residual stress profiles for the PBF-LB and PBF-EB after turning are shown in Fig. 9. The dashed lines show bulk values measured prior to the machining operation, in the as-built and heat-treated conditions. The turning test of the PBF-LB as-built material shows a great difference between the feed and cutting direction. The cutting direction shows a superficial tensile stress that drastically drops to a

compressive stress below the surface. For both directions, a compressive zone is shown, which extends deeper for the cutting direction. At greater depth, both directions gradually become tensile, until the bulk stress condition is reached at 300  $\mu\text{m}$ . Turning of PBF-LB in heat-treated condition induced high tensile stresses in the surface for both directions. The tensile stresses go into compressive stress at a depth of 10–30  $\mu\text{m}$  followed by a deep compressive stress zone. The total impact depth, i.e. the depth where the bulk stresses are reached, is however lower compared to the as-built sample with an impact 150–200  $\mu\text{m}$  deep.

The residual stress profiles after turning for the PBF-EB samples in as-built and heat-treated condition are shown in Fig. 9. Generally, close to the surface, it could be observed similar results, but at greater depths, the heat-treated condition has a deeper compressive stress compared to the as-built condition. It is further seen a greater variation in each measured position in the profile, seen in the error bars, which can be connected to large grains and texture

in these samples. For the as-built sample, both directions have tensile surface stresses that change into compressive ones below the surface at a depth of 10–30  $\mu\text{m}$ . The feed direction has a deep compressive zone, and at a depth of 300  $\mu\text{m}$ , the bulk stresses are reached. However, there is a great variation in stresses at this depth for the two directions. The total affected depth is not completely covered for these measurements and is located deeper than 300  $\mu\text{m}$ . Similarly, to the PBF-LB, machining of the heat-treated samples shows smoother-shaped profiles characterized by tensile stress, rather high in tangential direction. Below the surface, the stresses change into high compressive stresses with a maximum depth of 100–200  $\mu\text{m}$ . It is further observed a deeper impact with greater magnitudes compared to the as-printed profiles. The total impact depth is not completely covered in these measurements, but is in the range of 200–350  $\mu\text{m}$  in feed direction and greater than 300  $\mu\text{m}$  in cutting direction. It is shown that stresses differ greatly at depths greater than 150  $\mu\text{m}$ .

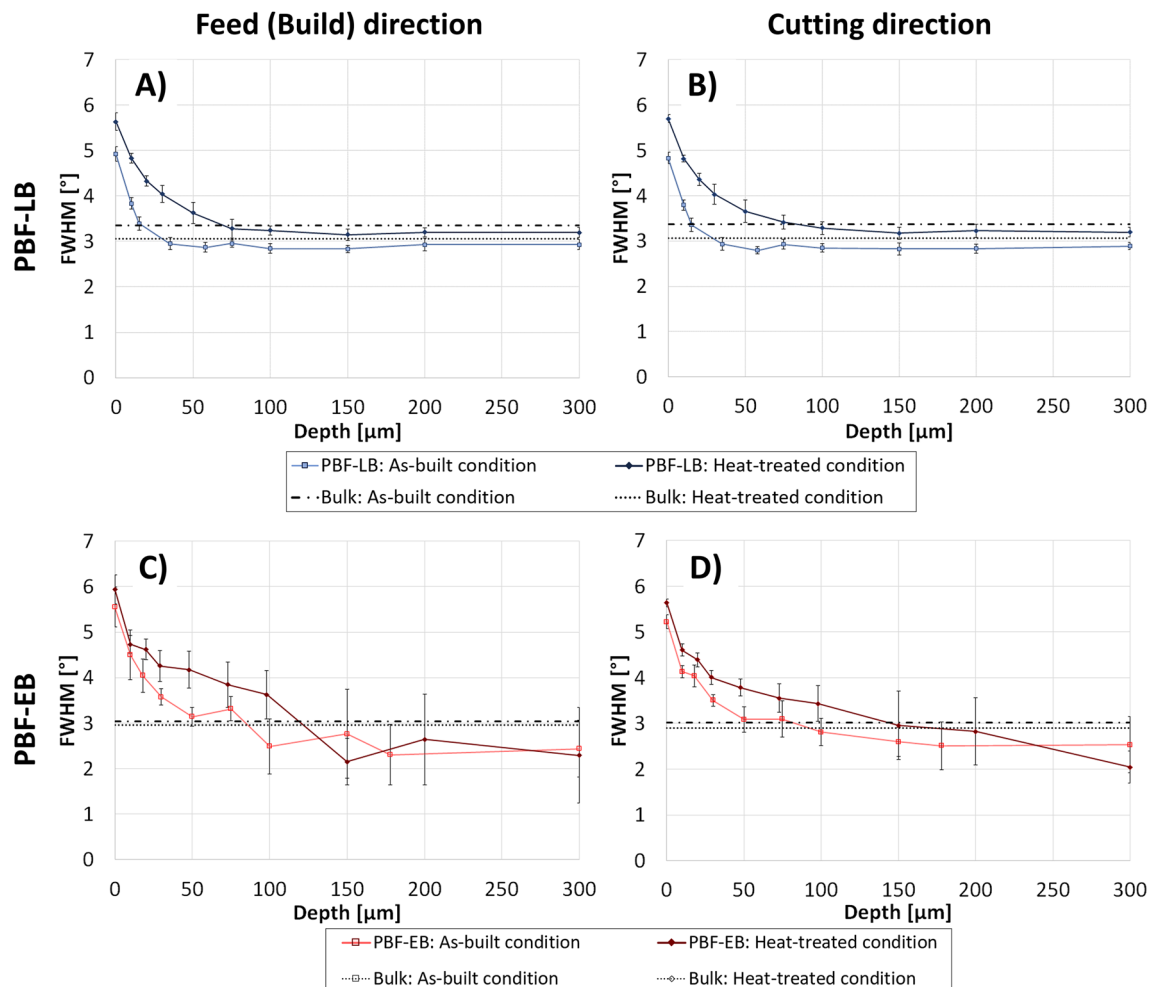
**Fig. 10** Full Width Half Maximum (FWHM) profiles after turning for as-built and heat-treated conditions of PBF-LB in feed direction (A), PBF-LB in cutting direction (B), PBF-EB in feed direction (C) and PBF-EB in cutting direction (D)

The machining-induced deformation could be evaluated from the diffraction peak broadening. In Fig. 10, the connected Full Width Half Maximum profiles are shown for the PBF-LB and PBF-EB samples in the two conditions. The dashed lines show the values from prior to the machining operation. The results show a significant difference between the two materials and also between the two conditions. The profiles for PBF-LB are smoother and show a low penetration depth of 25  $\mu\text{m}$ , while the heat-treated condition is 75–100  $\mu\text{m}$  deep. The surface deformation is also lower for the as-built condition. The PBF-EB shows much greater variation in the profiles and a much smaller difference in the surface deformation. The penetration depth is difficult to precisely define as the profiles vary, but it is shown that the as-built material is typically around 75–100  $\mu\text{m}$ , while the heat-treated condition shows a penetration depth of 125–150  $\mu\text{m}$ .

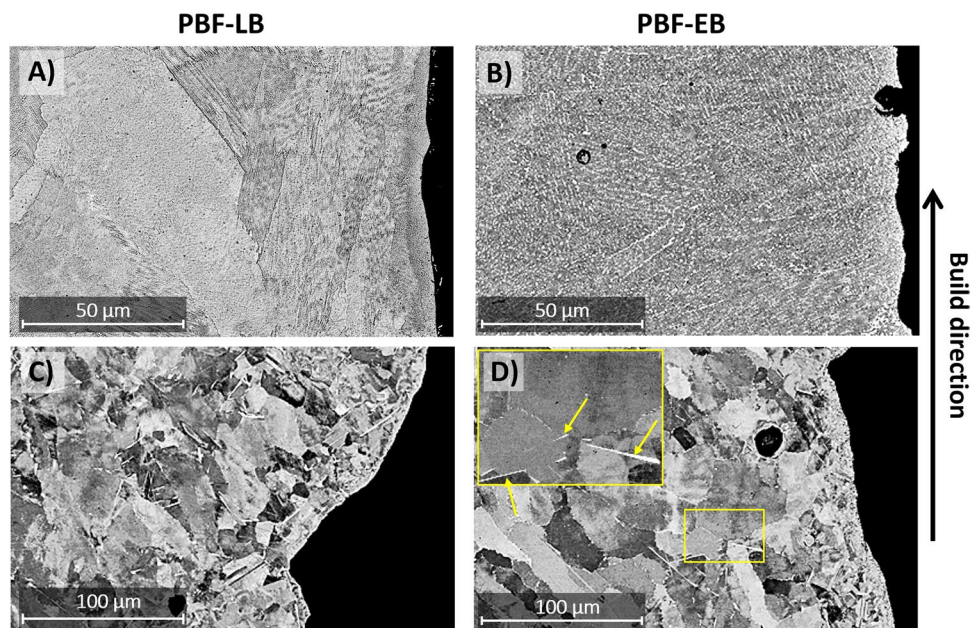
**Fig. 11** Microstructure of the samples of PBF-LB: As-built (A), PBF-LB: Heat treated (B), PBF-EB: As-built (C) and PBF-EB: Heat treated (D), delta-phase indicated by yellow arrows

The as-built and heat-treated microstructures were analysed in detail using Scanning electron microscopy (SEM). As shown in Fig. 11, the PBF-LB material has larger grains from the core of the specimen to the surface, whereas the PBF-EB materials contained smaller grains, especially close to the surface.

The LB-PBF material in Fig. 11A shows precipitates in the grain boundaries after printing, but no delta phase is evident. After heat-treatment of the PBF-LB material, more precipitates can be observed along the grain boundaries as shown in Fig. 11B. In contrast to the PBF-LB samples, the PBF-EB has a clearly visible printed contour with a thickness of 300–600  $\mu\text{m}$ . This is observed as a zone with

comparably smaller and almost equiaxed grains compared to the much larger grains elongated in the build direction in the core, not included in Fig. 11. Strain in the grains (in the PBF-EB images) is evidenced by different shades of grey within the grains. Delta phase is present, evident as large white needle-like precipitates in the grain boundaries, especially in the as-built material in Fig. 11A. After heat-treatment, the grain boundaries are increasingly more decorated with precipitates. Some strain has been relieved, and the delta phase is still present and observed as high contrasts within the grains in these micrographs.

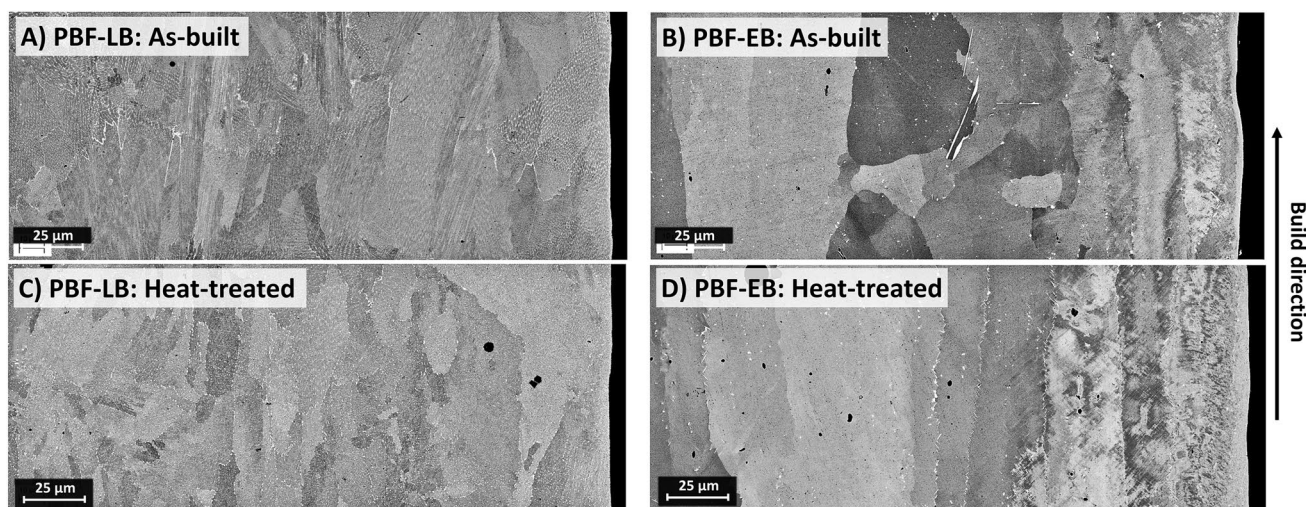
**Fig. 12** Microstructure after turning for PBF-LB as-built (A), PBF-EB as-built (B), PBF-LB heat-treated (C) and PBF-EB heat-treated (D). The cut surface is on the right side of each image, and the cutting direction is perpendicular to the image plane

The impact from the turning on the microstructure is shown in Fig. 12 for PBF-LB and PBF-EB. The deformation induced in the PBF-LB sample is low, no superficial deformed layer is shown in Fig. 12, and the precipitates decorating the grain boundaries are intact and still in place all the way to the surface. After finishing the PBF-EB material, where the printed contour is completely removed, the cut surface shows both strained grains, evidenced by shades of grey within grains, to a depth of about 40  $\mu\text{m}$  and a superficial layer with grain refinement. The superficial layer is very distinct and about 2  $\mu\text{m}$  thick when cutting in the as-printed material and less distinct up to 10  $\mu\text{m}$  thick when cutting in the heat-treated material.

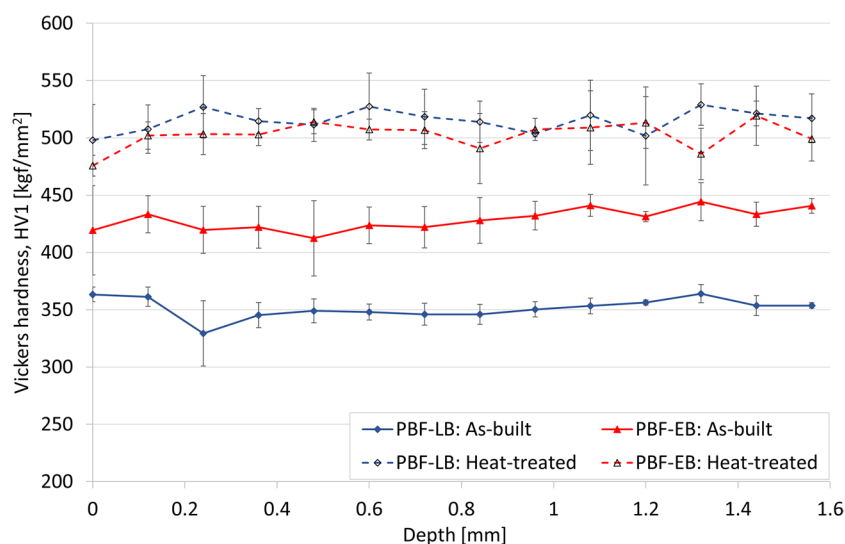
**Fig. 13** Hardness profiles for PBF-LB and PBF-EB samples in as-built and heat-treated condition

The mean hardness profiles for the as-built and heat-treated conditions from measurements at different positions

along the building direction of the samples are shown in Fig. 13. The error bars represent the standard deviation for the three positions. The results indicate a significant difference between the PBF-LB and the PBF-EB in the as-printed condition, whereas after heat-treatment, they possess comparable hardness values. In the as-built condition, the PBF-EB material exhibits higher hardness compared to the PBF-LB.

rake face. This may be explained by the large hardness increase from the heat treatment of PBF-LB as explained by Neikter et al. [49]. The hardness difference, as seen in Fig. 13, is a direct result of the grain size, amount and distribution of the precipitates, which clearly are different between the studied materials (before and after heat-treatment). The tool wear and consequently the work piece surface integrity will significantly be affected by the heat-treatment and thereof affecting the tool wear. This has previously been observed by Malakizadi et al. [21].

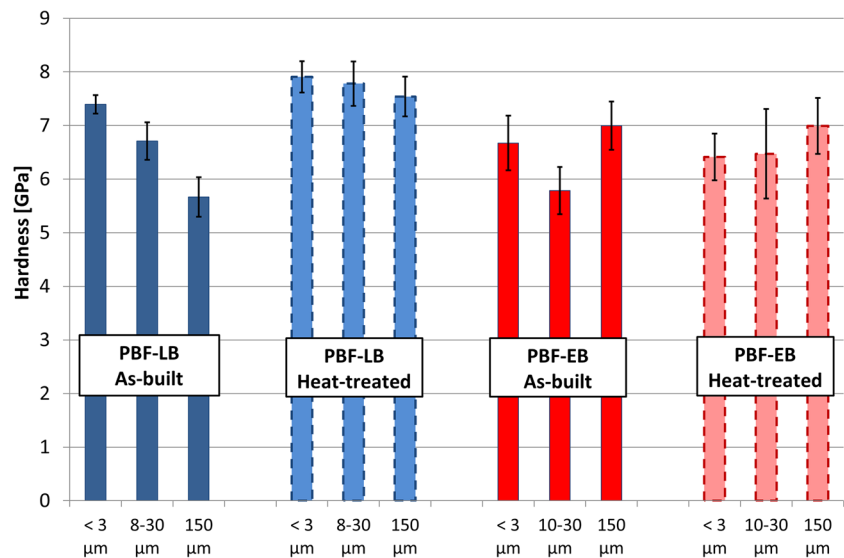
**Fig. 14** Hardness measured using nanoindentation in three regions: in a surface region with possible transformed material (1–3  $\mu\text{m}$ ), in a region deeper than any transformed layer (8–30  $\mu\text{m}$ ) and deeper than any deformed layer (at 150  $\mu\text{m}$ )

Nanoindentation was used to measure the hardness of superficial regions with the results as seen in Fig. 14. As both PBF-EB materials showed transformed superficial regions a few microns thick, the first region to be measured (on all samples) was at depths between 1 and 3  $\mu\text{m}$ . A heavily deformed region was found on the PBF-EB samples, so the second region measured on all samples was at depths between 8 and 30  $\mu\text{m}$  to capture any such region. In

addition to these two regions, the hardness at a depth of 150  $\mu\text{m}$  below the surface was measured. All measurements were made with a Berkovich tip and a target depth of 100 nm. All positions were confirmed, and every depth below the surface was measured in a microscope after the experiments. The values are different, but the order of the samples as measured in the deepest region corresponds to the order of the bulk Vickers hardness measurements shown in Fig. 13. It should be noted that the grain size is only slightly larger than the depth of these regions, which means the hardness levels may be influenced by differences in individual grains.

The measurements of the PBF-LB in as-built confirm that the cutting caused a significant increase in the hardness of this material, both in the outermost surface and in the intermediate region below that. In contrast, the heat-treated PBF-LB material which has a higher starting hardness has only a slight tendency to increase in hardness due to cutting. The two PBF-EB materials, as-built and heat-treated, seem to be harder in the deep region rather than in the surface region, and only the as-built material shows a tendency to have an increase in the very outermost region.
